# Inspection Photos

API: 071-09838

Operator: WAPITI OPERATING LLC

Inspection Date: 3/29/2022

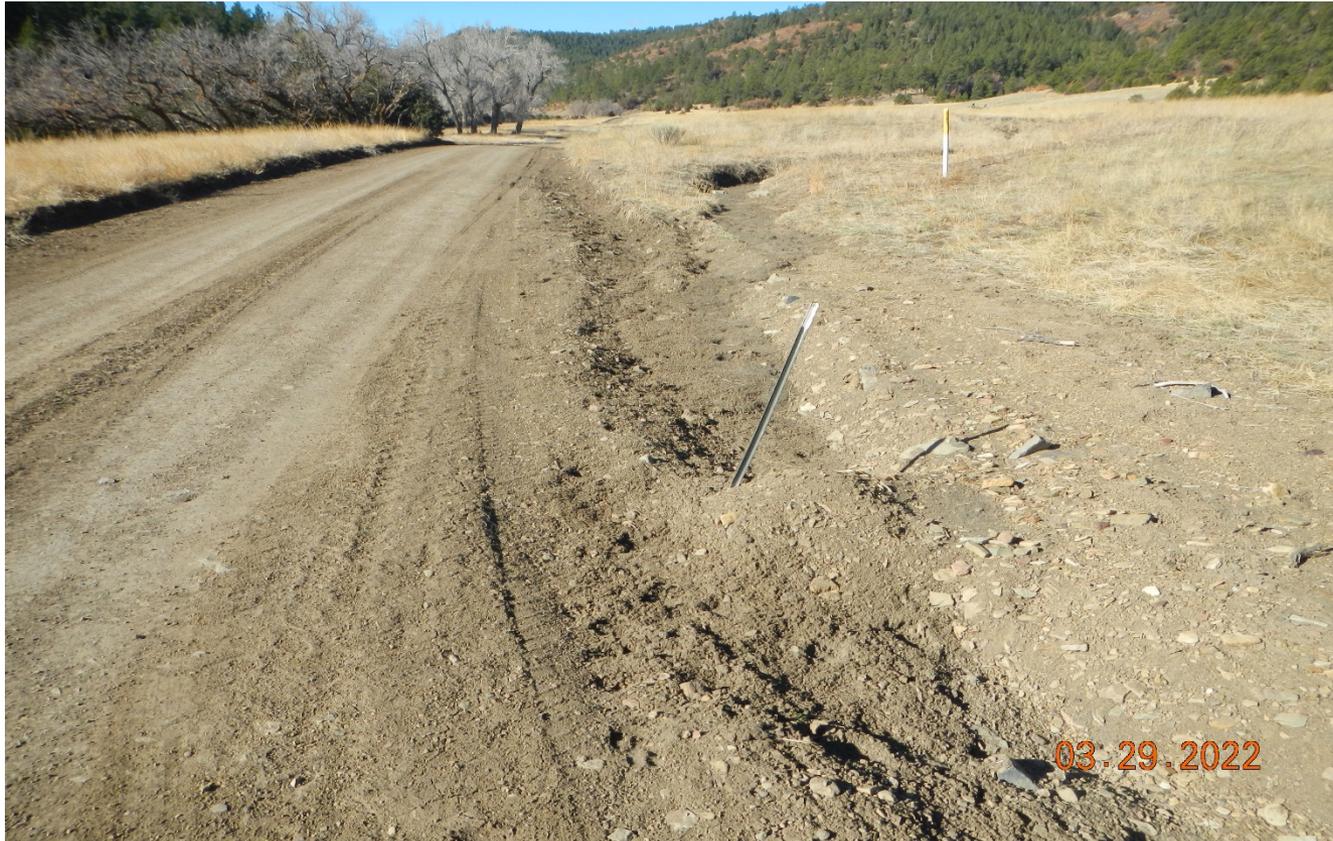
**Photo 1.** Facing southwest along the main road near the well site. Stormwater has washed across the road causing erosion. The culvert is filled in with sediment and has not been repaired. Previous corrective action not completed.

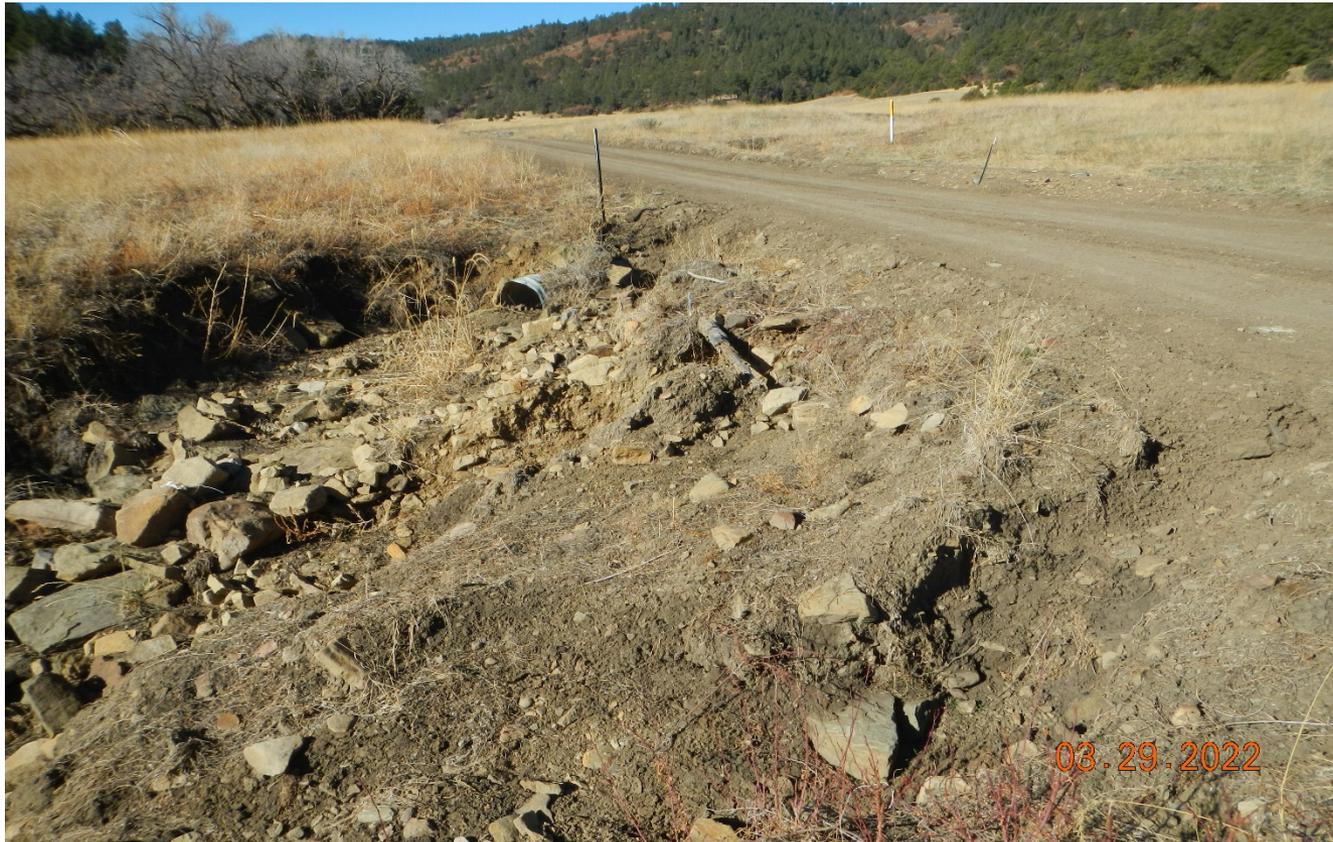
**Photo 2.** The culvert outlet is eroded and has not been repaired. No culvert outlet protection installed. Previous corrective action not completed.

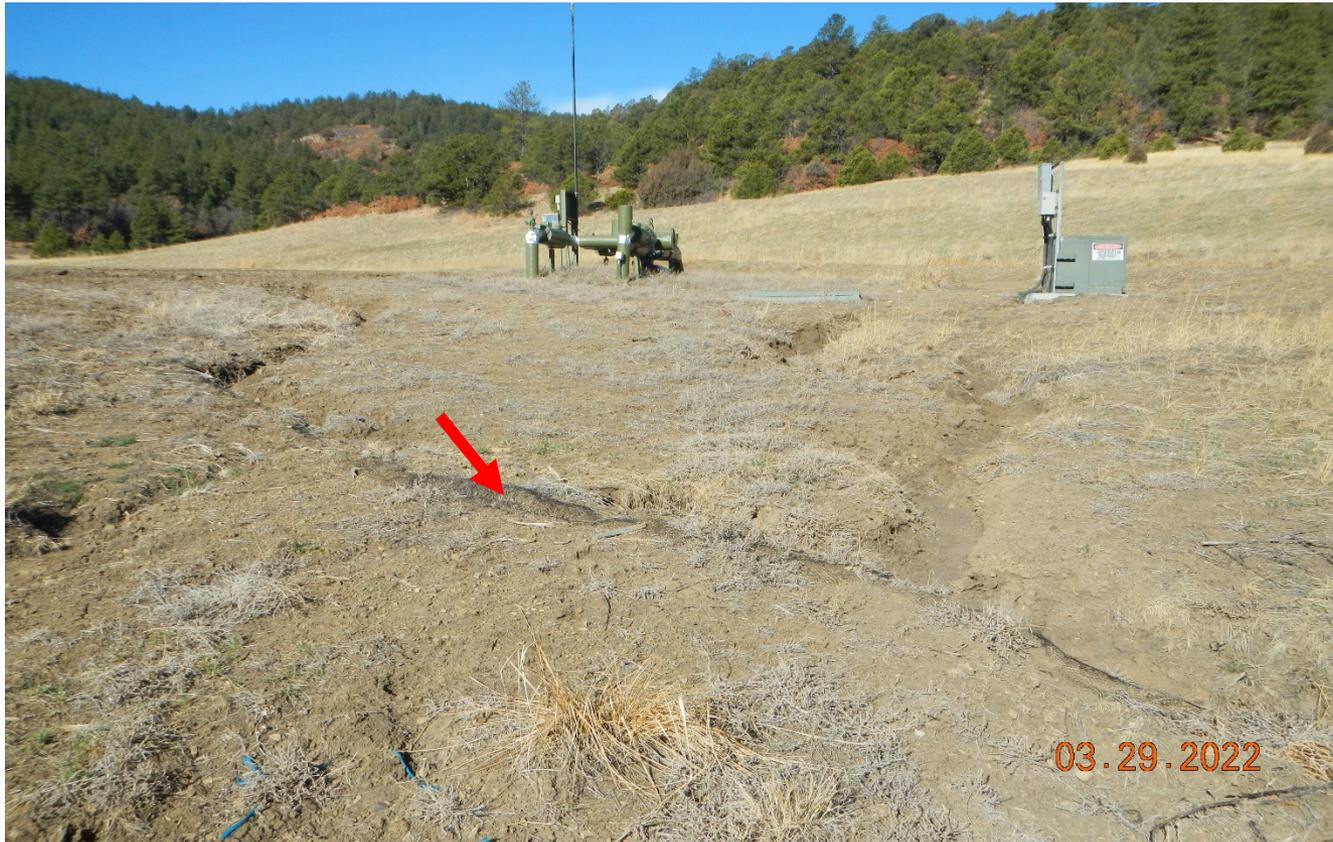
**Photo 3.** Facing toward the northeast side of the location. This area is not stabilized and there is an erosion. The wattles are degraded shown at red arrow. Previous corrective action not completed.

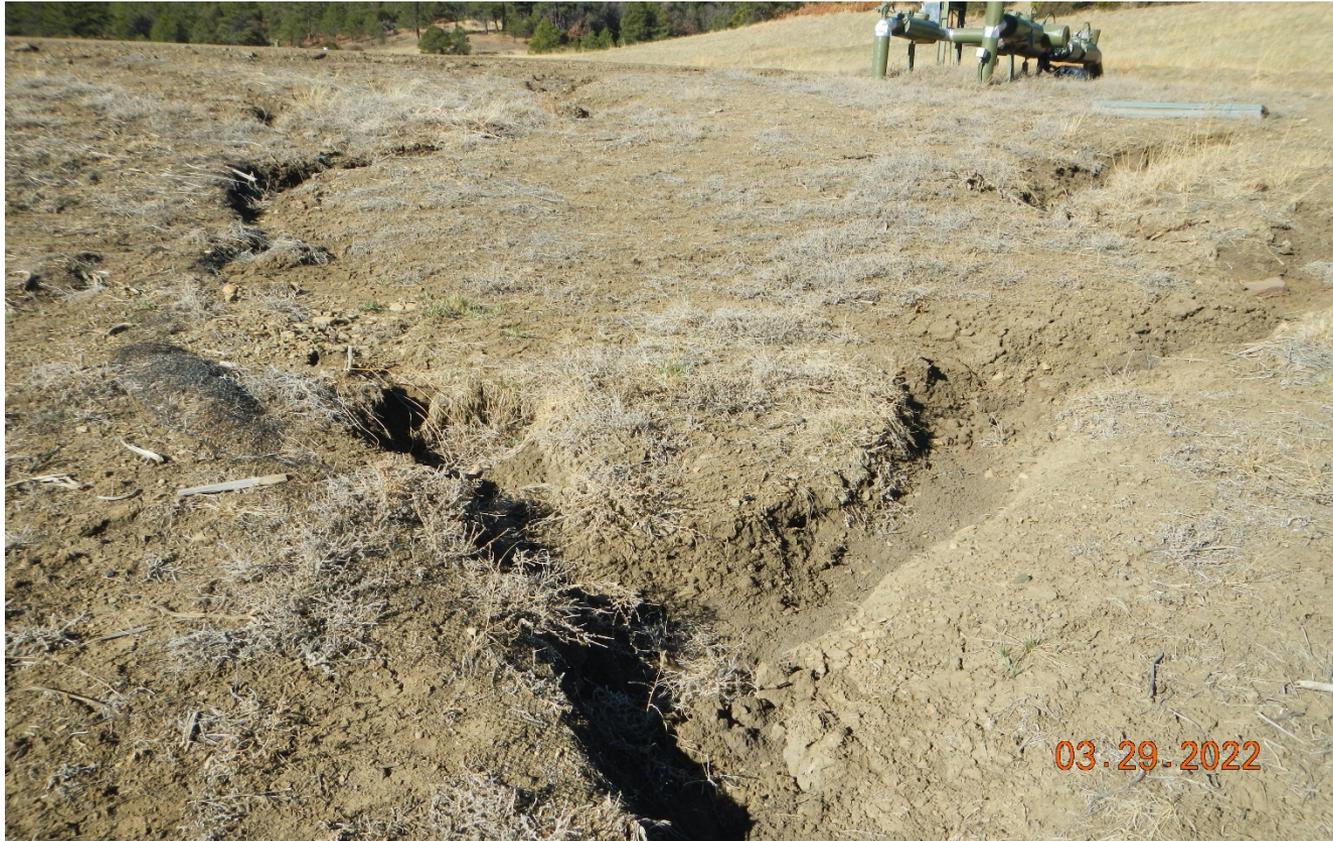
**Photo 4.** Facing toward the northeast side of the location. This area is not stabilized and there is an erosion channel that will need to be repaired. Previous corrective action not completed.
