Inspection Photos

API: 071-08769

Operator: WAPITI OPERATING LLC

Inspection Date: 3/29/2022

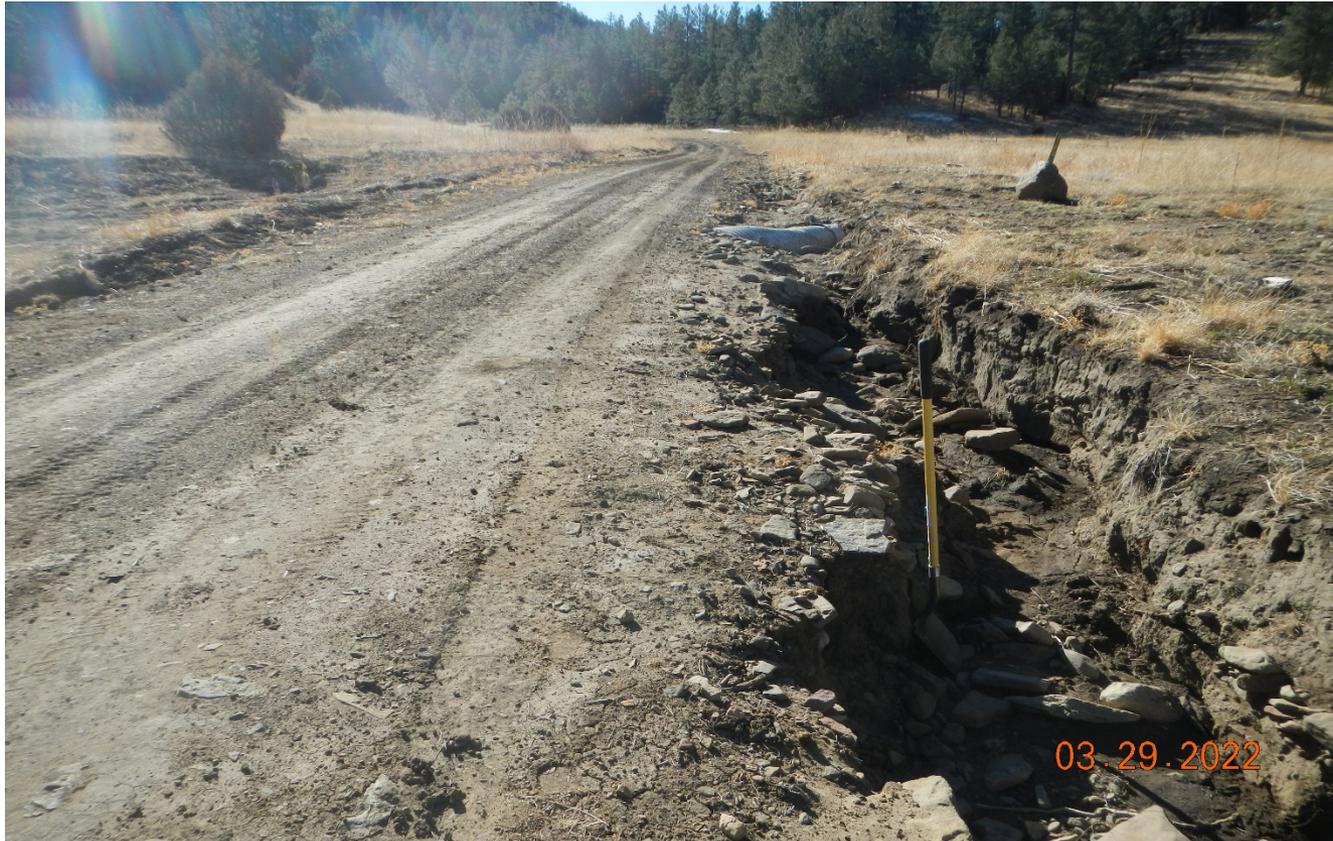
Photo 1. Facing southeast along the main road at the upper part of Lorencito Canyon. There is erosion along the road from recent storm event. Stormwater is bypassing the culvert. Previous corrective action was not completed.

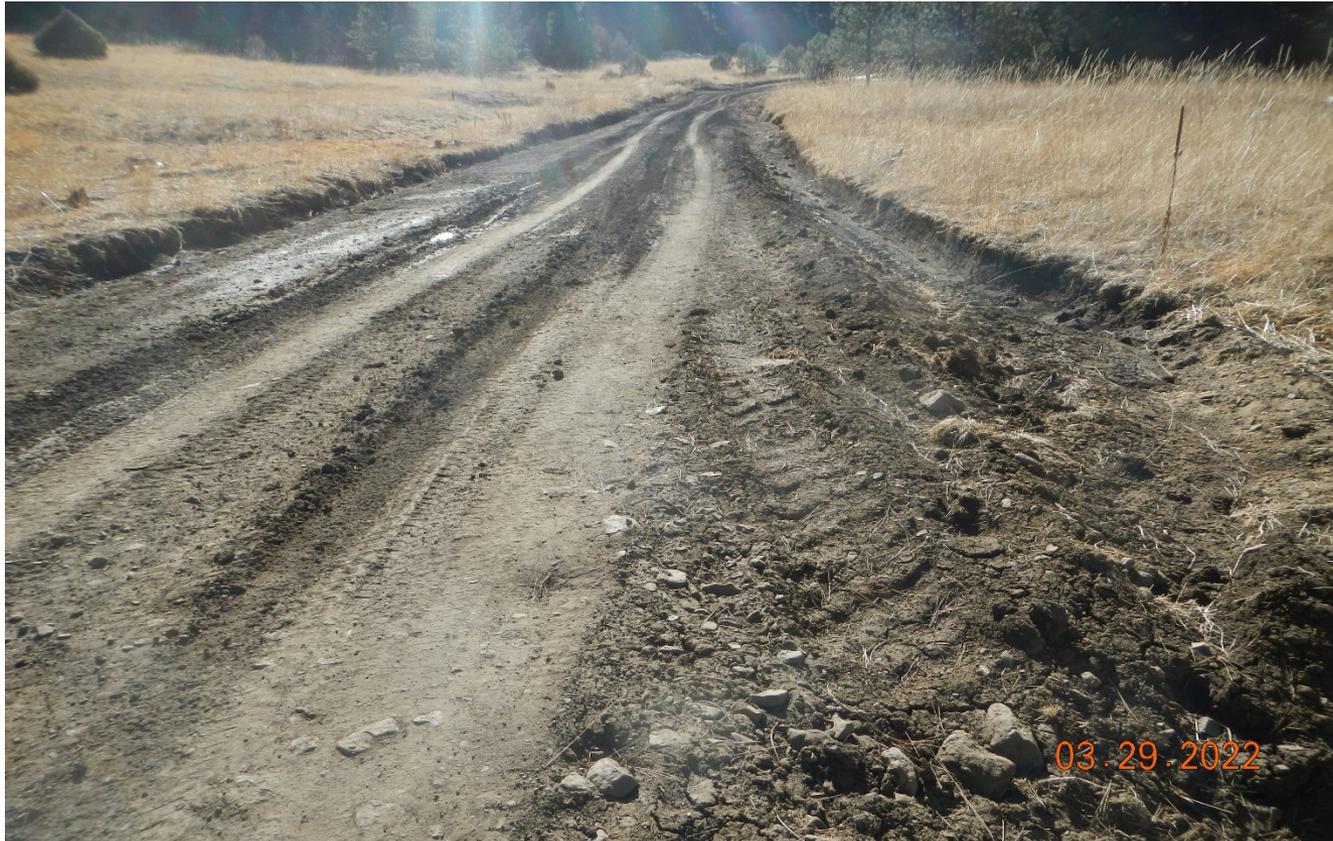
Photo 2. The culvert along the road is filled in with sediment causing stormwater to flow down the side of the road. Lat/Long:37.00499,-104.83742. Previous corrective action was not completed.

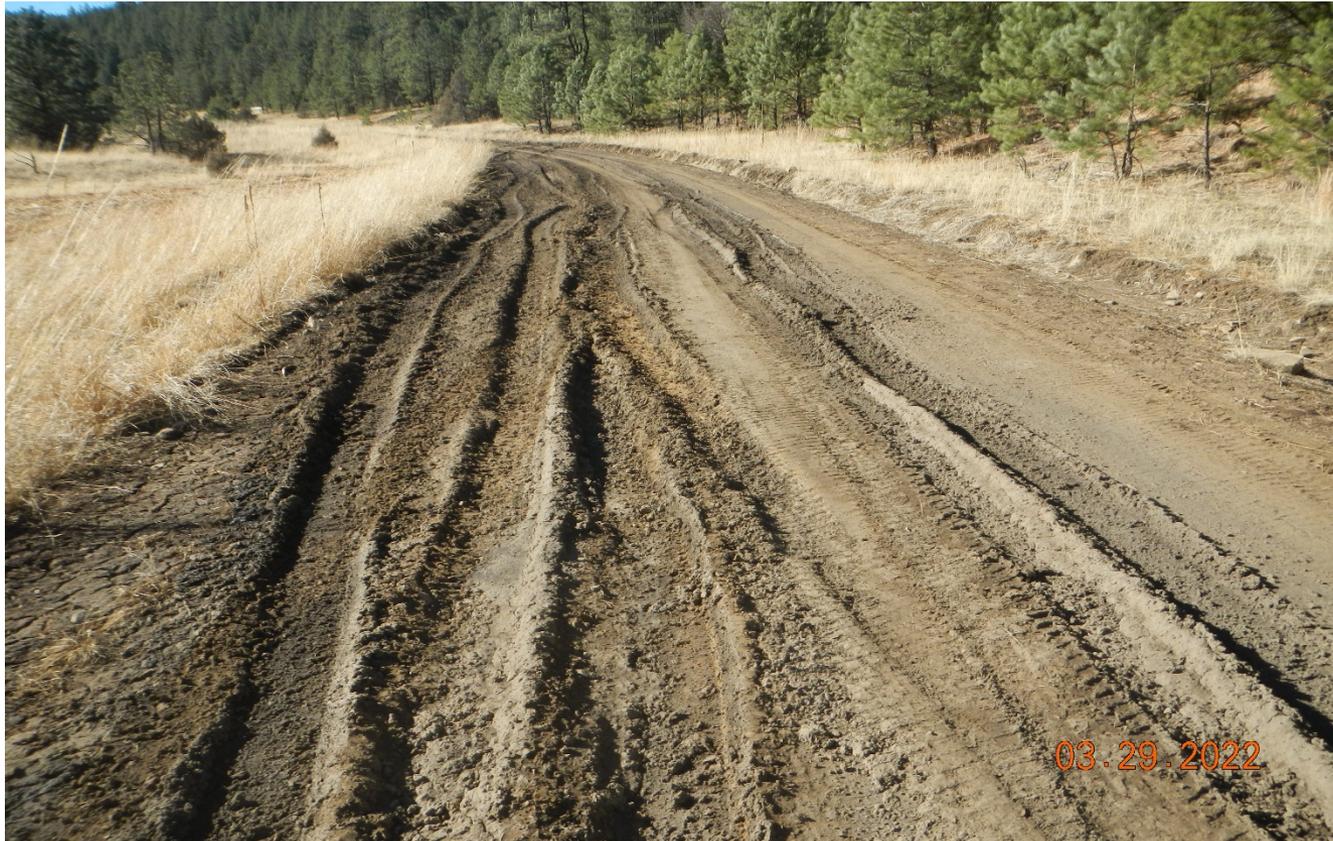
Photo 3. The road along the canyon is not stabilized and there is rutting and vehicle tracking occurring. The road needs to be repaired and stabilized.

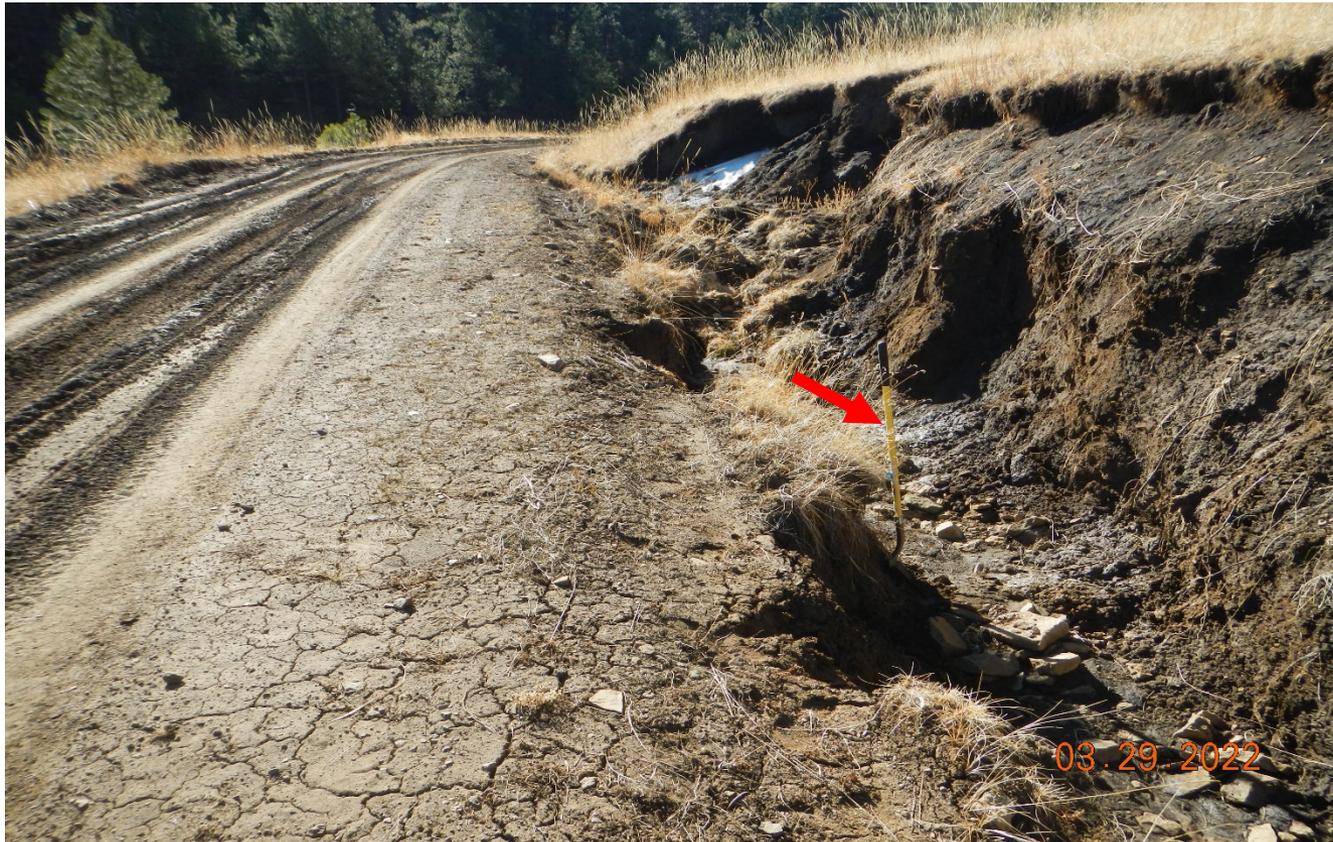
Photo 5. The side of the road is eroded and is not stabilized at Lat/Long:36.99952,-104.83425. This area or erosion needs to be repaired and stabilized. Previous corrective action not completed. Red arrow points to 4.5 ft. shovel.

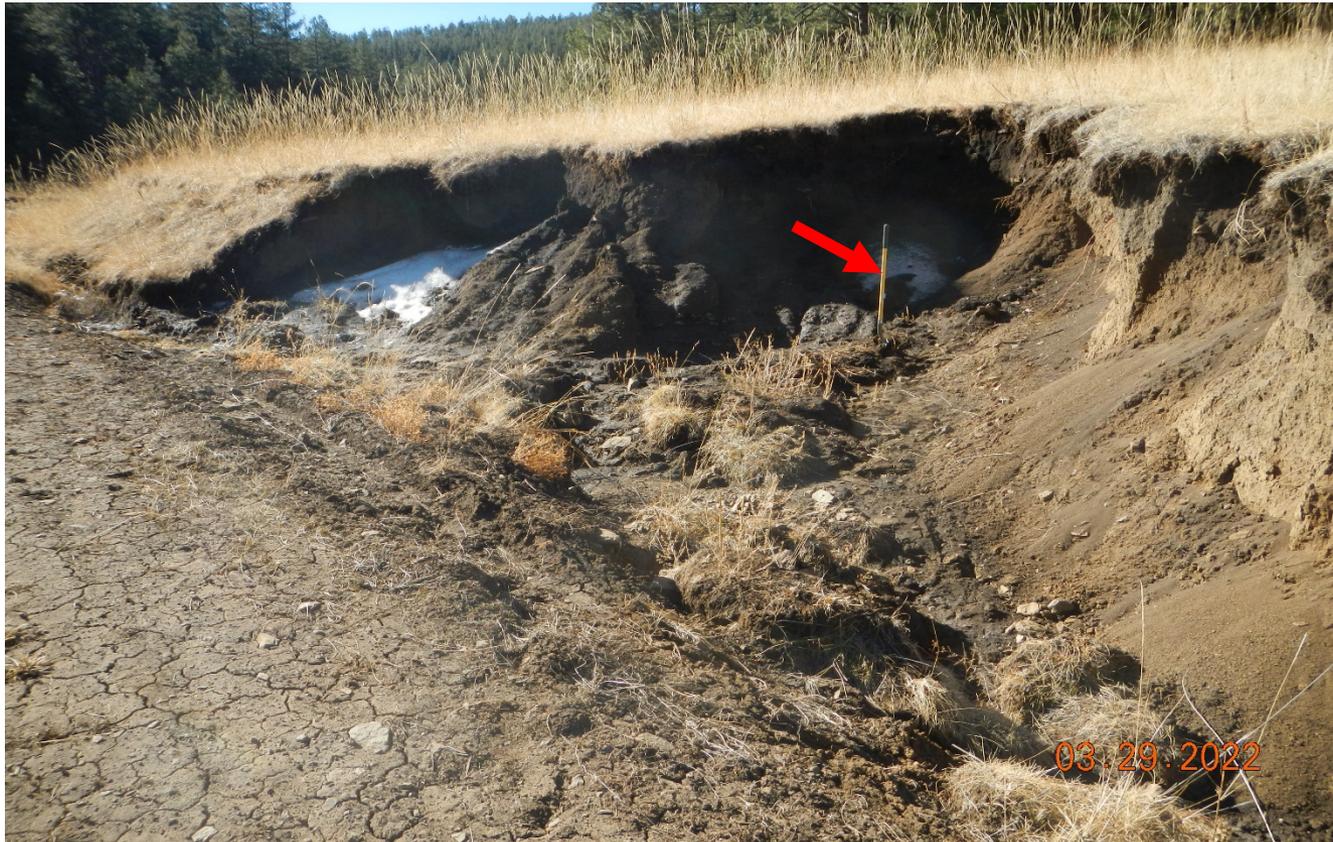
Photo 6. The side of the road is eroded and not stabilized at Lat/Long:36.99952,-104.83425. Erosion head cutting is continuing to occur further back. This area needs to be repaired and stabilized. Previous corrective action not completed. Red arrow points to 4.5 ft. shovel.

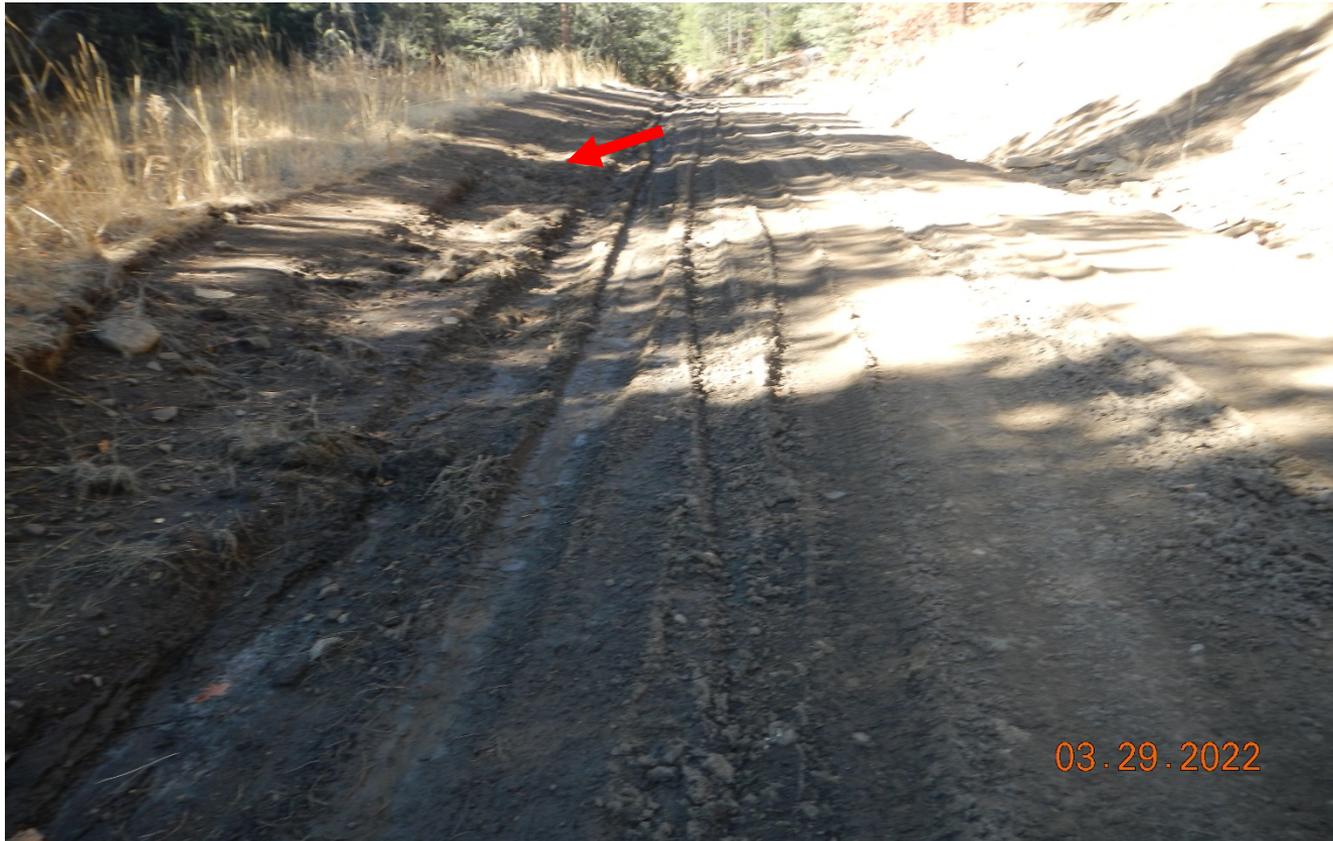
Photo 7. There was grading performed along the road. The disturbance along the side of the road shown at red arrow needs to be seeded and reclaimed. Previous corrective action not completed.

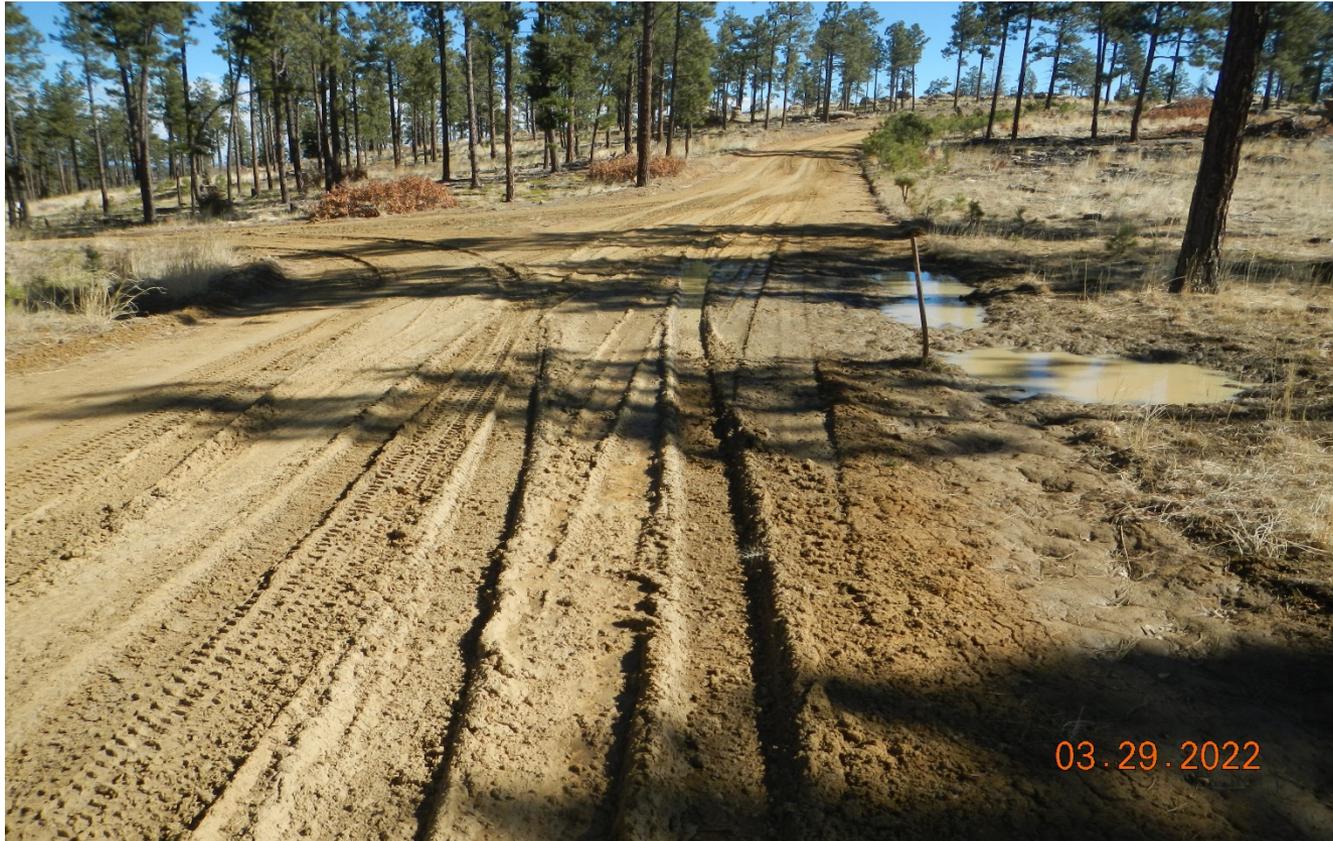
Photo 8. The culvert along the road is filled in with sediment at Lat/Long:36.99405,-104.84710.
