Inspection Photos

Location Name: TEP ROCKY MOUNTAIN LLC PA-66S95W /28SESE

Location ID: 335356

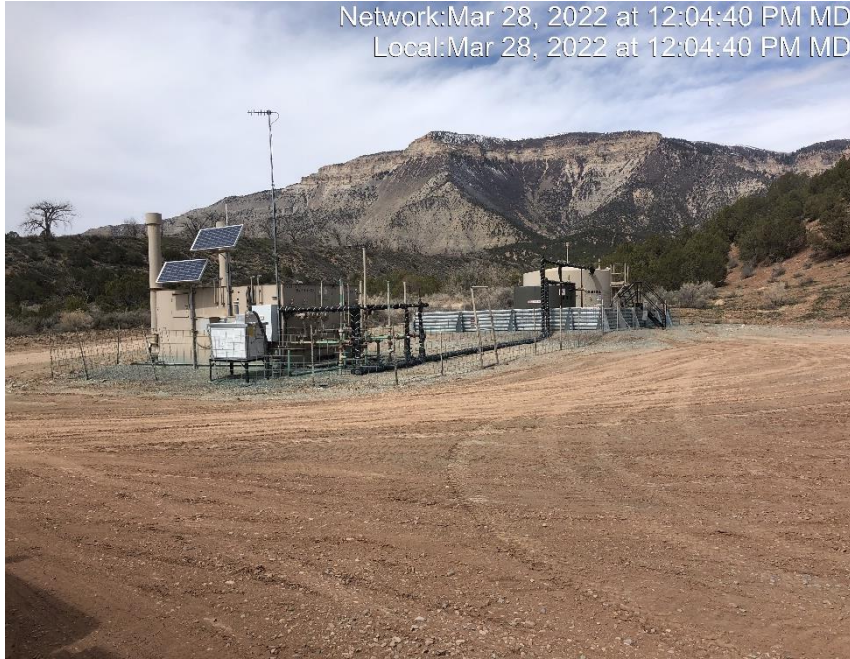
Photo #6312 from entrance to location.

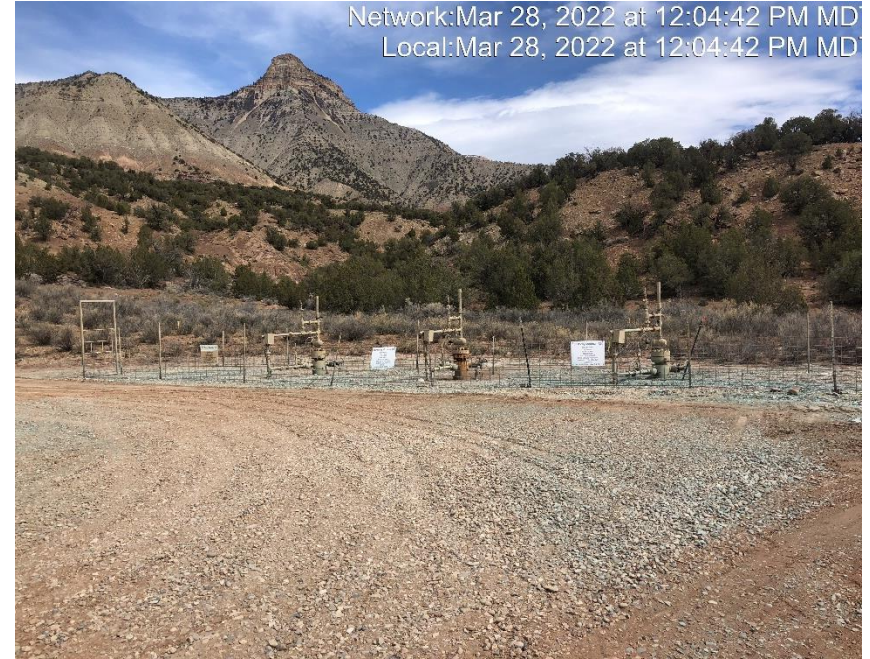
Photo #6313 from entrance to location.

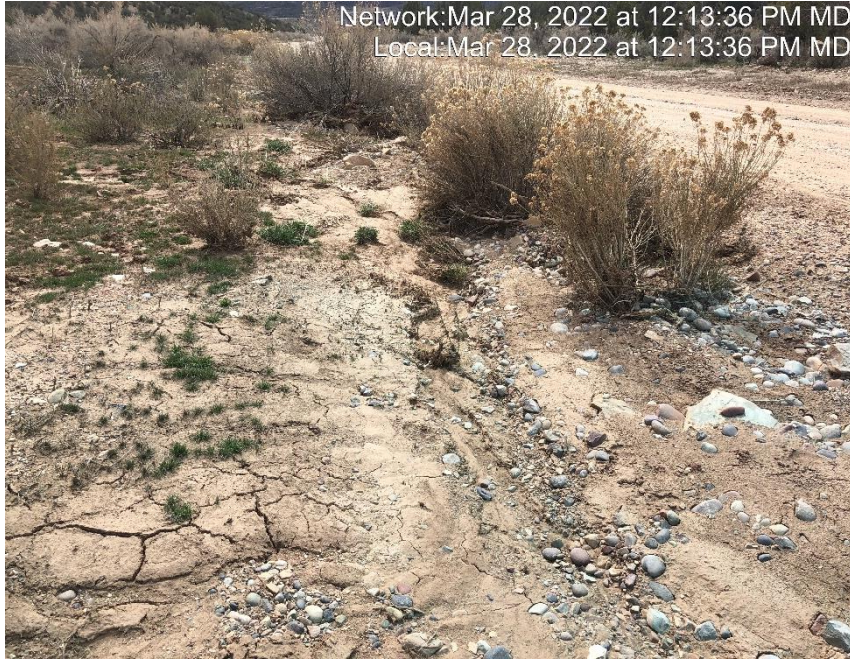
Photo #6314 Rill erosion occurring in ditch.

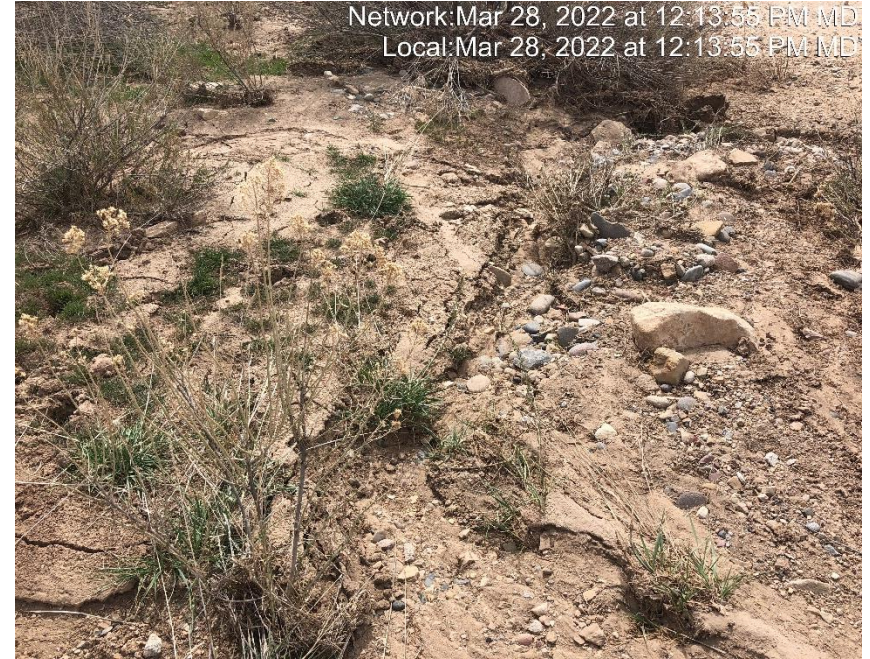
Photo #6315 Rill erosion occurring in ditch.

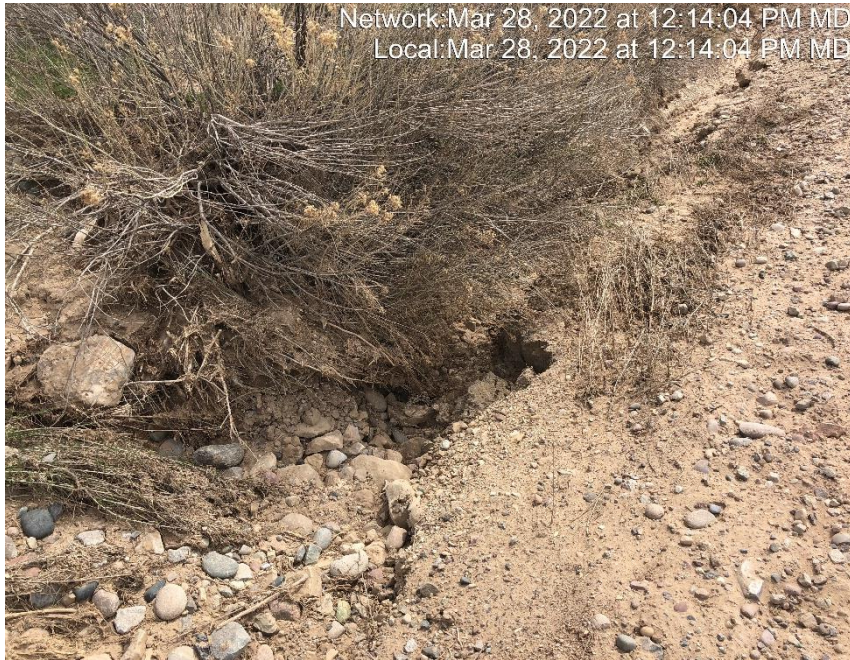
Photo #6316 Rill erosion occurring in ditch.

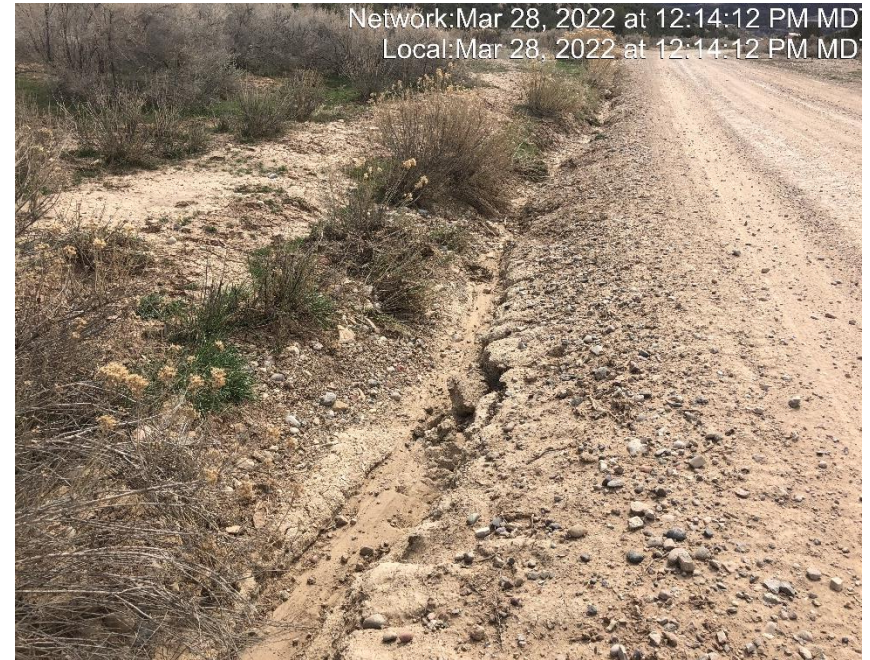
Photo #6317 Insufficient velocity checks in ditch.

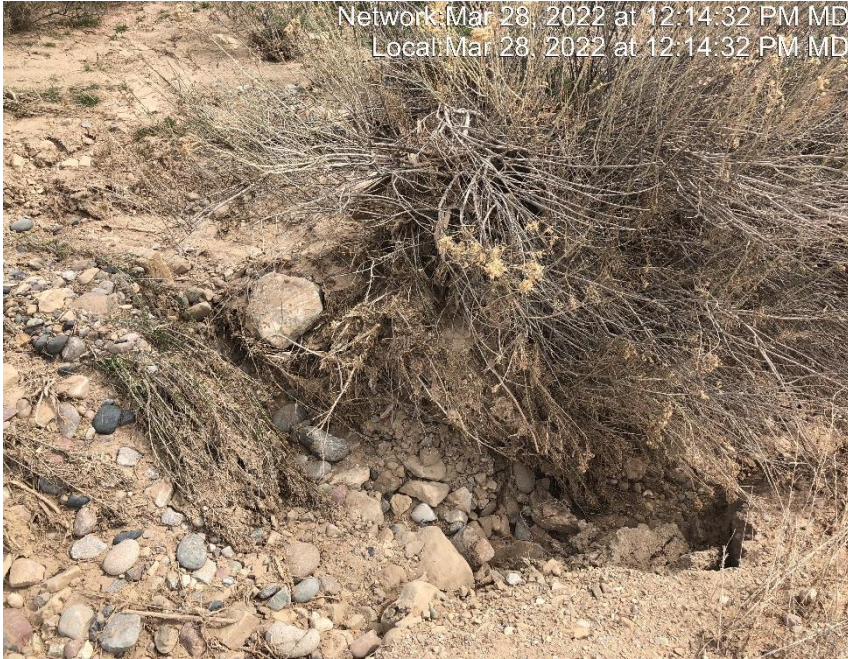
Photo #6318 Sediment is encroaching on vegetation.

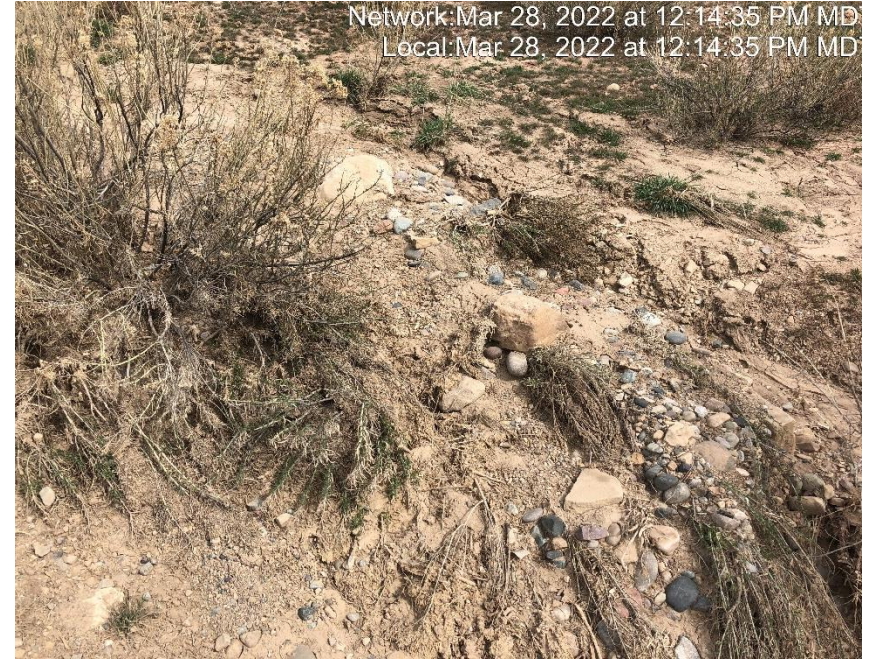
Photo #6319 Sediment chocking off vegetation.
