TEP  
KP 23-17  
Location # 335208

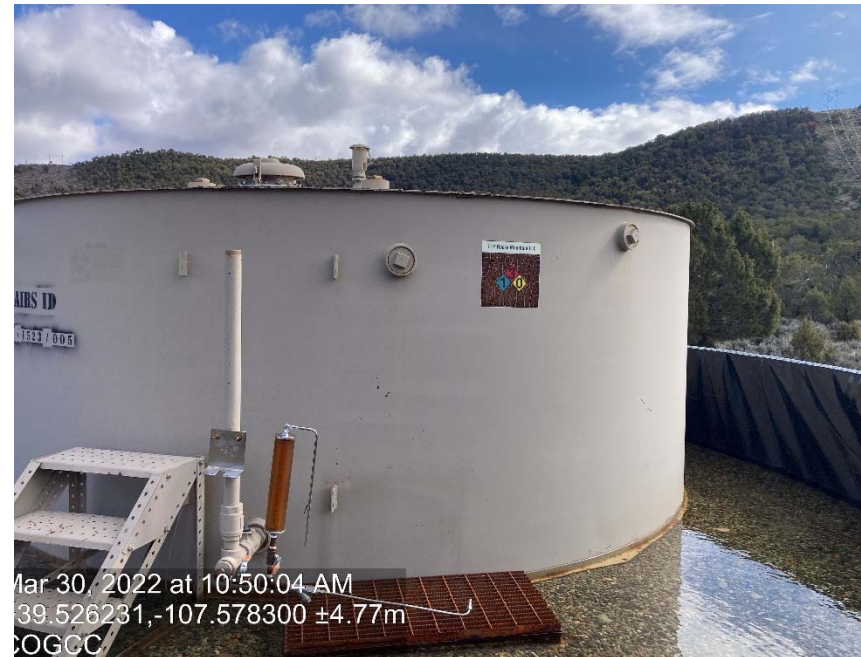
Tank signage is illegible

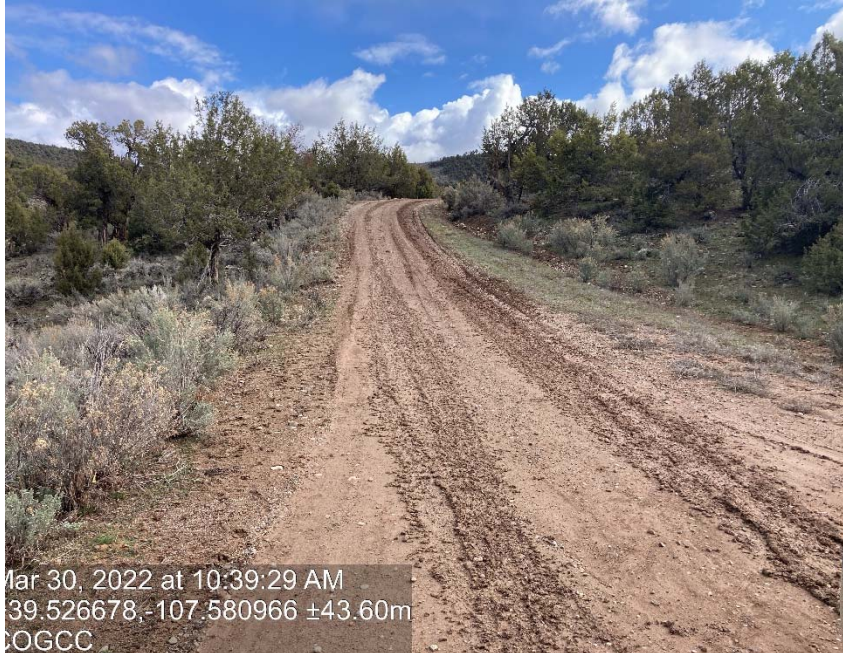
**Lack of stabilization/compaction/ degradation**

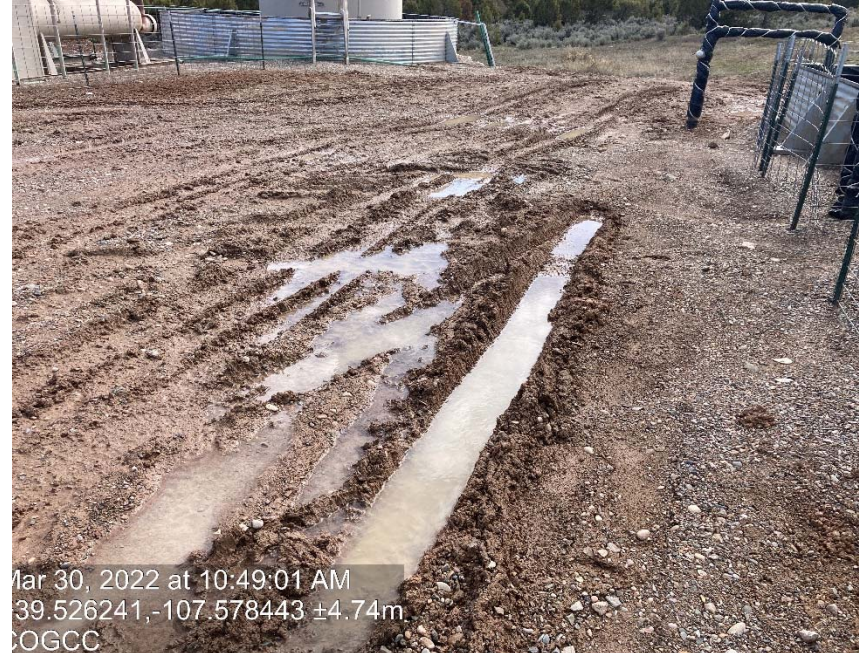
**Lack of stabilization/compaction/ degradation**

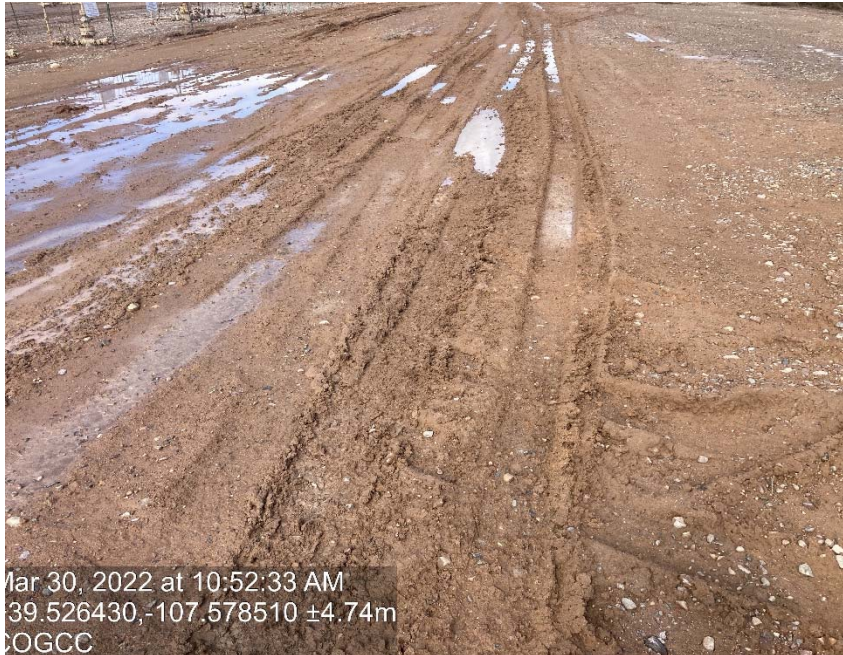
**Lack of stabilization/compaction/ degradation**

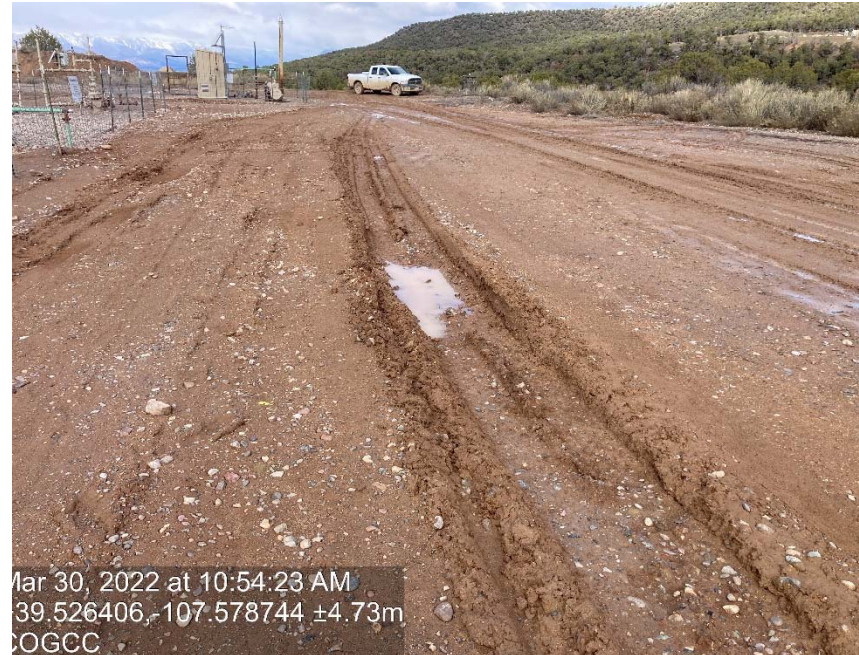
**Lack of stabilization/compaction/ degradation**

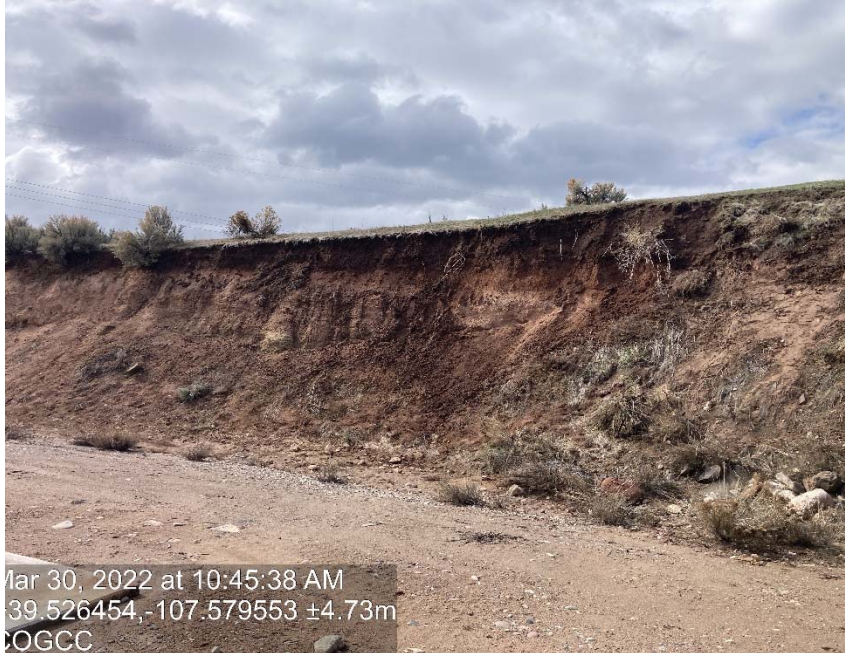
**Lack of stabilization/erosion**

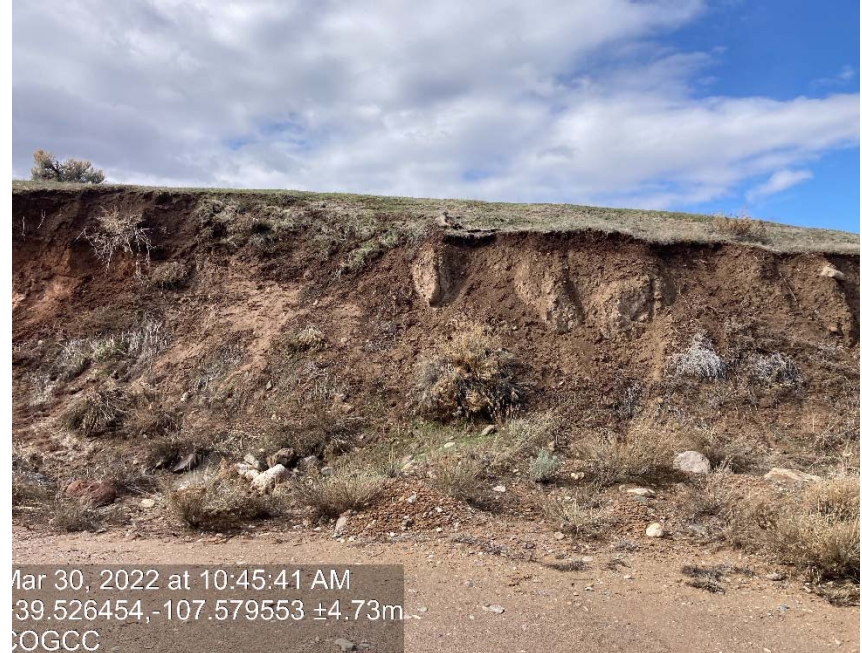
**Lack of stabilization/erosion**

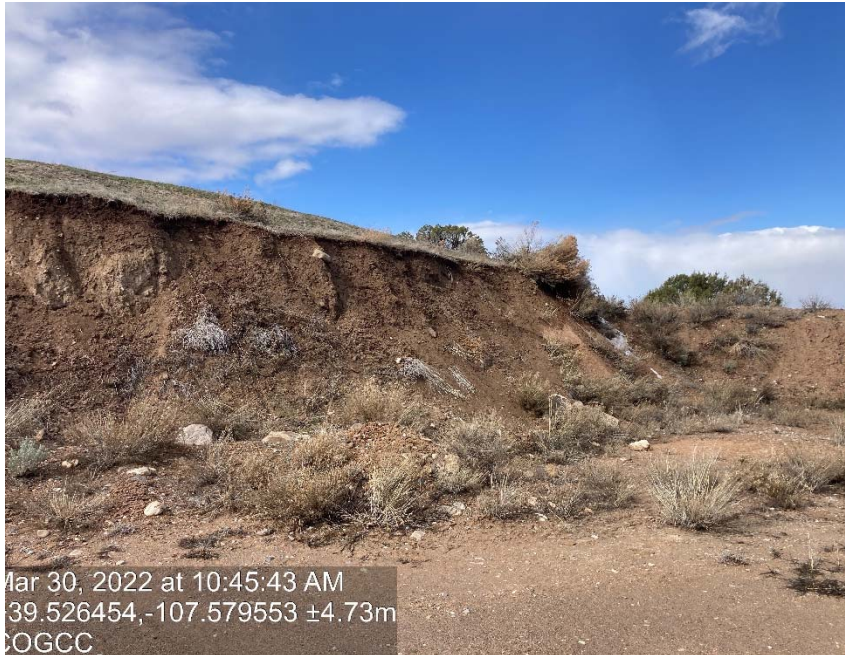
**Lack of stabilization/erosion**

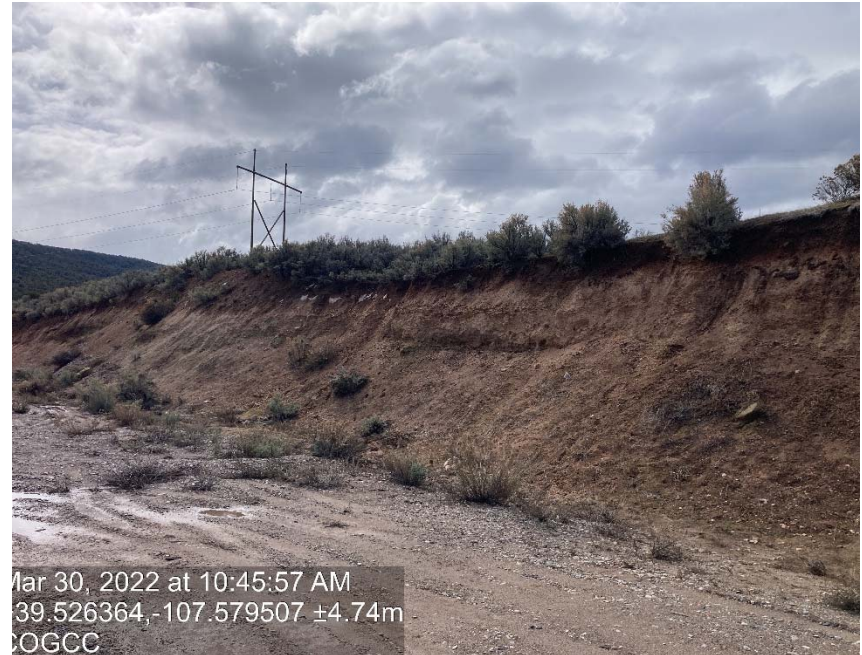
**Lack of stabilization/erosion**

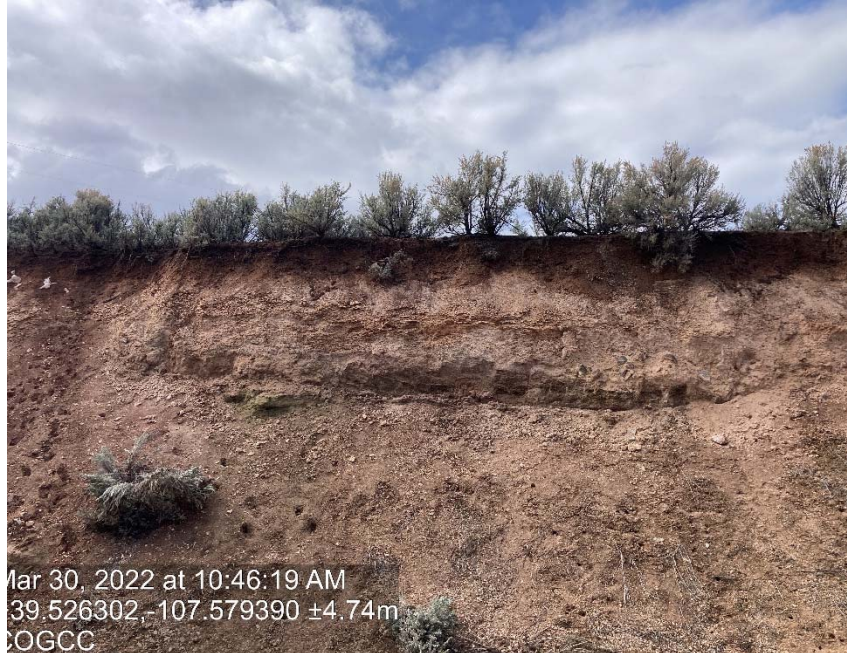
**Lack of stabilization/erosion**

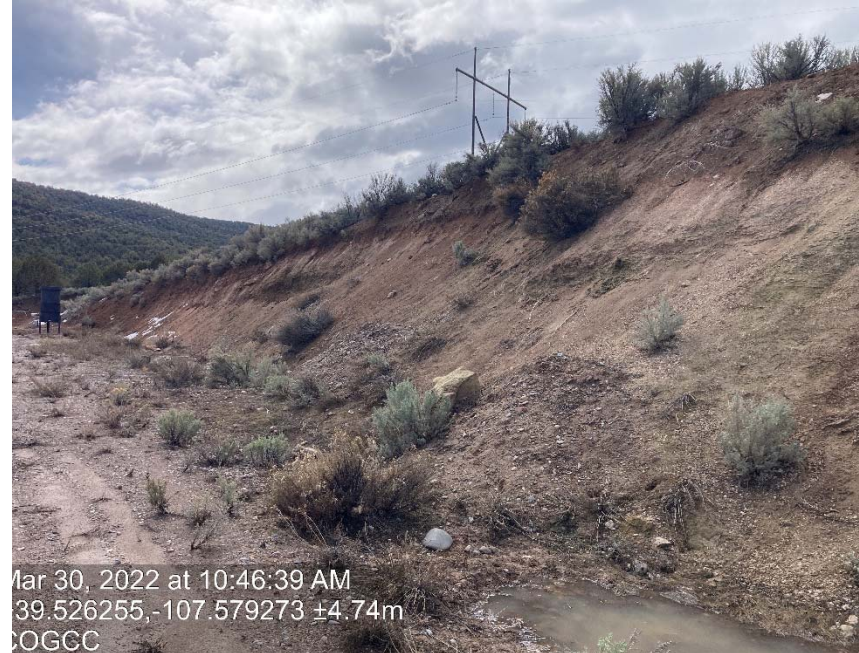
**Lack of stabilization/erosion**

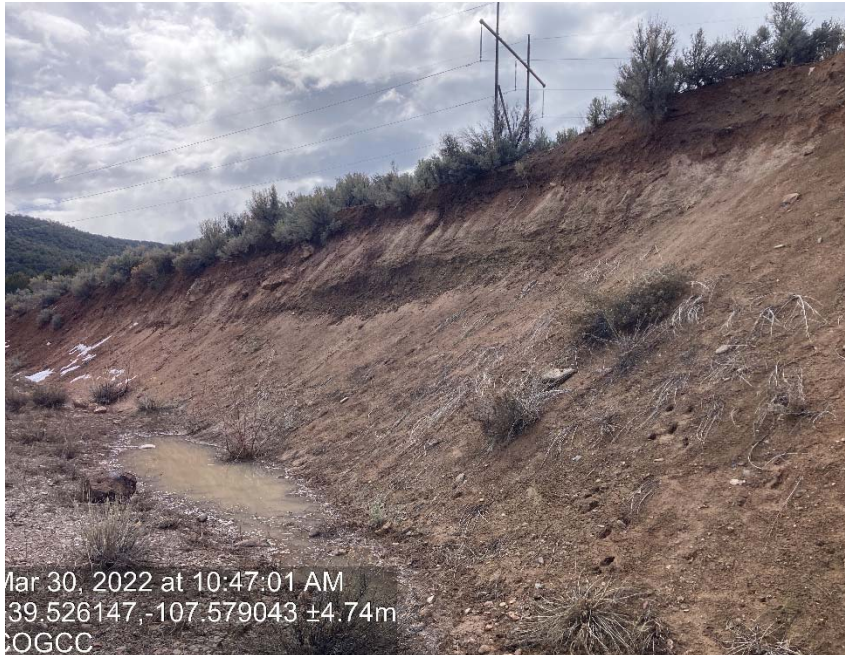
**Lack of stabilization/erosion**

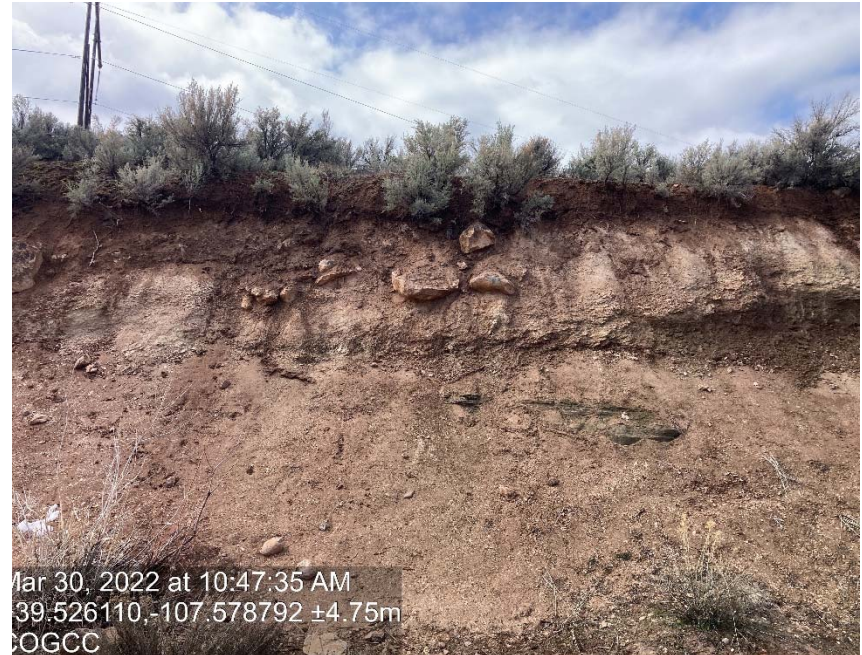
**Lack of stabilization/erosion**

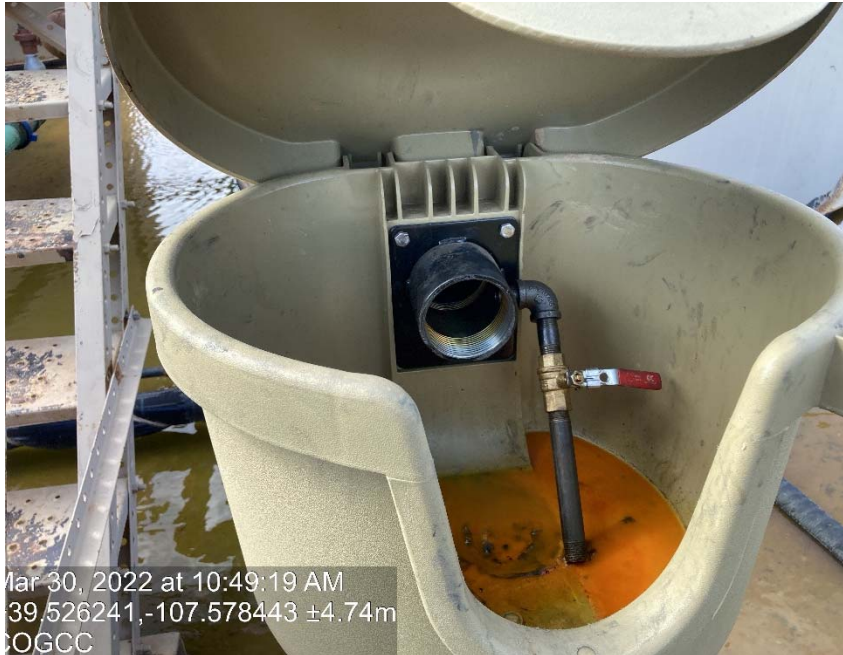
**Missing cap/plug**

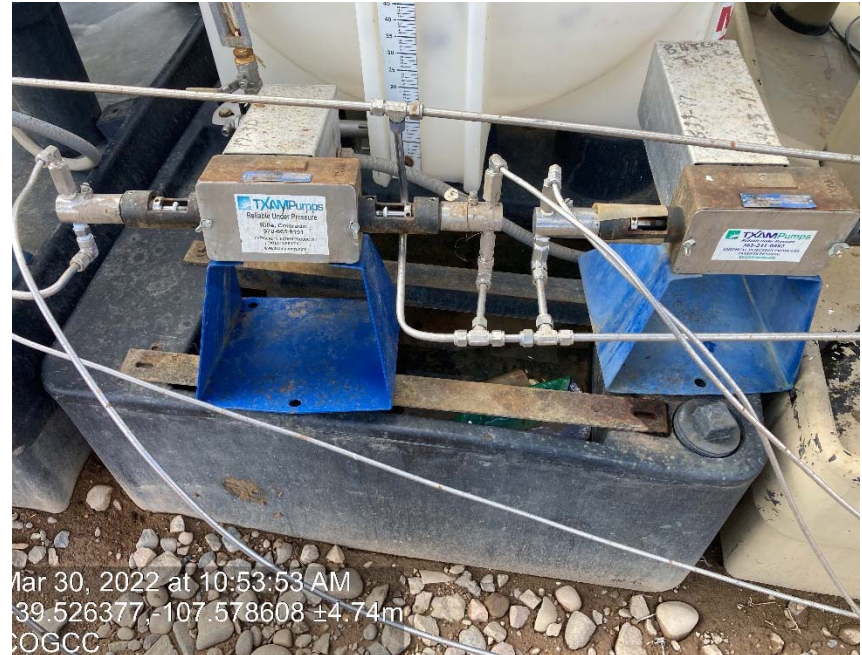
**Chemical tank containment full of fluid**

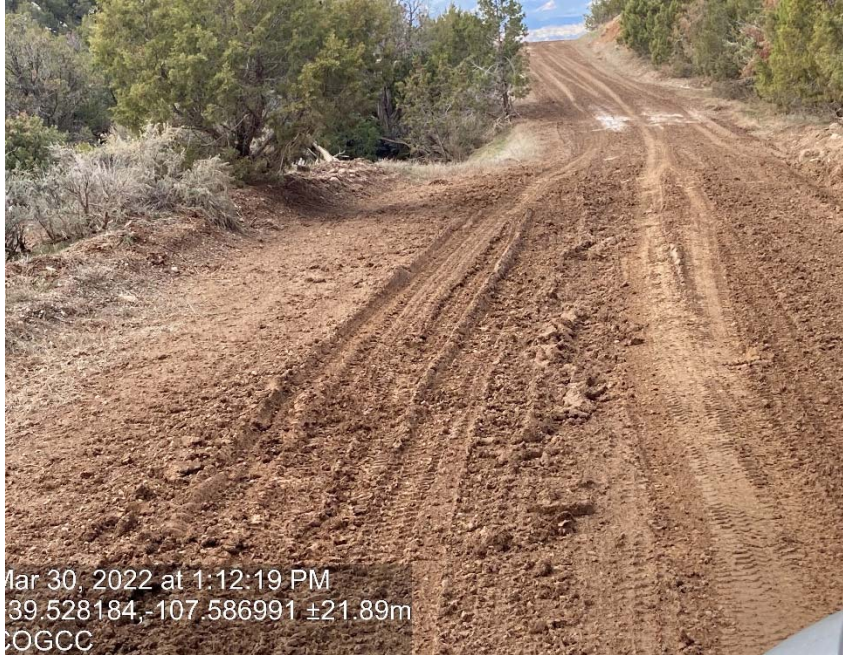
**Main access road lack of stabilization**
