Inspection Photos
Location Name: A21-13 /Pad
Location #: 449369

**Rampart A33-730, A33-740, A33-750, A33-760,
A33-770** Wellsite

Waiting on Completion | WO

Frac Operations: Active; Rampart A33-730, A33-750

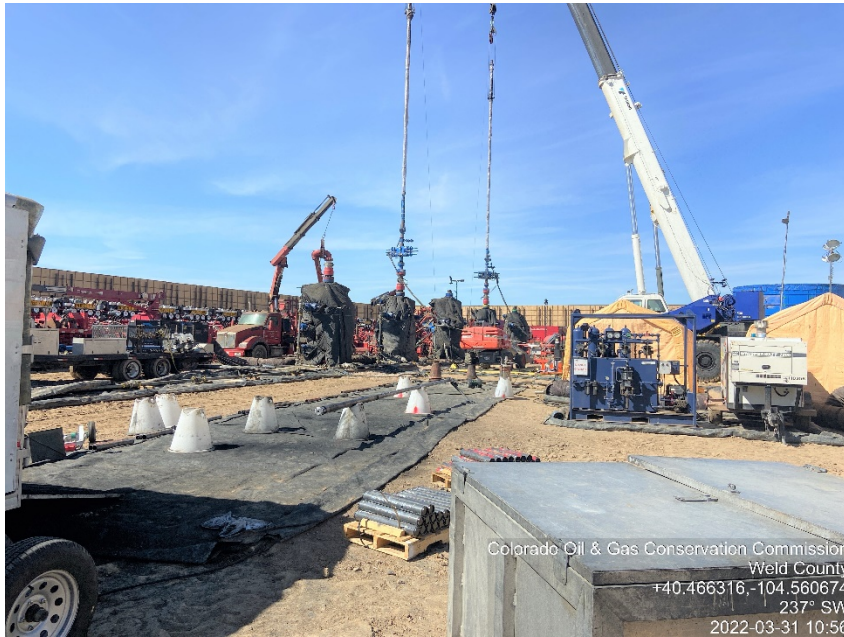
Photo #1

Frac: Halliburton crew, NE corner

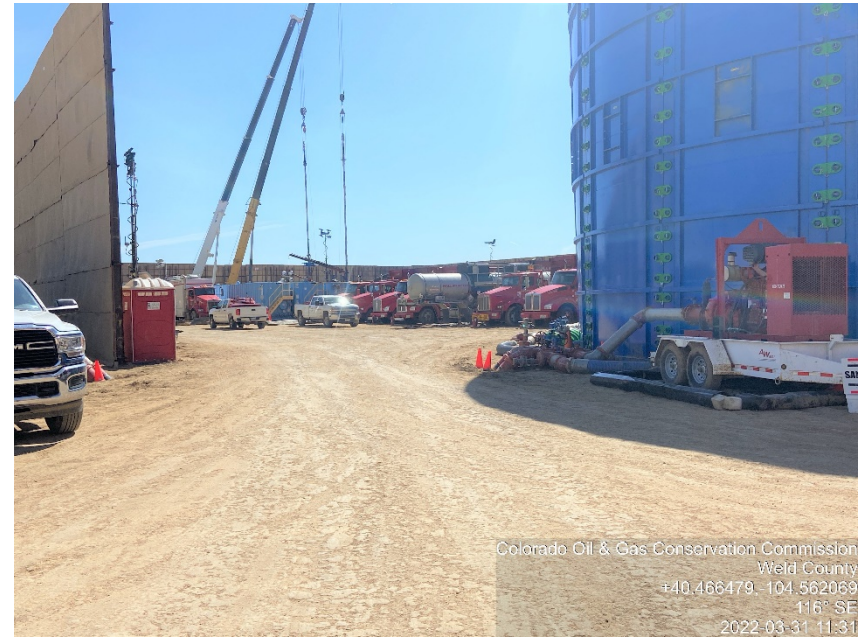
Photo #2

Frac: Halliburton crew, NW corner

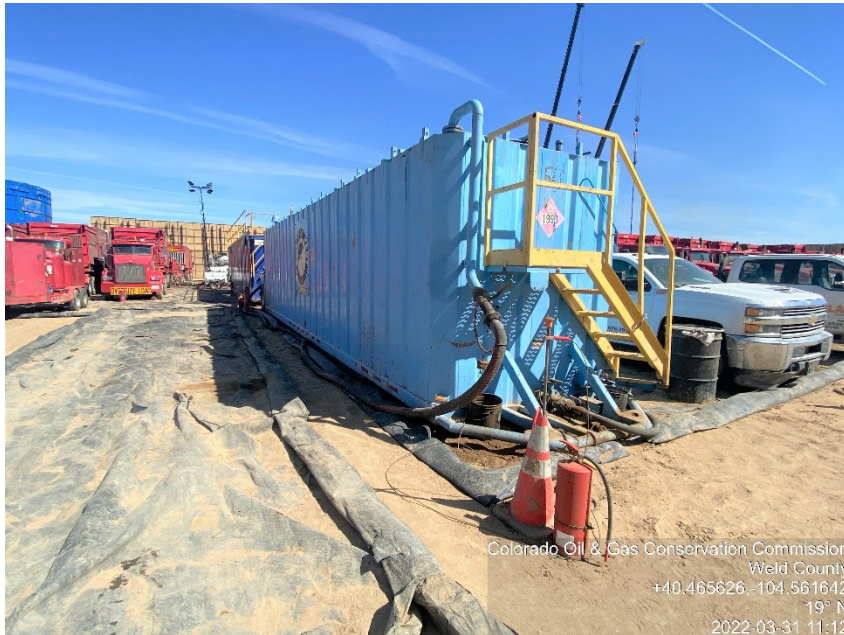
Photo #3

Diesel tanks: Grounded

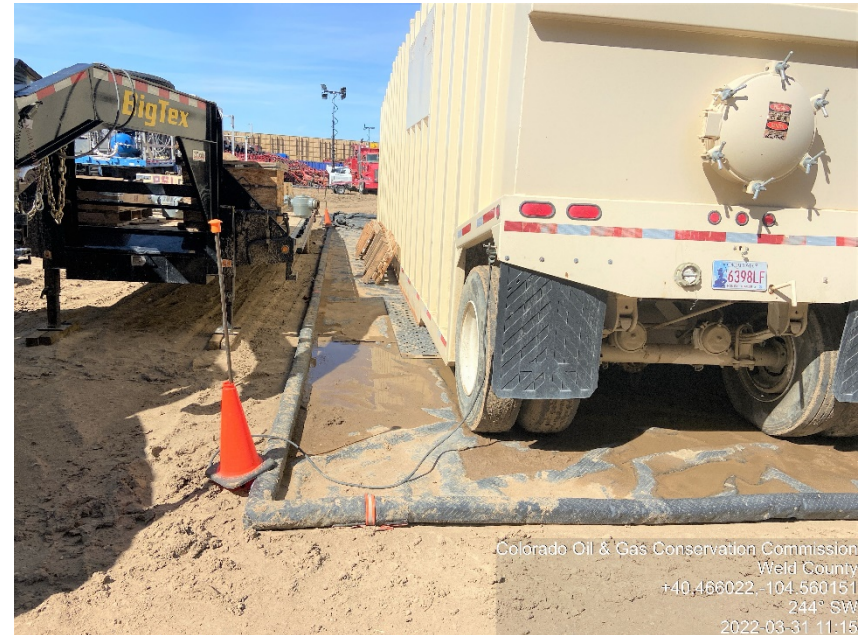
Photo #4

Flow tanks: Grounded

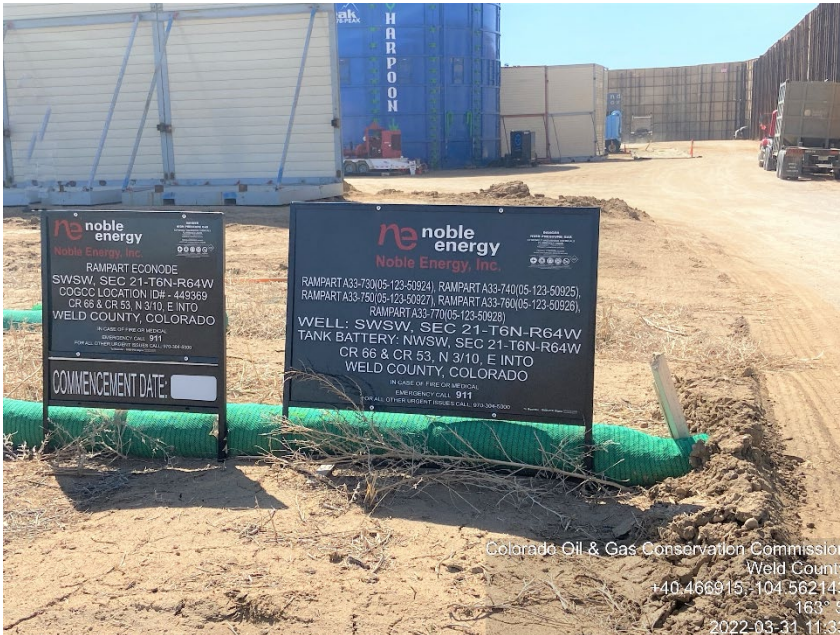
Photo #5

Site entrance: signage

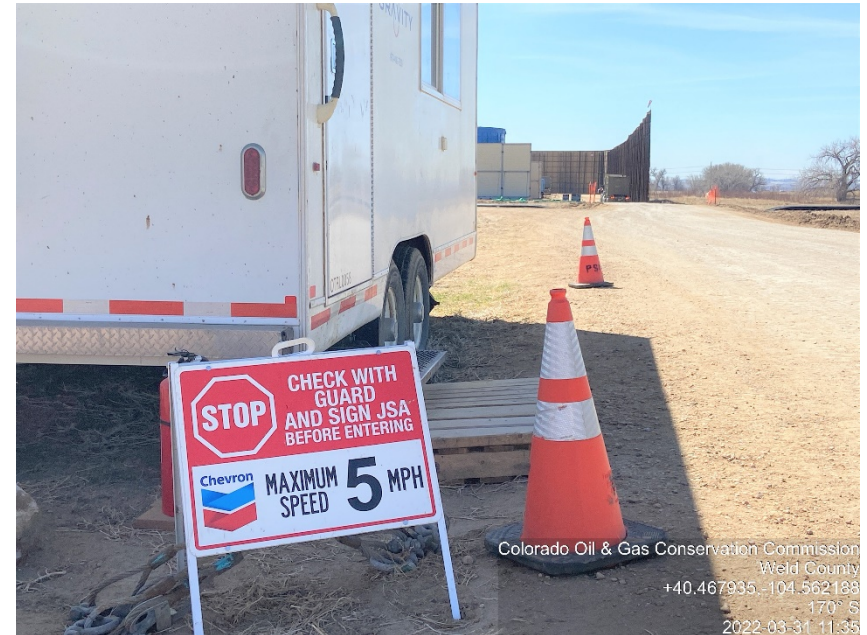
Photo #6

Site entrance: Safety signage
