Inspection Photos
Operator Name: Caerus
Location ID: 334942

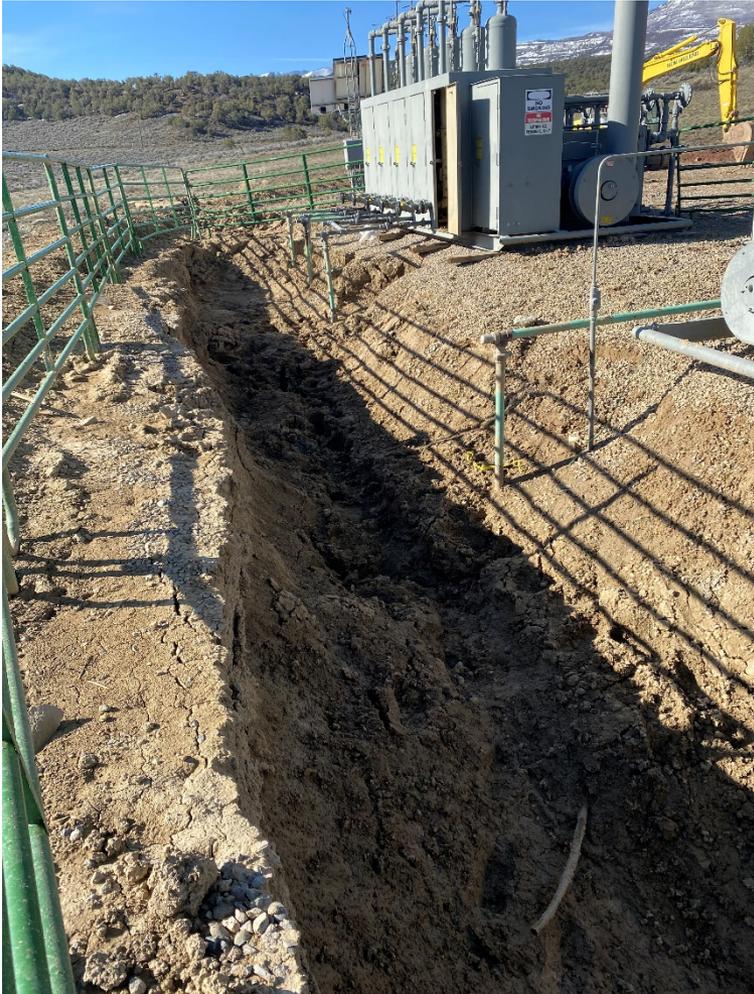
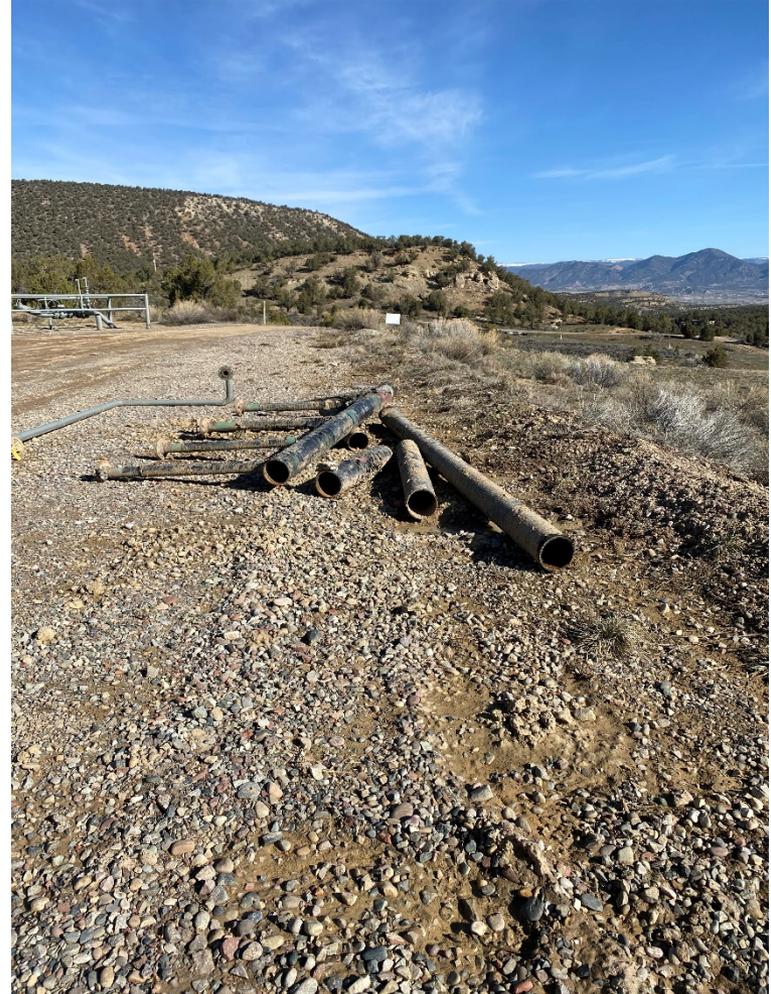
Existing sales flowline was abandoned and removed from location

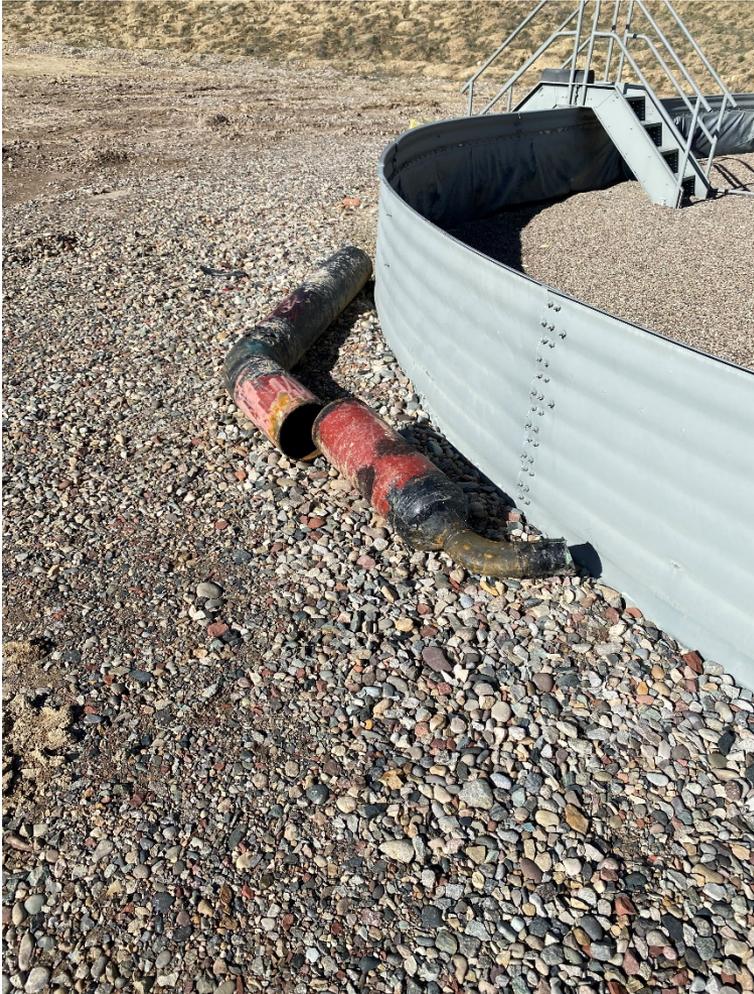
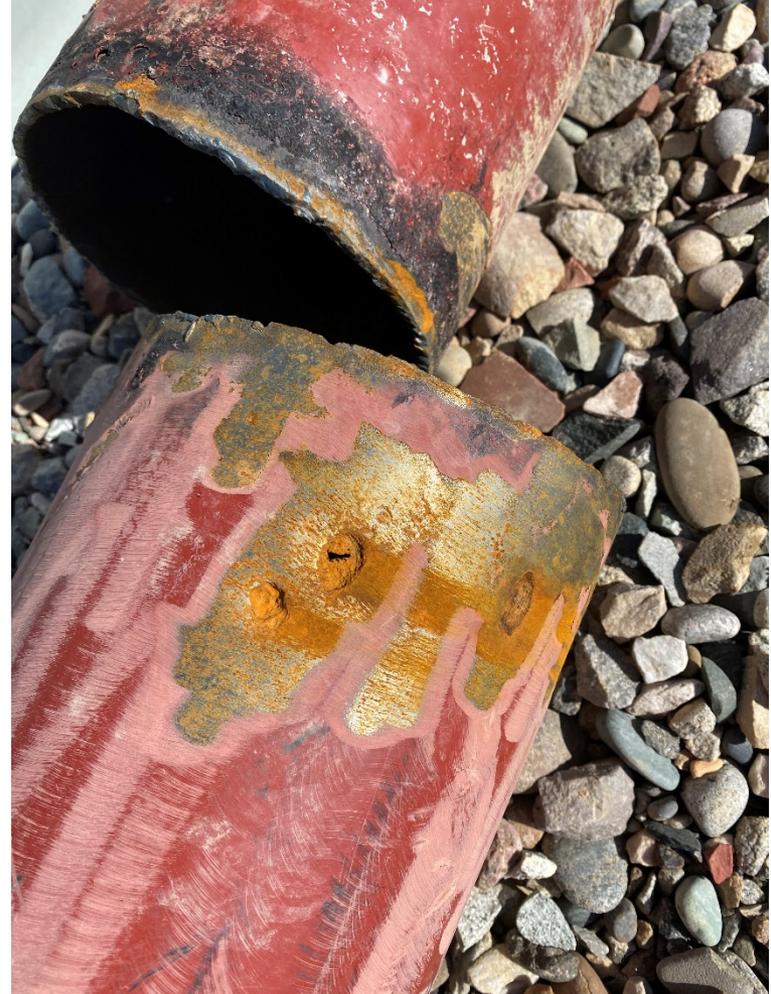
Appears to be external corrosion
