**Inspection Photos**  
**Operator: Logos Operating**  
**API: 067-09136**  
**Date: 3/21/2022**

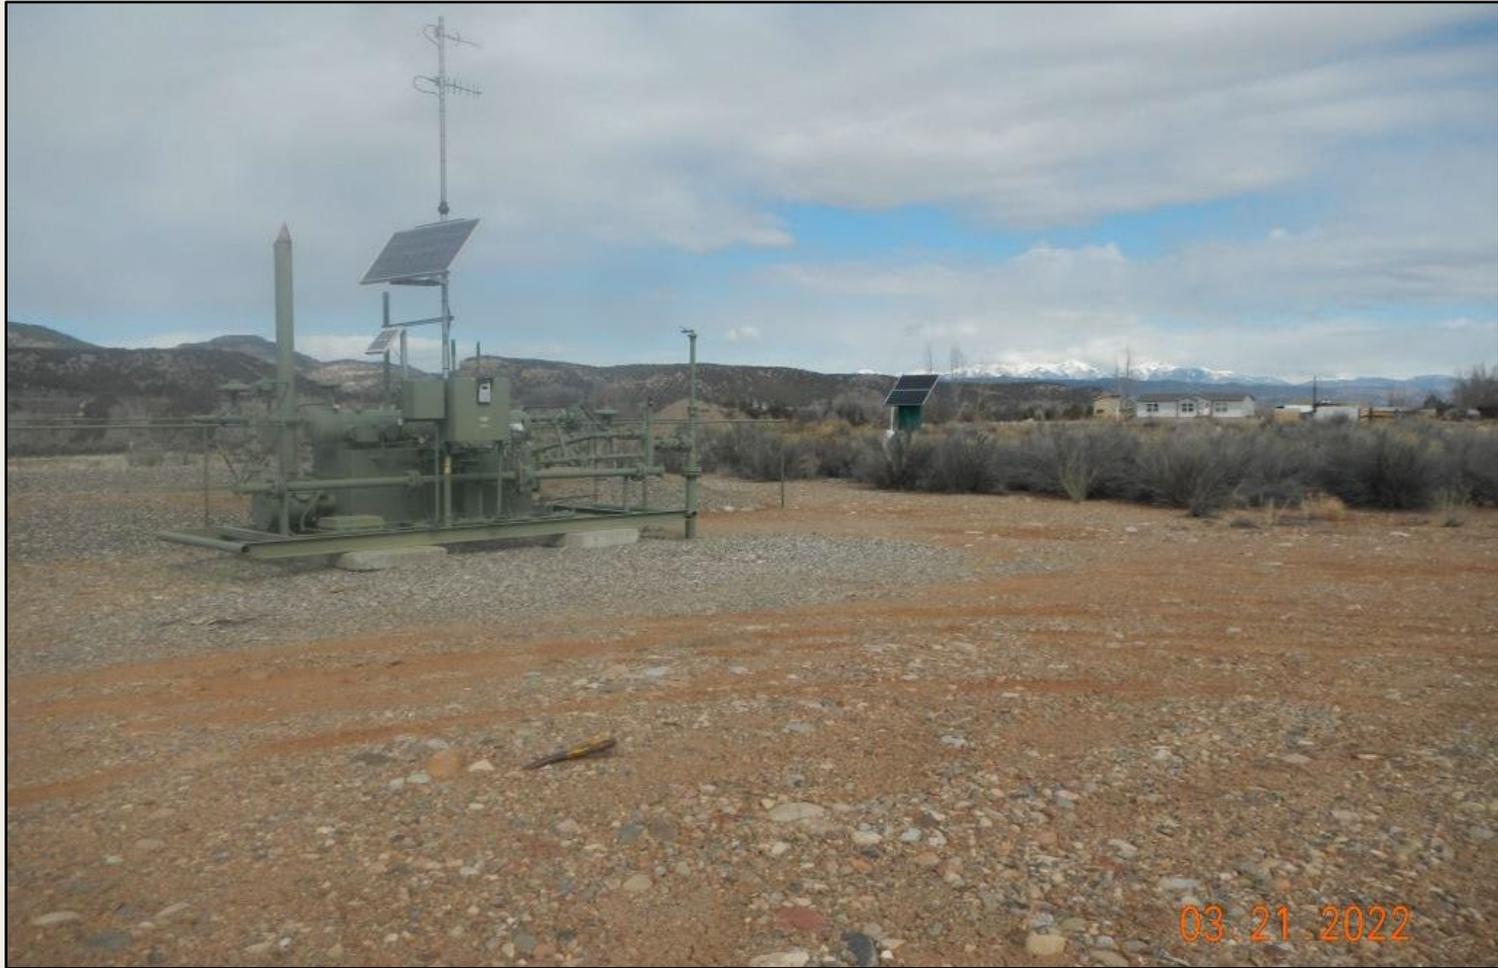
Photo 1. View of the project area from the well pad entrance facing center.

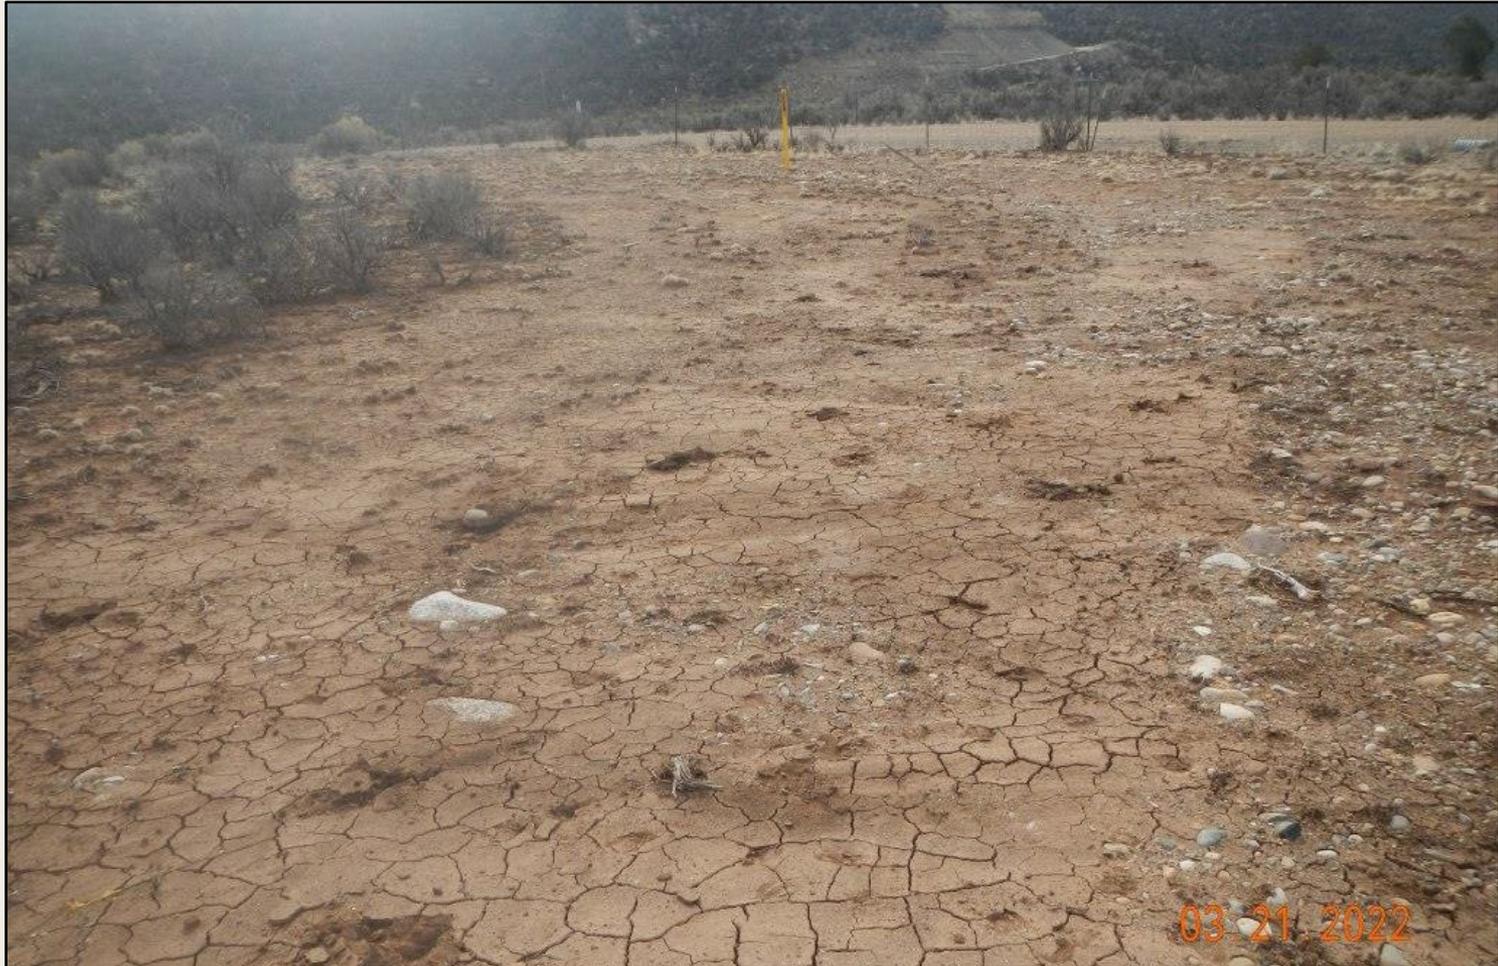
Photo 2. View of area where it appears that herbicide overspray has killed vegetation. Corrective action to revegetate areas where vegetation is killed from previous reclamation inspection is not addressed.

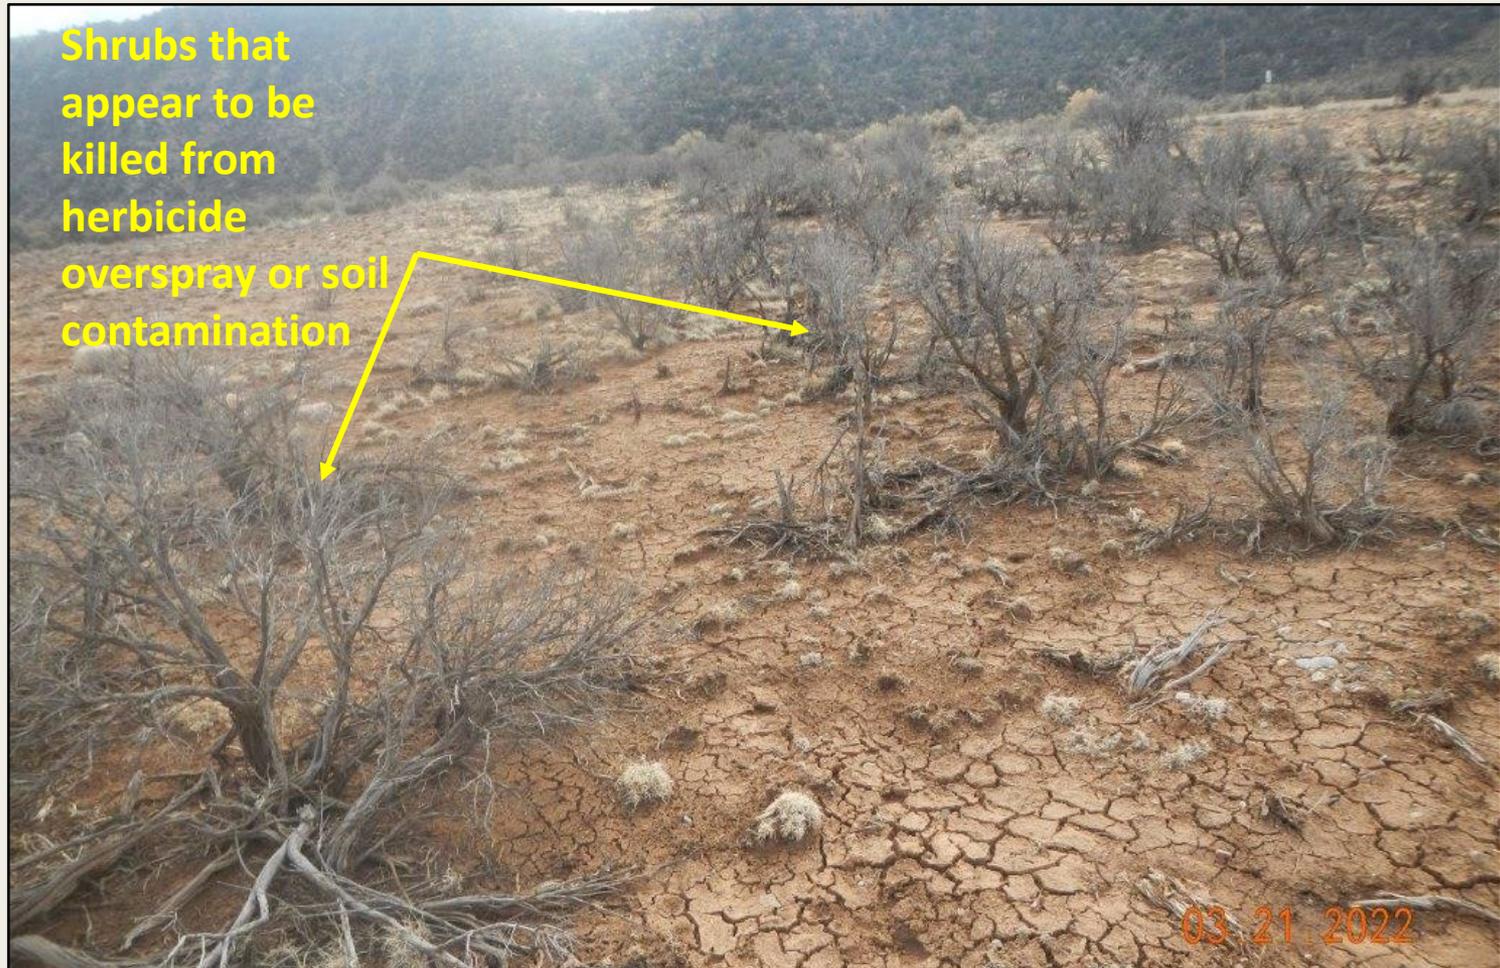
Photo 3. View of shrubs in the southeastern project area that appear to have been killed by herbicide overspray or soil contamination.

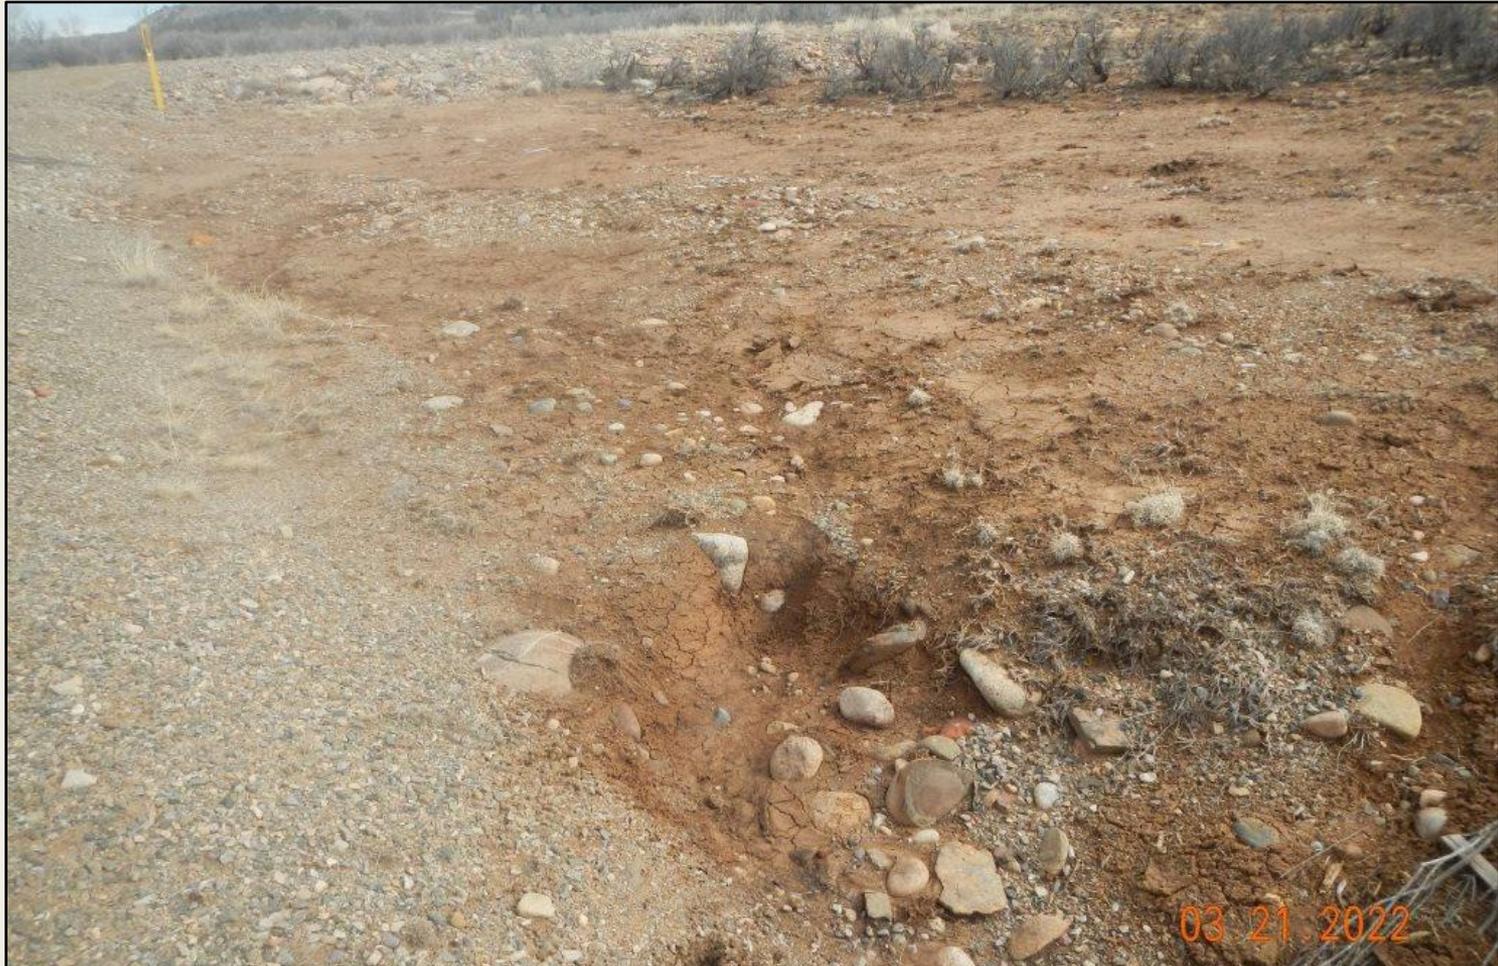
Photo 4. Another view of area in the southern project area (between access road and well pad, where vegetation is killed. Revegetation has not been conducted here. Topsoil scouring, pedestalling, and rilling observed.

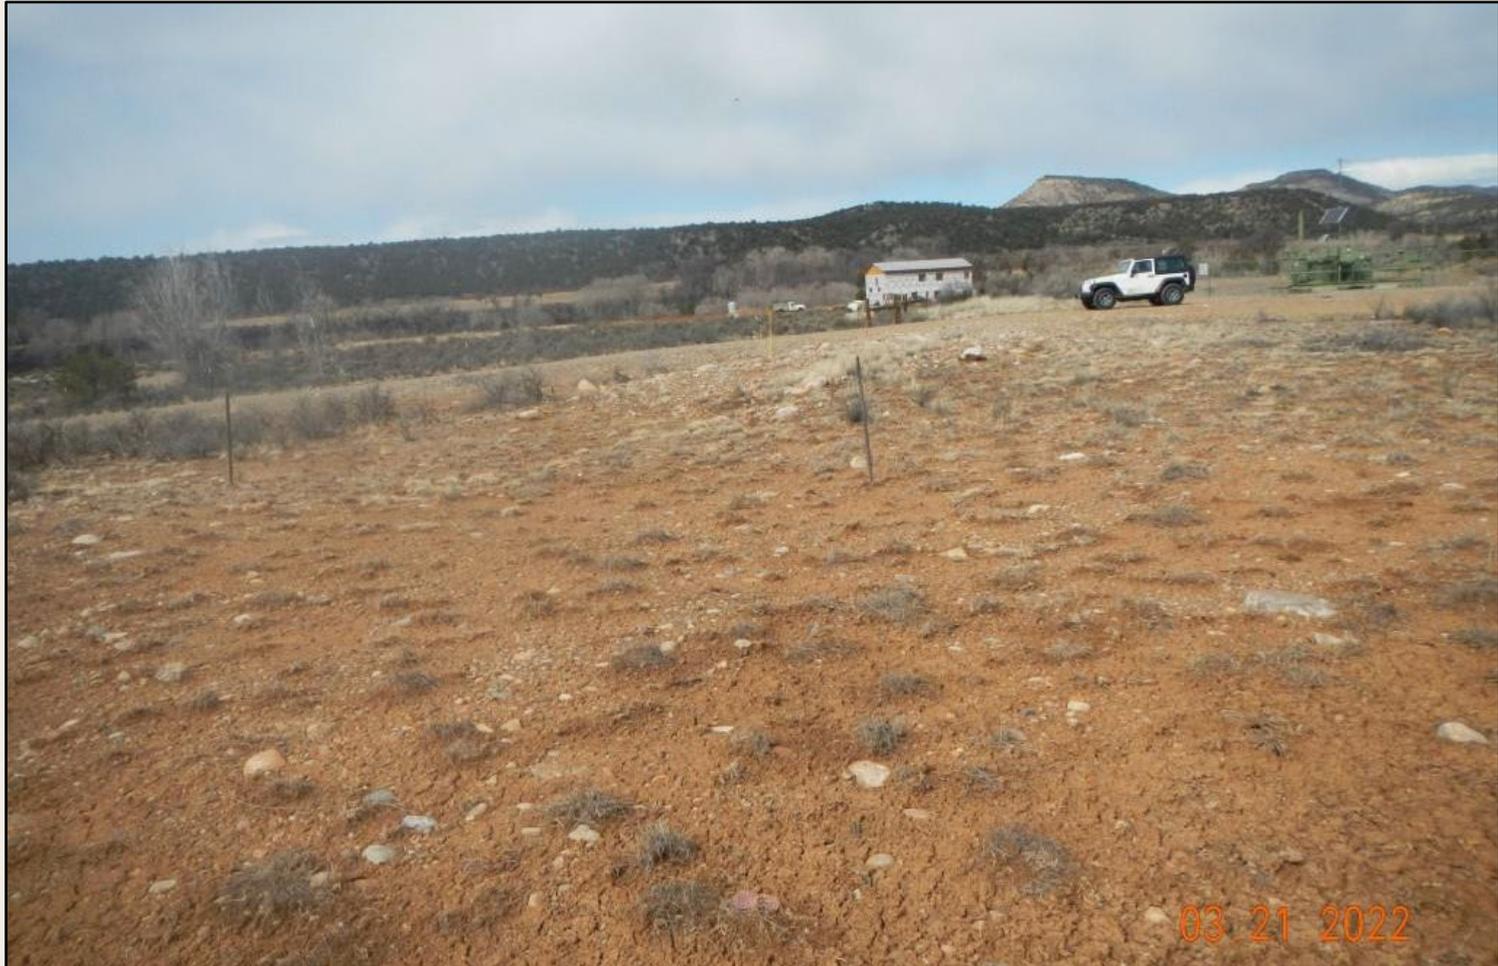
Photo 5. View of the southern project area from the southeastern corner facing westward. Grasses in the foreground largely appear dead. Spot seeding is needed in areas with sparse and bare vegetation and where there is vegetation die-off.

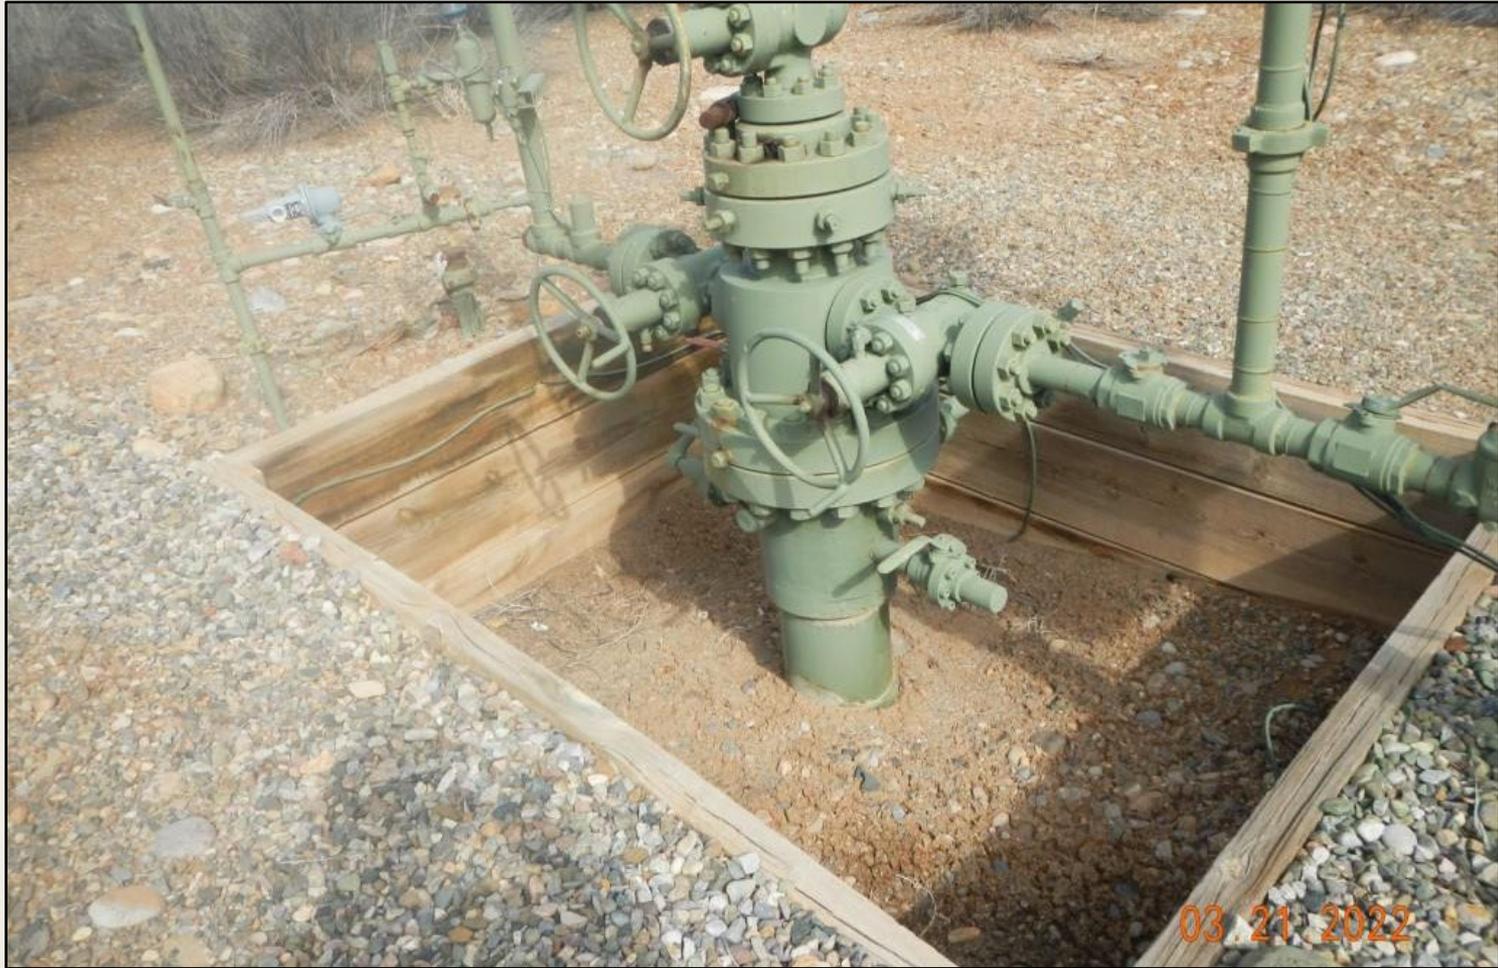
Photo 6. View of open cellar around the wellhead needing cover for wildlife protection.

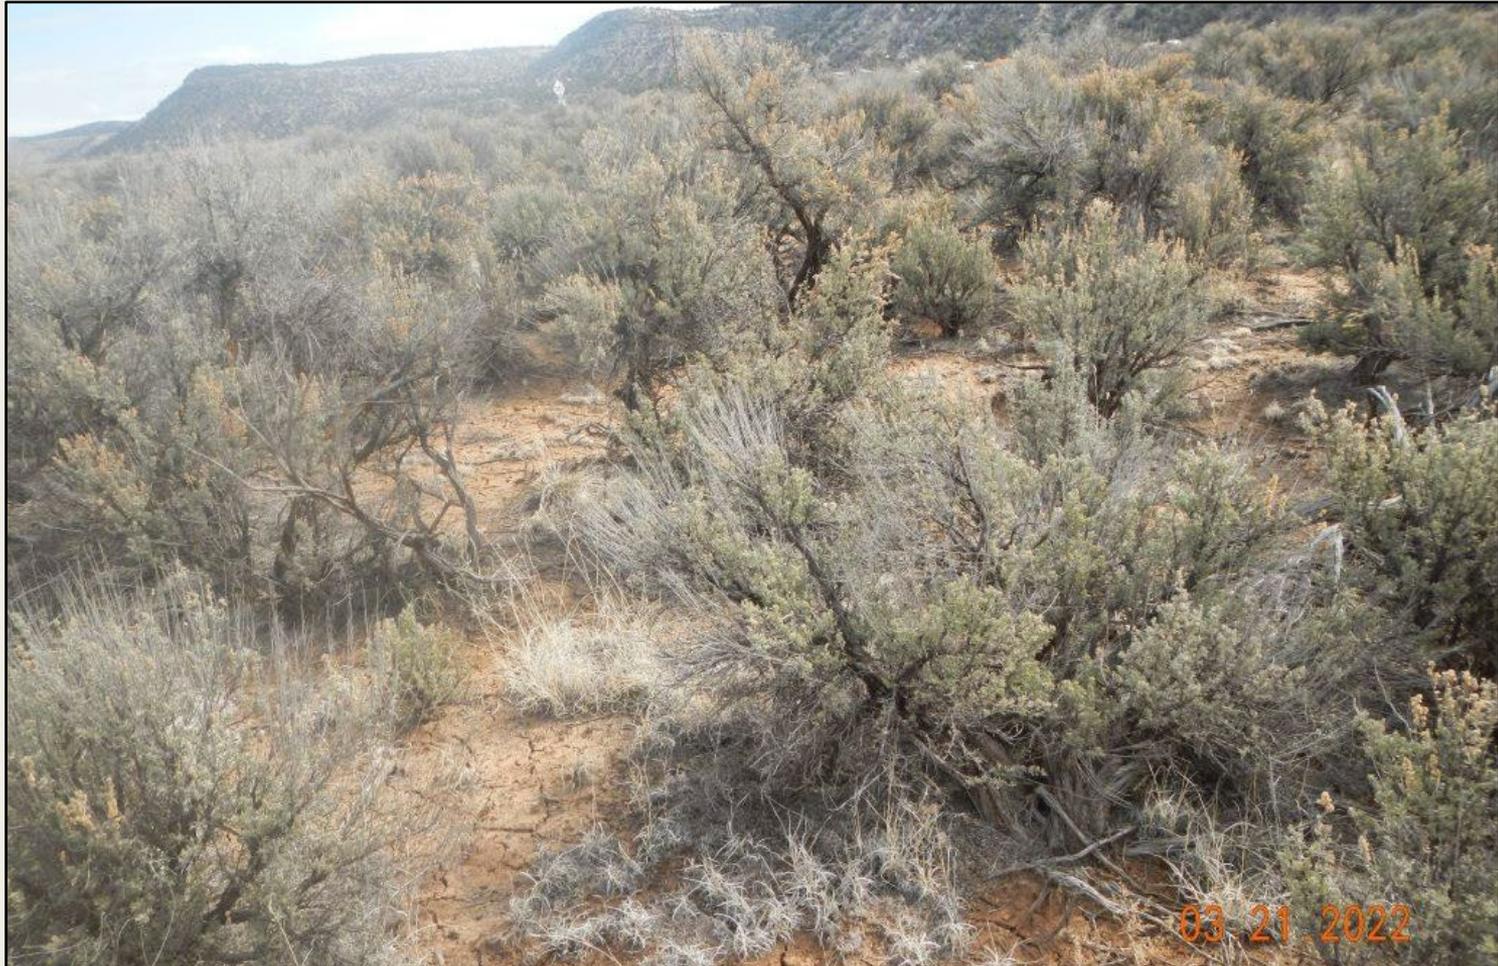
Photo 7. View of reference area comprised of sagebrush shrubland with understory of James galleta, squirreltail, prickly pear, and penstemon.
