Inspection Photos  
Operator: Amoco  
API: 385503  
Date: 3/21/2022

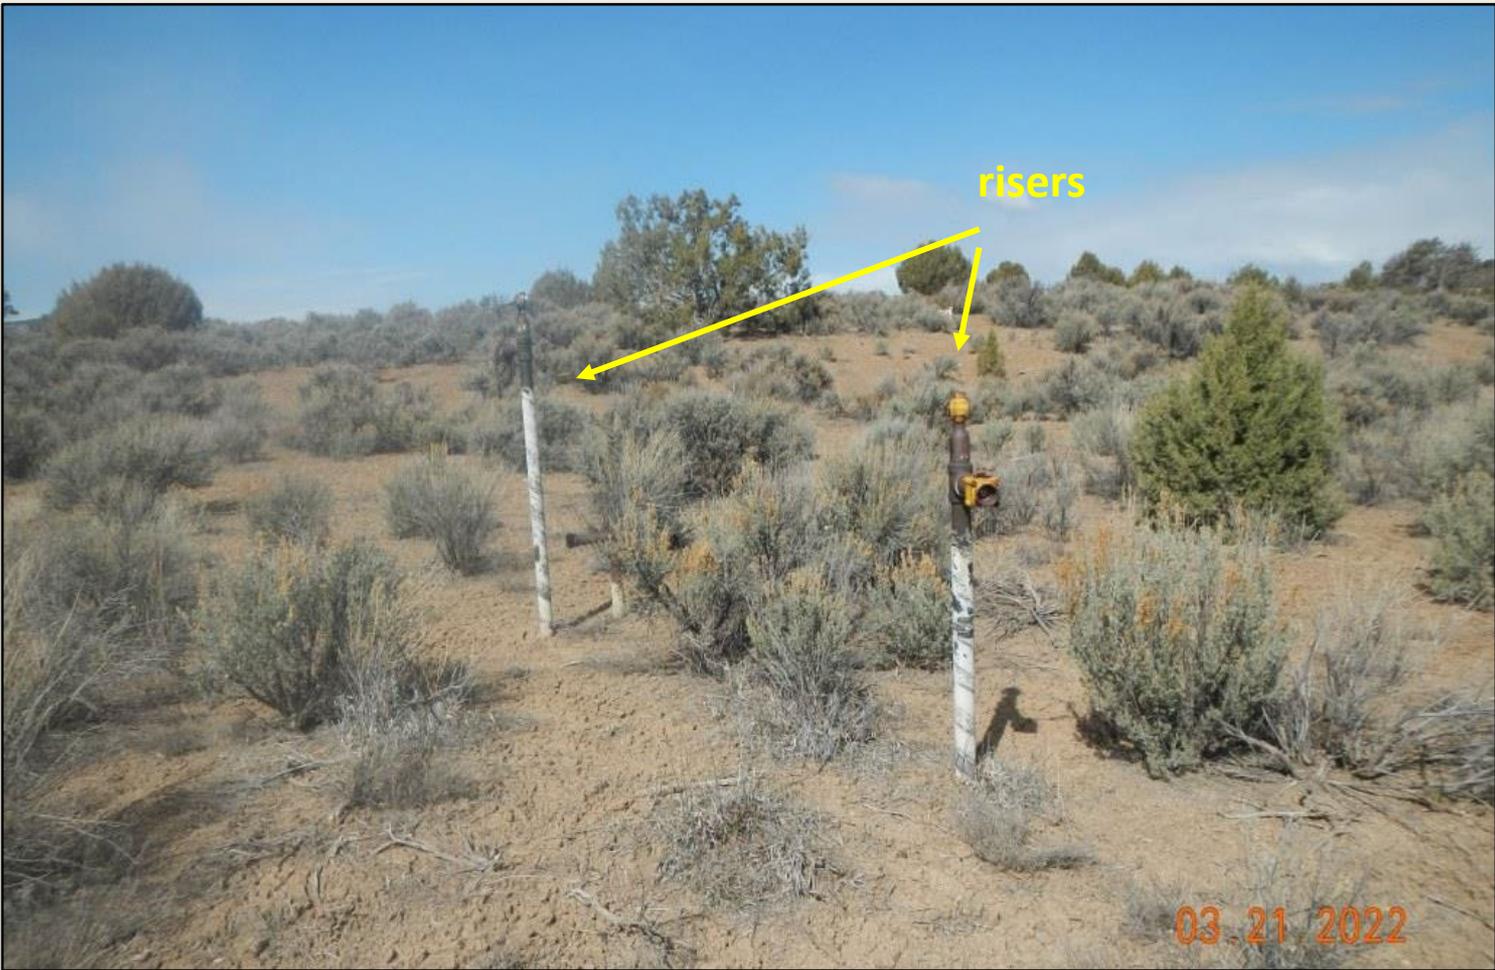
Photo 1. View of risers that remain within the former facilities area.

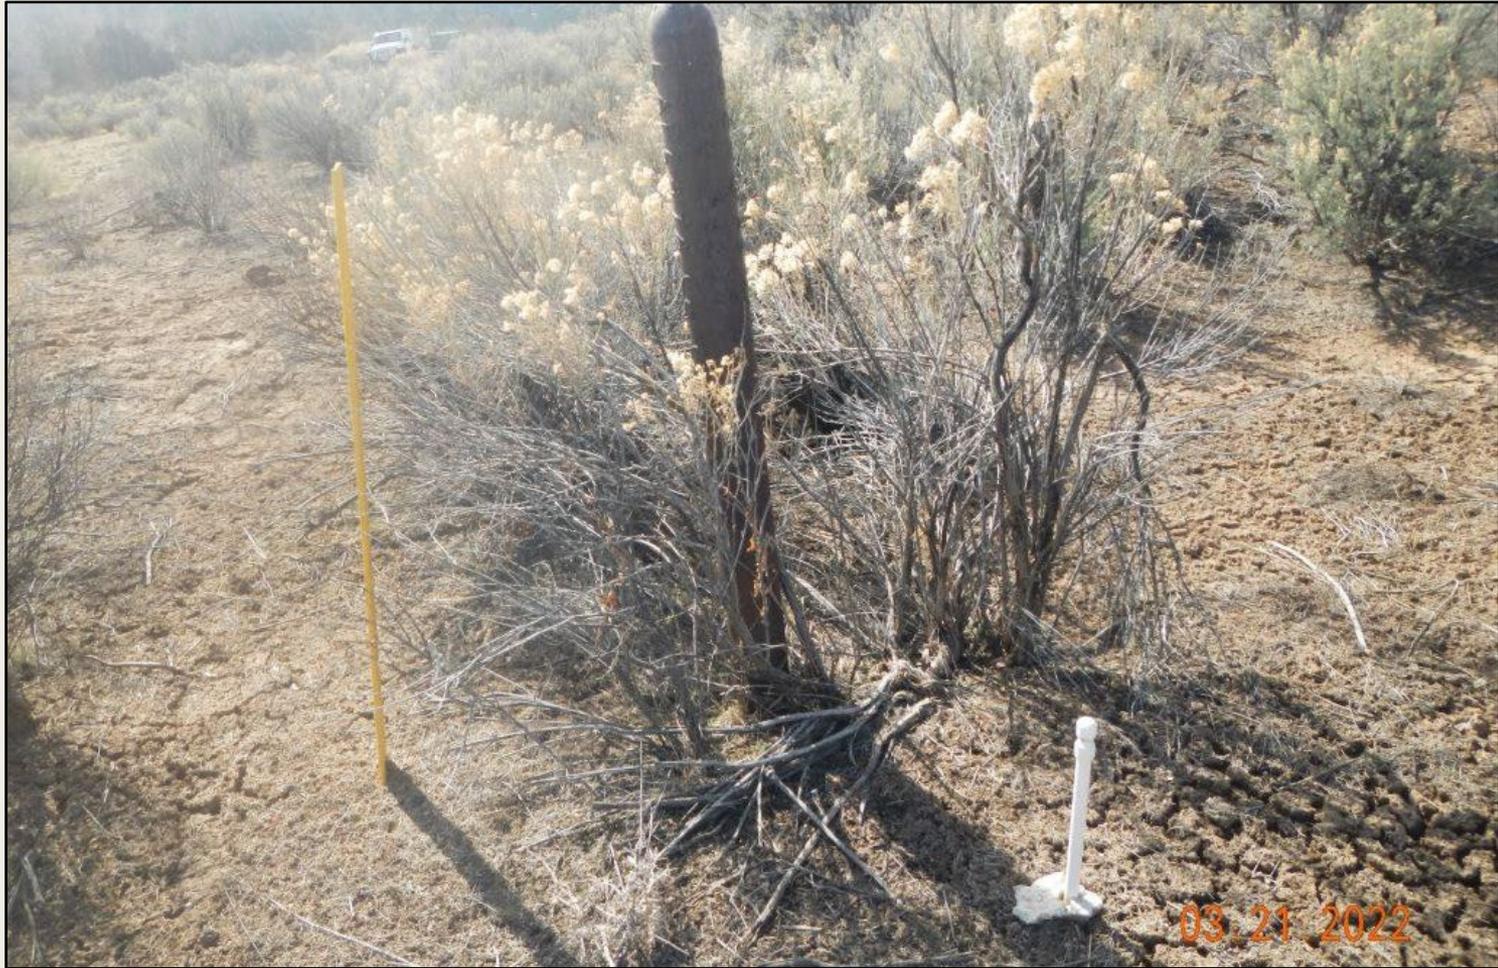
Photo 2. View of risers that remain around the wellhead marker.

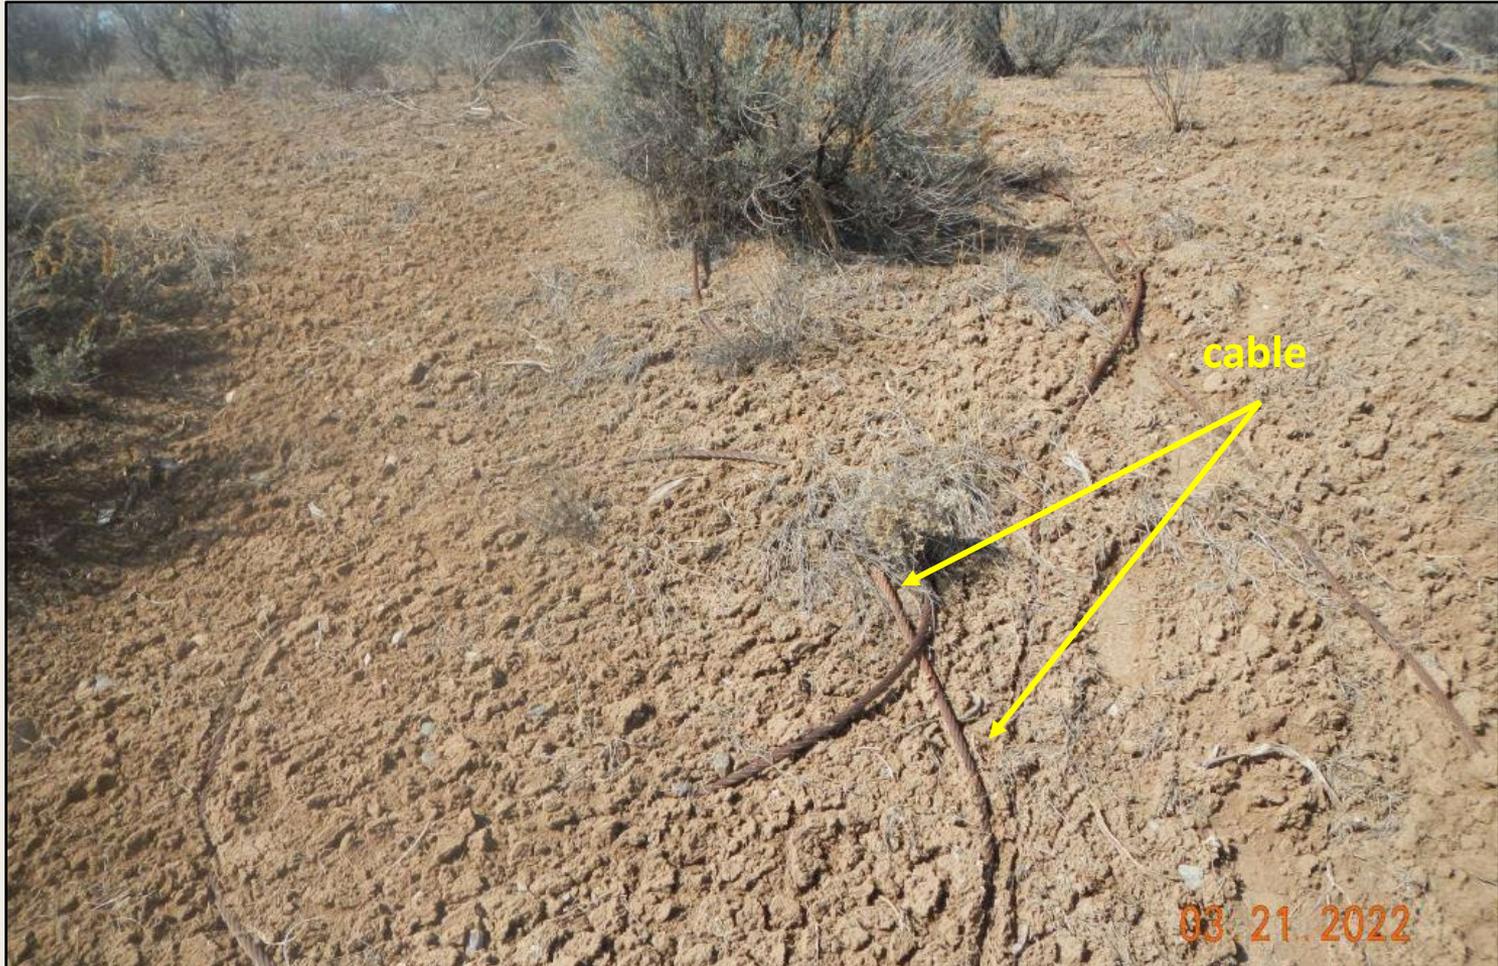
Photo 3. View of cable debris that remains within the eastern project area.

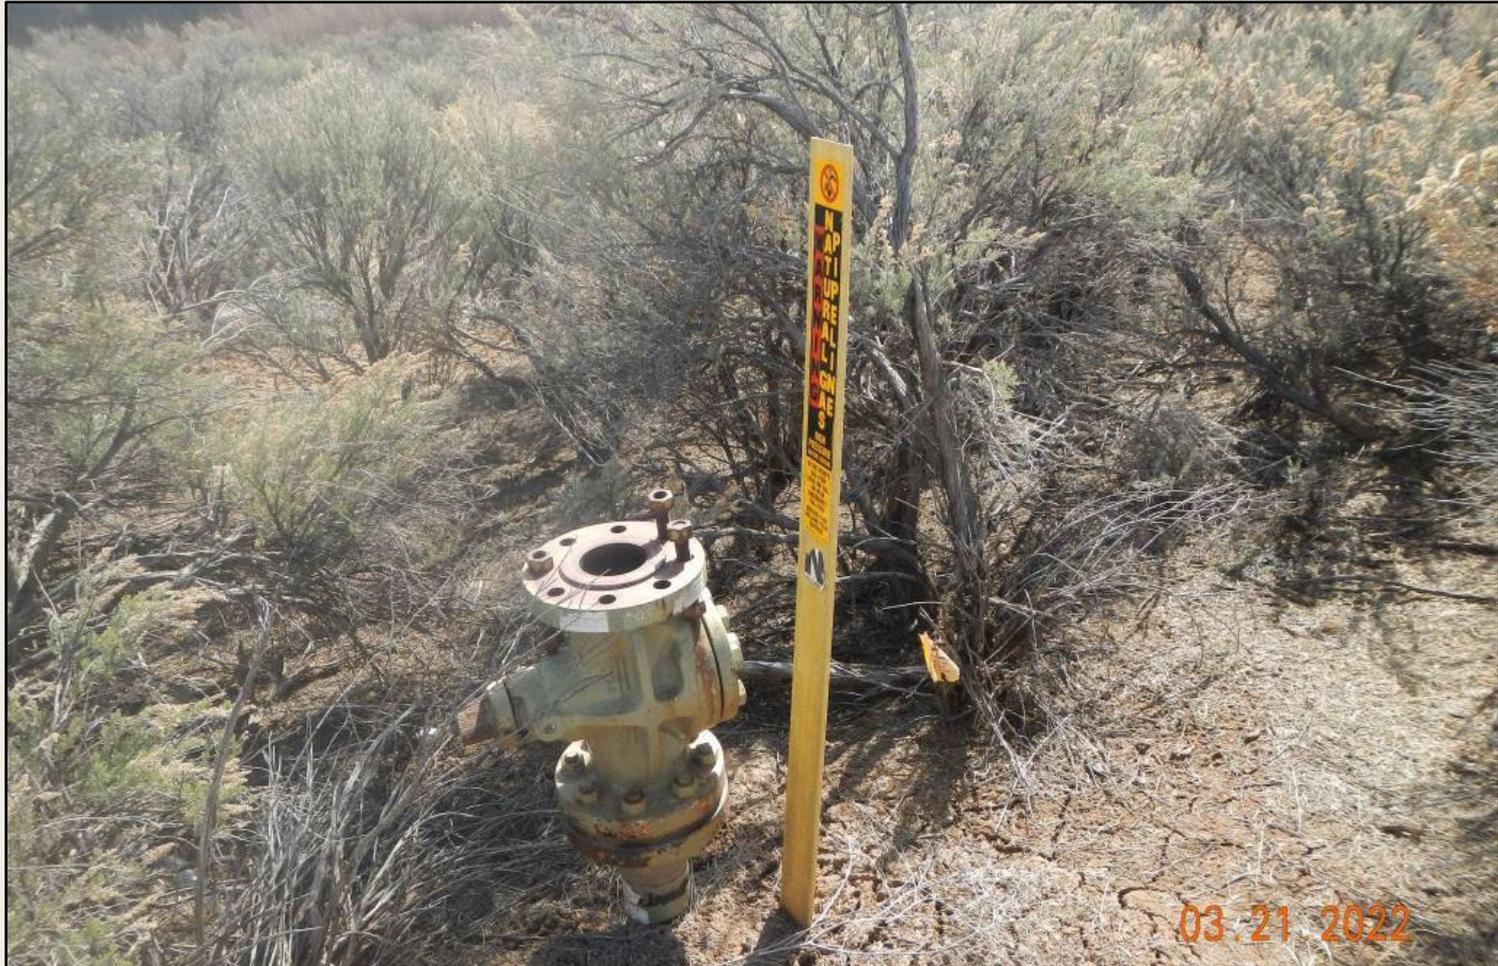
Photo 4. View of riser east of the former well pad that appears to be no longer in use.
