## Inspection Photos

**Location Name: CAERUS PICEANCE LLC KEINATH-68S96W /4SENW**

**Location ID: 334387**

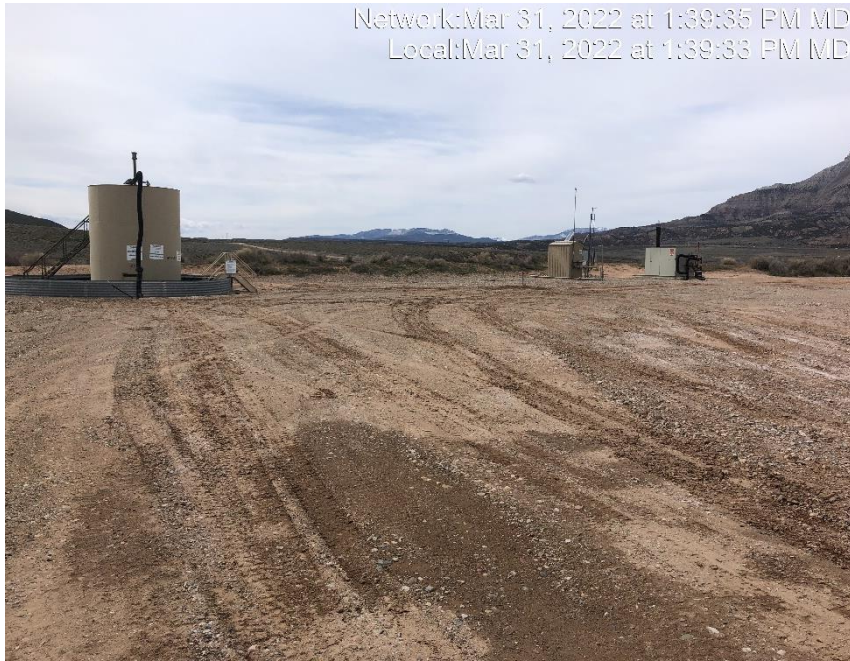
**Photo #6335 from entrance to location.**

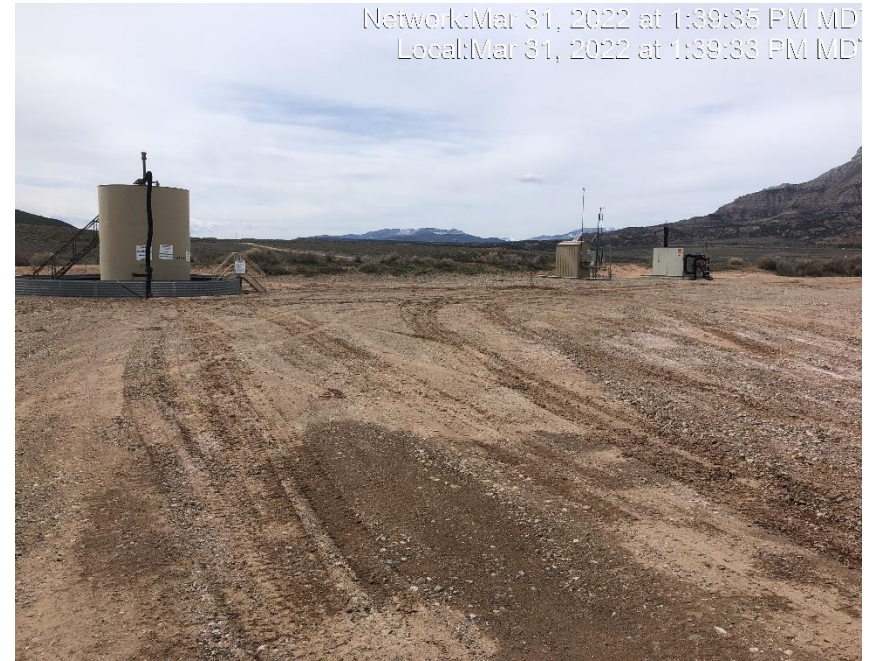
**Photo #6335 No battery sign located at the tank battery.**

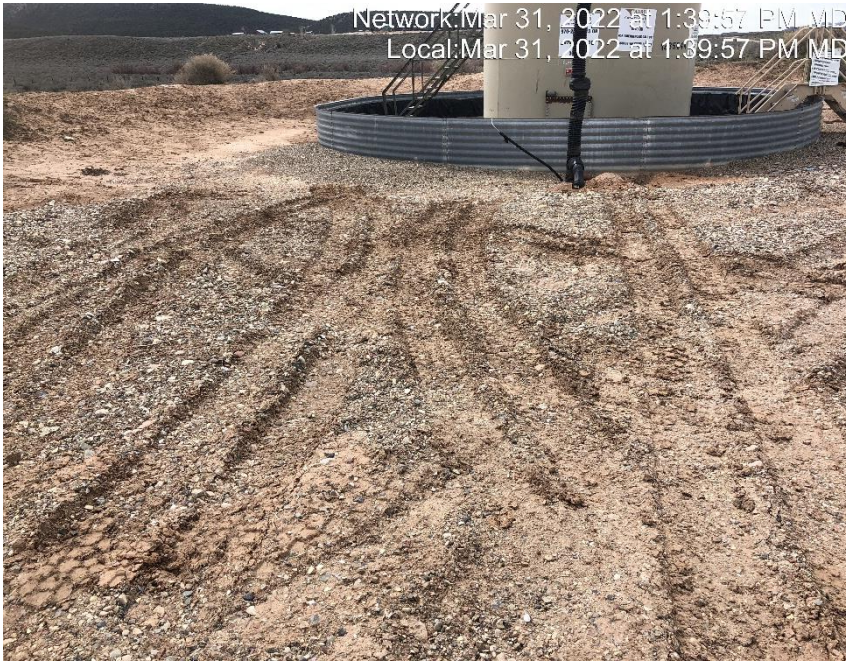
**Photo #6337** Location lacks stabilization.

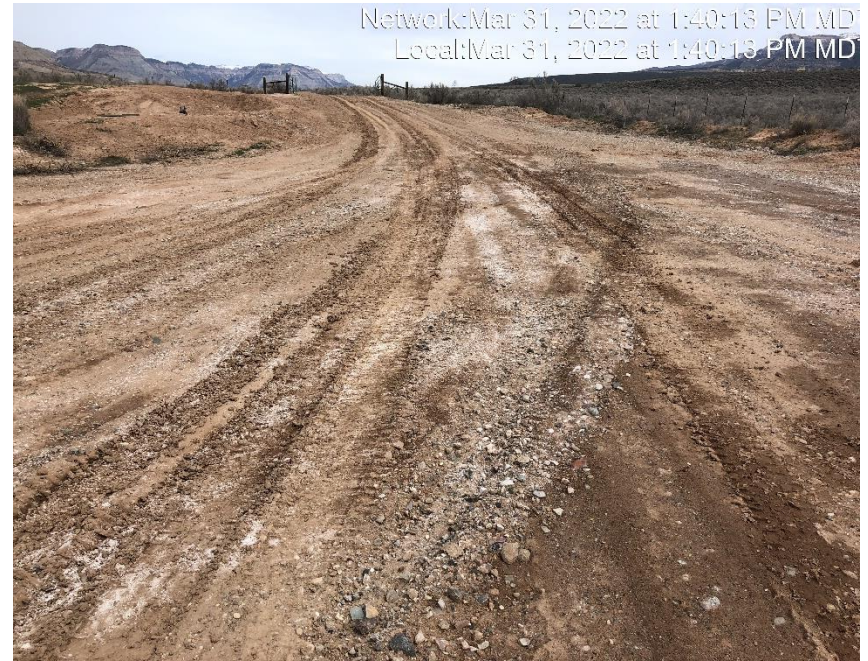
**Photo #6338** Insufficient tracking control located at entrance to location.
