Inspection Photos
Marie Gerhart 9 Spill
Facility ID: 481902

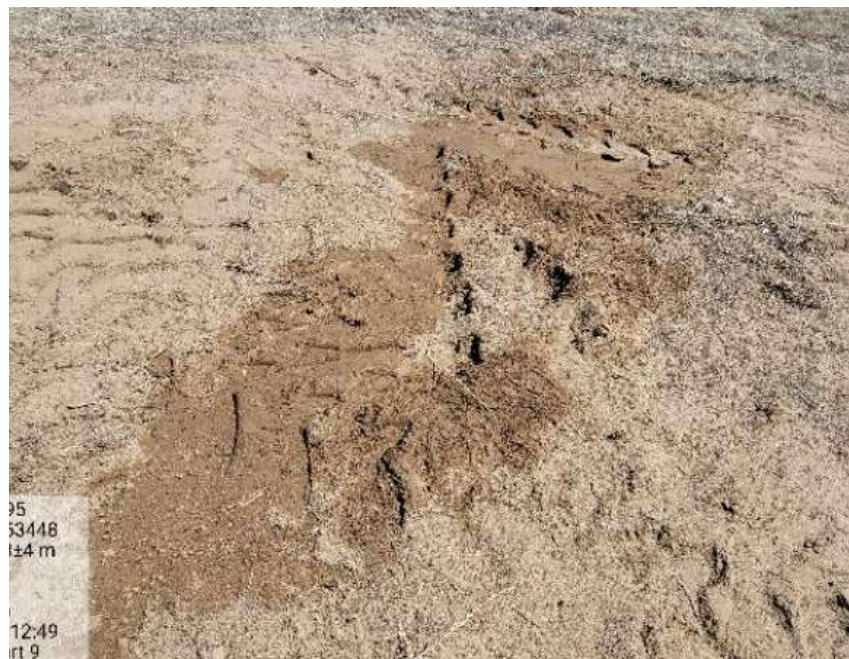
Photo 1 – Spill Location – Stained soils remain in-situ

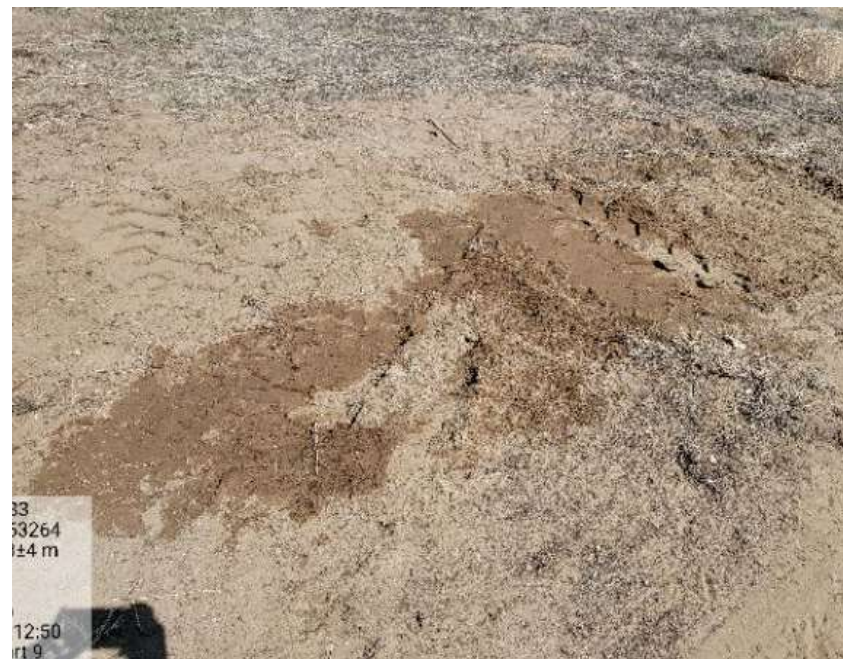
Photo 2 – Spill location – Stained soils remain in-situ

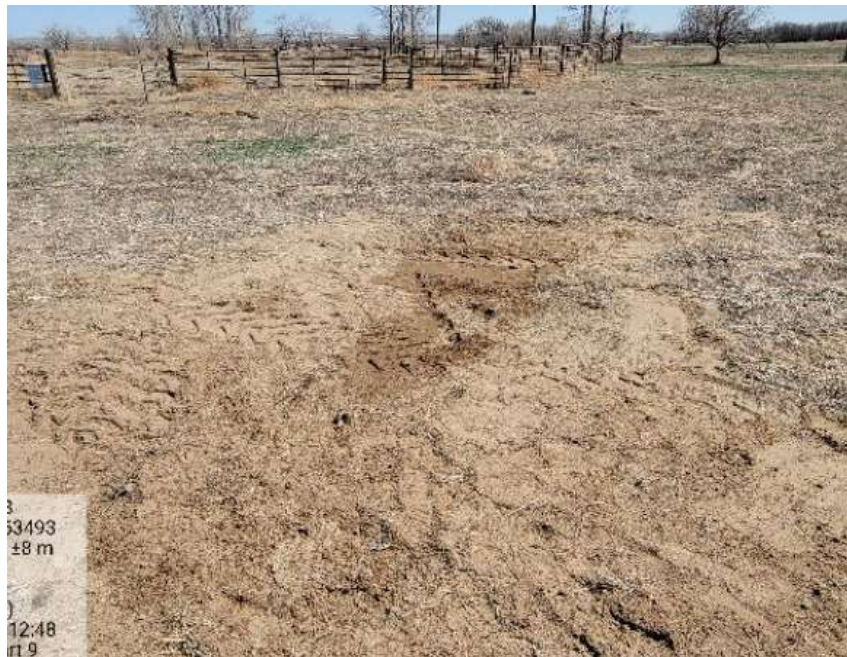
Photo 3 – Spill location relative to livestock pins

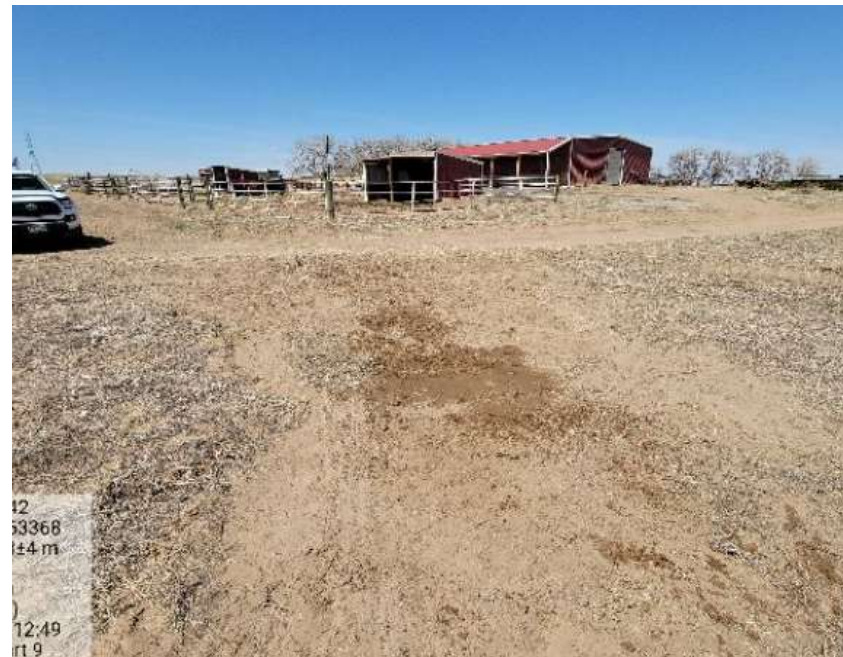
Photo 4 – Spill location relative to livestock pins

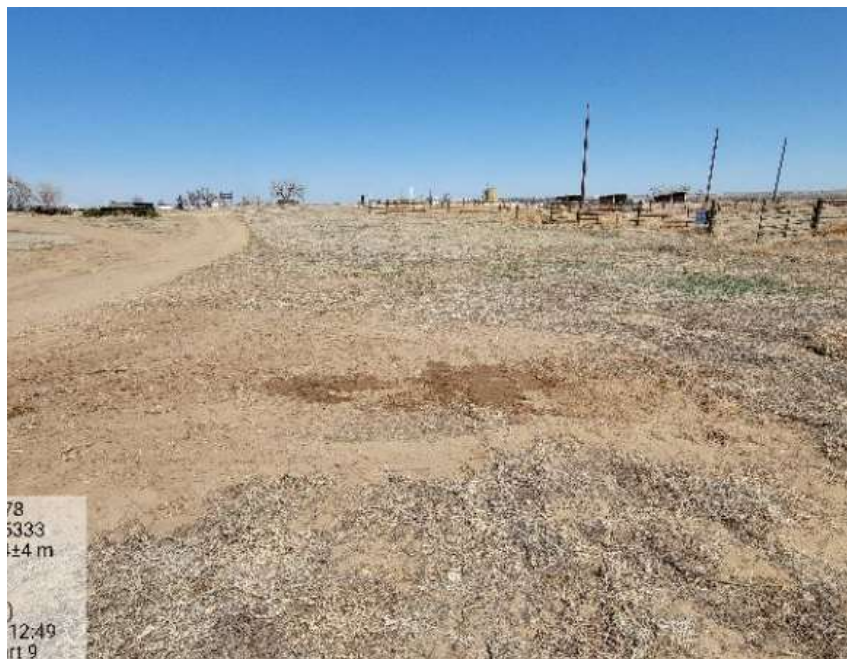
Photo 5 – Spill location relative to Landowner road

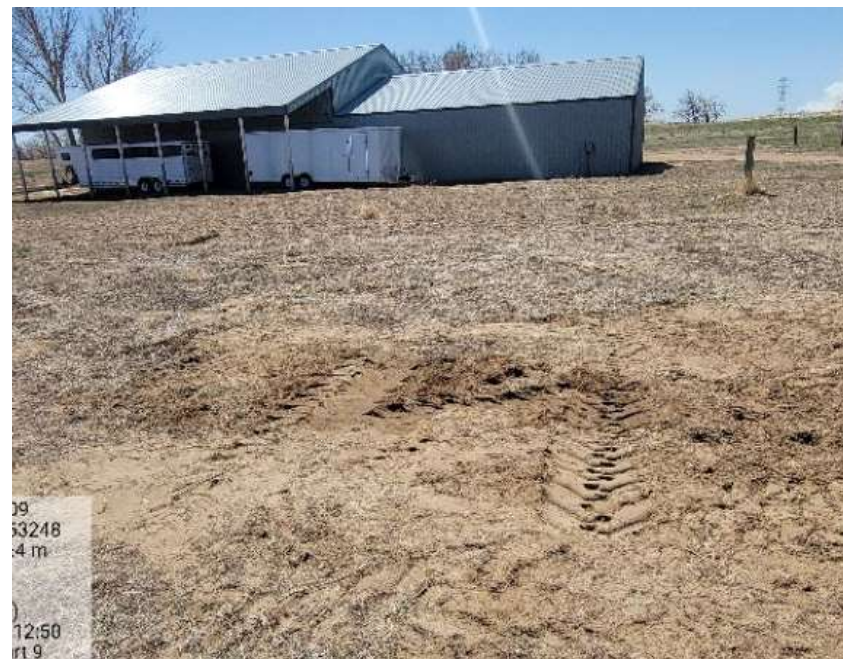
Photo 6 – Spill location relative to Landowner out buildings
