Inspection Photos
Operator: Simcoe
API: 067-07266
Date: 3/28/2022

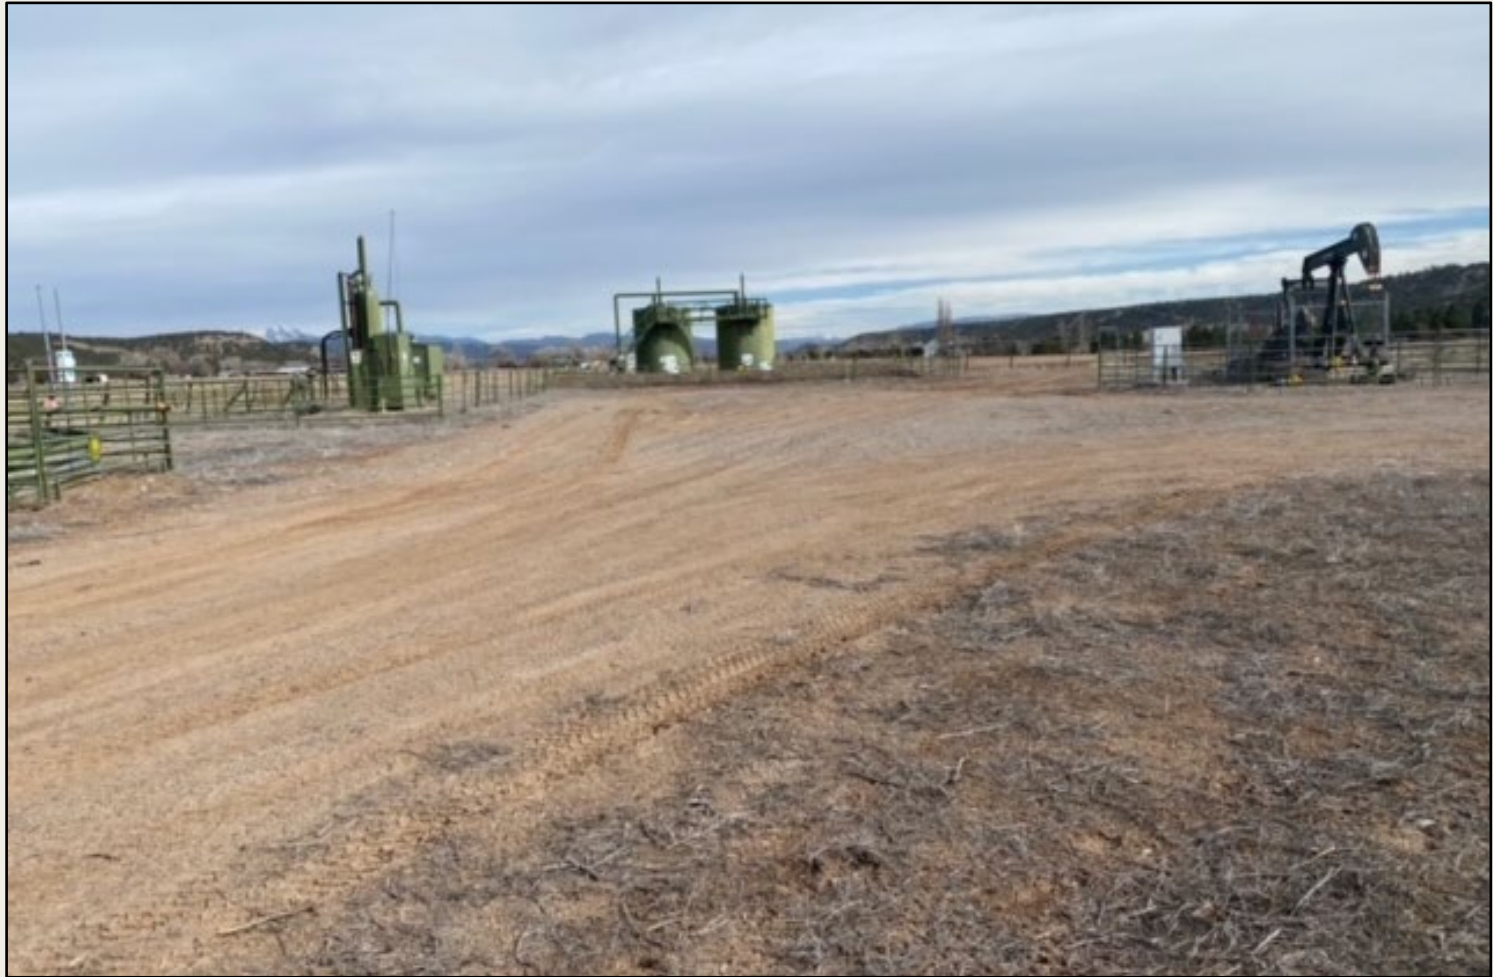
Photo 1. View of the project area from the well pad entrance facing center.

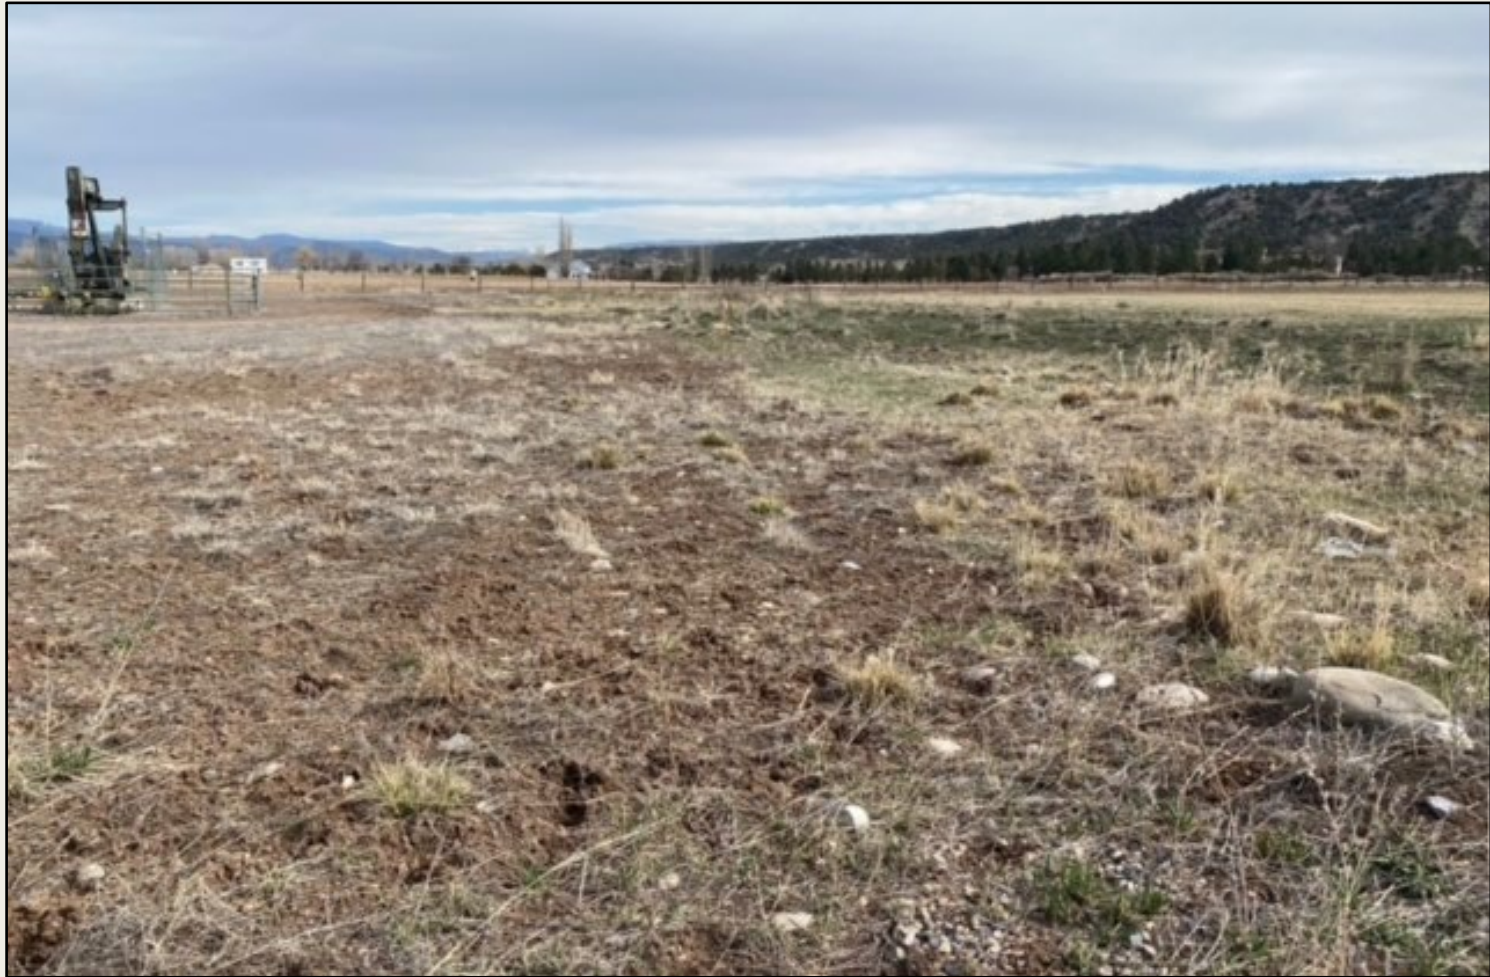
Photo 2. View of the eastern project area from the southeastern corner facing northward. Revegetation is progressing with irrigated and non-irrigated grasses such as western wheatgrass, crested wheatgrass, smooth brome, and sand dropseed.

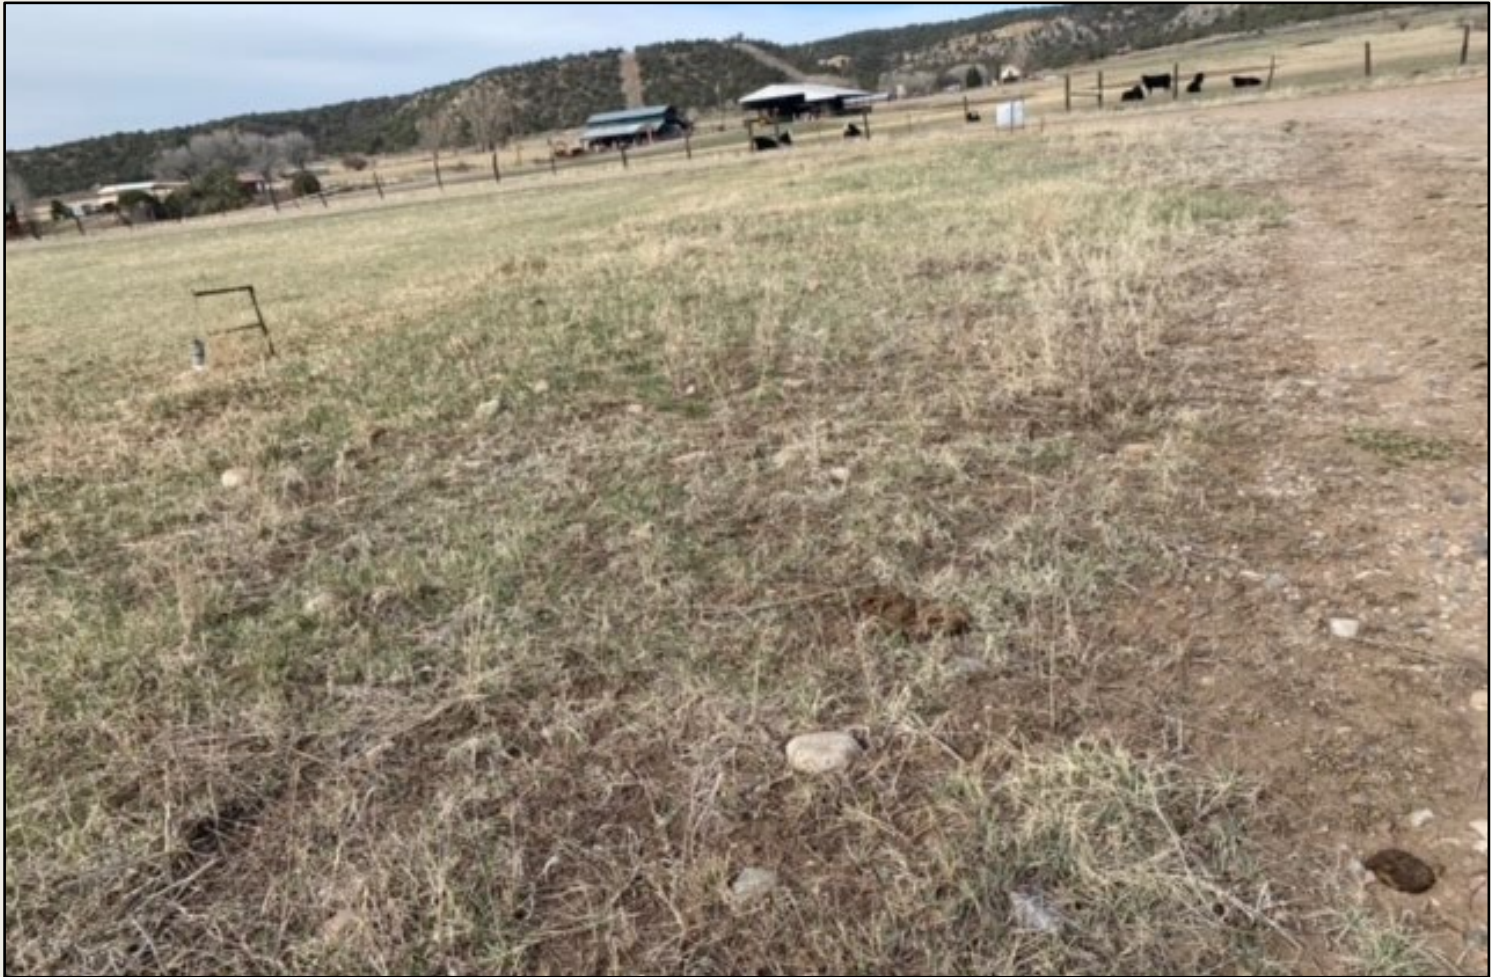
Photo 3. View of the southern project area from the southeastern corner facing westward.

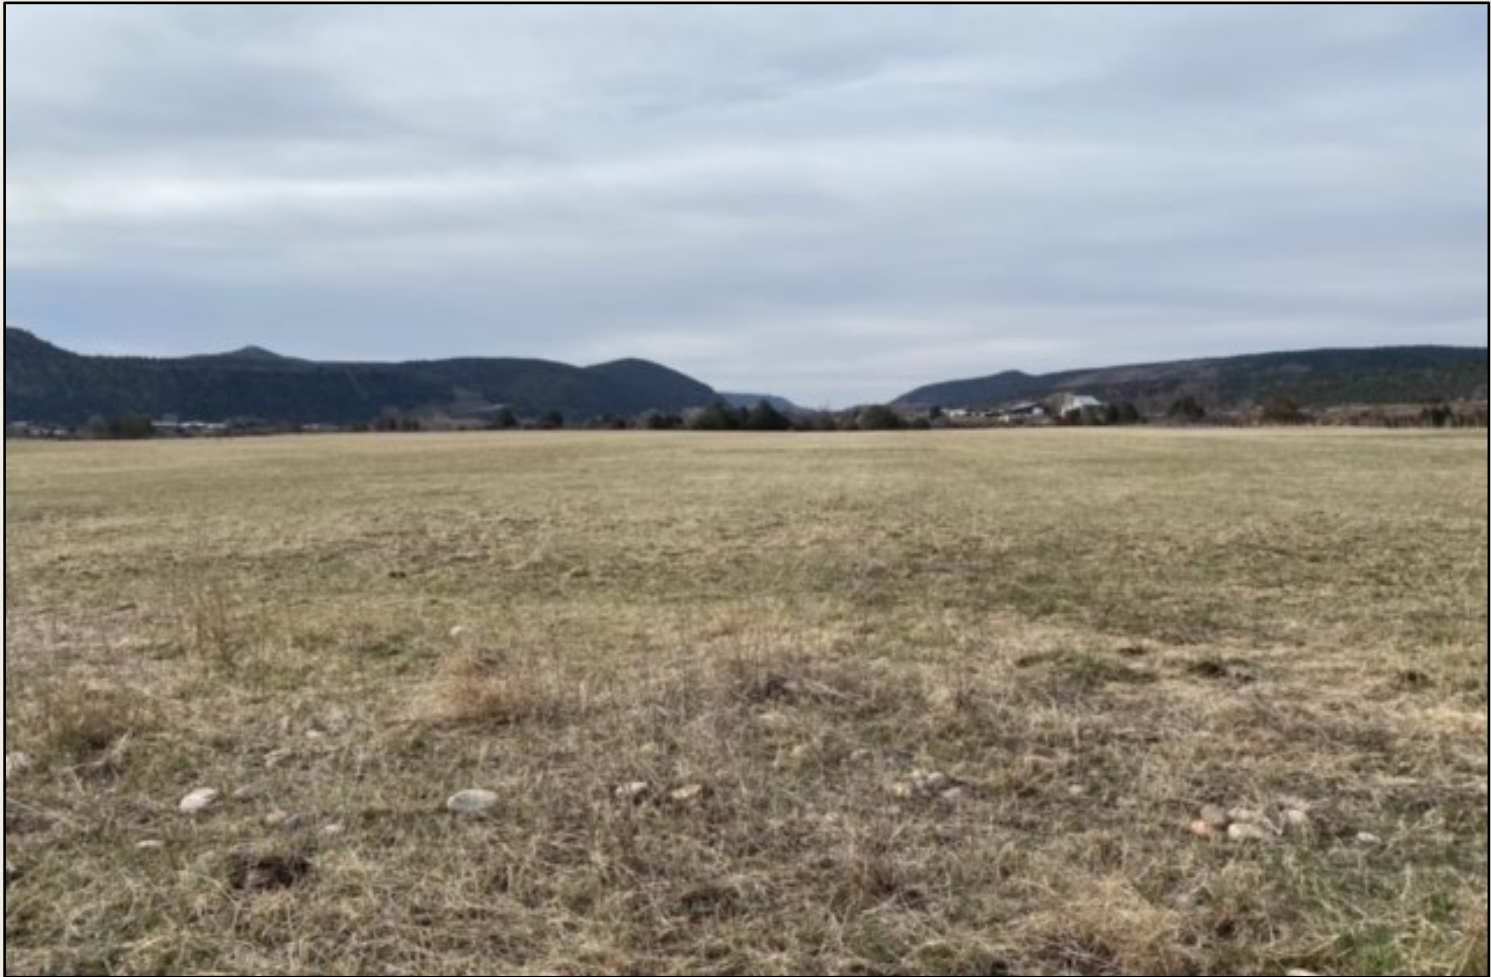
Photo 4. View of reference area comprised of irrigated grass field with smooth brome and western wheatgrass observed.
