Inspection Photos
Operator: Simcoe
API: 067-06330
Date: 3/28/2022

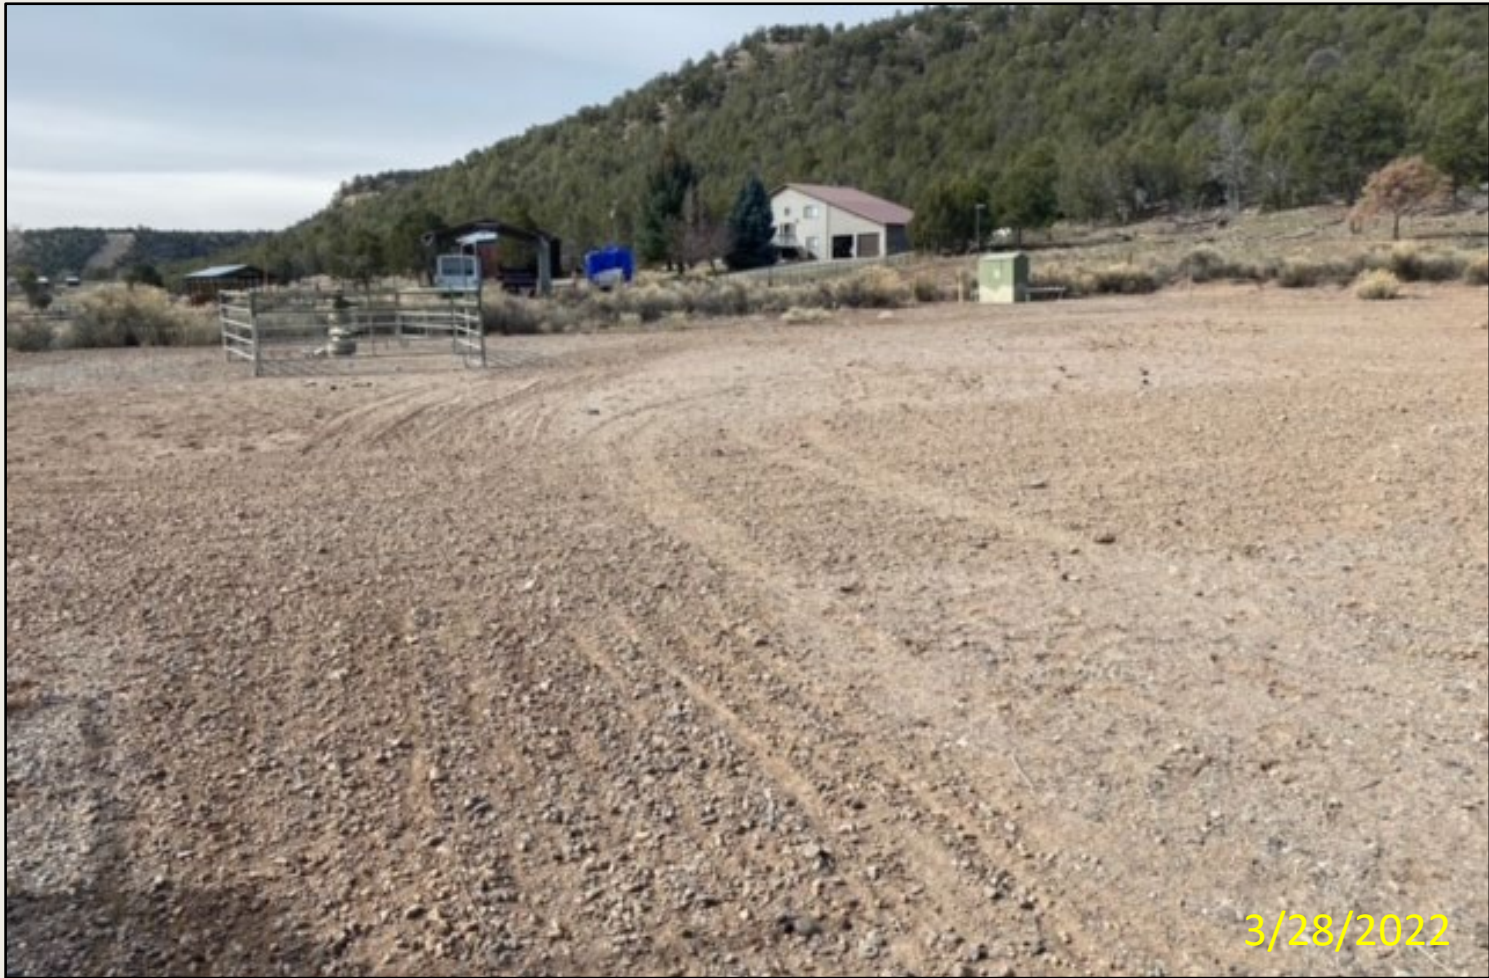
Photo 1. View of the project area from the well pad entrance facing center.

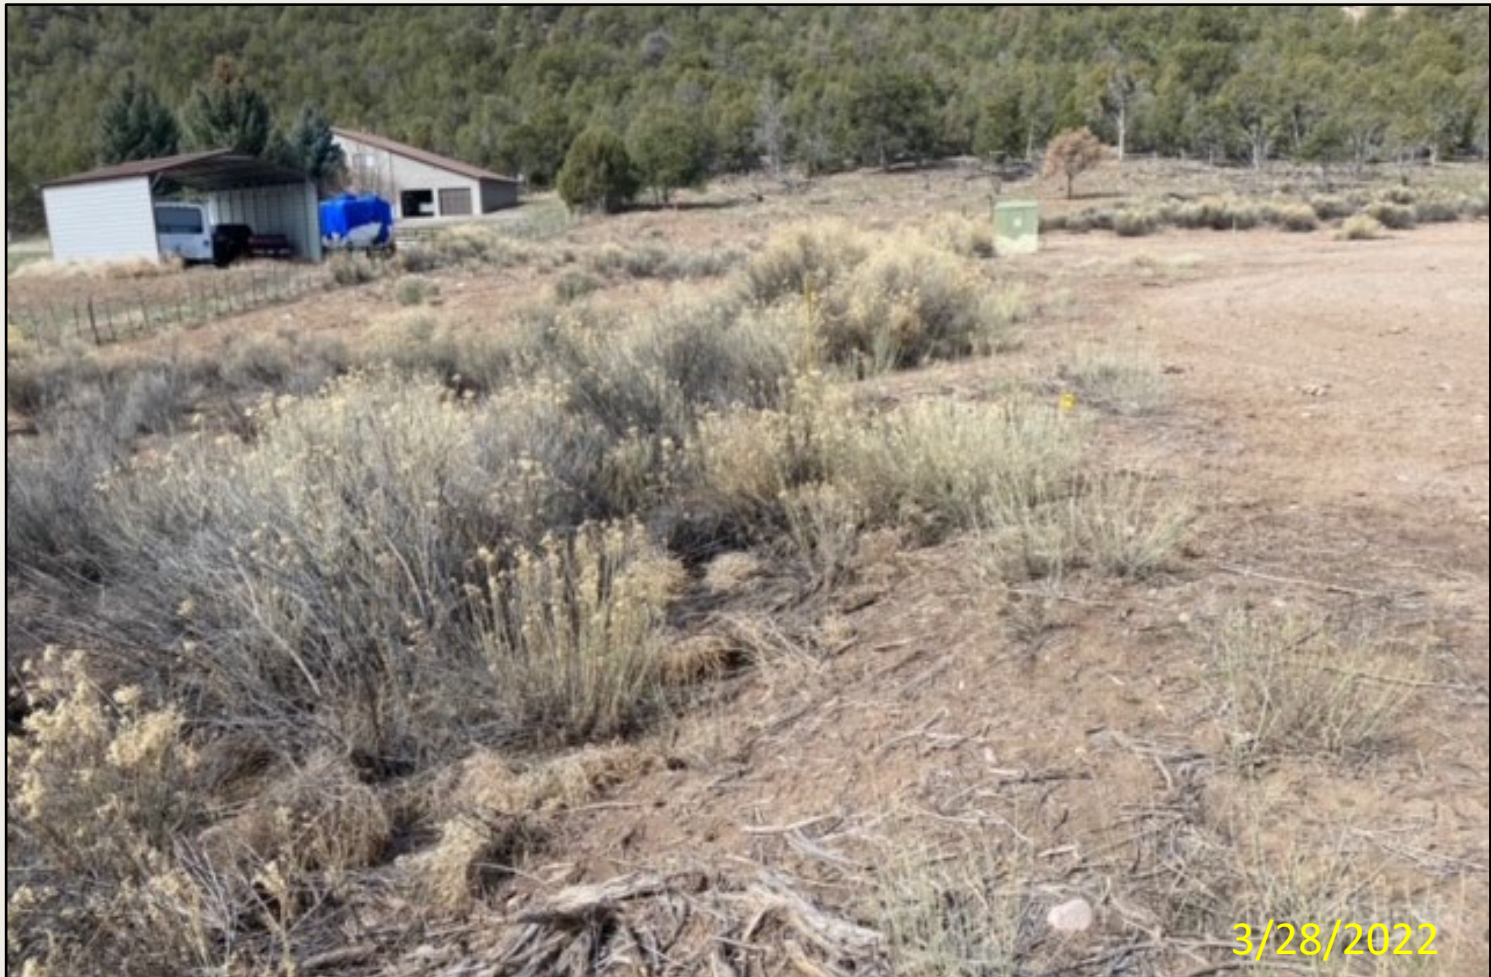
Photo 2. View of the southern project area from the southeastern corner facing westward. Revegetation is progressing here with dense rubber rabbitbrush.

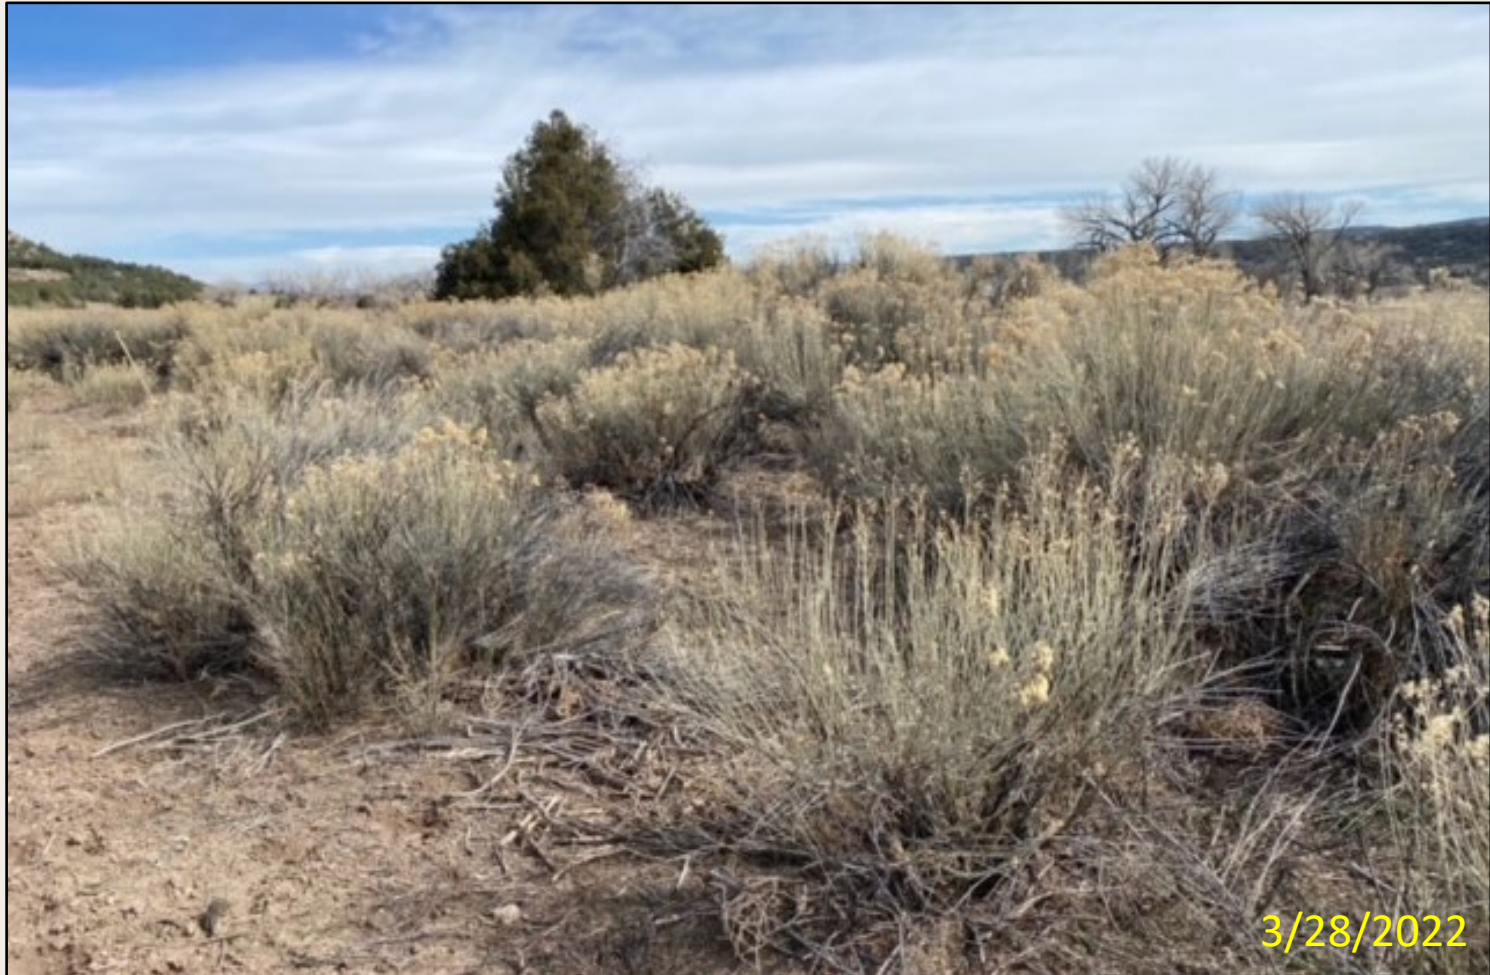
Photo 3. View of the eastern project area from the southeastern corner facing northward.

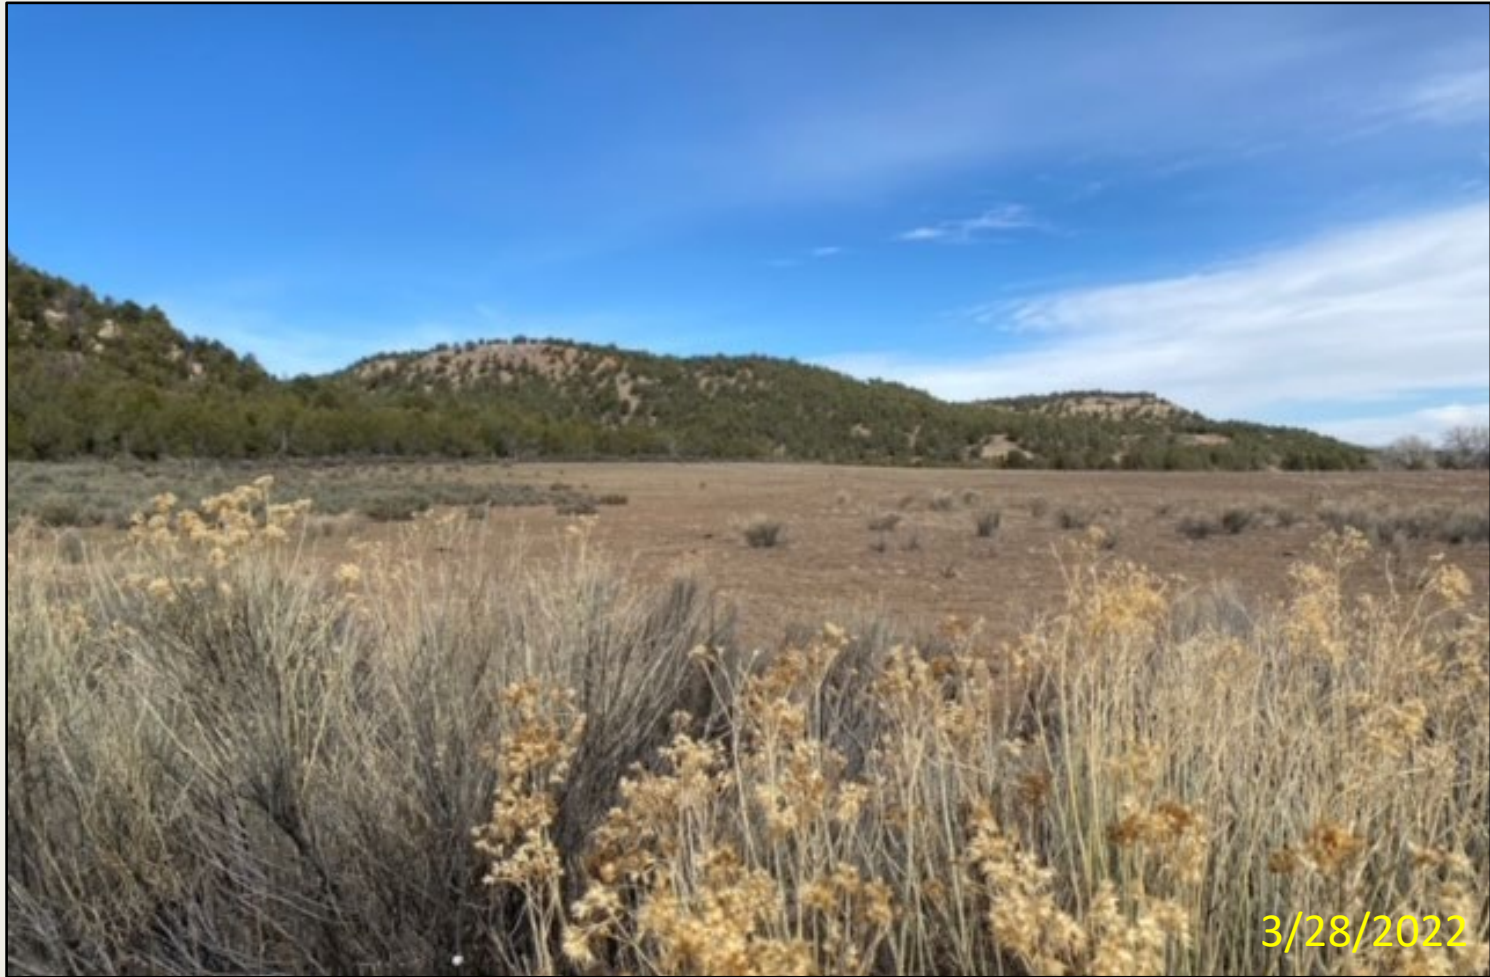
Photo 4. View of reference area comprised of rubber rabbitbrush shrubland and grass field with grasses largely in a grazed vegetative condition at this time.
