Inspection Photos

4/04/2022

Operator: GUNNISON ENERGY LLC - 10515

Location ID: 324464

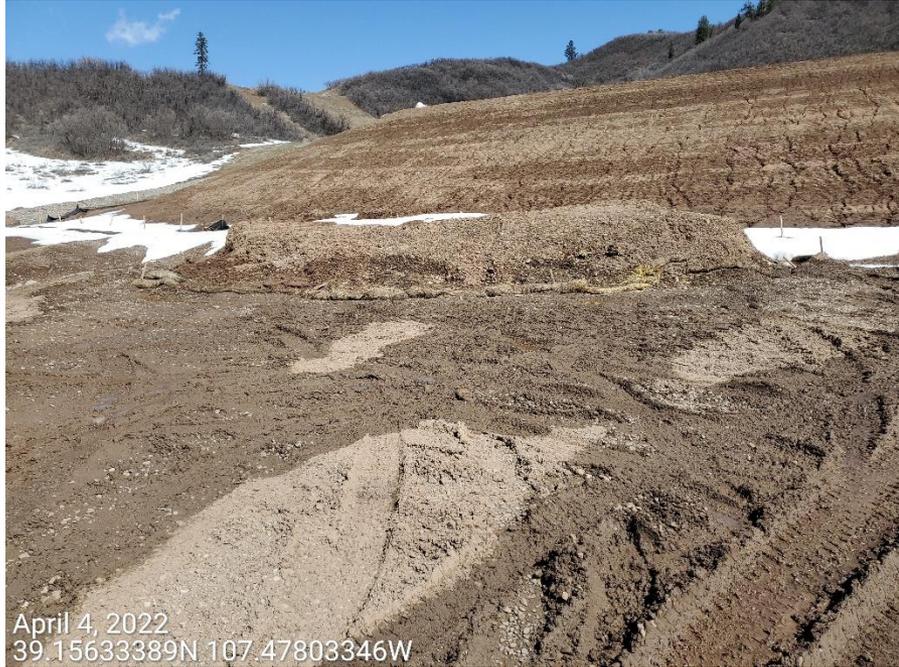
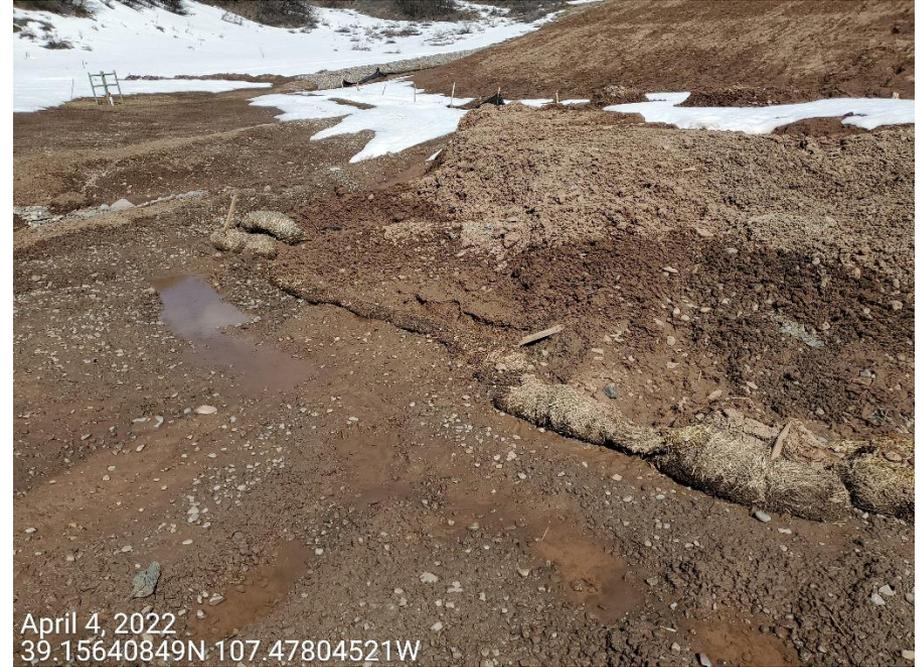
Photo 1: Photos taken from the soil stockpile on the Location; Operator has placed a straw wattle at base of stockpile; BMP has not been installed per good engineering practices, or maintained in a proper functioning condition. BMPs at stockpile remain inadequate.

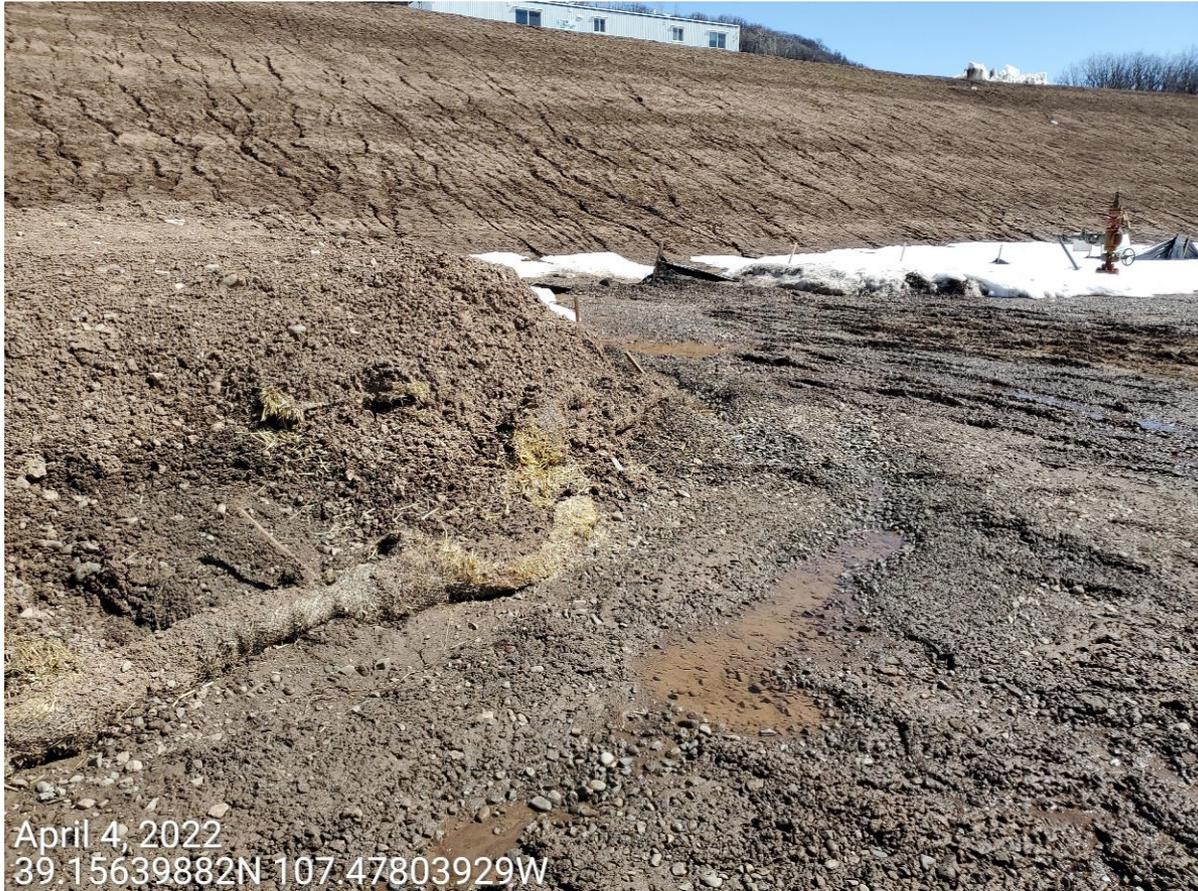
Photo 2: Photos taken from the soil stockpile on the Location; Operator has placed a straw wattle at base of stockpile; BMP has not been installed per good engineering practices, or maintained in a proper functioning condition. BMPs at stockpile remain inadequate.

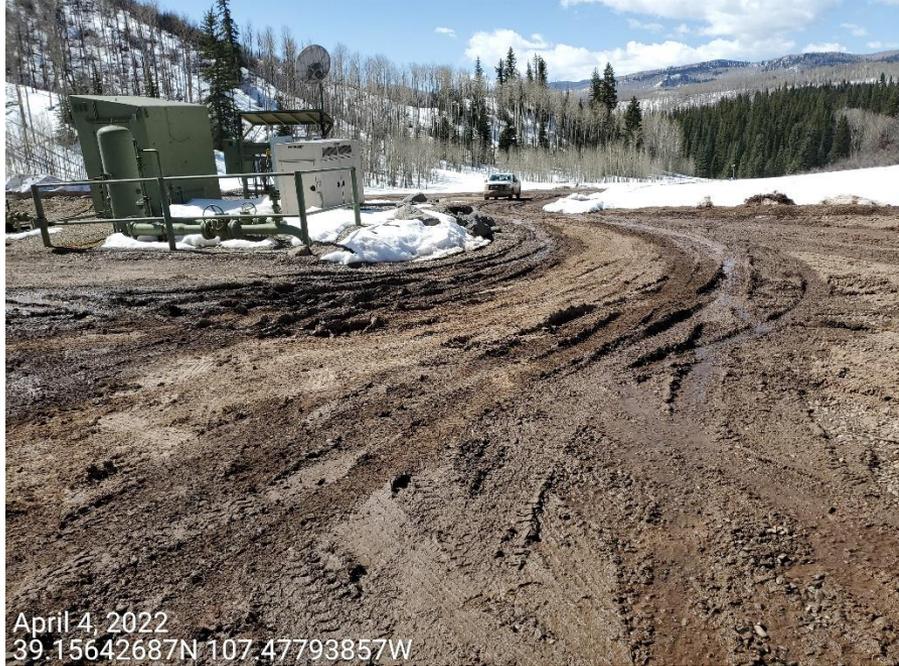
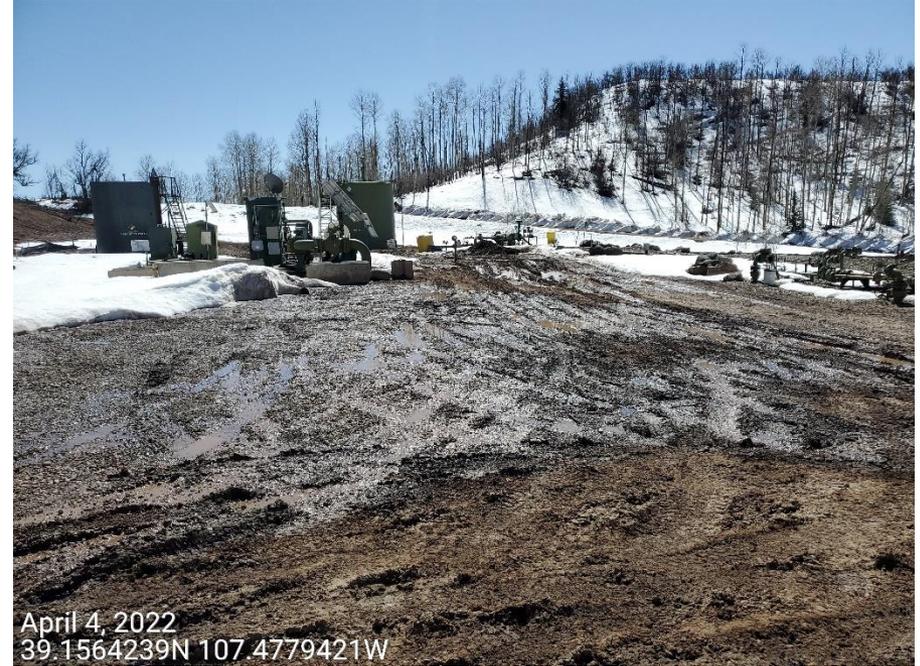
Photo 3: Photos show inadequate stabilization and tracking BMPs on the Location.

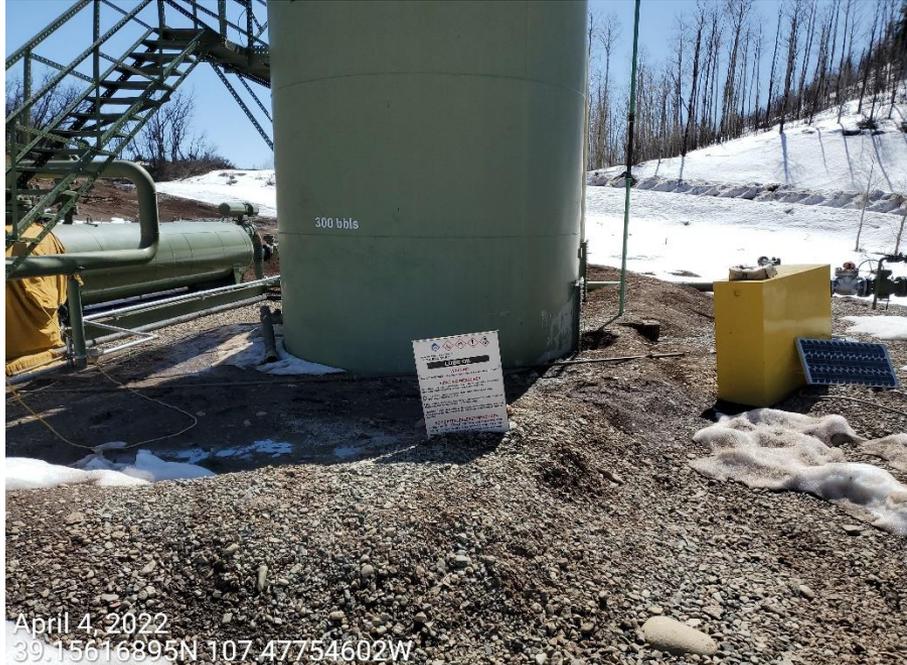
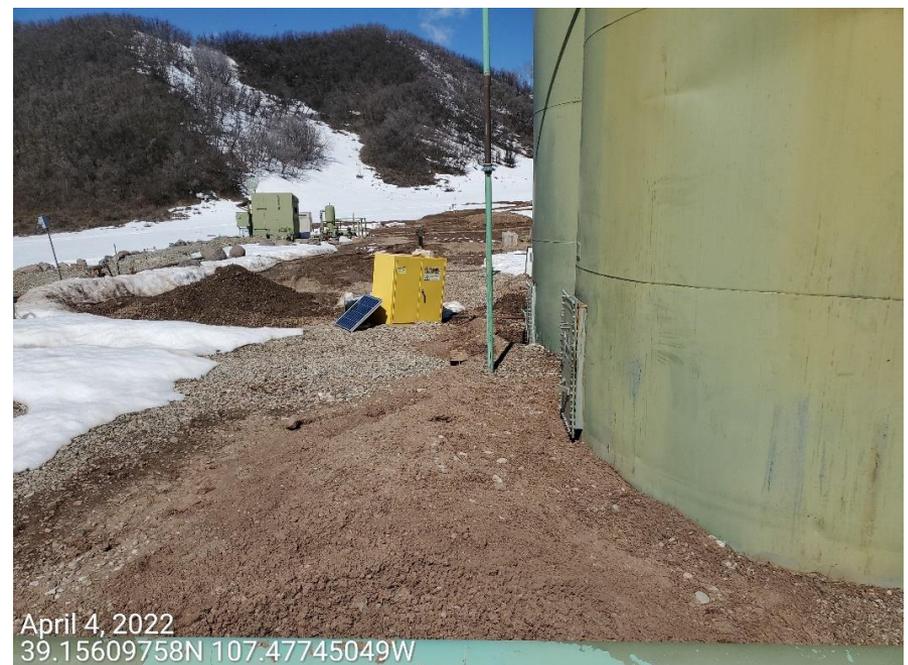
Photo 4: Photos show adequate, impervious containment has not been installed at the tanks in accordance with good engineering practices.

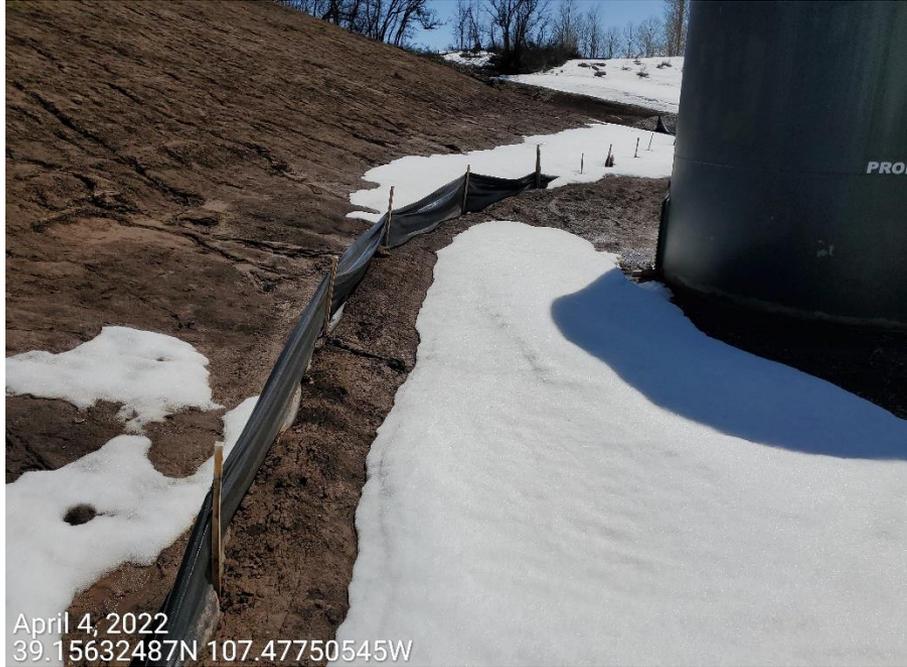
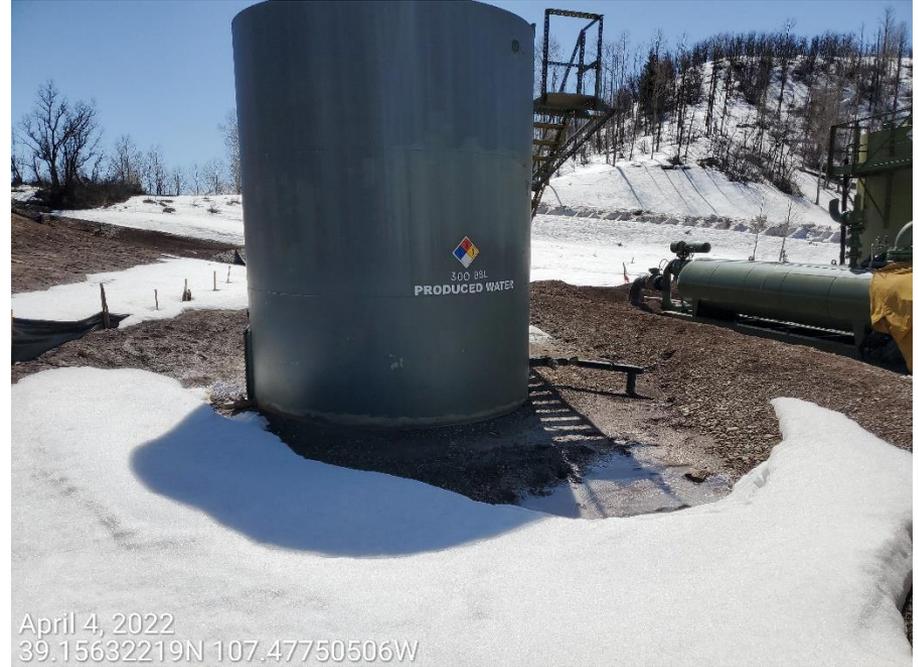
Photo 5: Photos show adequate, impervious containment has not been installed at the tanks in accordance with good engineering practices.

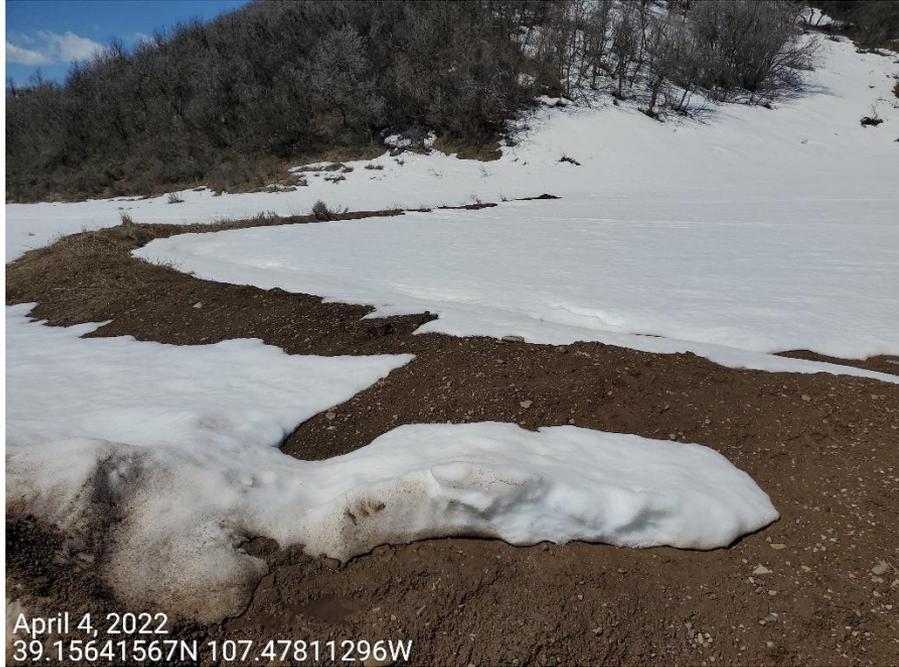
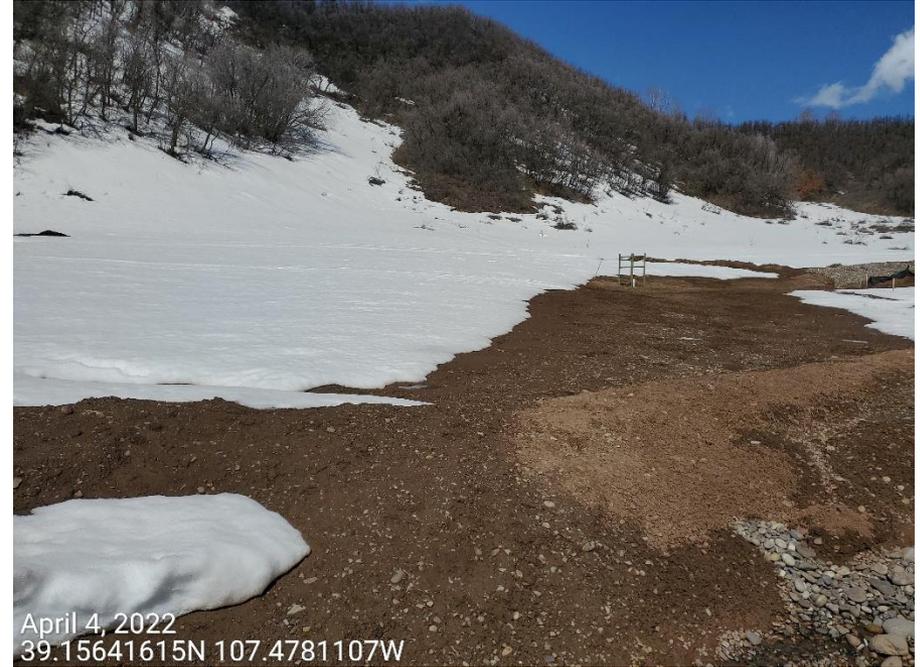
Photo 6: Photos taken from the interim areas on the north/northwest end of the Location. Equipment/Vehicles/Trash/Debris/etc.. previously being stored on interim areas have been removed. Limited visibility due to snow cover prevented Reclamation Specialist from conducting an accurate assessment of the interim areas; however, unable to find evidence that reclamation per Rule 1003.b has been conducted on areas not needed for production, and no “CA Complete” resolution has been submitted with documentation showing work was completed..
