Inspection Photos  
Operator: Logos  
API: 067-08097  
Date: 4/5/2022

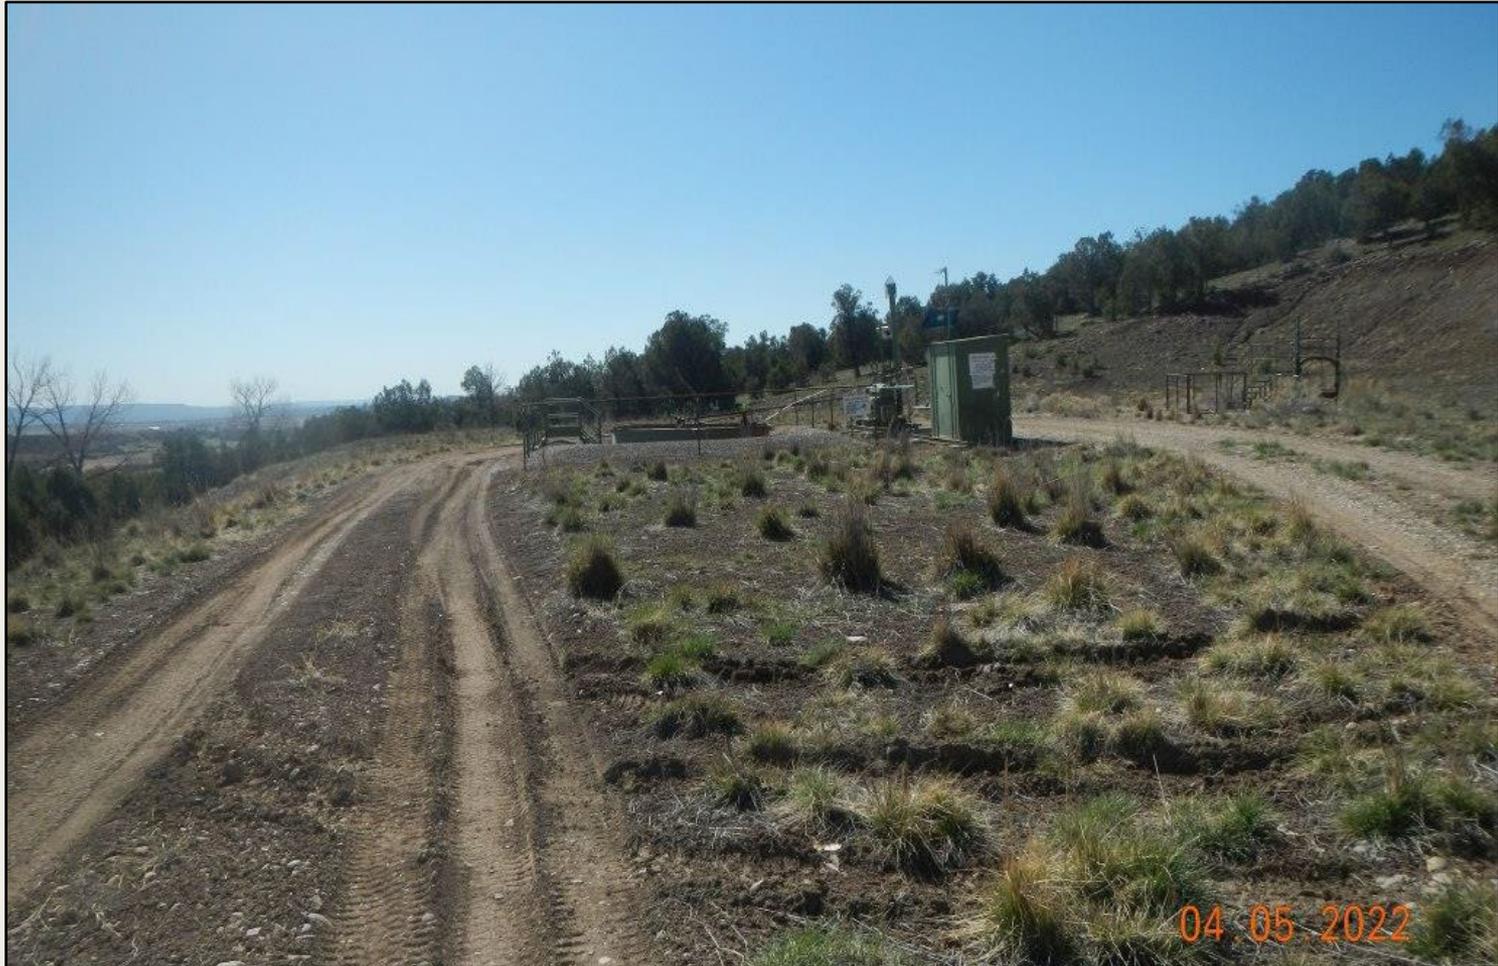
Photo 1. View of the project area from the well pad entrance facing center.

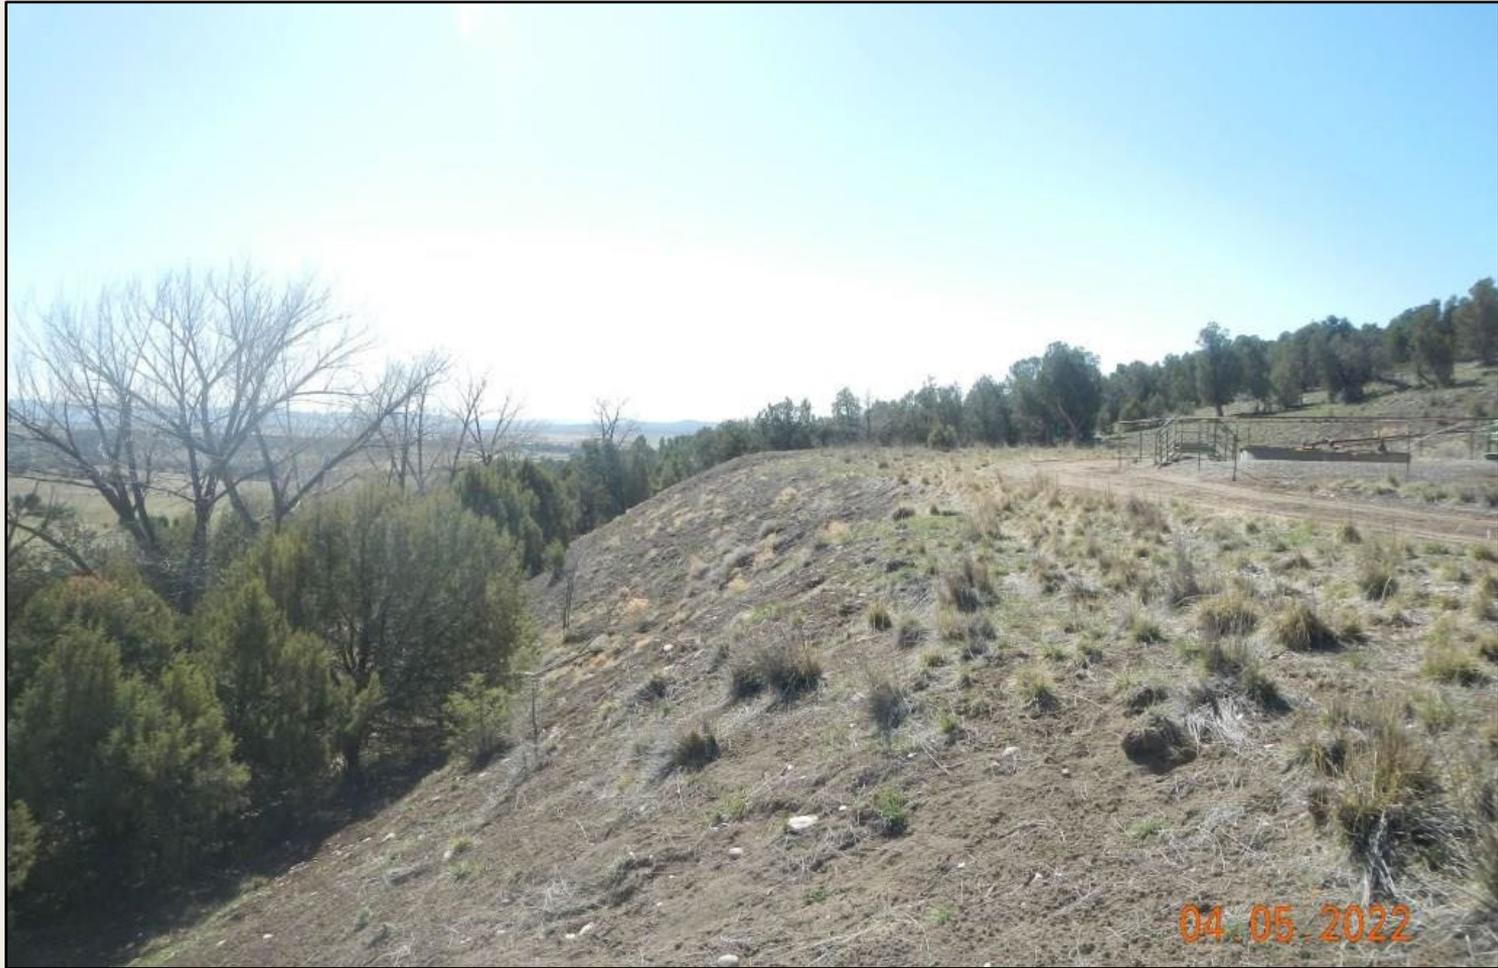
Photo 2. View of the eastern fill slope from the northeastern corner facing southward. Revegetation remains sparse on this slope with scattered grasses such as crested wheatgrass and intermediate wheatgrass becoming established in portions.

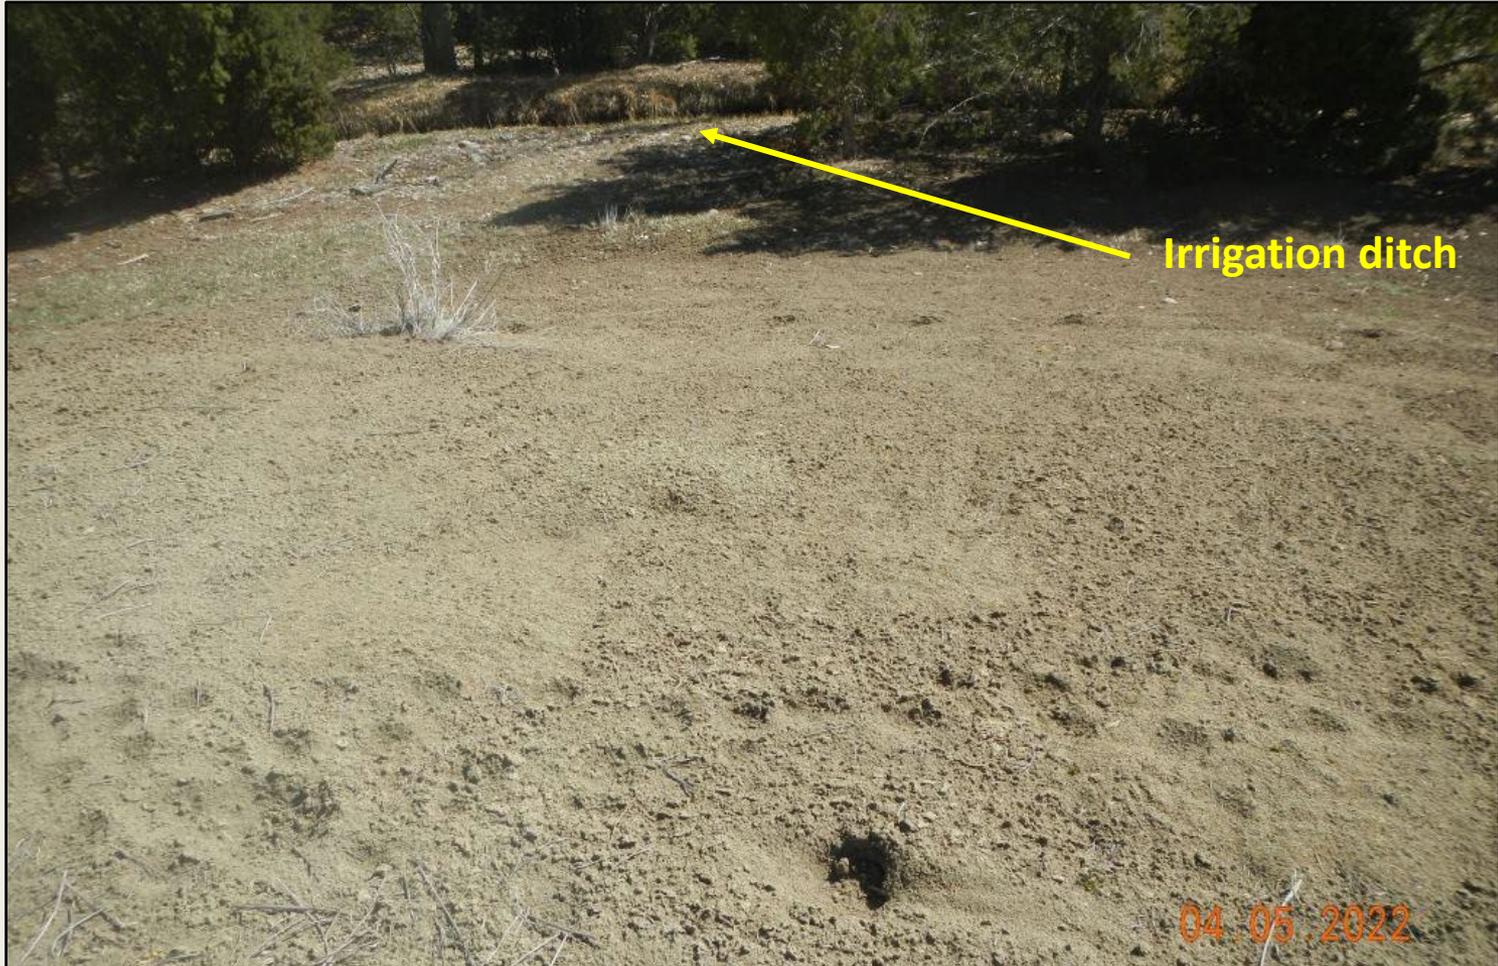
Photo 3. View of bare soils within the eastern fill slope, facing downslope. Irrigation ditch observed at the bottom of the slope.

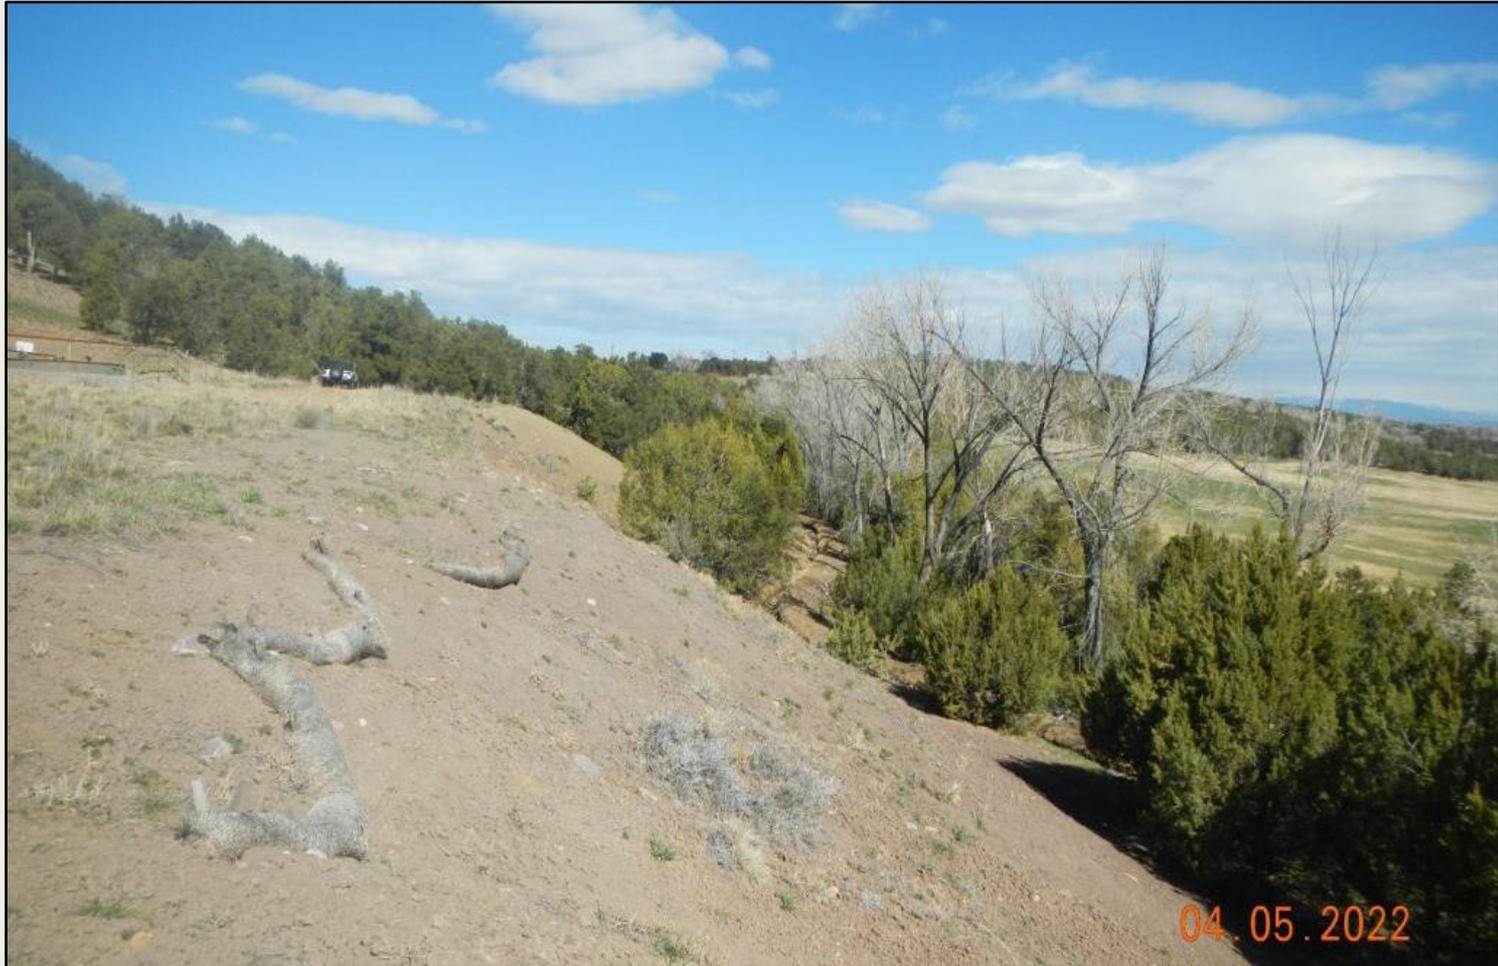
Photo 4. View of the southeastern portion of the fill slope facing northward. Wattles are full of sediment with gaps observed through them. Additional stabilization is needed.

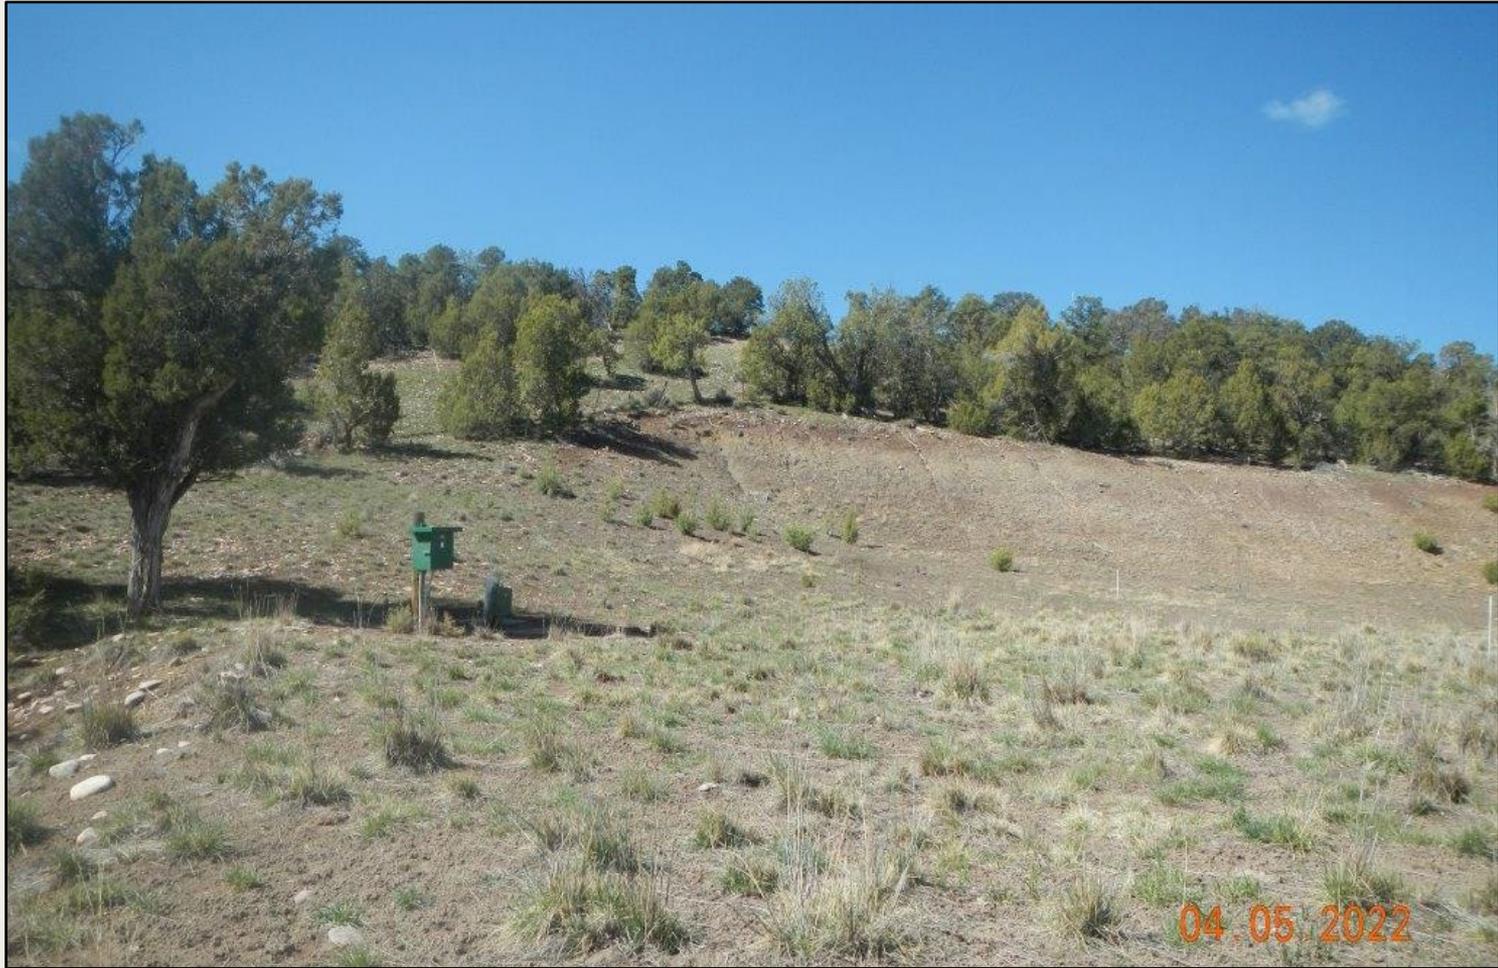
Photo 5. View of the southern project area from the southeastern corner facing westward.

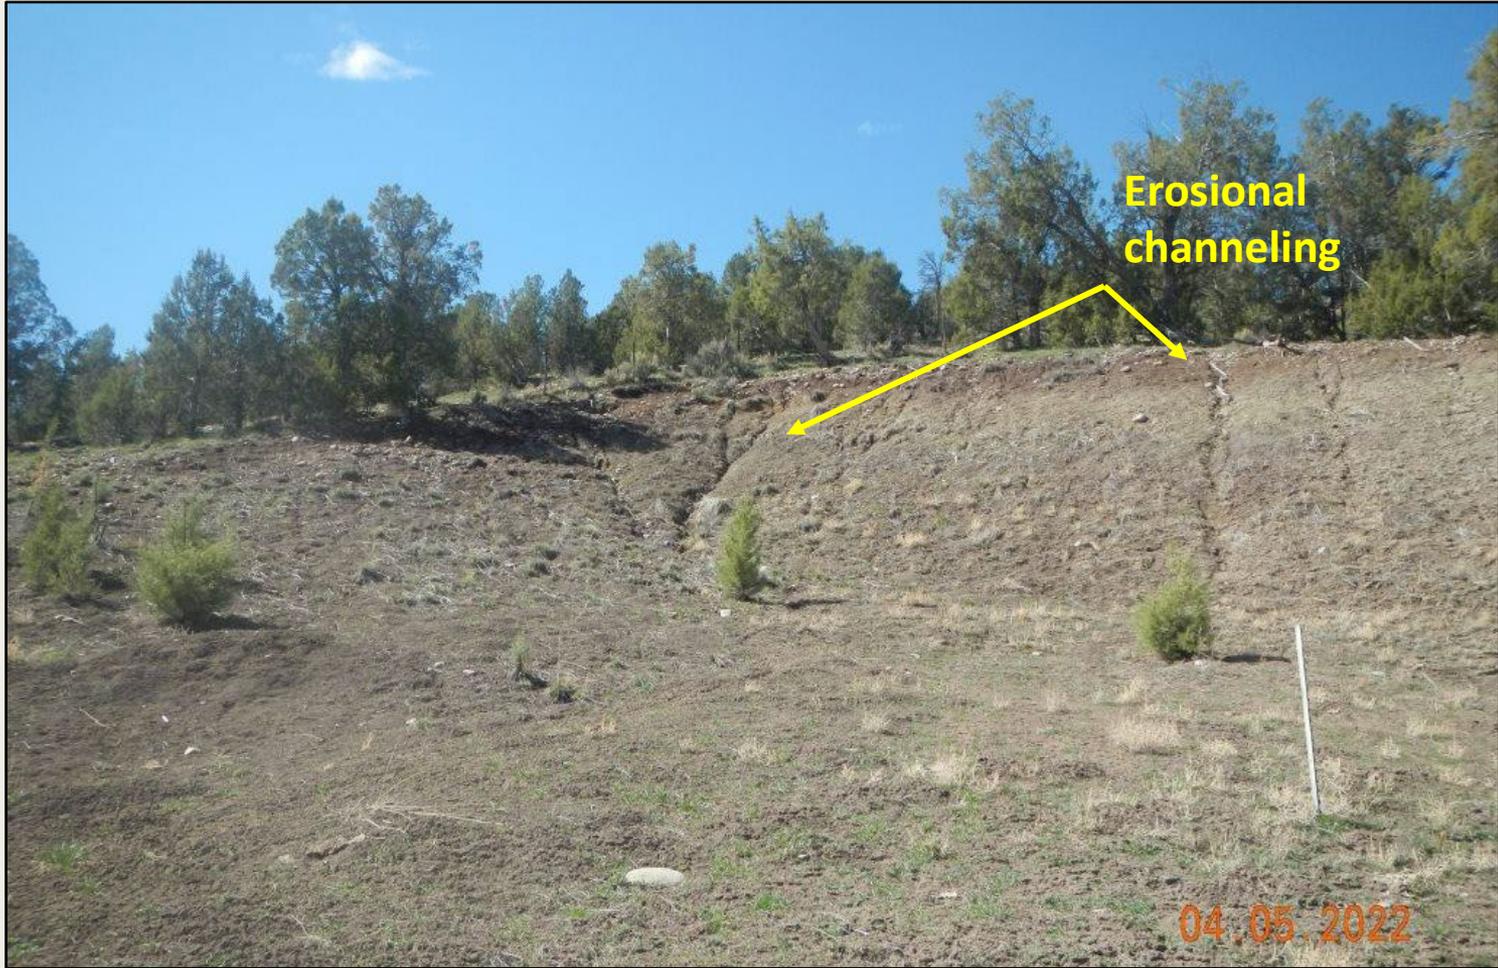
Photo 6. View of erosional channeling on the southeastern cut-slope, approximately 1-2 ft wide and deep.

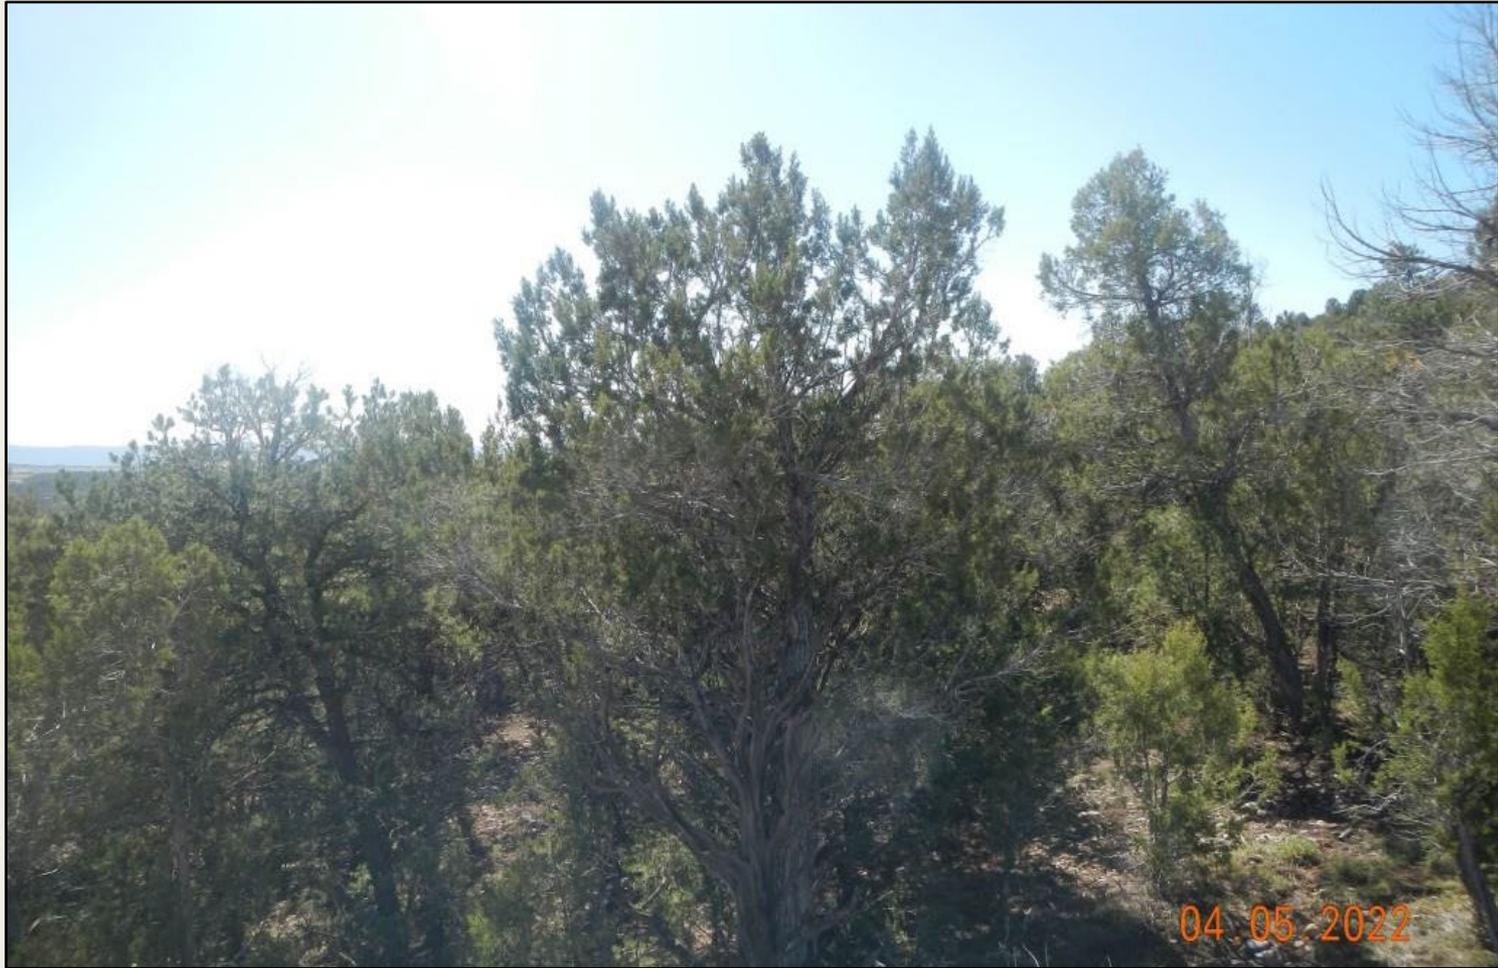
Photo 7. View of reference area comprised of pinyon and juniper woodland with understory of blue grama, prickly pear, Indian ricegrass, sagebrush, and banana yucca.
