Inspection Photos  
Operator: Hilcorp  
API: 067-08671  
Date: 4/5/2022

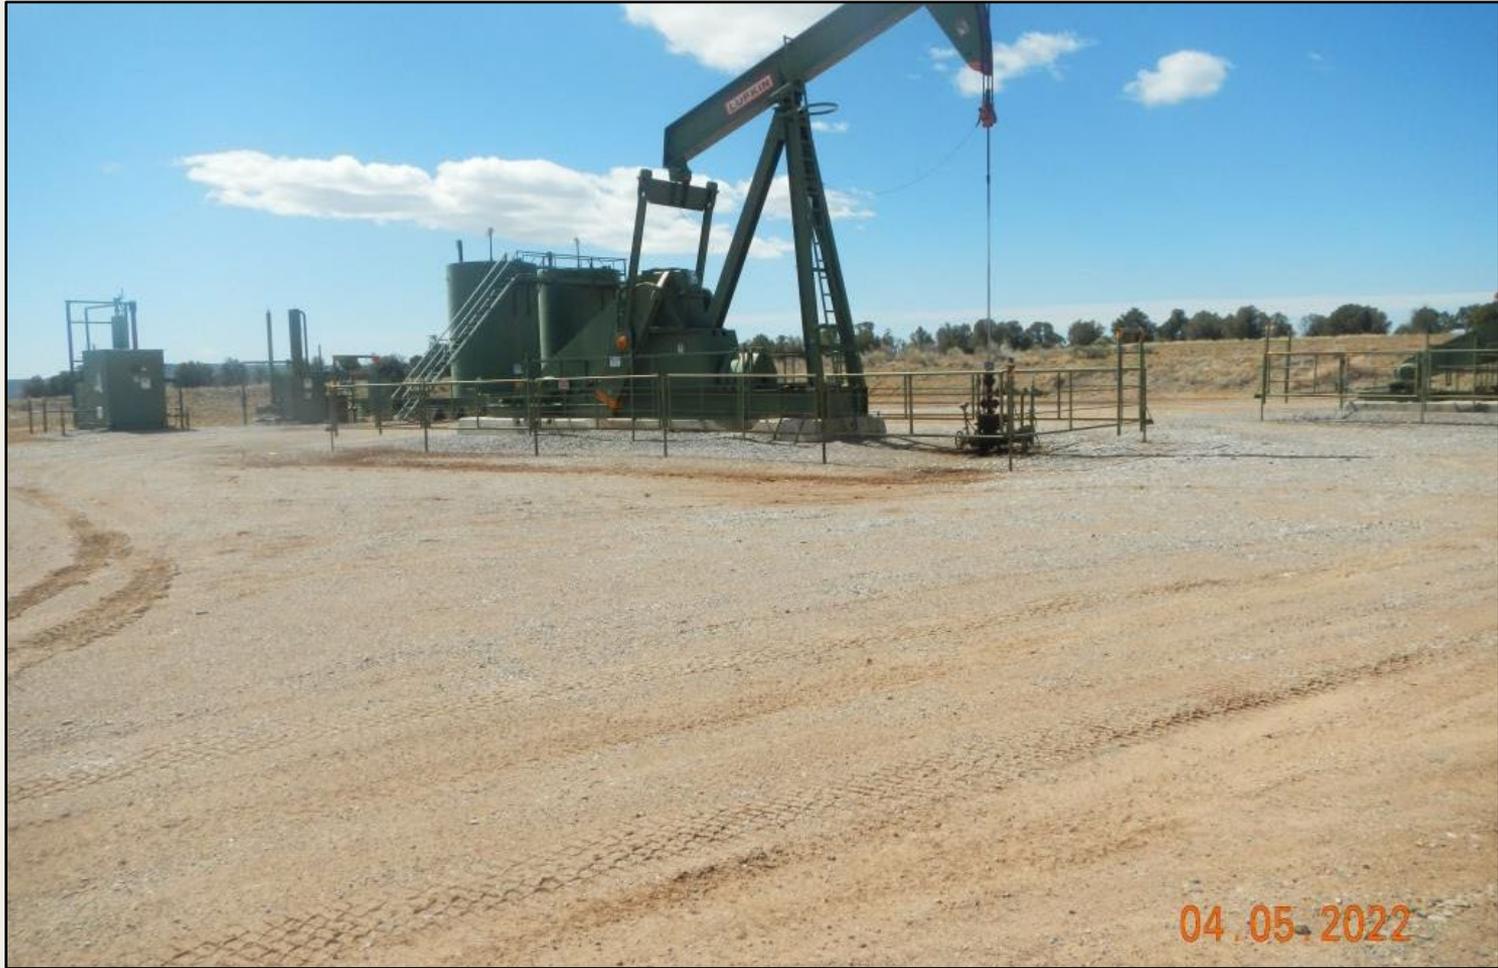
Photo 1. View of the project area from the well pad entrance facing center.

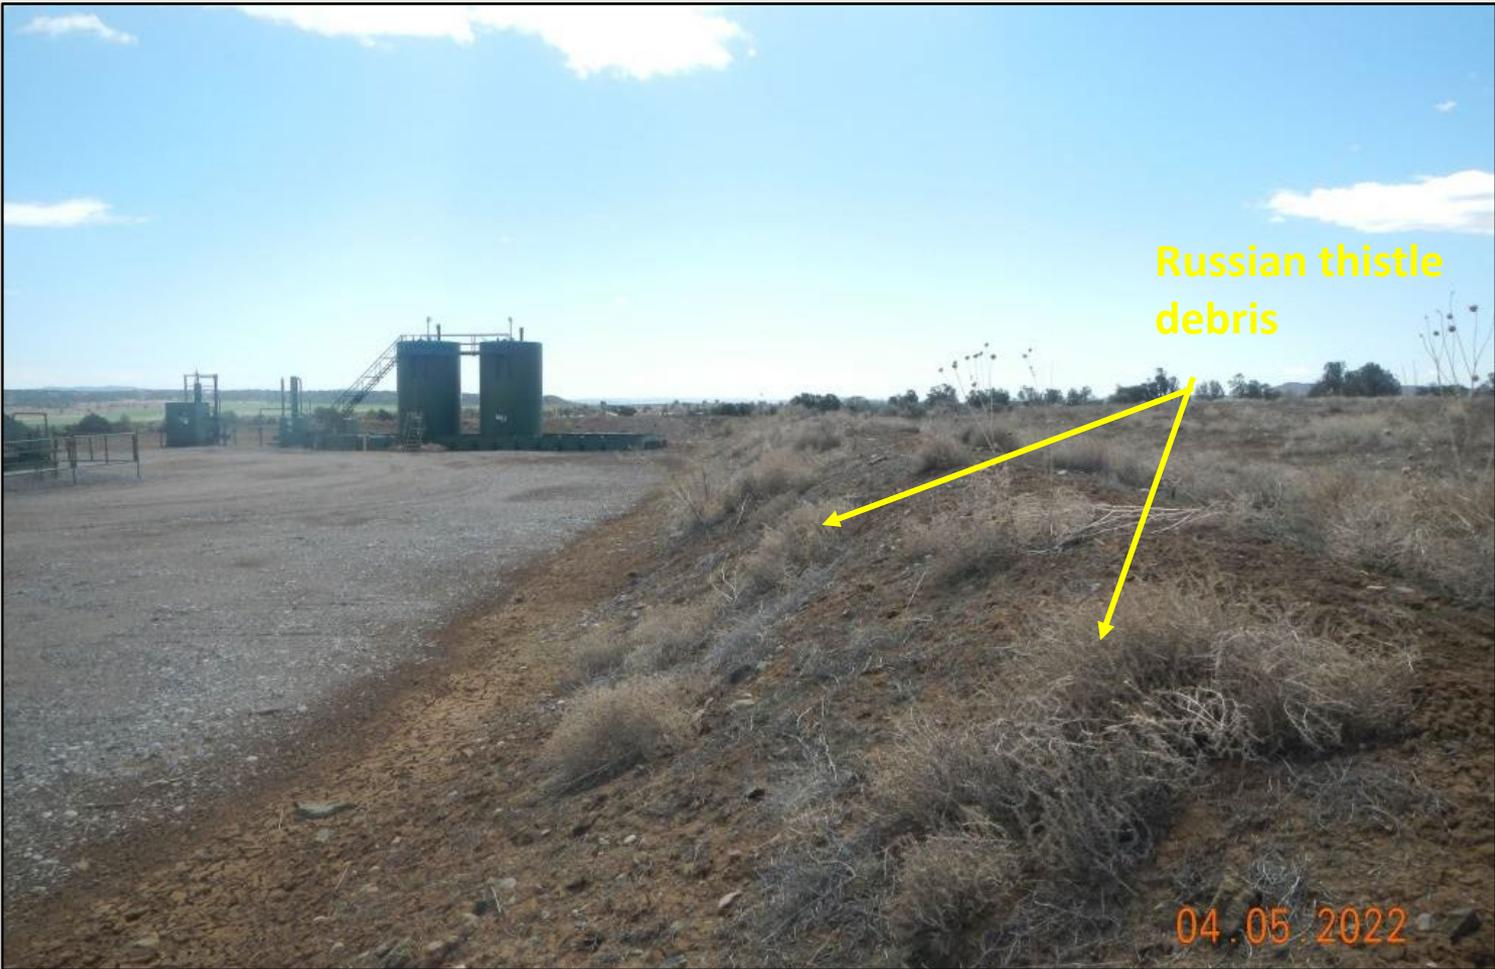
Photo 2. View of the western project area from from the northwestern corner facing southward. Dense Russian thistle debris needs to be removed and properly disposed of.

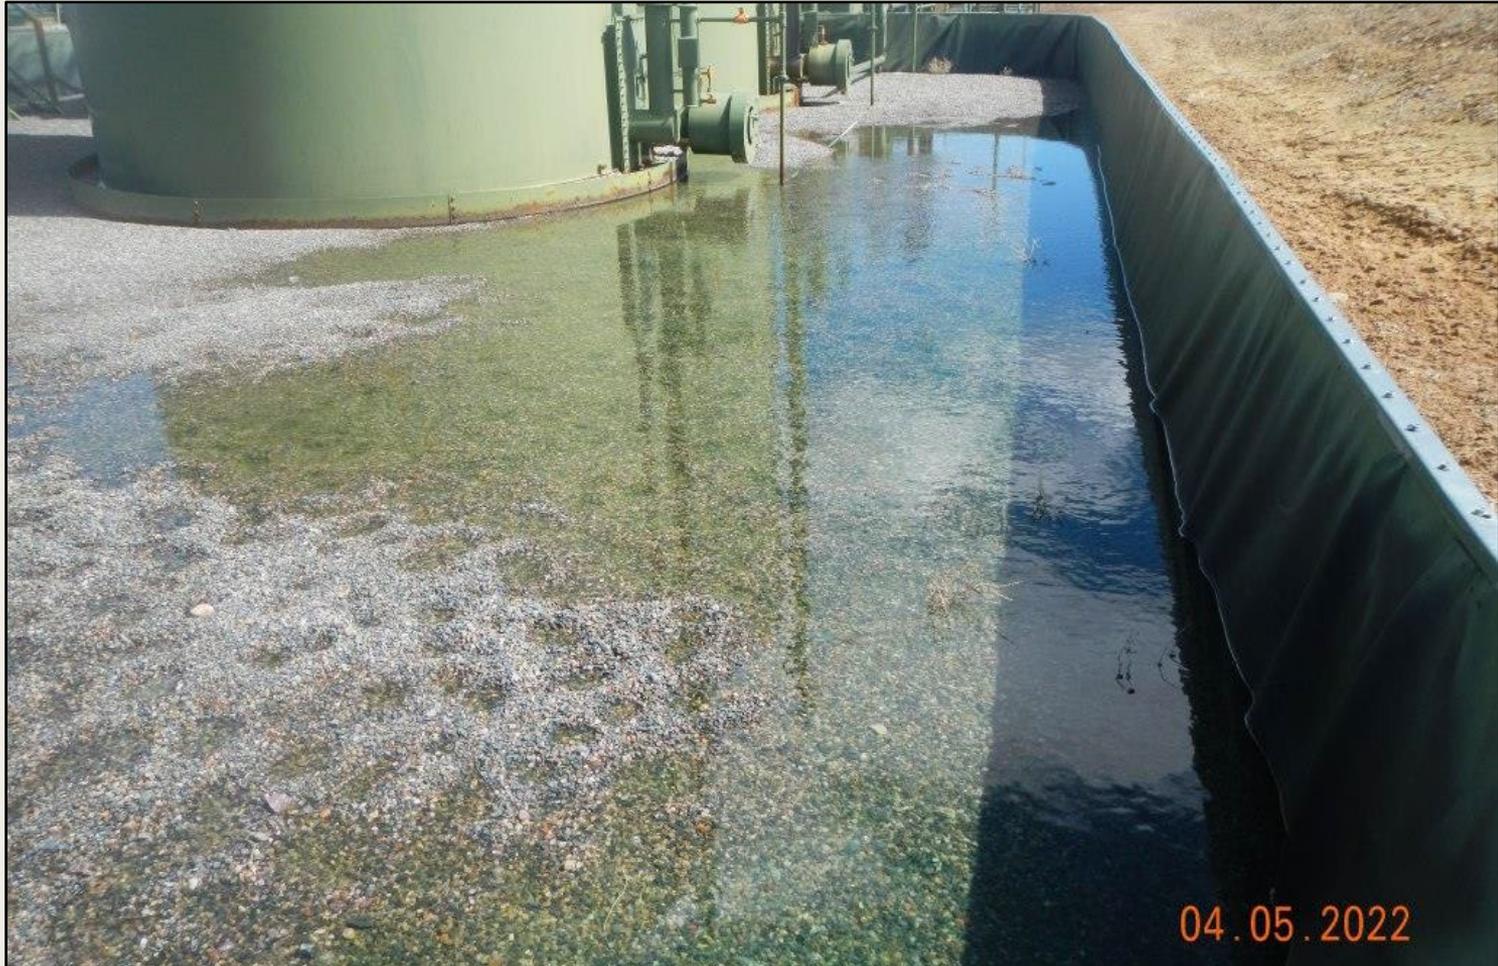
Photo 3. View of water ponding within secondary containment. It appears ponding may be result of long-term slow leak from tank plumbing.

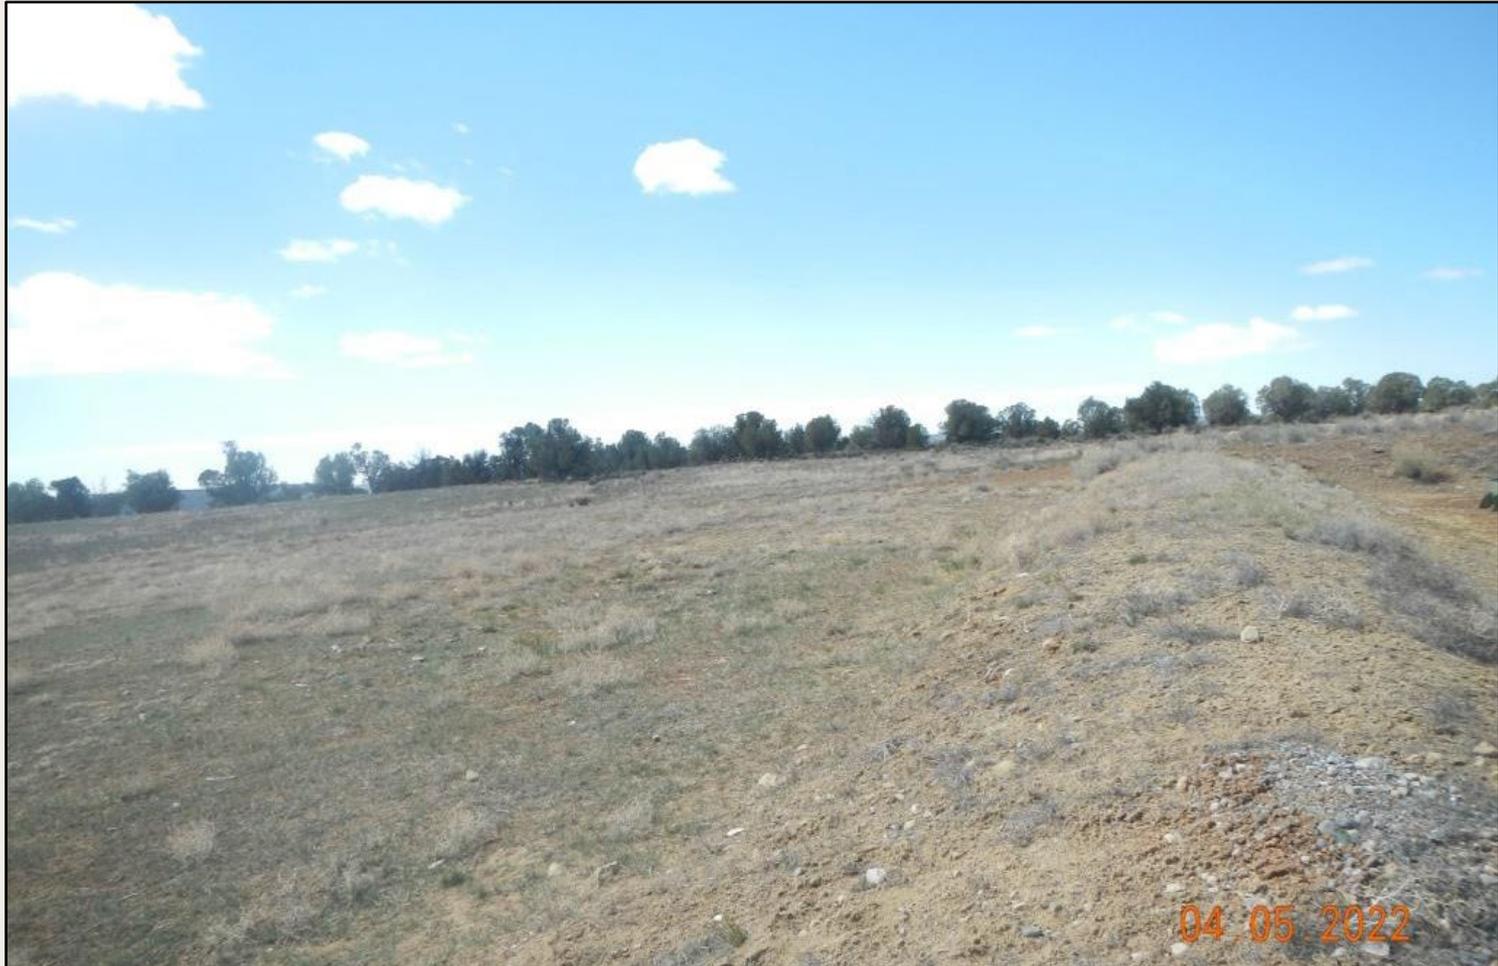
Photo 4. View of the southern project area from the southeastern corner facing westward.

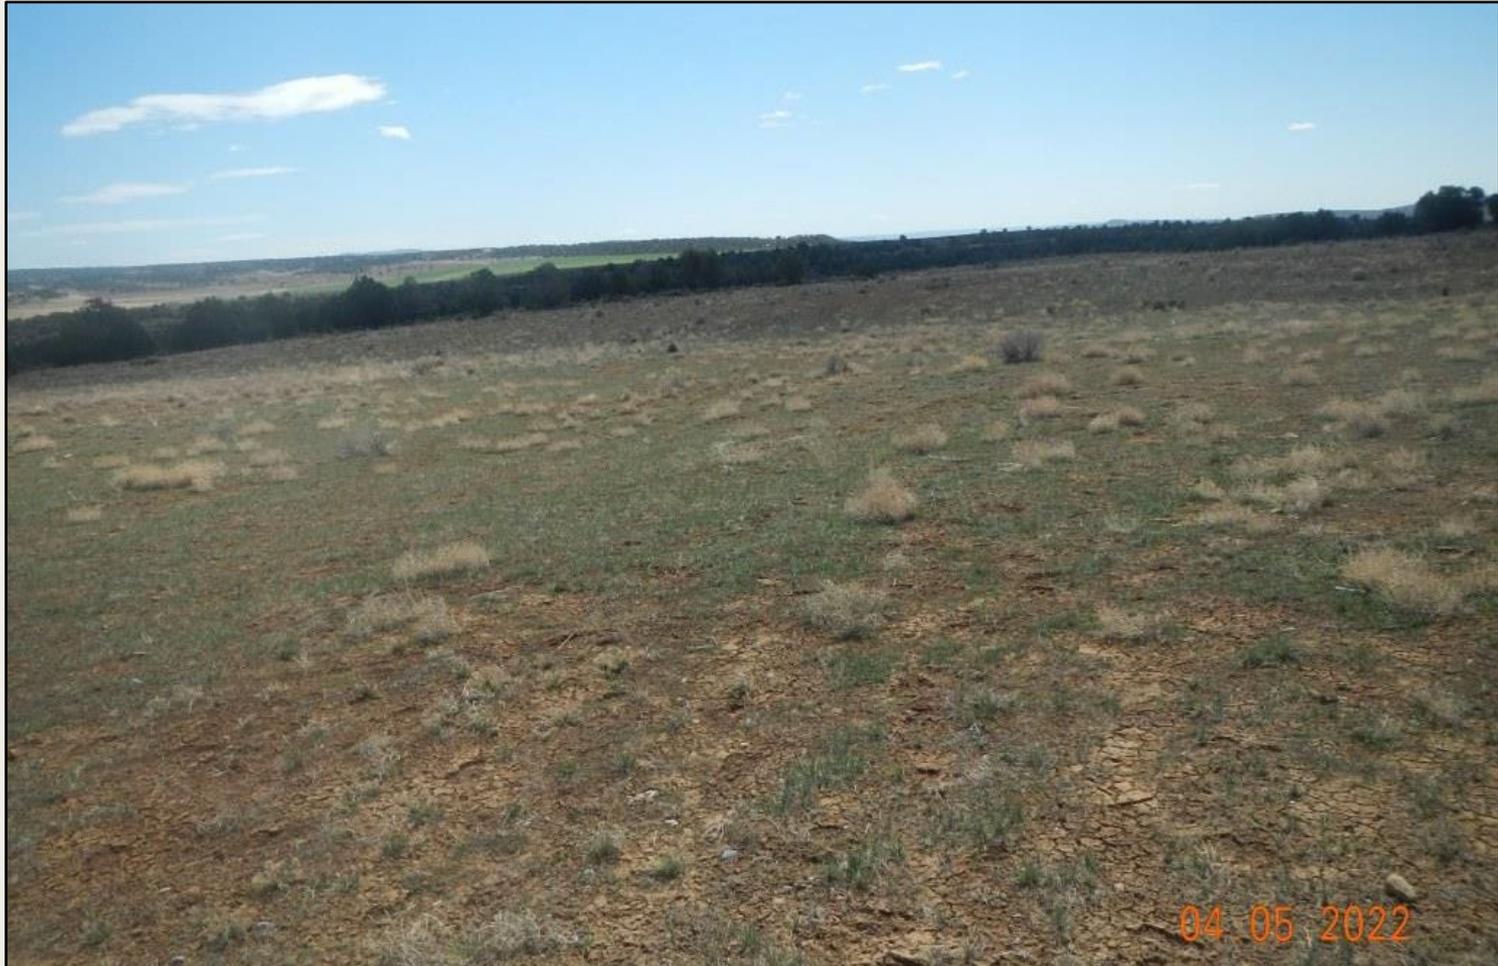
Photo 5. View of reference area comprised of open grass field, with scattered rubber rabbitbrush and sagebrush shrubs, and western wheatgrass.
