Inspection Photos
Location Name: Federal-Chamberlin 22-1
Location ID: 312863

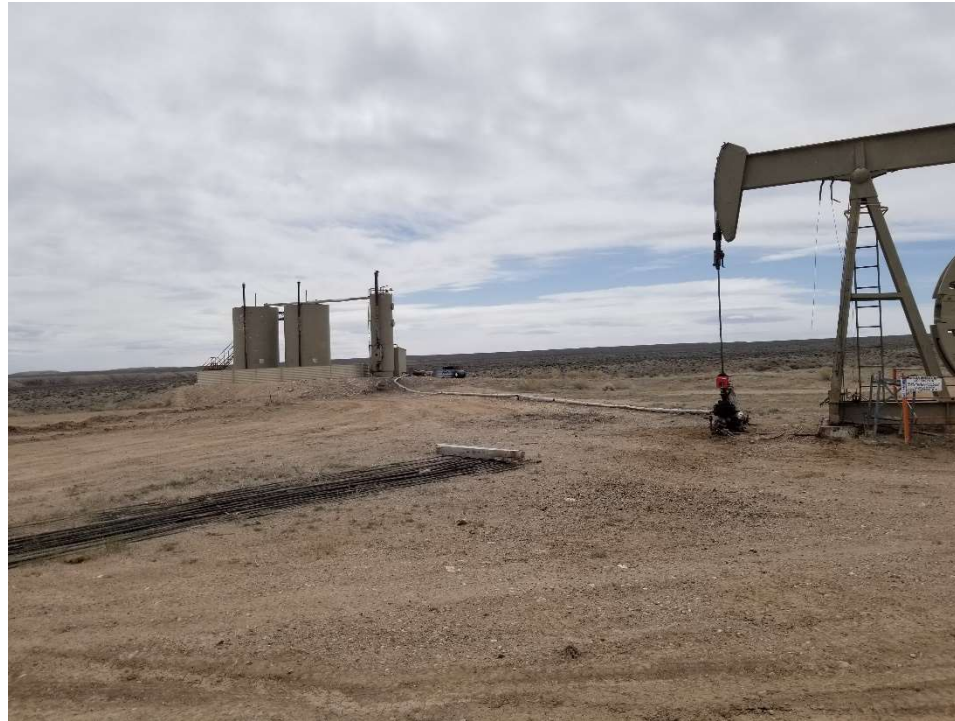
Photo 1. Overview of location taken facing southeast. Tubing stored at wellhead.

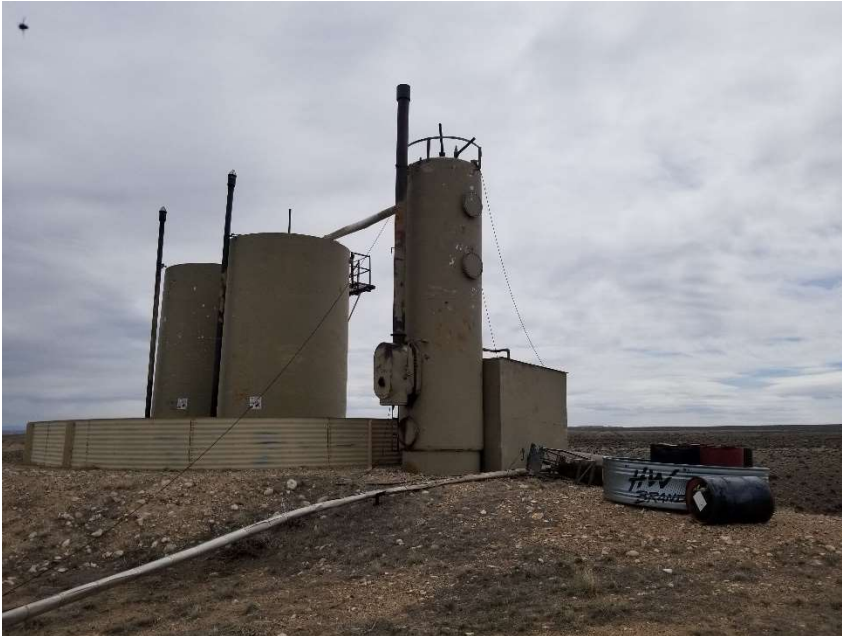
Photo 3. Fired vessel less than 50 feet from crude tanks.

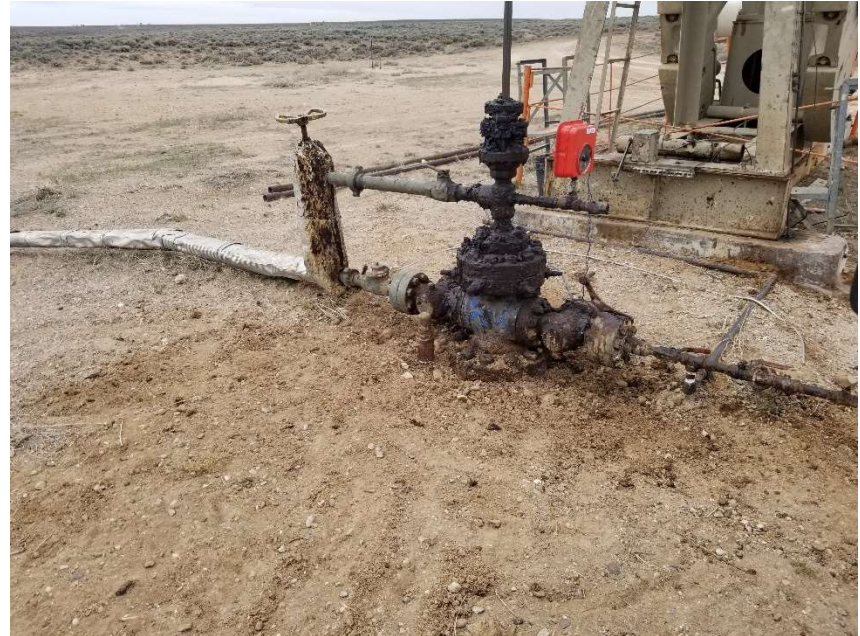
Photo 3. Stained soil at wellhead.
