Inspection Photos
Location Name: Haugen #1-30
Location ID: 319699

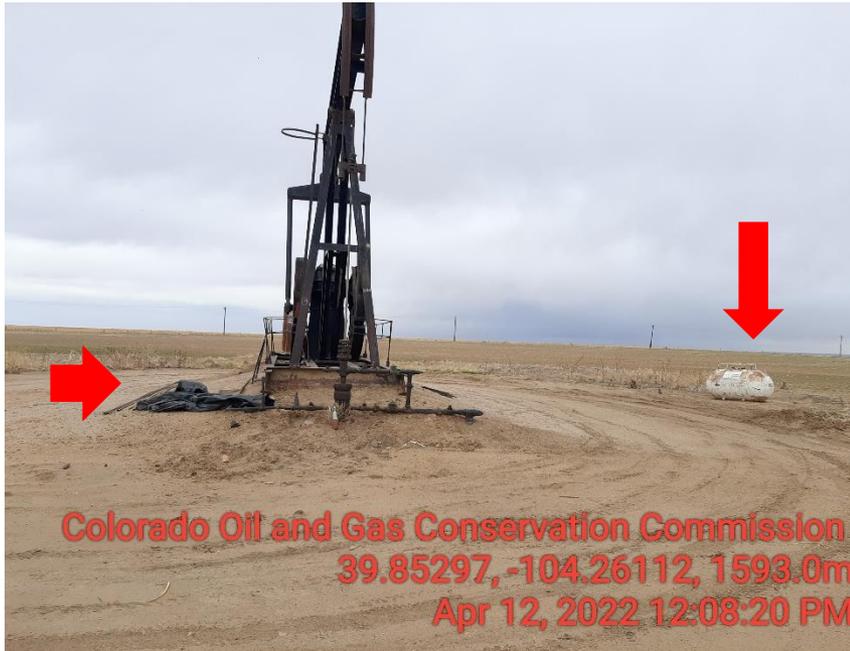
Photo 1 Well head. Trash and unused equipment

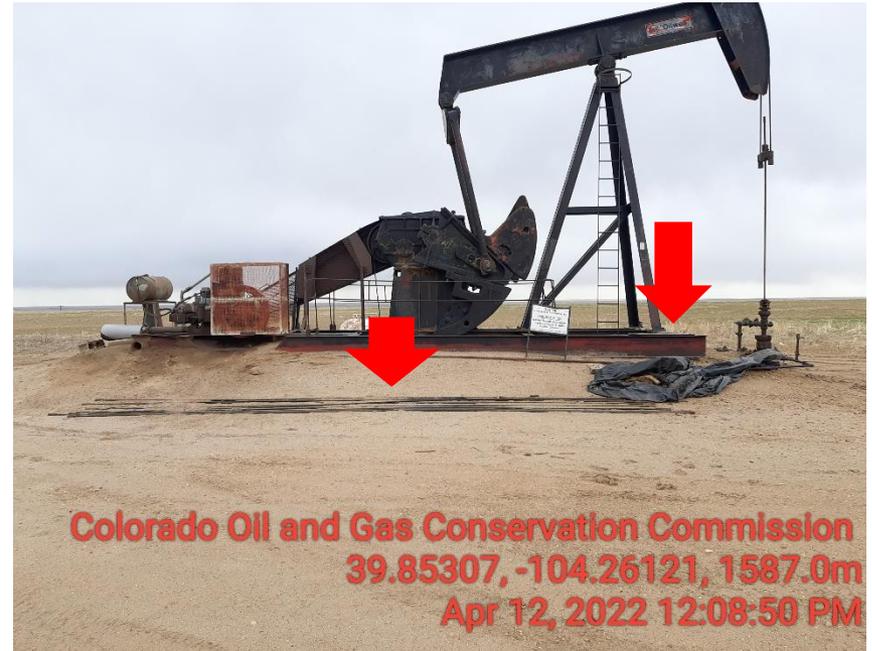
Photo 2 Trash and unused equipment.

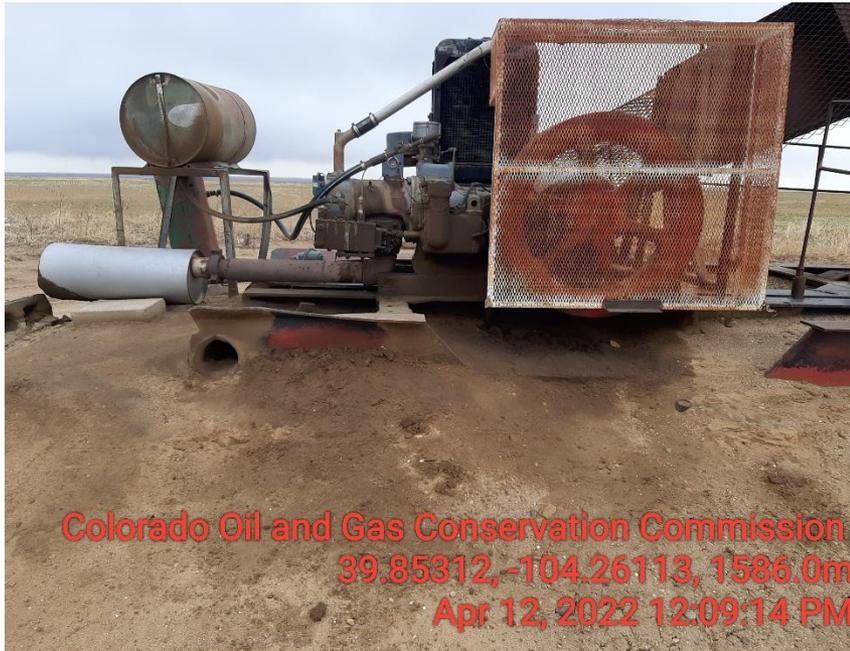
Photo 3 Mechanical issue and stained soil under and around gas powered motor.

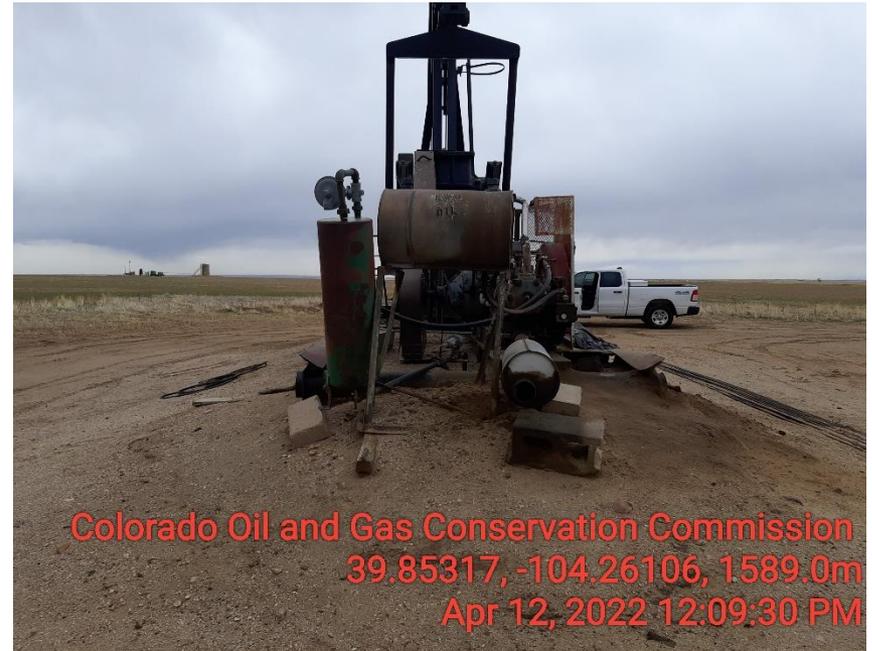
Photo 4 Mechanical issue and stained soil under and around gas powered motor.

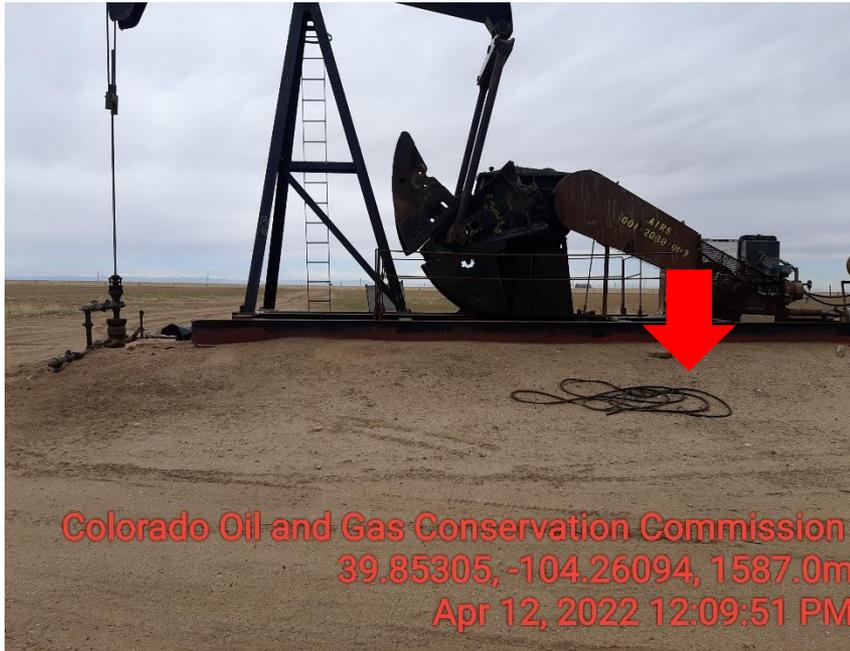
Photo 5 Trash (PU belts)

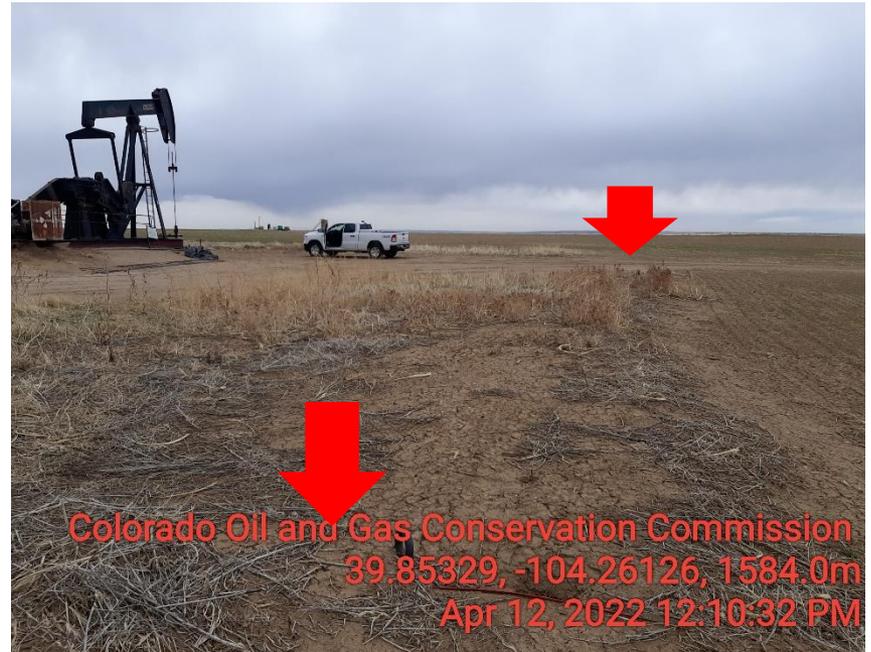
Photo 6 Guy line anchors not properly marked. Dead weeds around location.

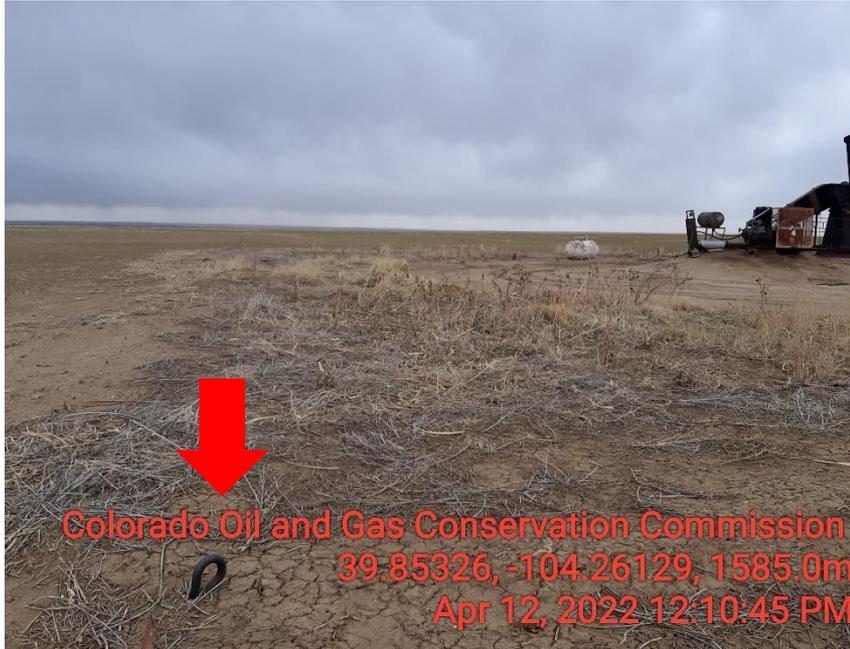
Photo 7 Guy line anchors not properly marked. Dead weeds around location.

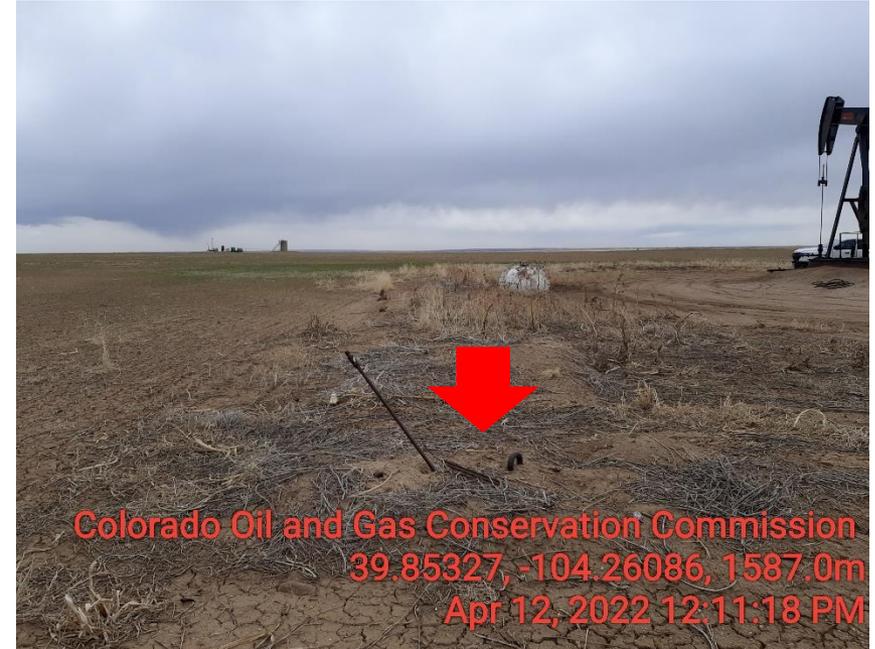
Photo 8 Guy line anchors not properly marked. Dead weeds around location.

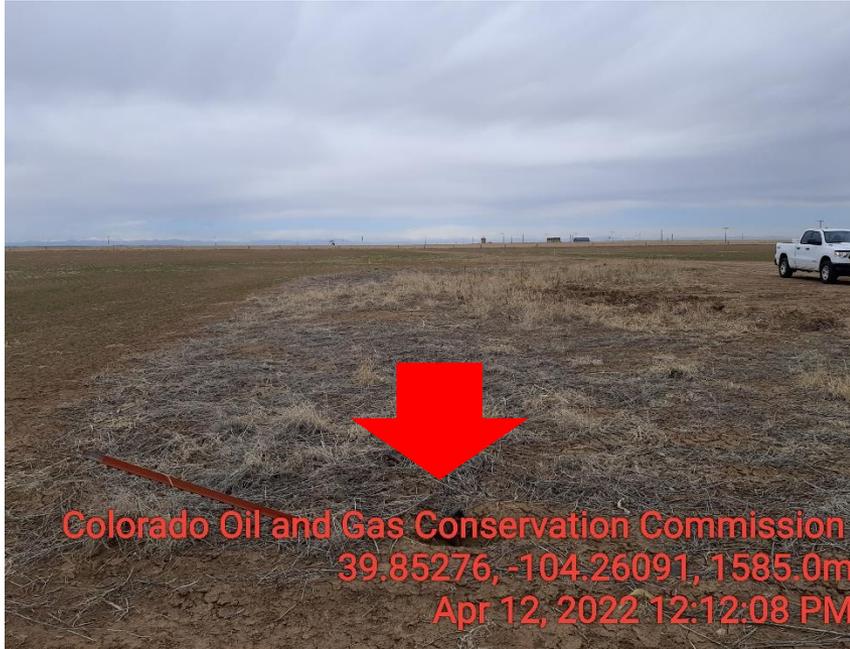
Photo 9 Guy line anchors not properly marked. Dead weeds around location.

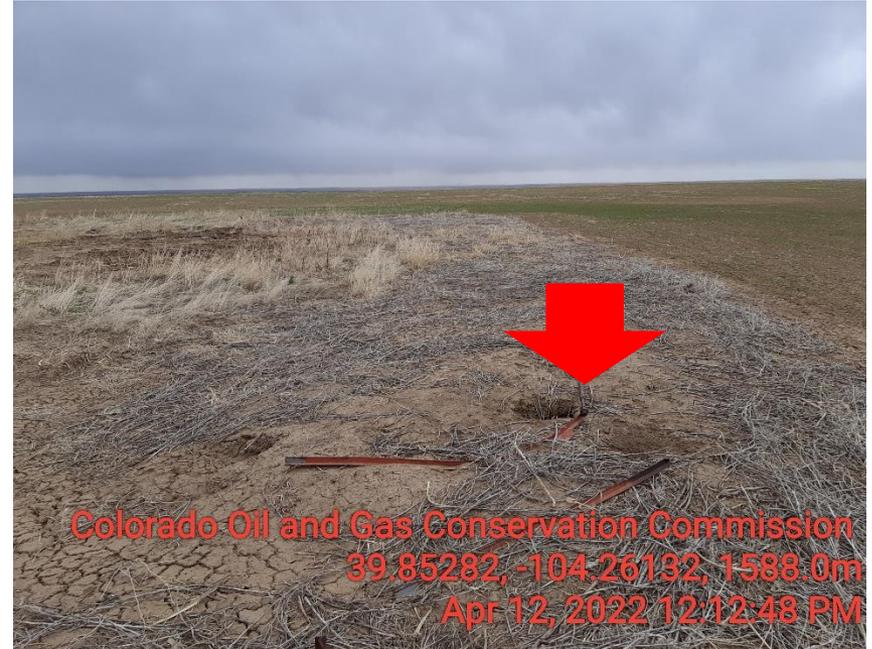
Photo 10 Guy line anchors not properly marked. Dead weeds around location.

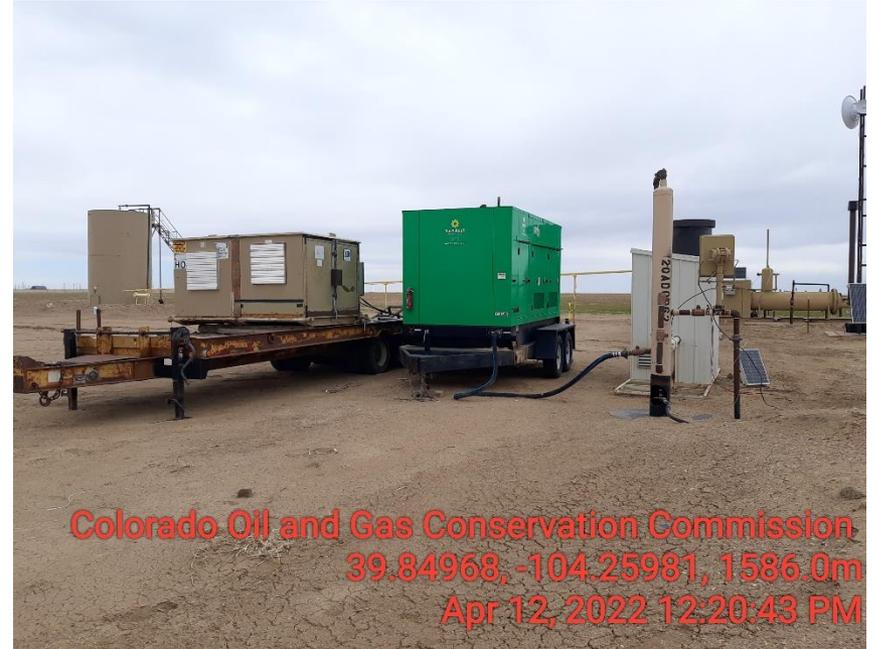
Photo 12 Production equipment (Crypto mining equipment)

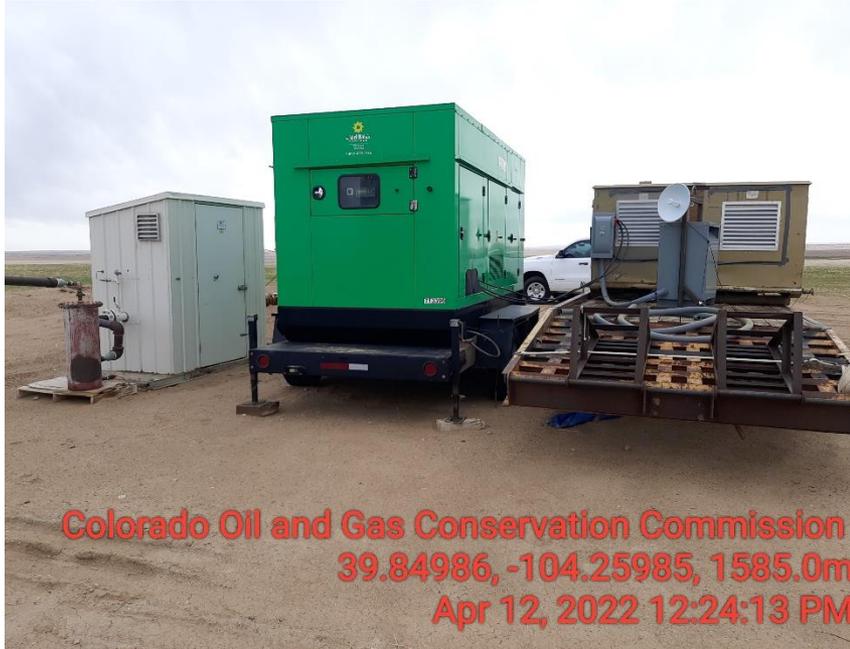
Photo 13 meter house and crypto mining equipment

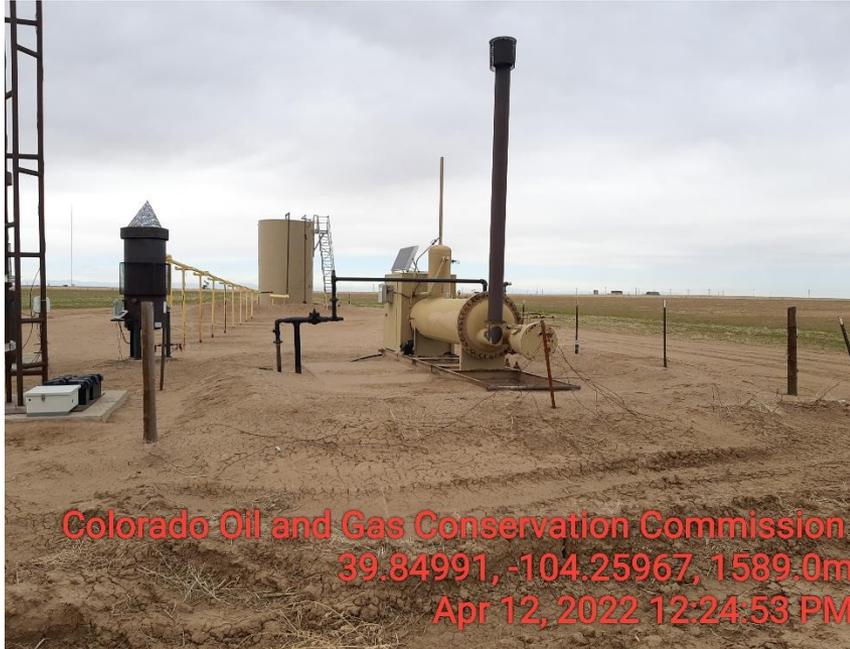
Photo 15 production equipment. Barb wire fence in disrepair.

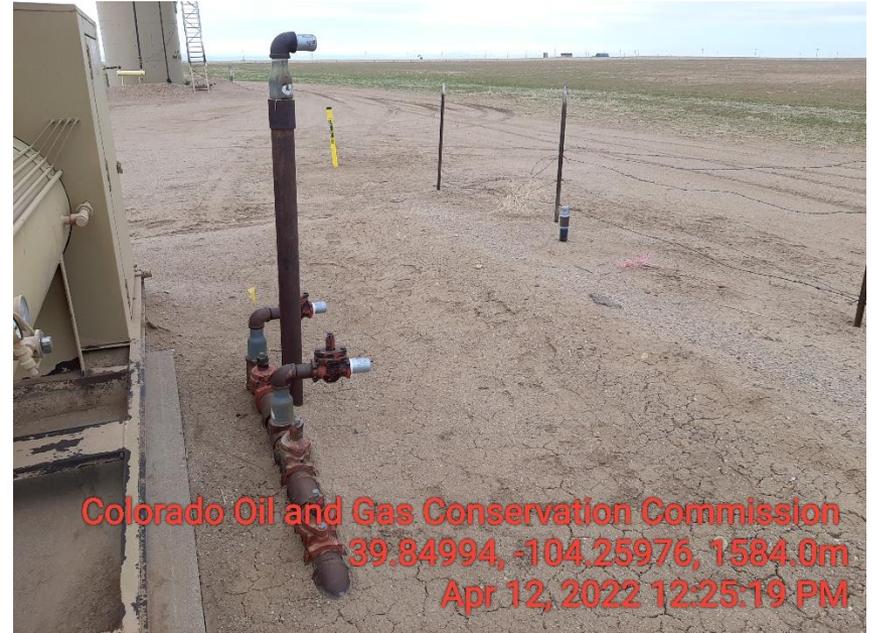
Photo 16 2" piping not LOTO

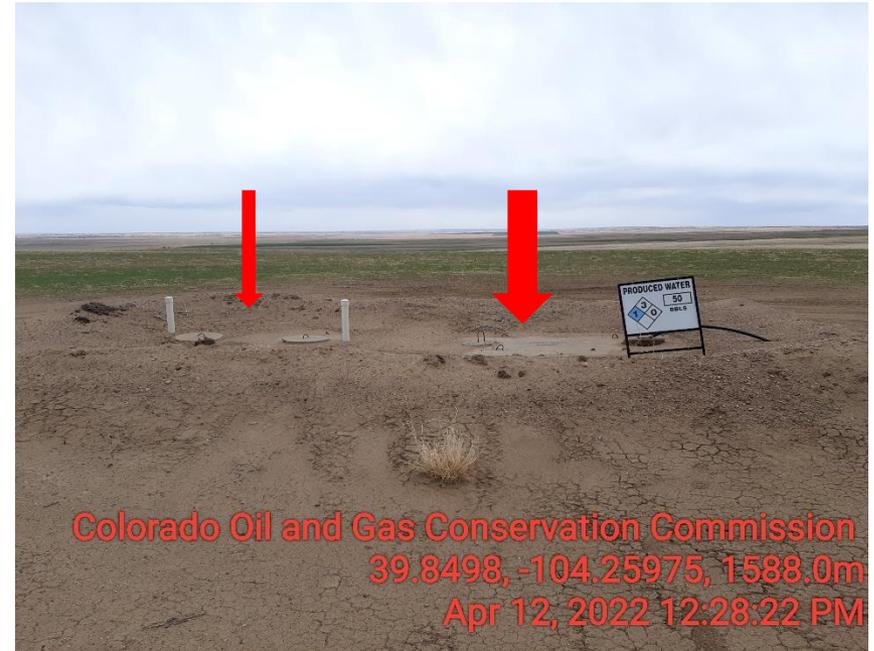
Photo 18 Produced water vaults. There are two vaults and only signage for one tank. Secondary containment has eroded away and is Inadequate.

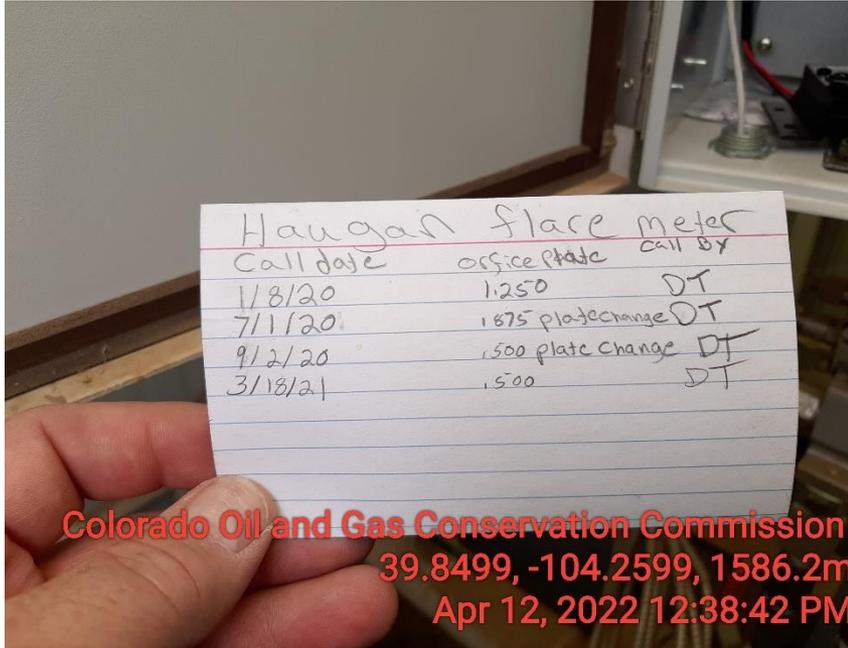
Photo 19 Meter calibration card is past annual inspection inside meter house.

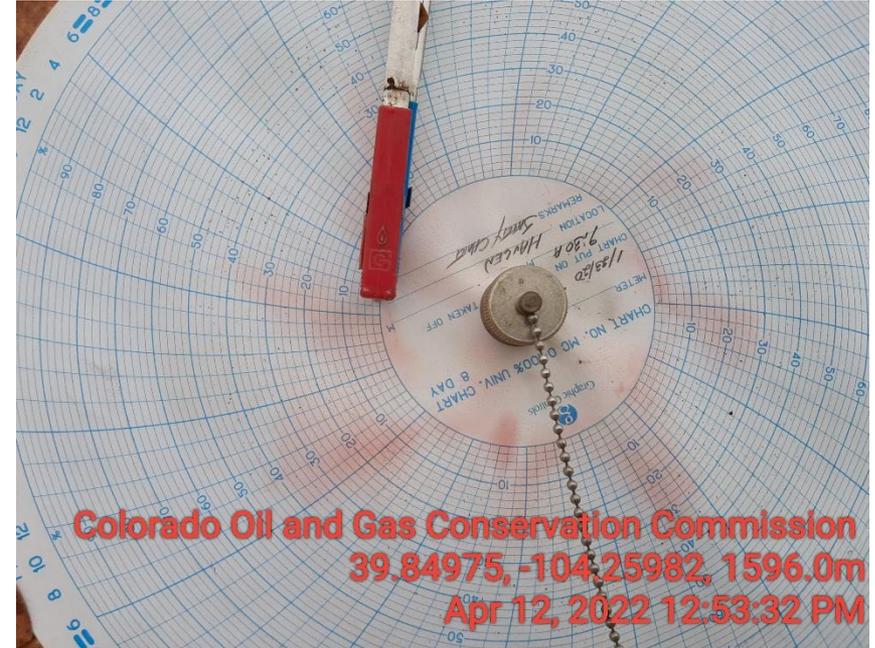
Photo 20 chart on unconnected meter on inlet to meter house. Chart dated 2020

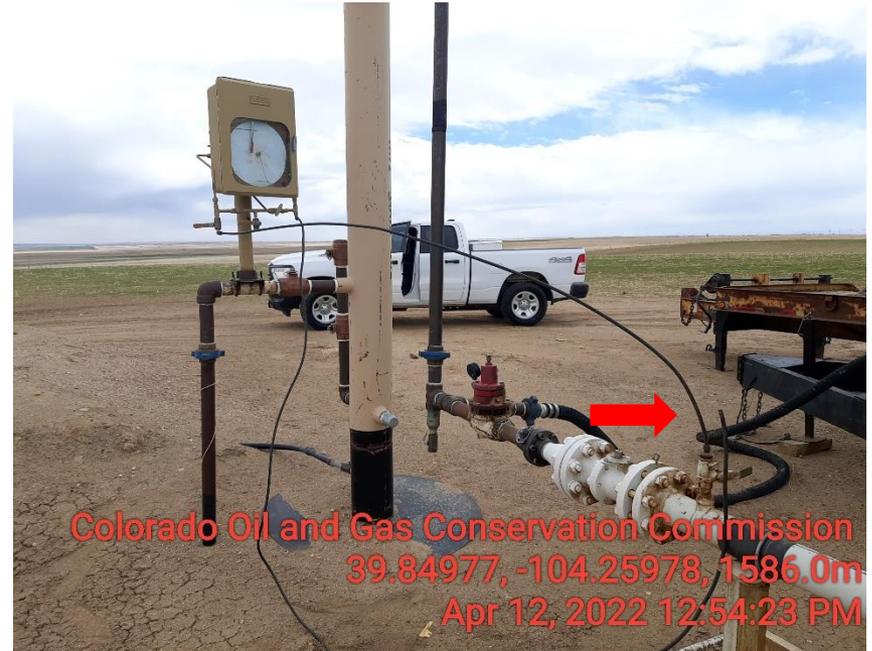
Photo 22 Piping to inlet of meter house and gas supply to generator. Meter tubing not connected.

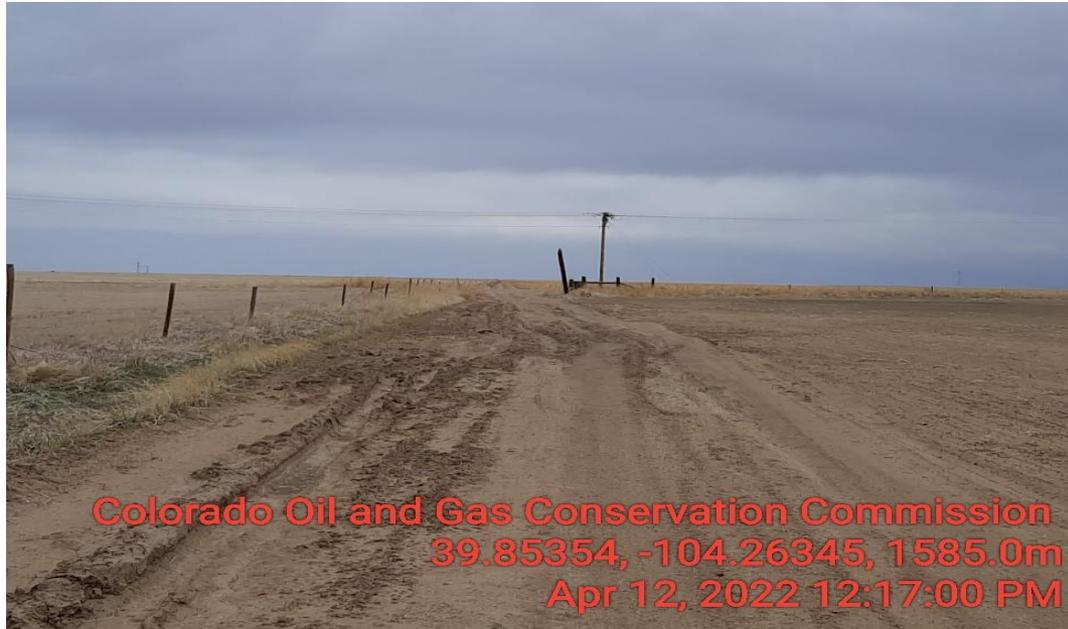
Photo 25 Access road off county road in disrepair vehicles driving off road and in farmers field.
