Inspection Photos
Location Name: Alfred Herman unit1
Location ID: 332917

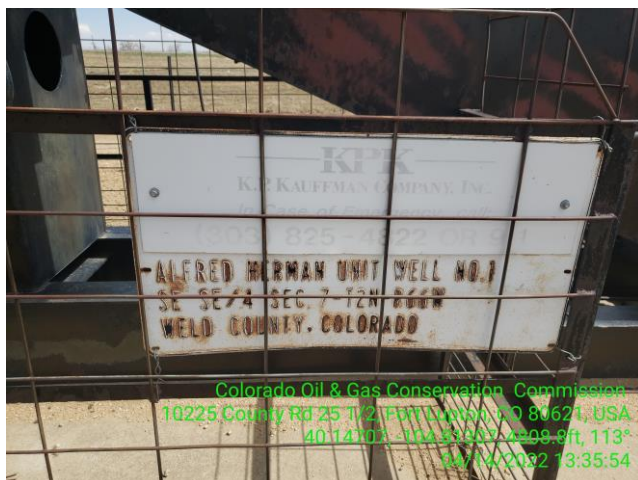
Photo 1 WH sign.

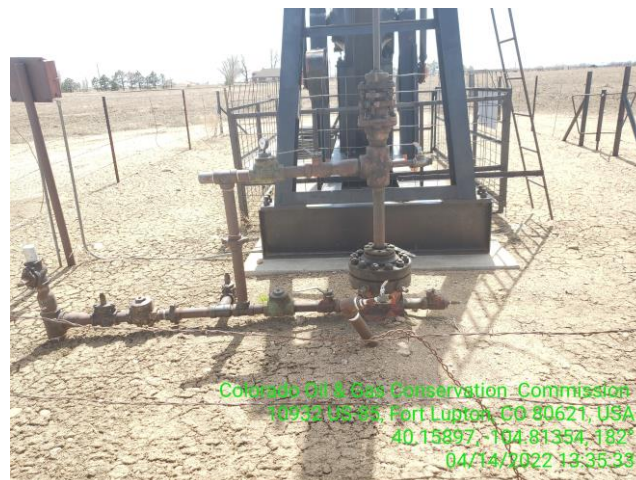
Photo 2 WH

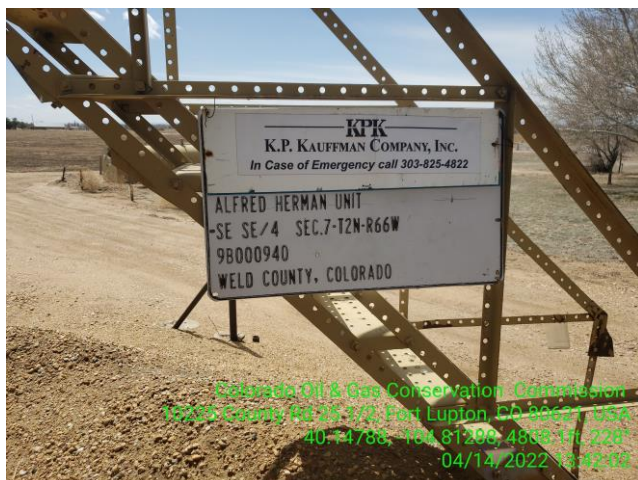
Photo 3 TB sign.

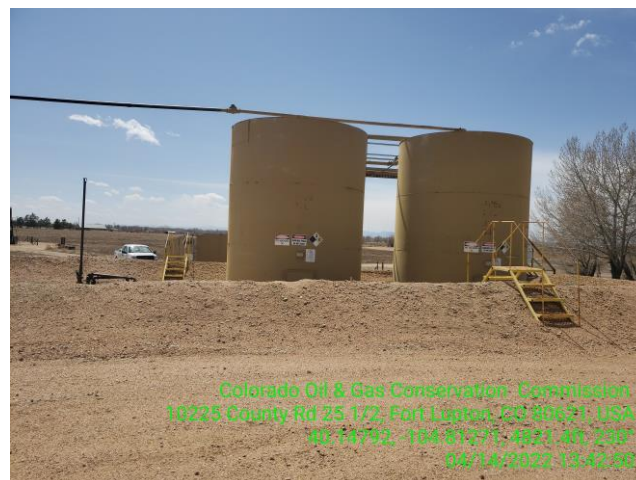
Photo 4 TB tank volume faded

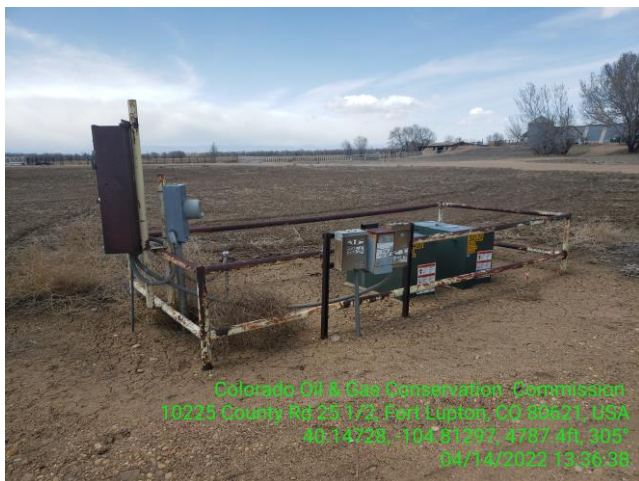
Photo 5 Ancillary equip..

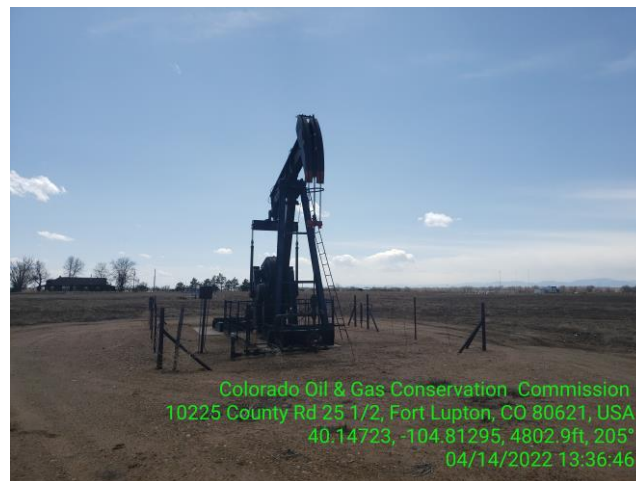
Photo 6 Pump jack

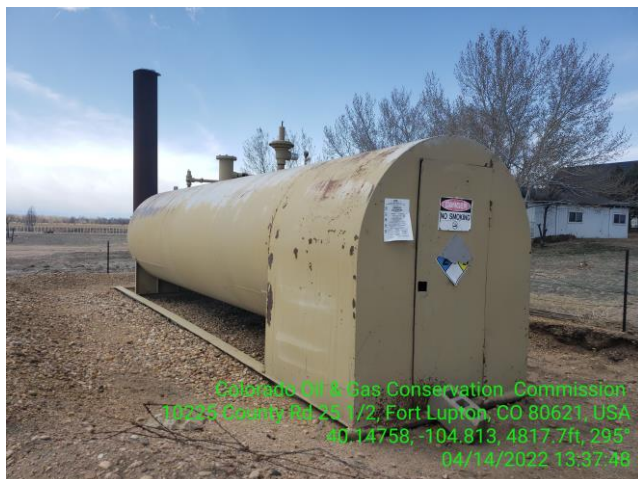
Photo 7 Horiz. Heated Sep.

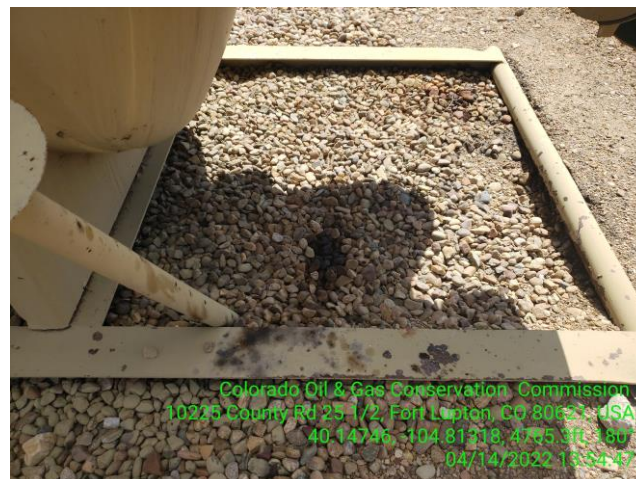
**Photo 8 Stained soil has been cleaned up from initial insp.
But the leak is still dripping.**

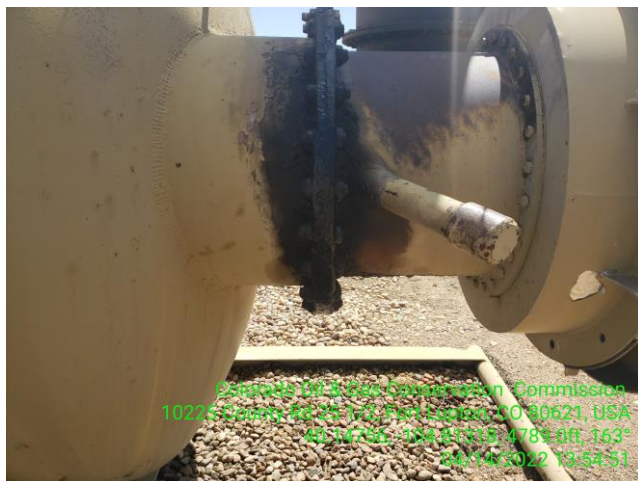
Photo 9 Slow leaking gasket on Horiz. Heated Sep.

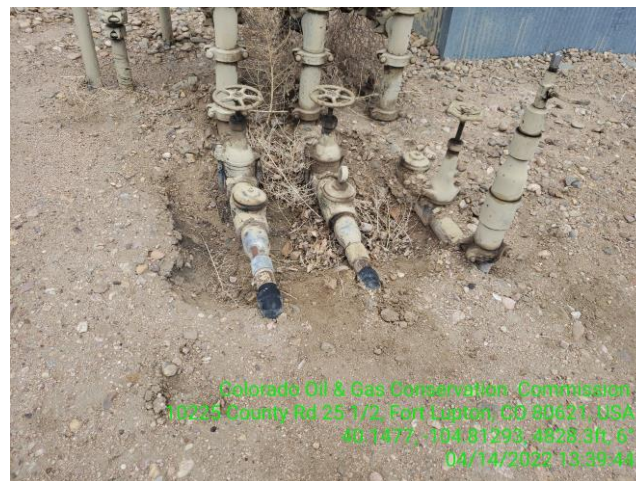
Photo 10 Stained soil has been cleaned up around flow line manifold.

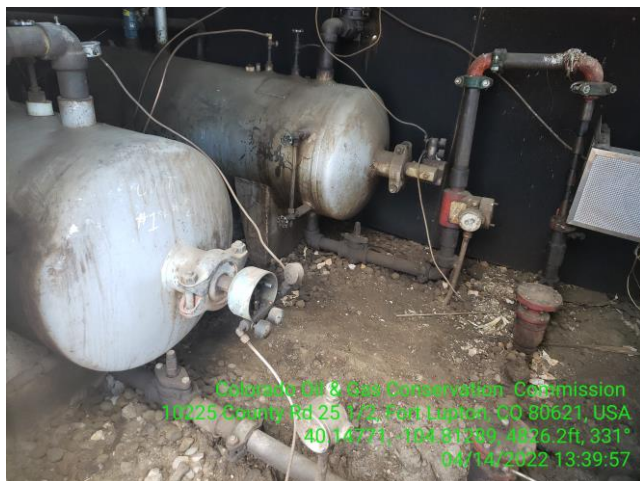
Photo 11 Horizontal Sep. stained soil in housing

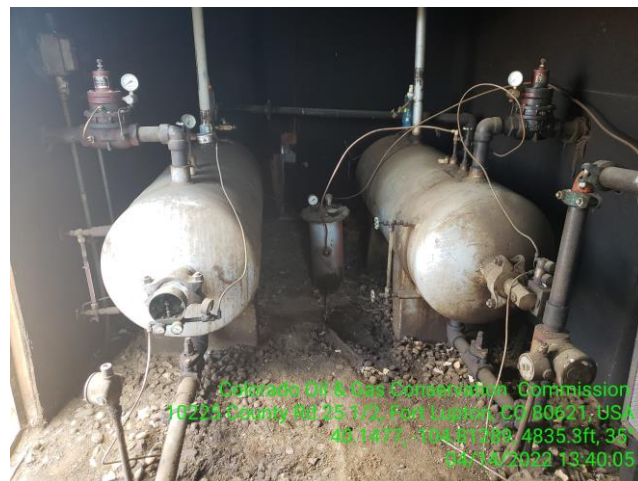
Photo 1 Horizontal Sep. stained soil in housing

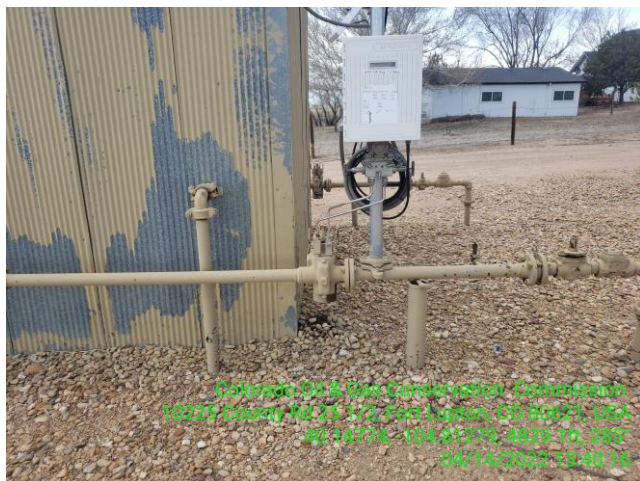
Photo 13 Gas Meter Run

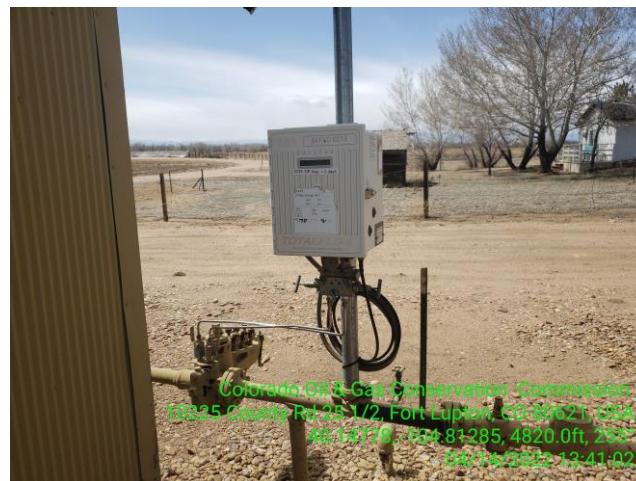
Photo 14 Gas Meter Run

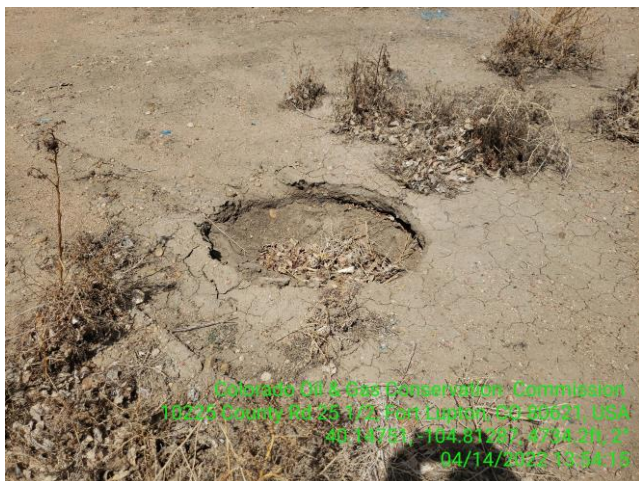
Photo 15 sink hole south of Separator house

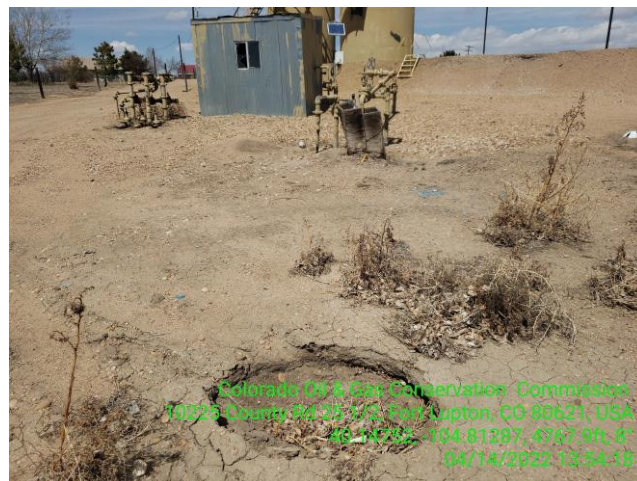
Photo 16 sink hole south of Separator house
