**Inspection Photos**  
**Location Name: Two Mile Creek 22-13H**  
**Location ID: 422116**

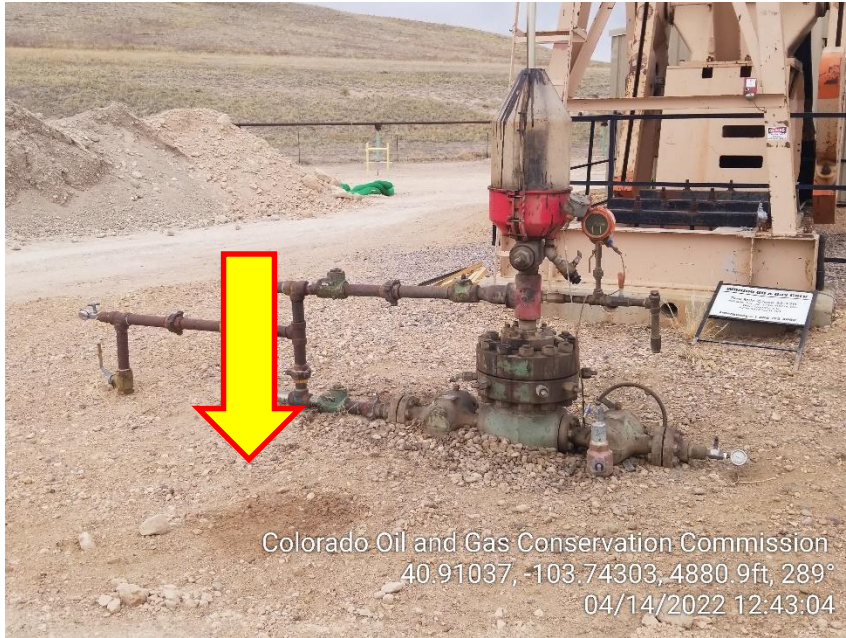
**Photo 1 - Wellhead – Stained Soil**

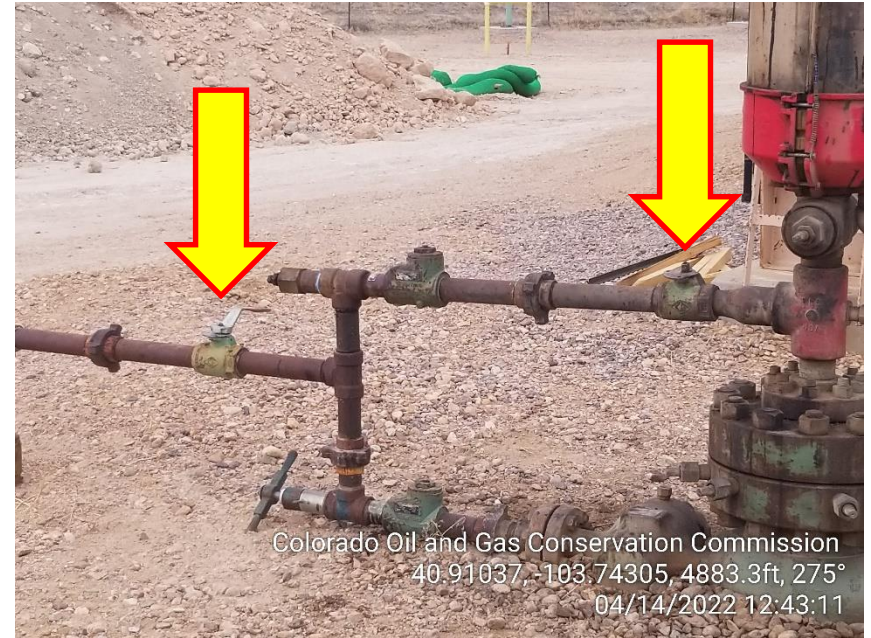
**Photo 2 – Wellhead – Tubing Valves appear to be Closed Position**

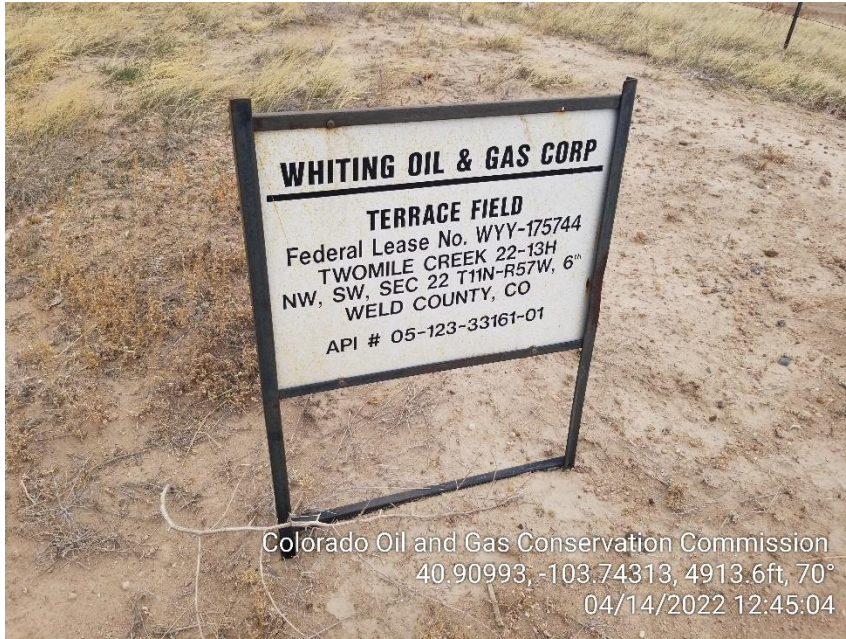
**Photo 3 – Tank Battery Sign**

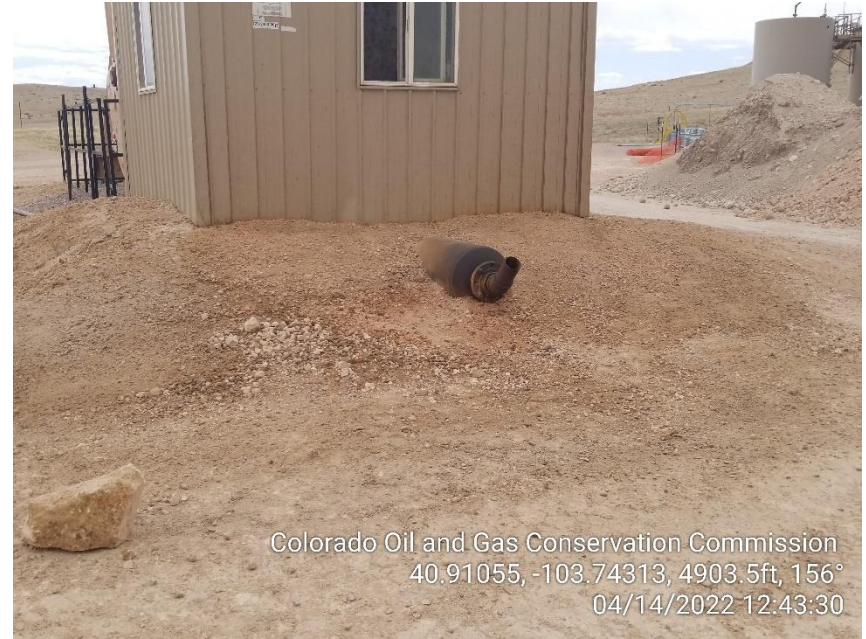
**Photo 4 – Stained Soil at Gas Engine Exhaust has been mitigated**
