Caerus Piceance LLC
J18
Location # 334865

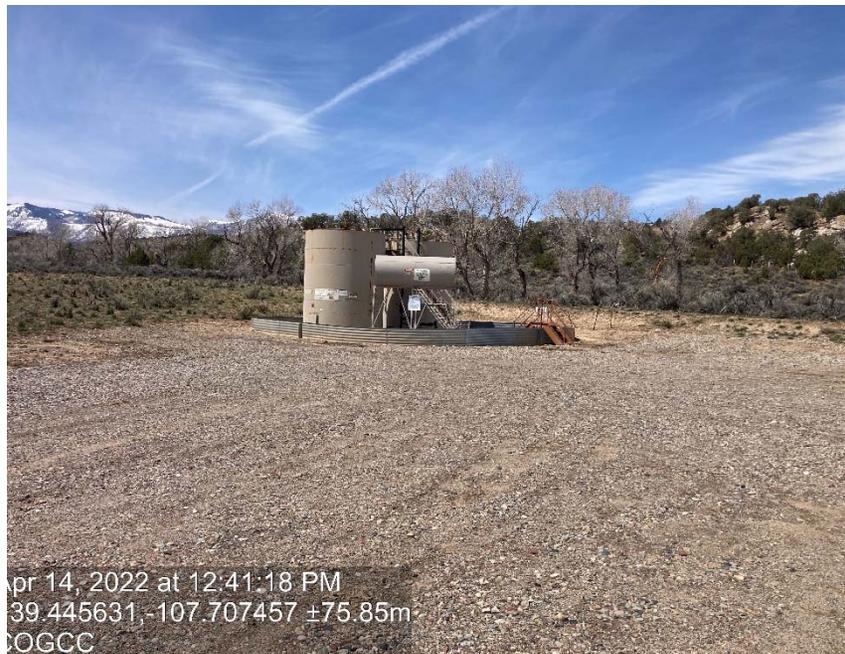
Location/ lack of battery signage

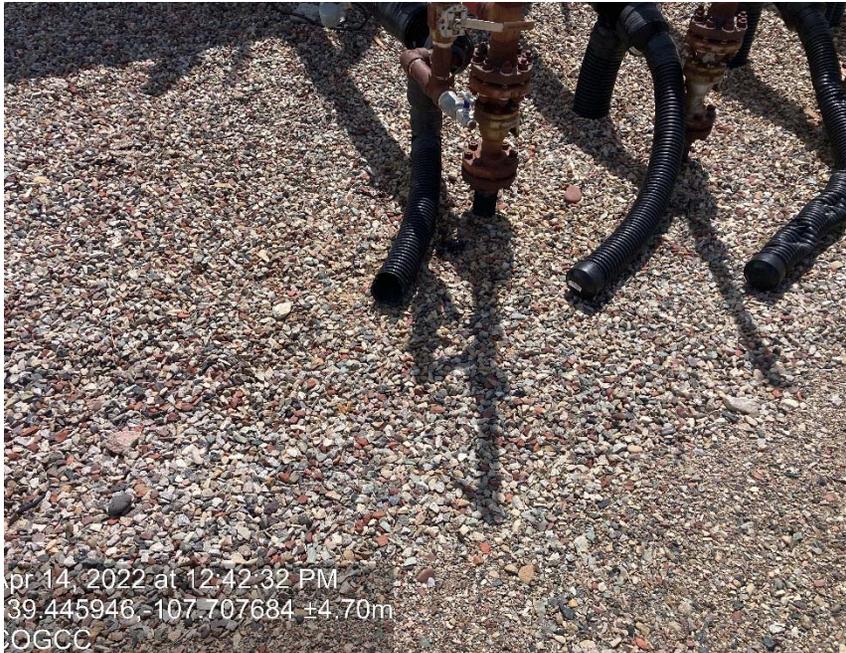
Open pipe

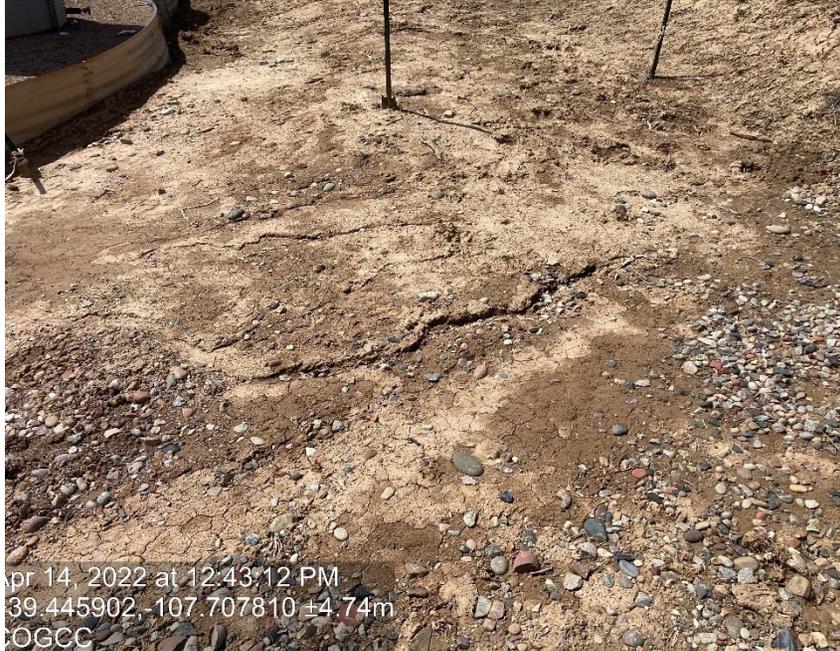
Lack of stabilization/ compaction/ erosion

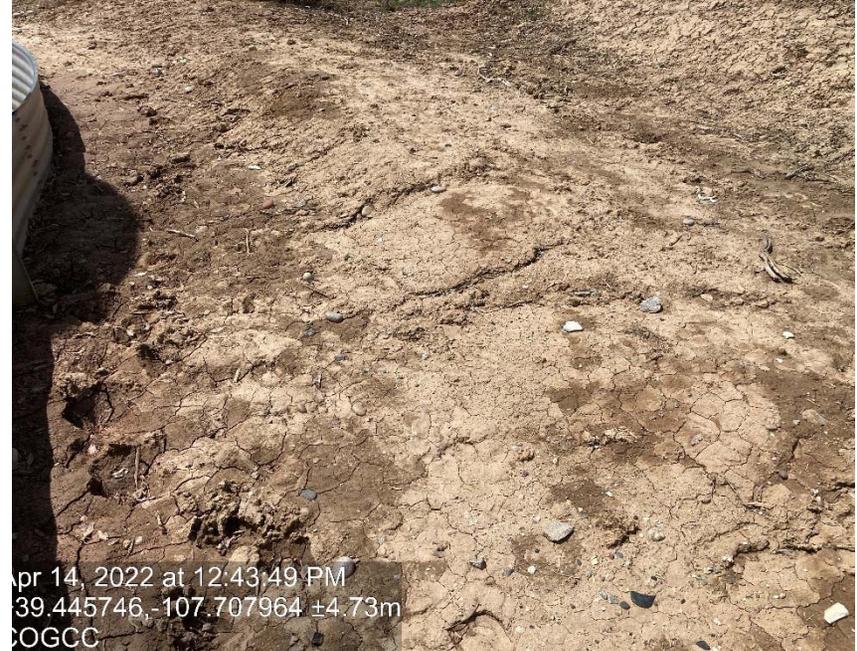
Lack of stabilization/ compaction/ erosion

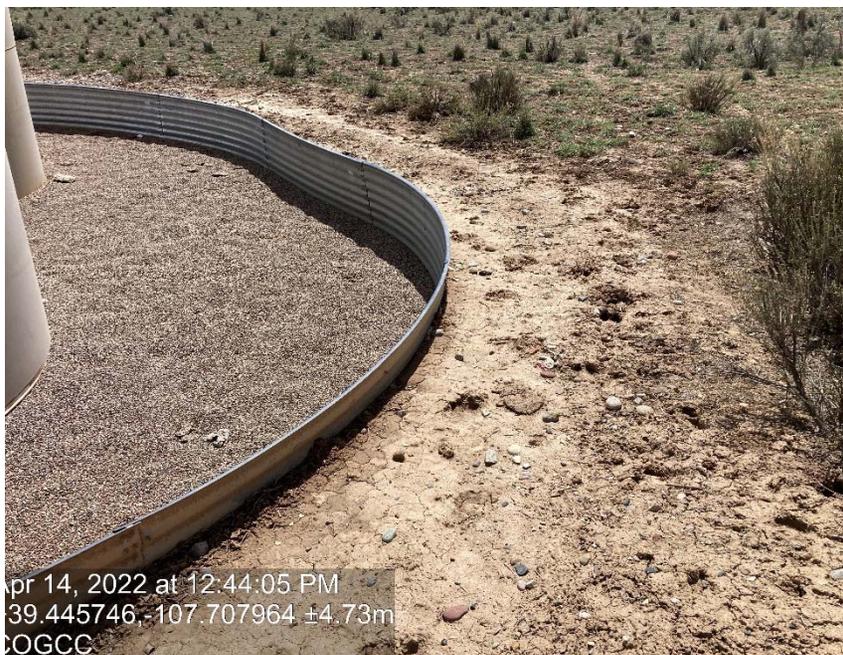
Sediment piled up on battery containment

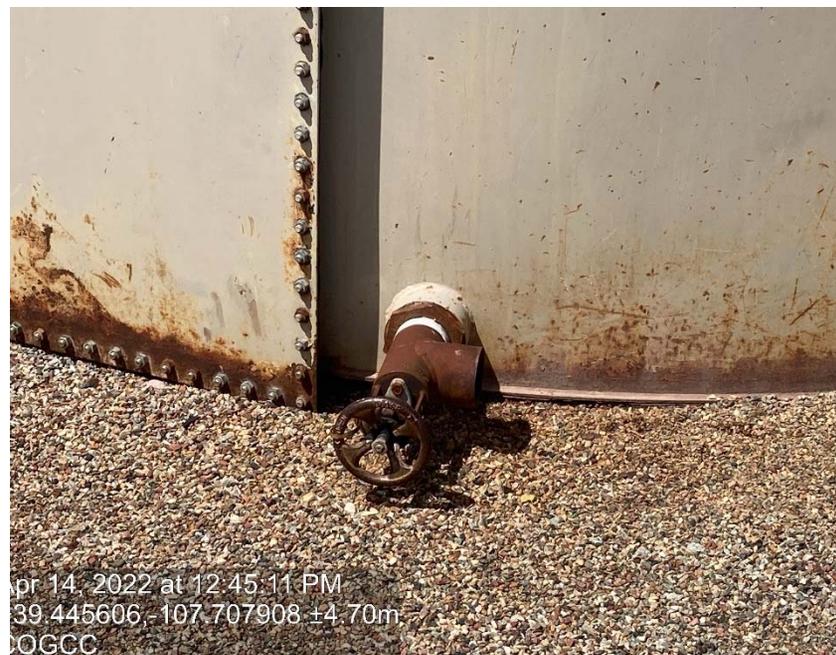
Lack of cap/plug

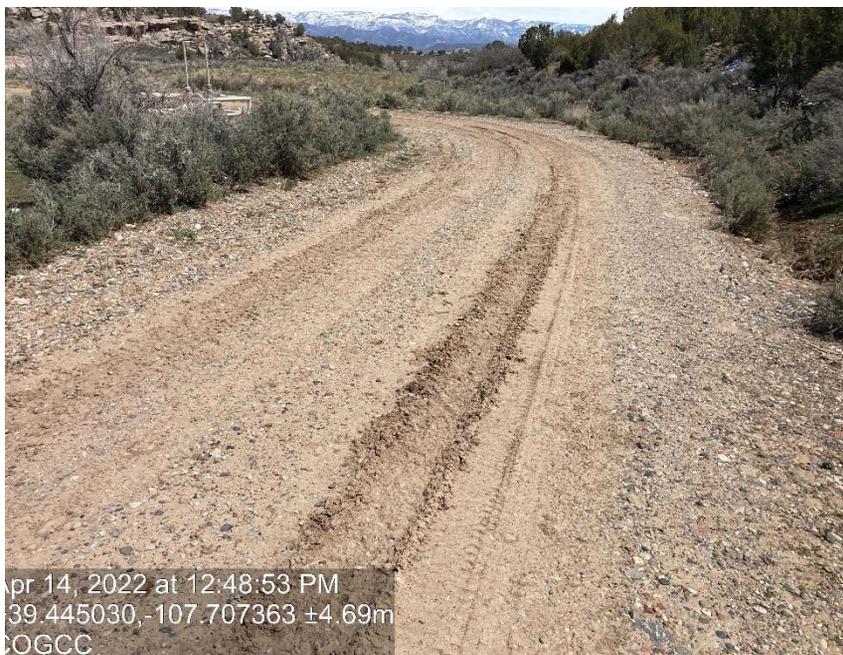
Lack of stabilization/compaction

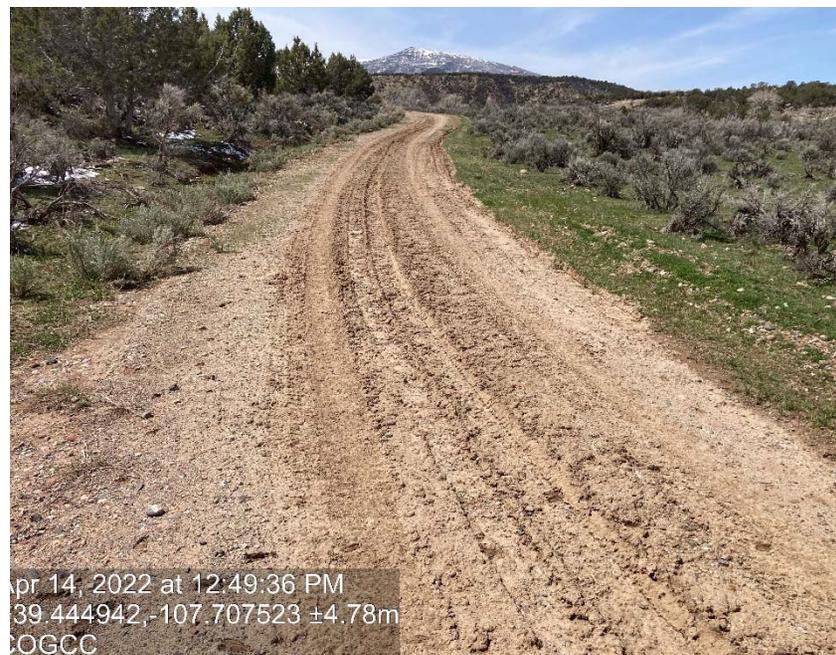
Lack of stabilization/compaction
