## Root Cause Analysis

**Incident Type :** Fire

**Location :** Interchange A Pad

**Date:** 3/12/2022

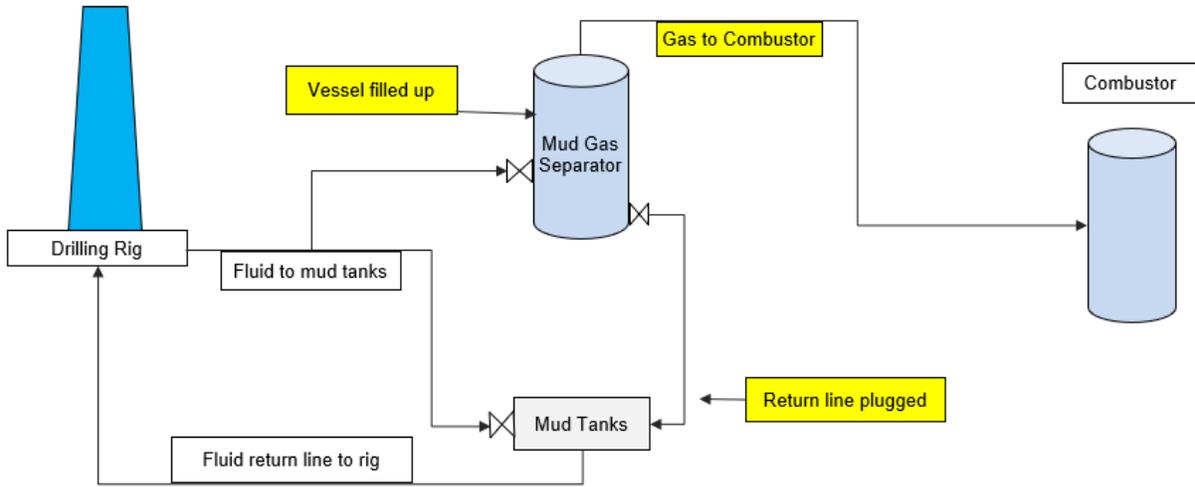
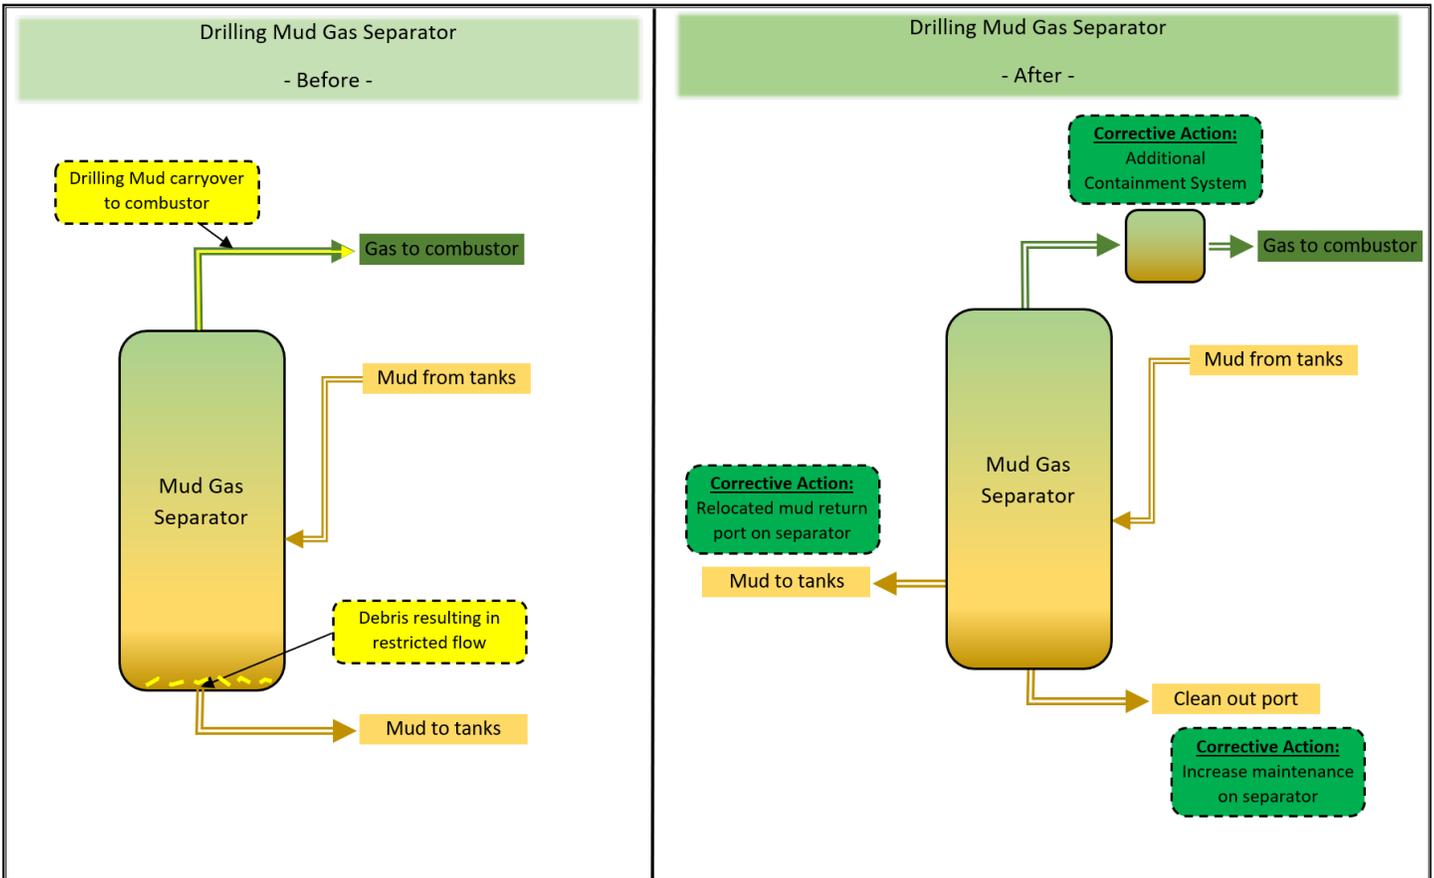
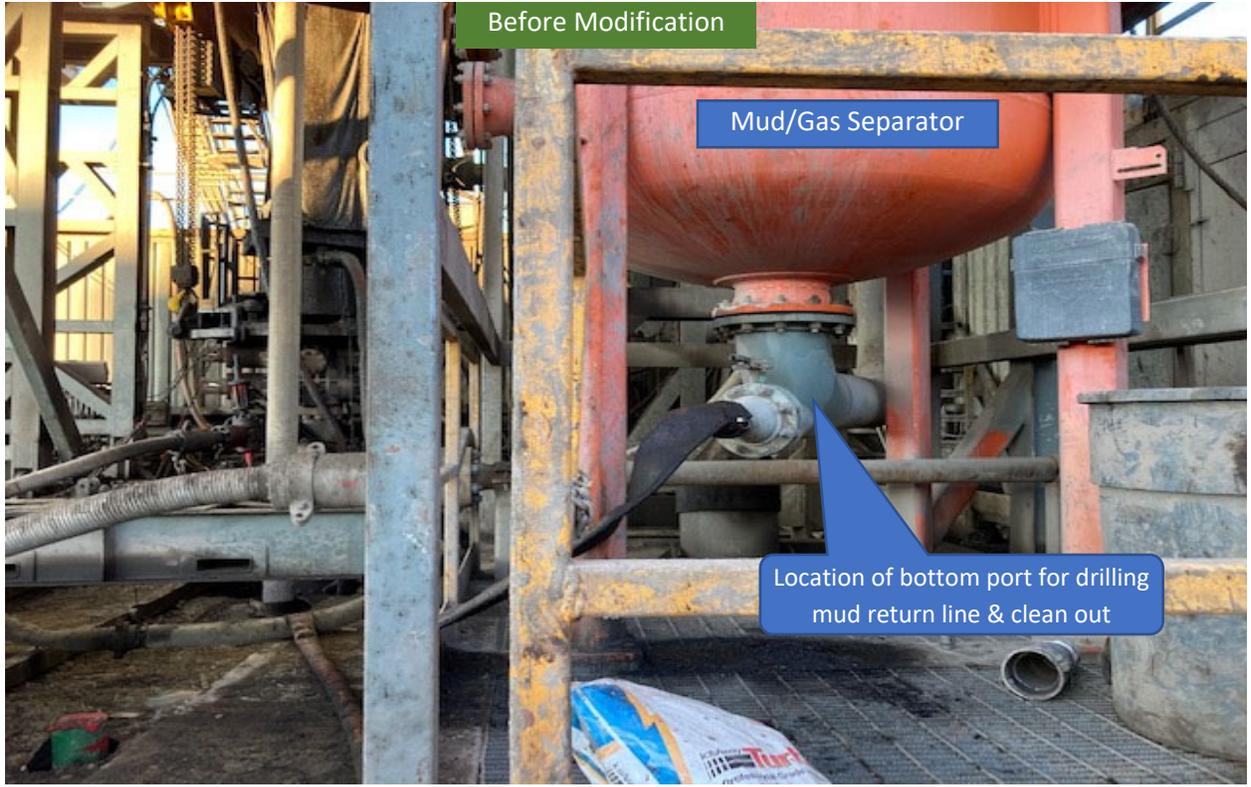
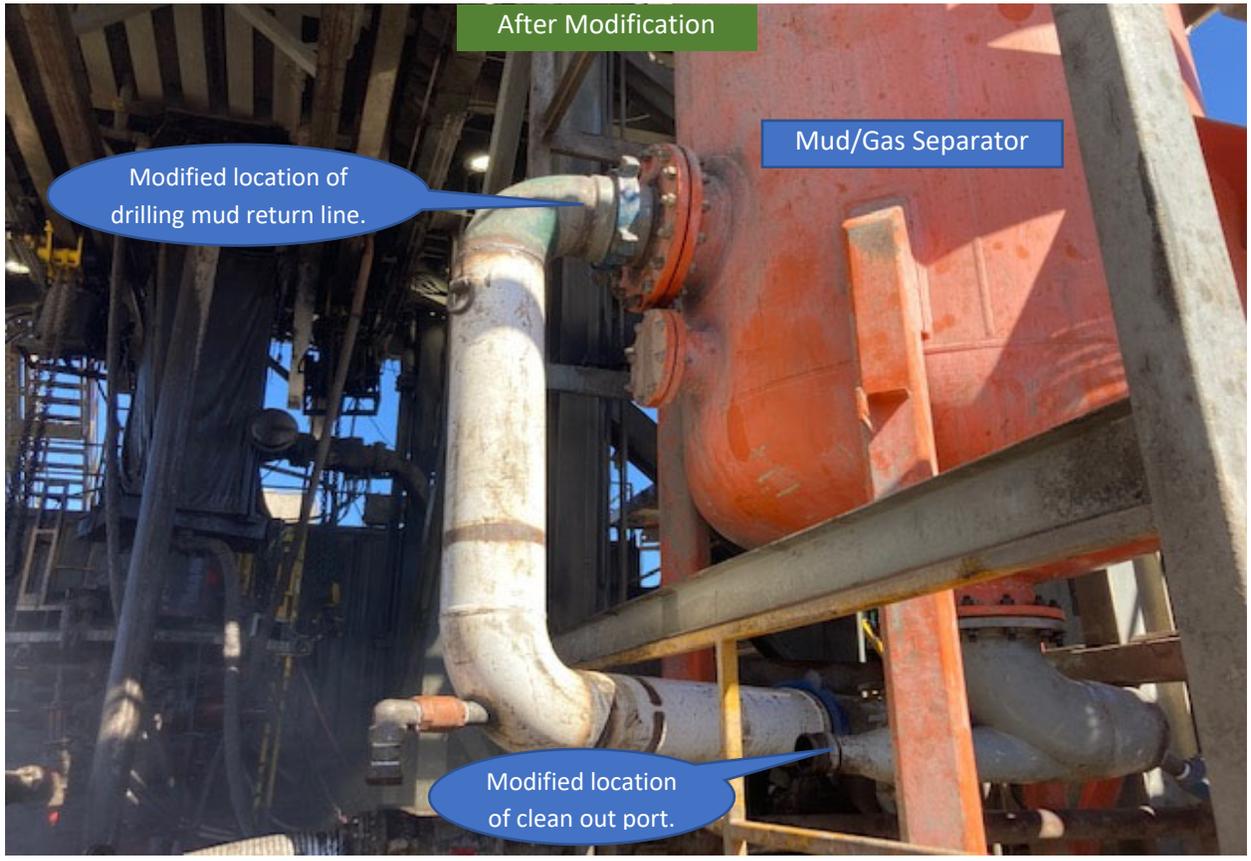
# Flow Diagram

At 4:36 p.m., drilling operations were preparing to drill through the curve and to do so had switched to the mud/gas separator. The purpose of the mud/gas separator is to separate gas from drilling mud as it returns to the surface. The fluid flows into the mud/gas separator through a side port which hits a plate and allows the gas to rise and the mud and cuttings to flow out the bottom port and back into the mud system. We have now determined that the flow rate through the bottom port had in this instance become restricted and plugged with drill cuttings and as a result, drilling mud accumulated in the mud/gas separator and directed liquids to the combustor. The drilling mud was ignited, resulting in flames within and directly above, and immediately outside the perimeter of the combustor. The fire was quickly controlled and almost completely extinguished by on-site personnel. NMFD arrived onsite and extinguished remaining flames inside the combustor with approximately 5 gallons of non-PFAS foam (Microblaze).

<b>Location Equipment Inventory</b>	<b>How did this piece of equipment contribute to the incident?</b>	<b>How was this equipment affected by the incident?</b>
Mud/gas separator	Drilling mud from the well enters the vessel and allows any gas to travel to the top port to be sent to the combustor.	Bottom port became plugged with drill cuttings, not allowing any return flow to mud tanks and directing liquid to the combustor.
Combustor	N/A	Combustor overwhelmed, causing visible flames above the walls.

- 1) Bottom port of mud/gas separator became plugged restricting normal returns.
- 2) Estimated one barrel of drilling mud entered combustor.
- 3) Cleanout maintenance frequency of mud/gas separator resulting in the buildup of drill cuttings within the vessel.
- 4) Monitoring of drilling mud return rates when switching to the mud/gas separator.

1. Mud/gas separator flowlines modified for optimal flow rate, circulation, and maintenance cleanouts.
2. Completed internal visual inspection of combustor on 3/12/2022 and put back in service.
3. Inspection of equipment with Broomfield inspector and NMFD prior to resumption of drilling. Completed 3/13/2022.
4. Submitted report related to BMP 51 on 3/13/2022.
5. Follow up meeting with COGCC 3/14/2022 discussing event and decision to file Form 22. Submitted 3/14/2022.
6. Area air monitors showed no abnormal spikes during the incident.
7. Initiated company internal root cause investigation.
8. The fire and subsequent black smoke that resulted from the incident was contained to the ground combustor and posed no safety risk to the community.

1. Increase maintenance to mud/gas separator. Specifically, every time that the mud/gas separator is taken off-line and prior to it being put back on-line, it will be drained and then washed-out using drilling mud introduced into the vessel through a high-pressure line installed during the modification of the clean-out port.
2. Additional monitoring of drilling mud return lines during transition of the mud/gas separator.
3. Inclusion of additional ecological containment system between mud/gas separator and ground combustor
4. Civitas will apply these corrective actions to other drilling locations.
