Inspection Photos

API: 071-08113

Operator: EVERGREEN NATURAL RESOURCES

Inspection Date: 4/19/2022

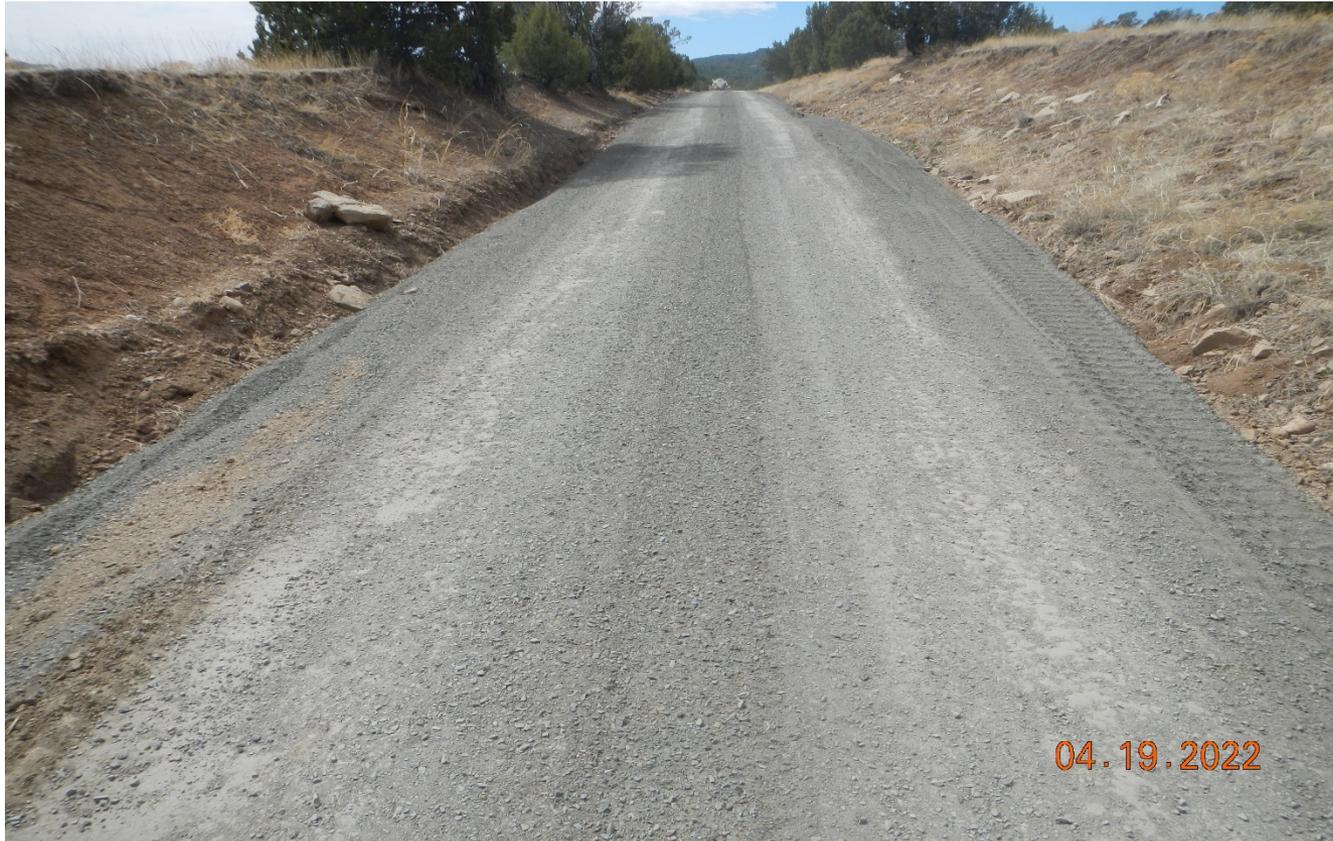
Photo 1. Facing southwest along the main road near the electric gate. There has been roadbase applied to this area of the road.

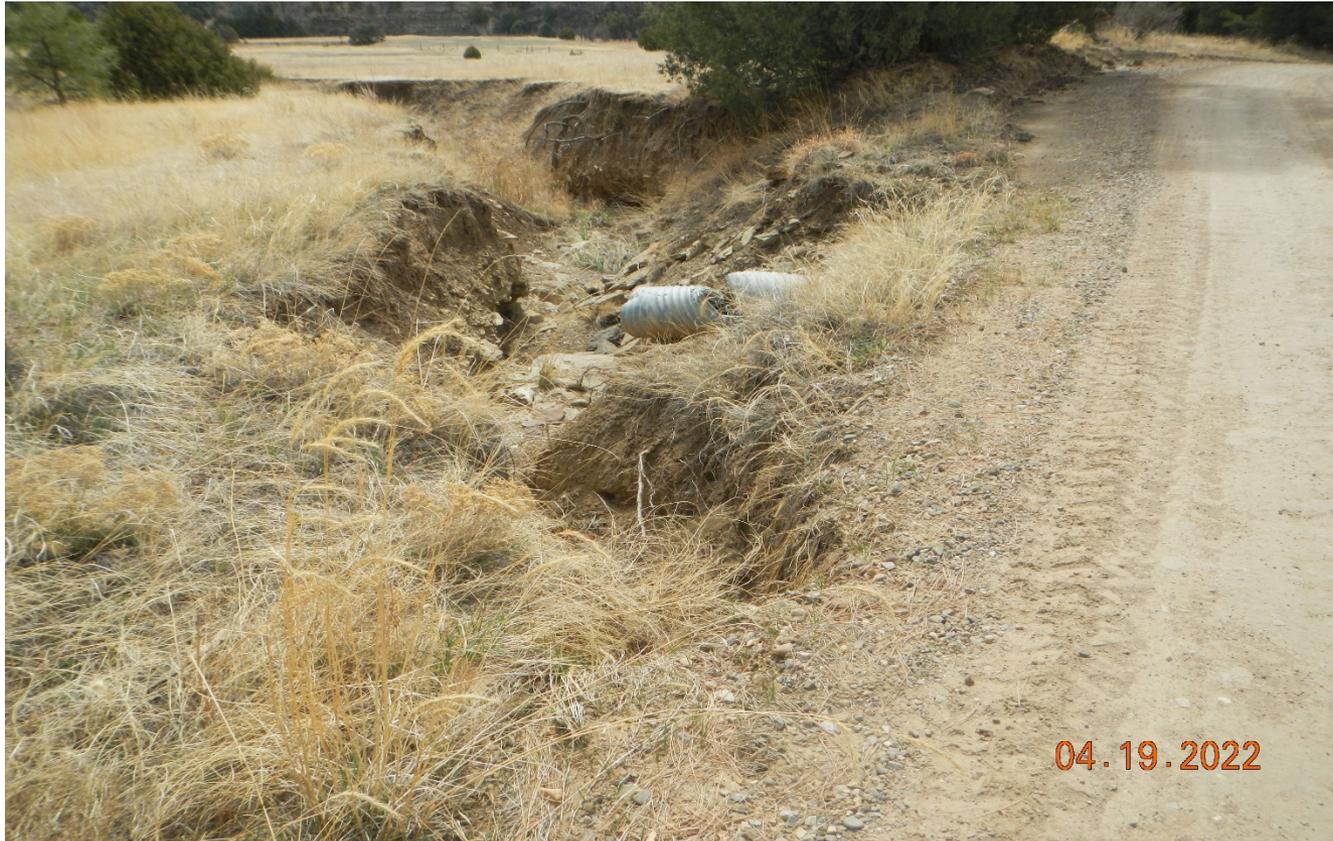
Photo 2. This culvert along the main road is partially washed out and needs to be repaired. Lat/Long:37.08136,-104.62910. This has not been repaired.

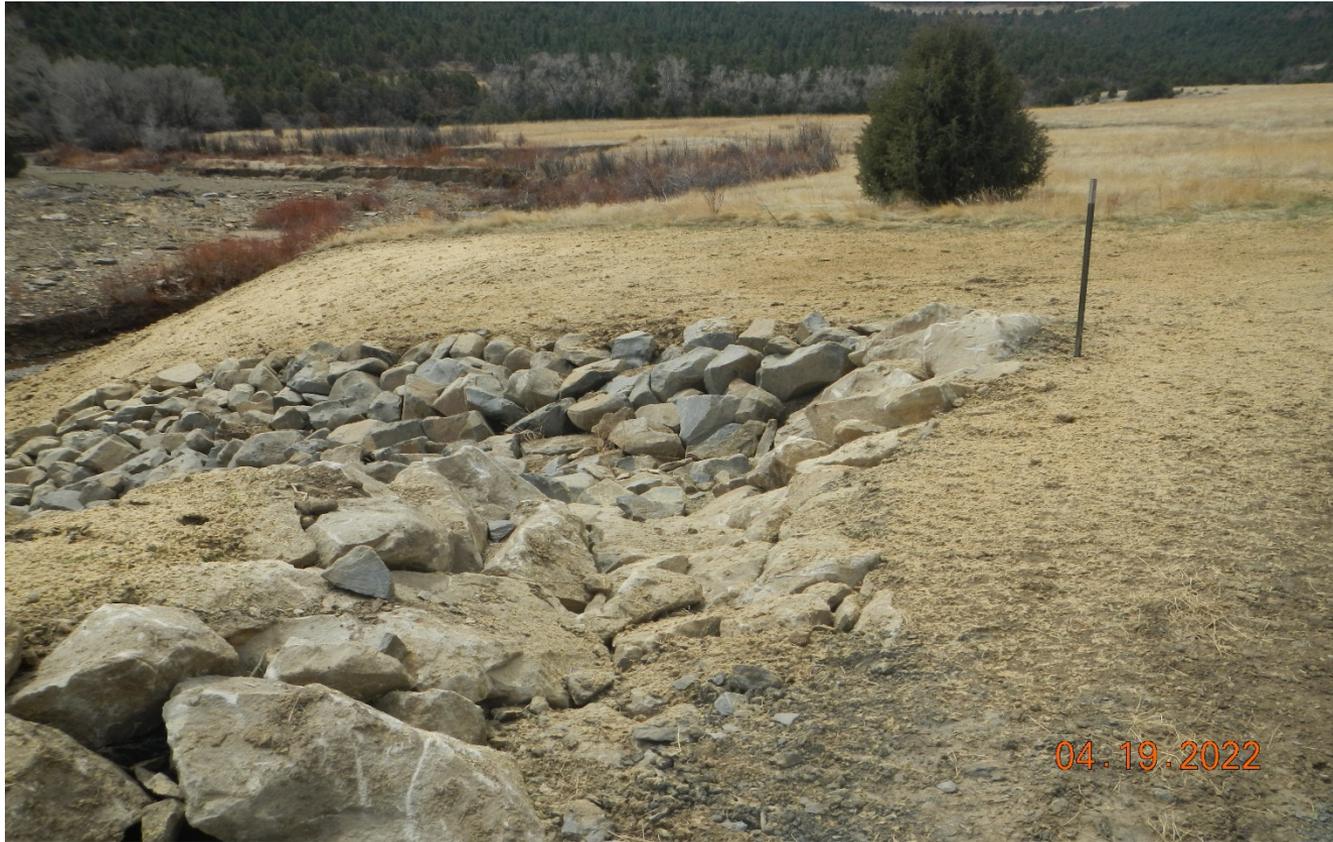
Photo 3. Further along the road the culvert outlet was repaired and rock outlet protection was installed.

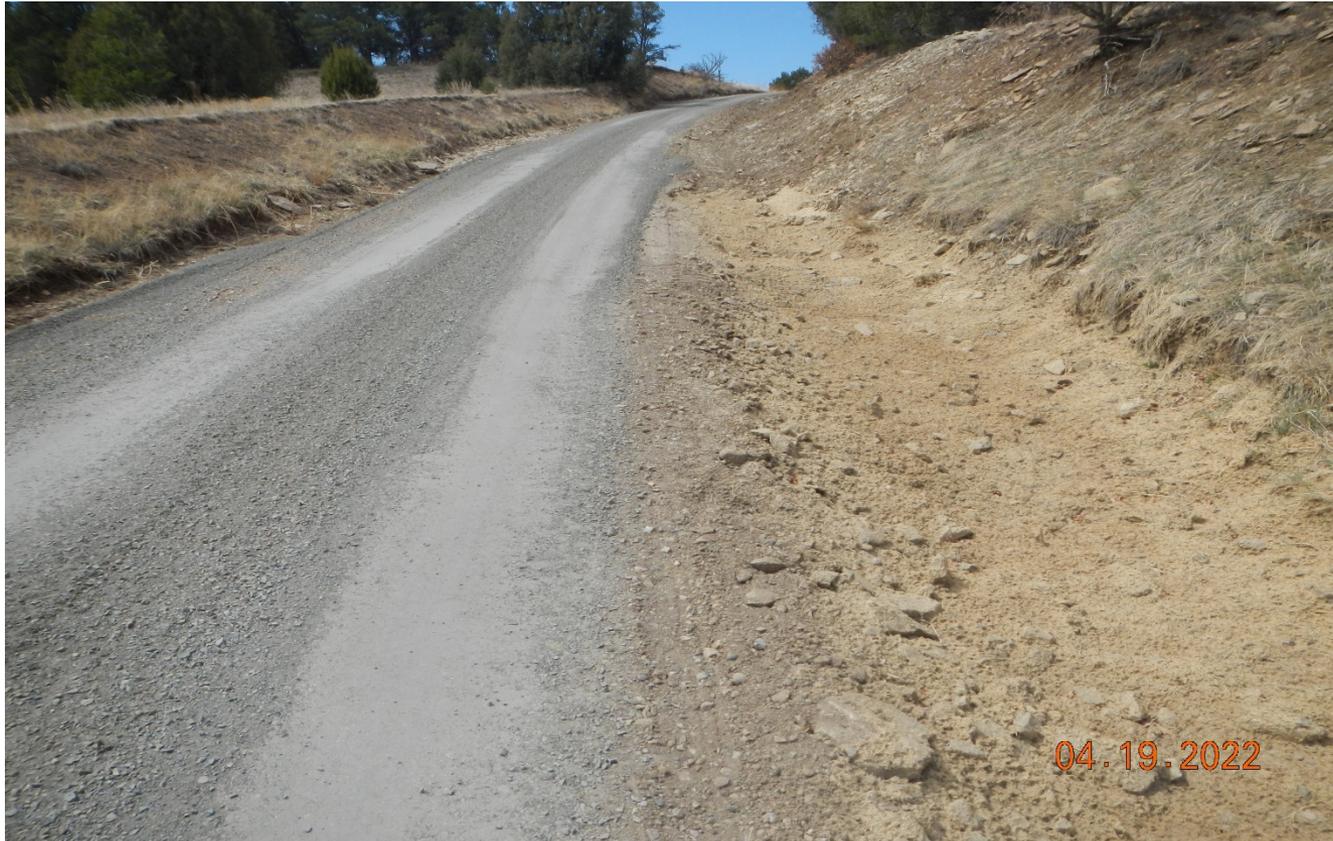
Photo 4. The road side has been repaired and stabilized.

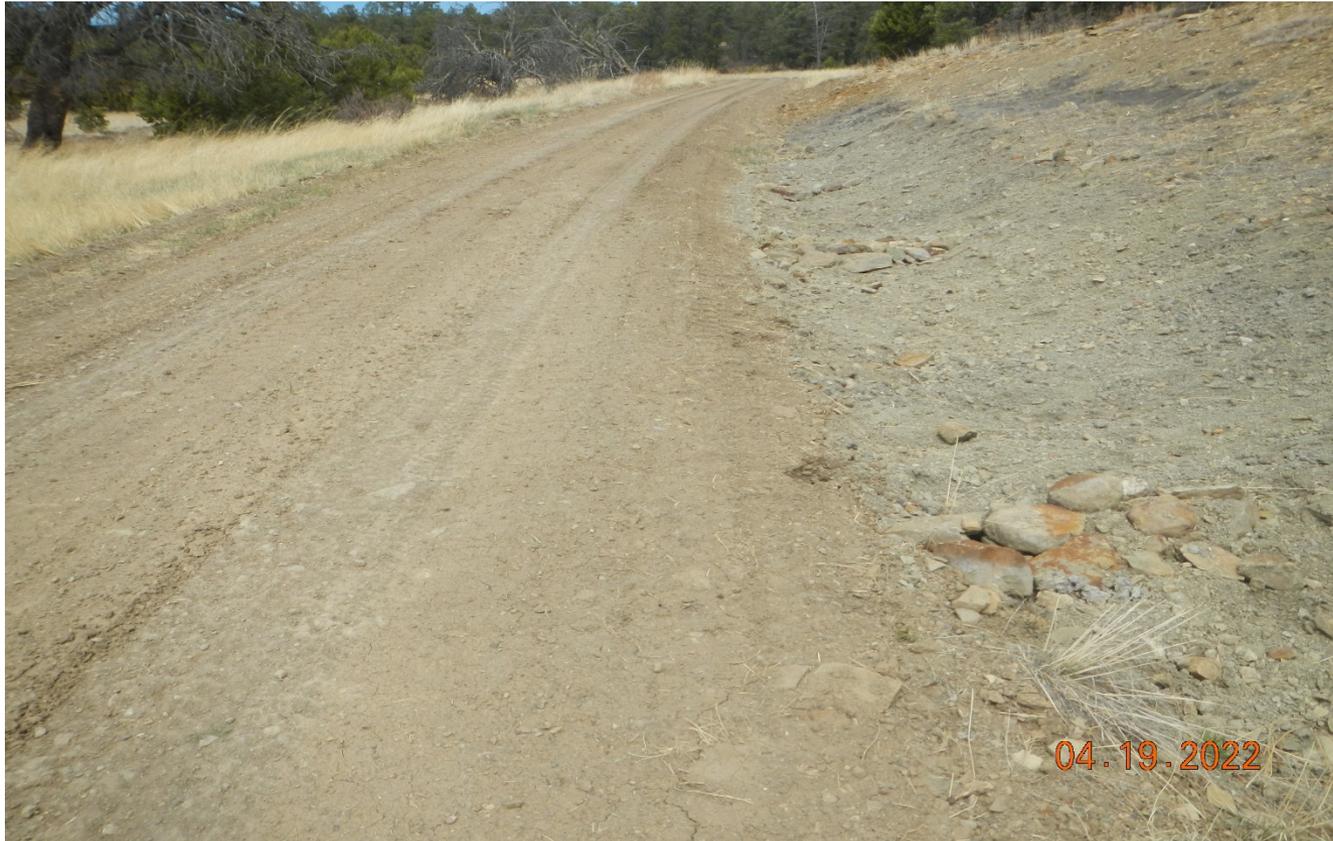
Photo 5. Further west along the access road. This area has been repaired. There are rock check dams installed however they are small and may not hold up very well.

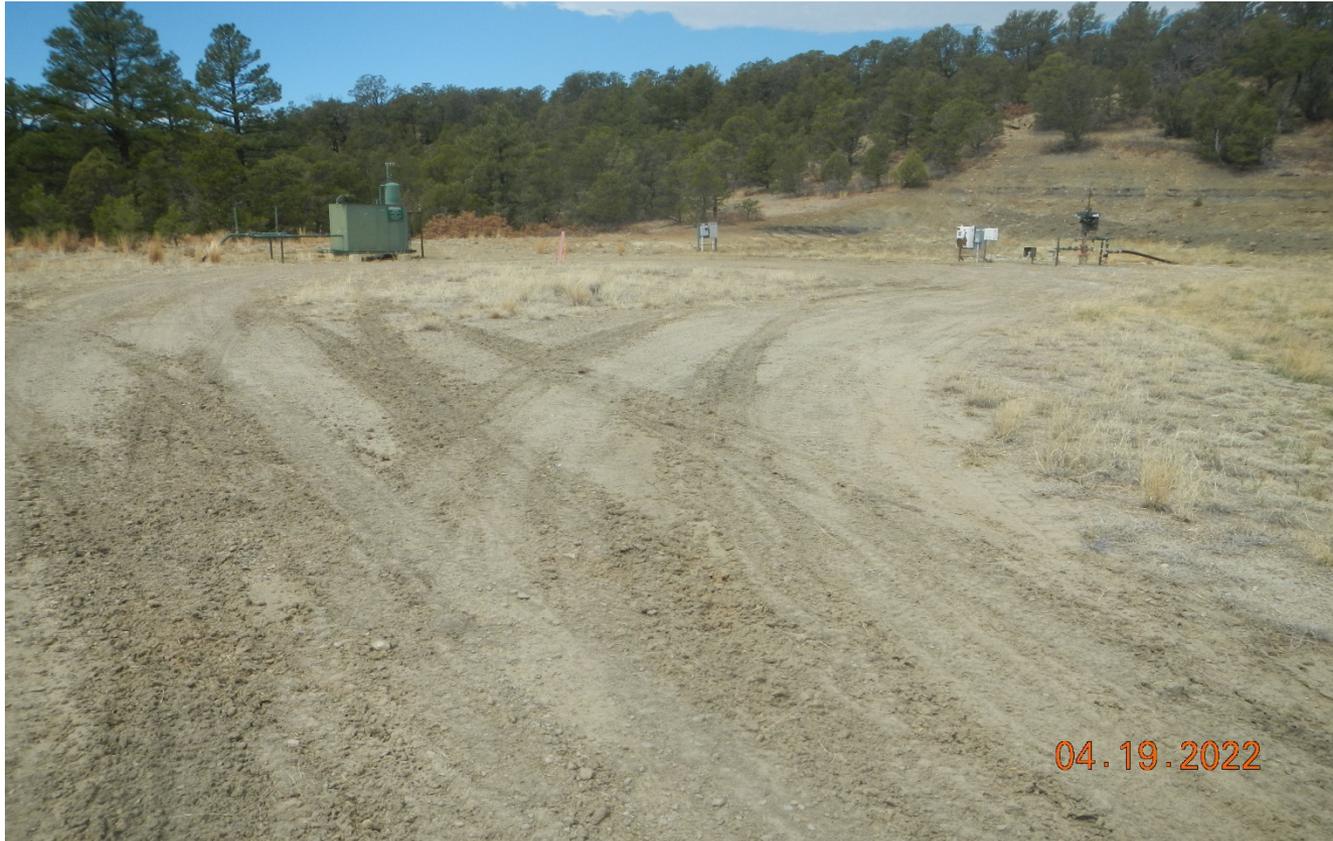
Photo 6. Facing southwest toward the well site.

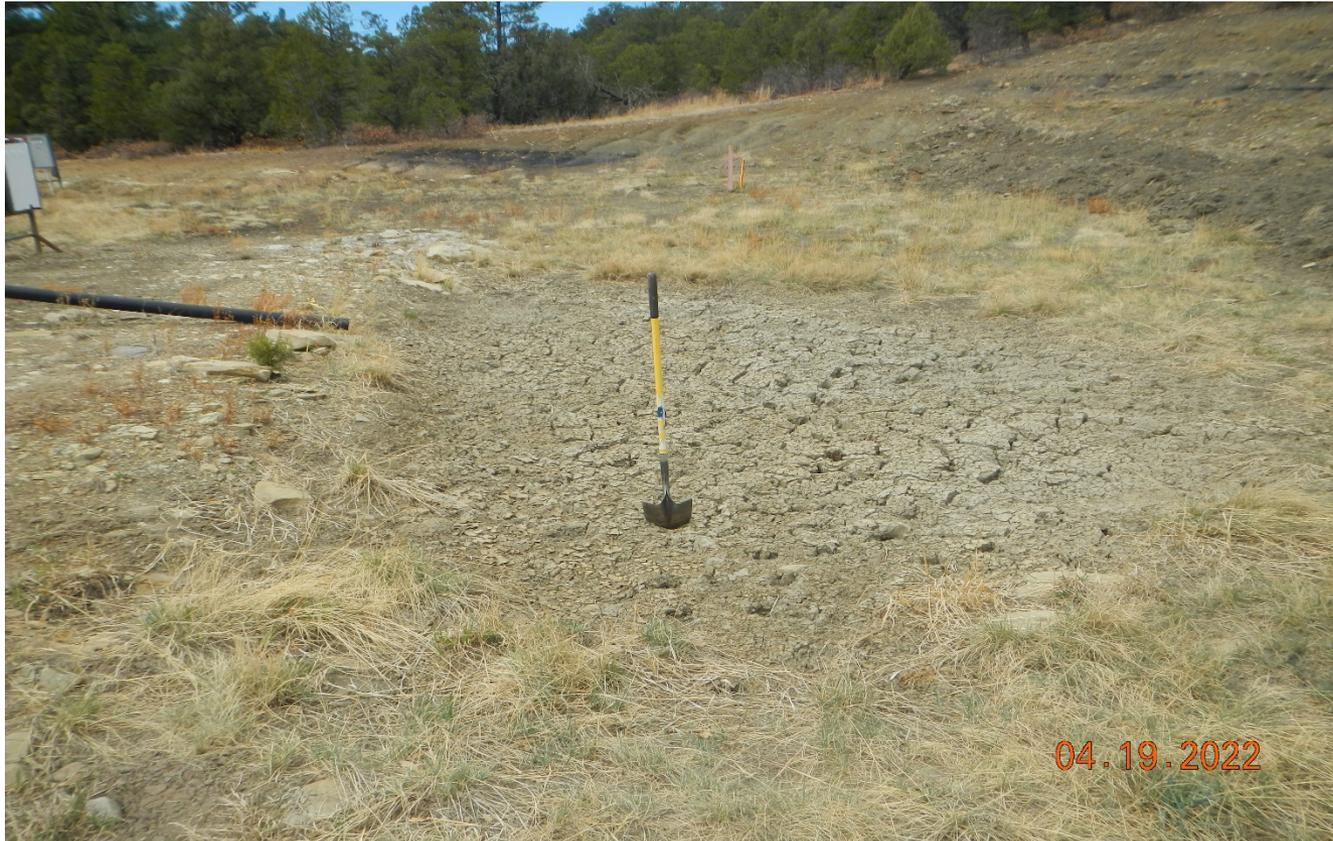
Photo 7. Facing toward the pit. Water level has been lowered. The pit is shallow <2 ft. deep and needs to be constructed to allow 2 ft. freeboard. Previous corrective action was not completed.
