# Inspection Photos

API: 071-07085

Operator: EVERGREEN NATURAL RESOURCES

Inspection Date: 4/19/2022

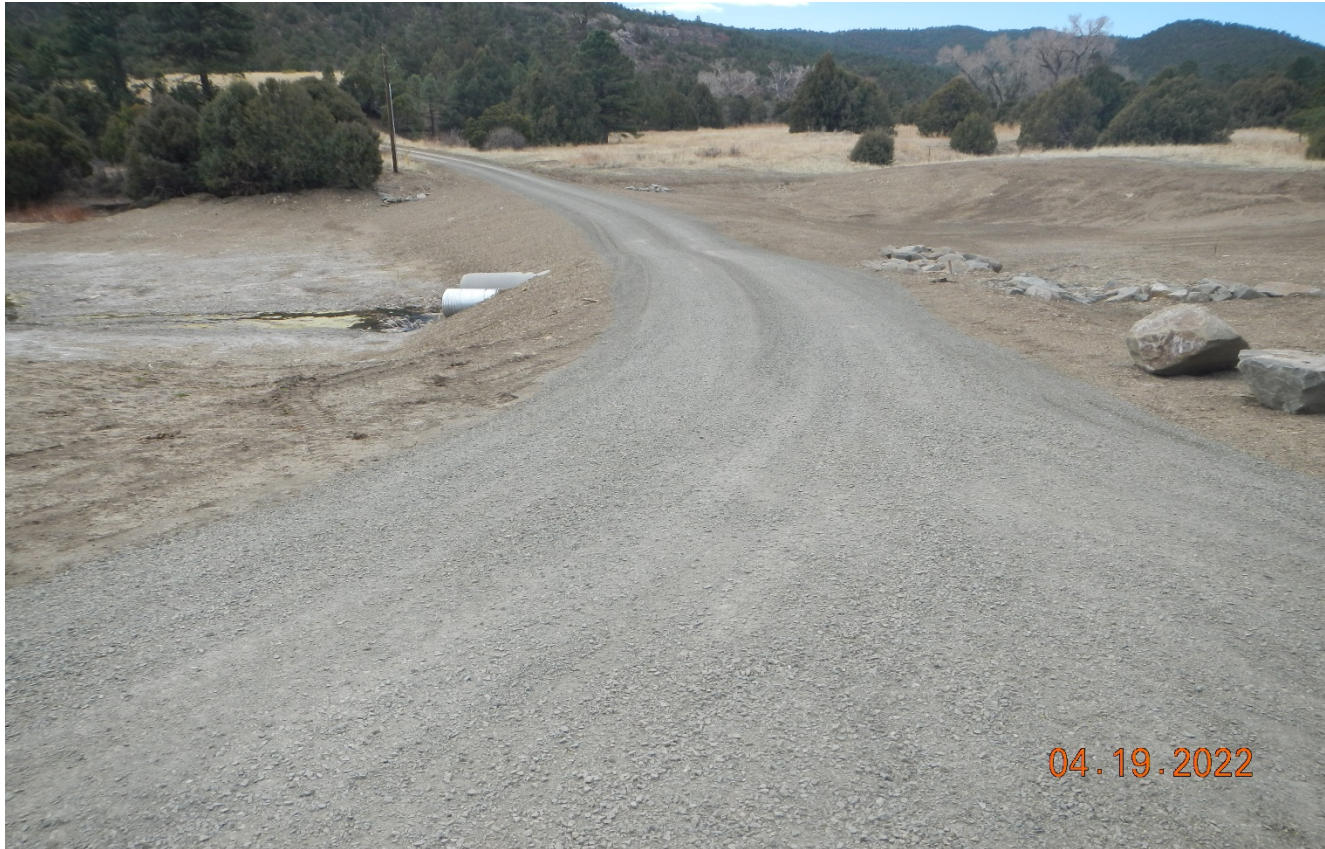
**Photo 1.** Facing south toward the access road stream crossing. There is no bank stabilization at the outlet side.

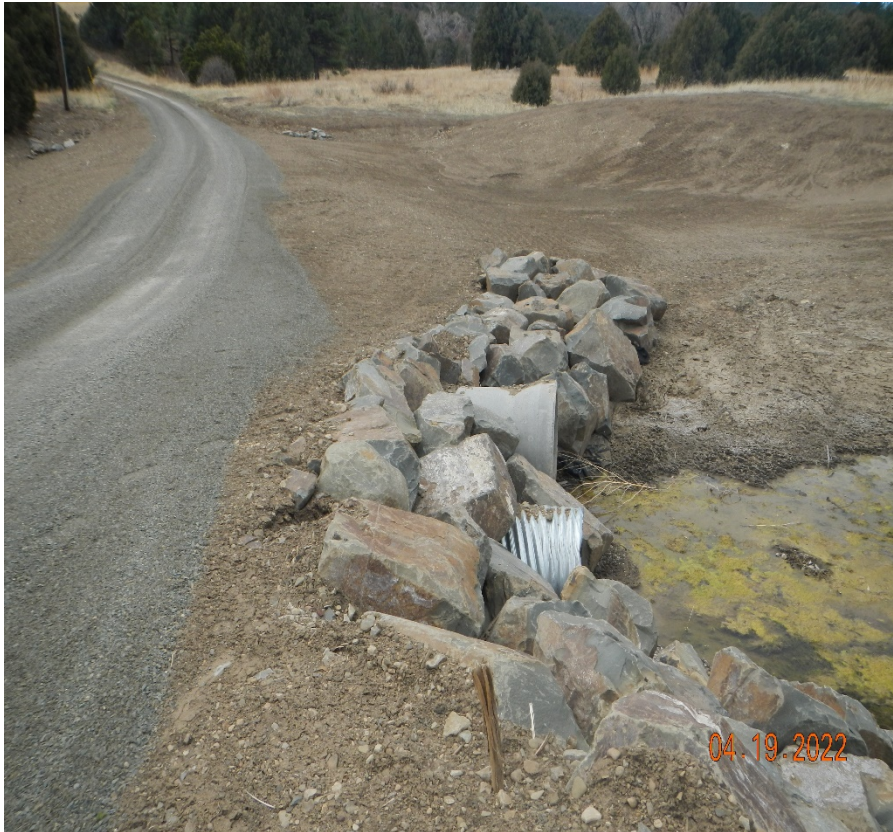
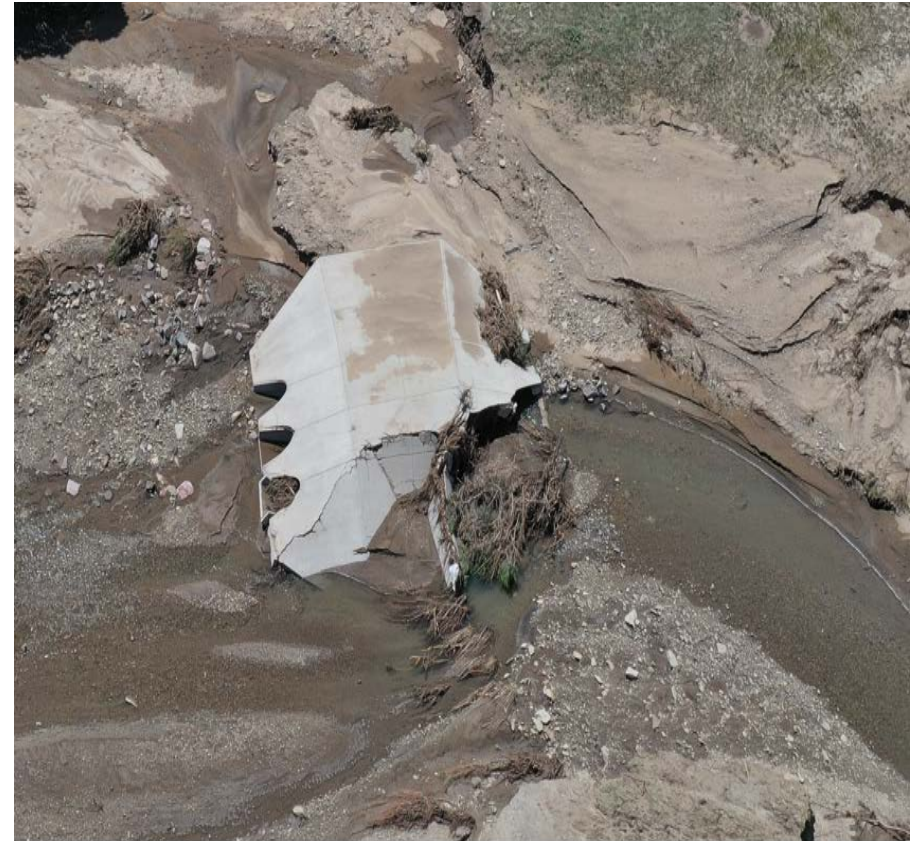
**Photo 2.** There are two culverts installed at the stream crossing. This appears to be inadequate as the prior cement culvert shown in the photo on the right had 3 large culverts.

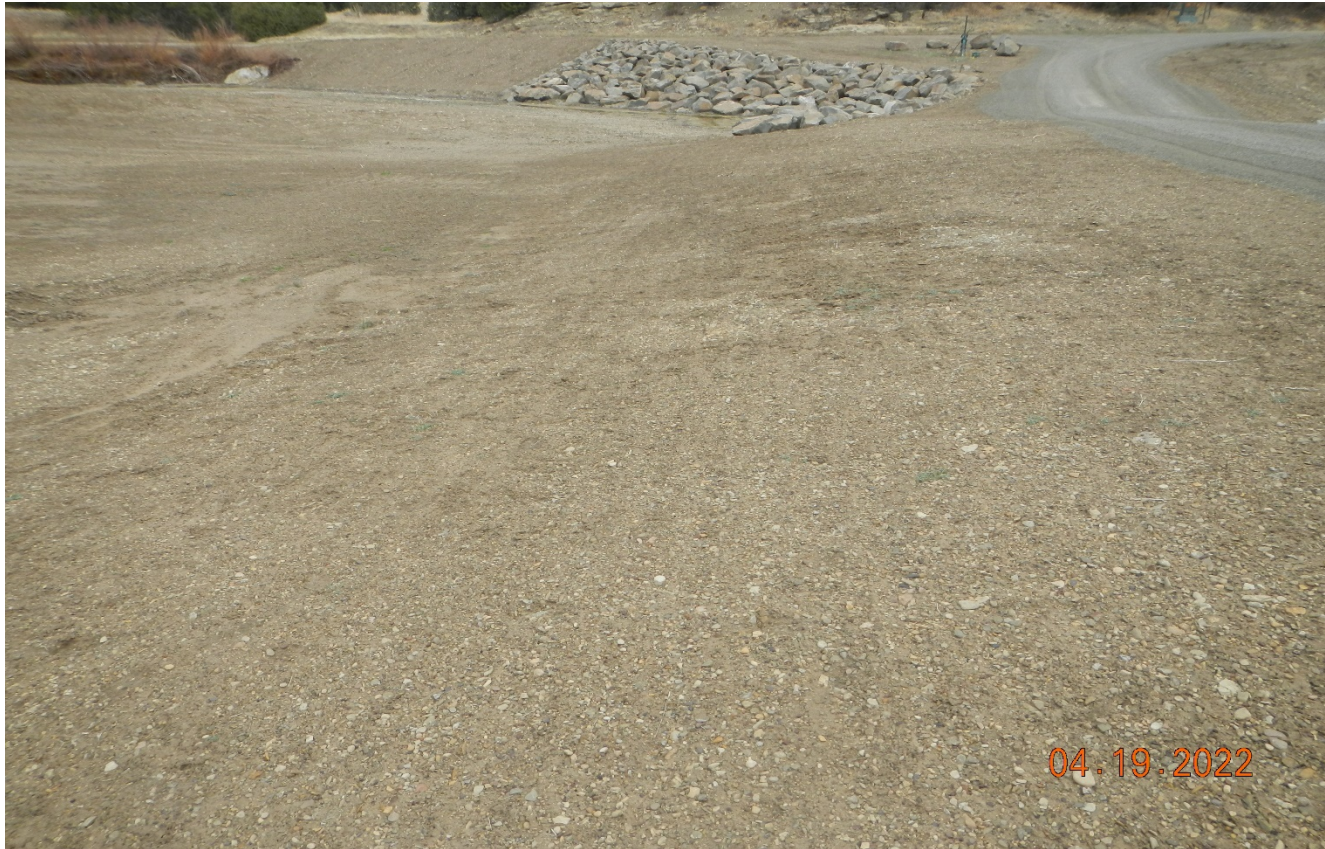
**Photo 4.** Facing northwest along the side of the access road. All disturbed areas along the road side need to be seeded and stabilized.

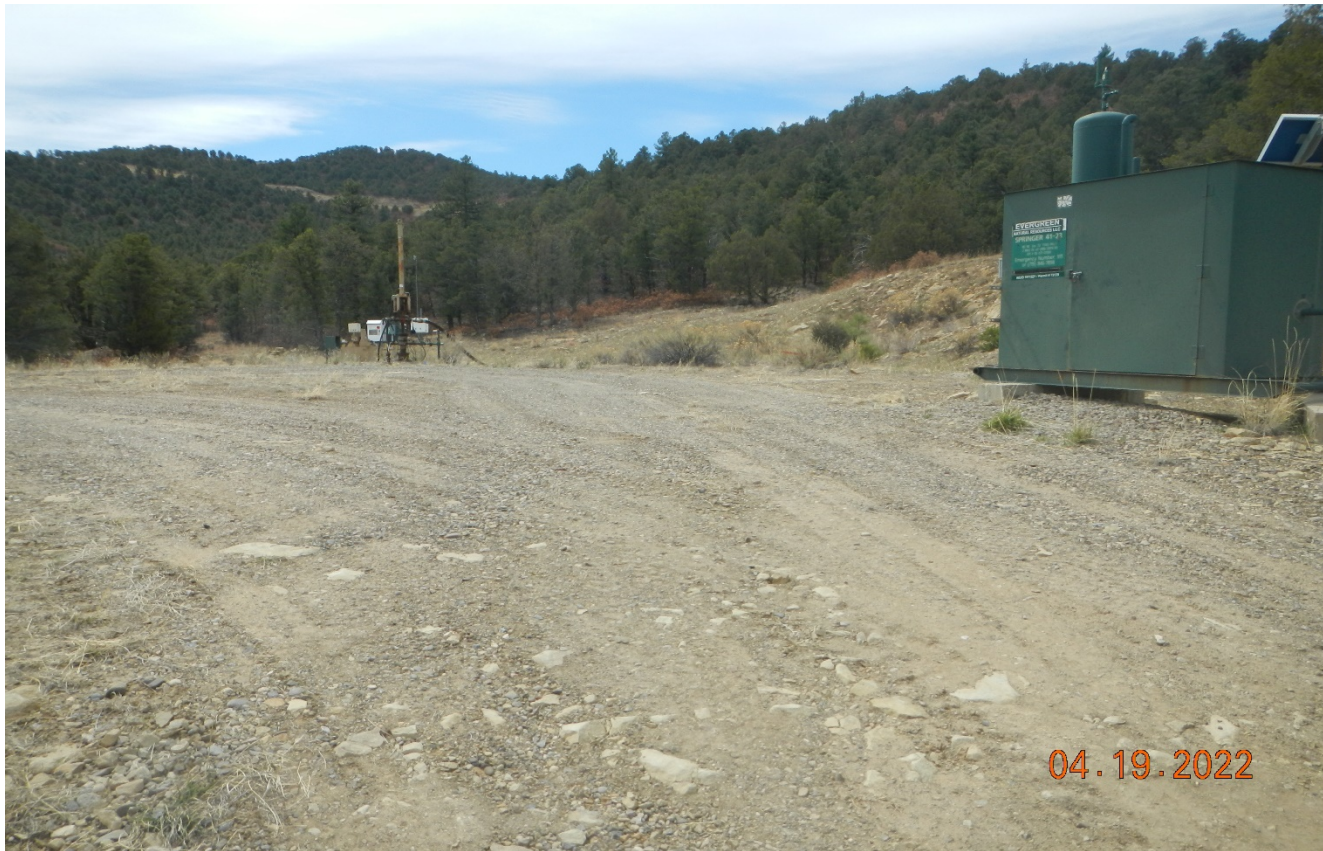
**Photo 5.** Facing southeast toward the well site.
