Inspection Photos
Operator: Simcoe
API: 067-06329
Date: 4/19/2022

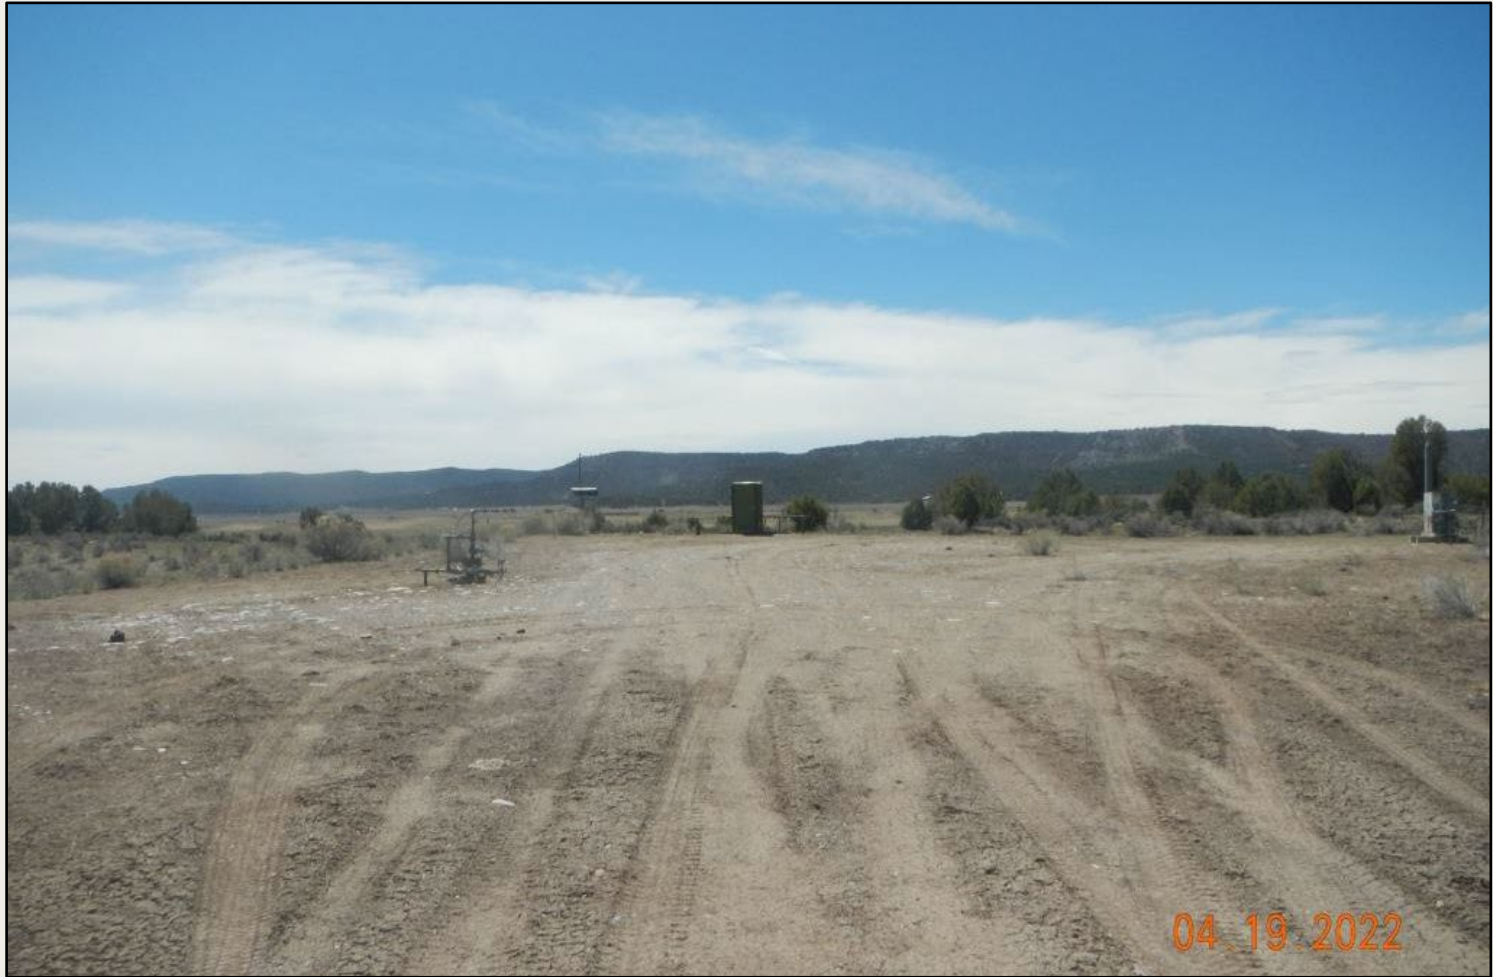
Photo 1. View of the project area from well pad entrance facing center.

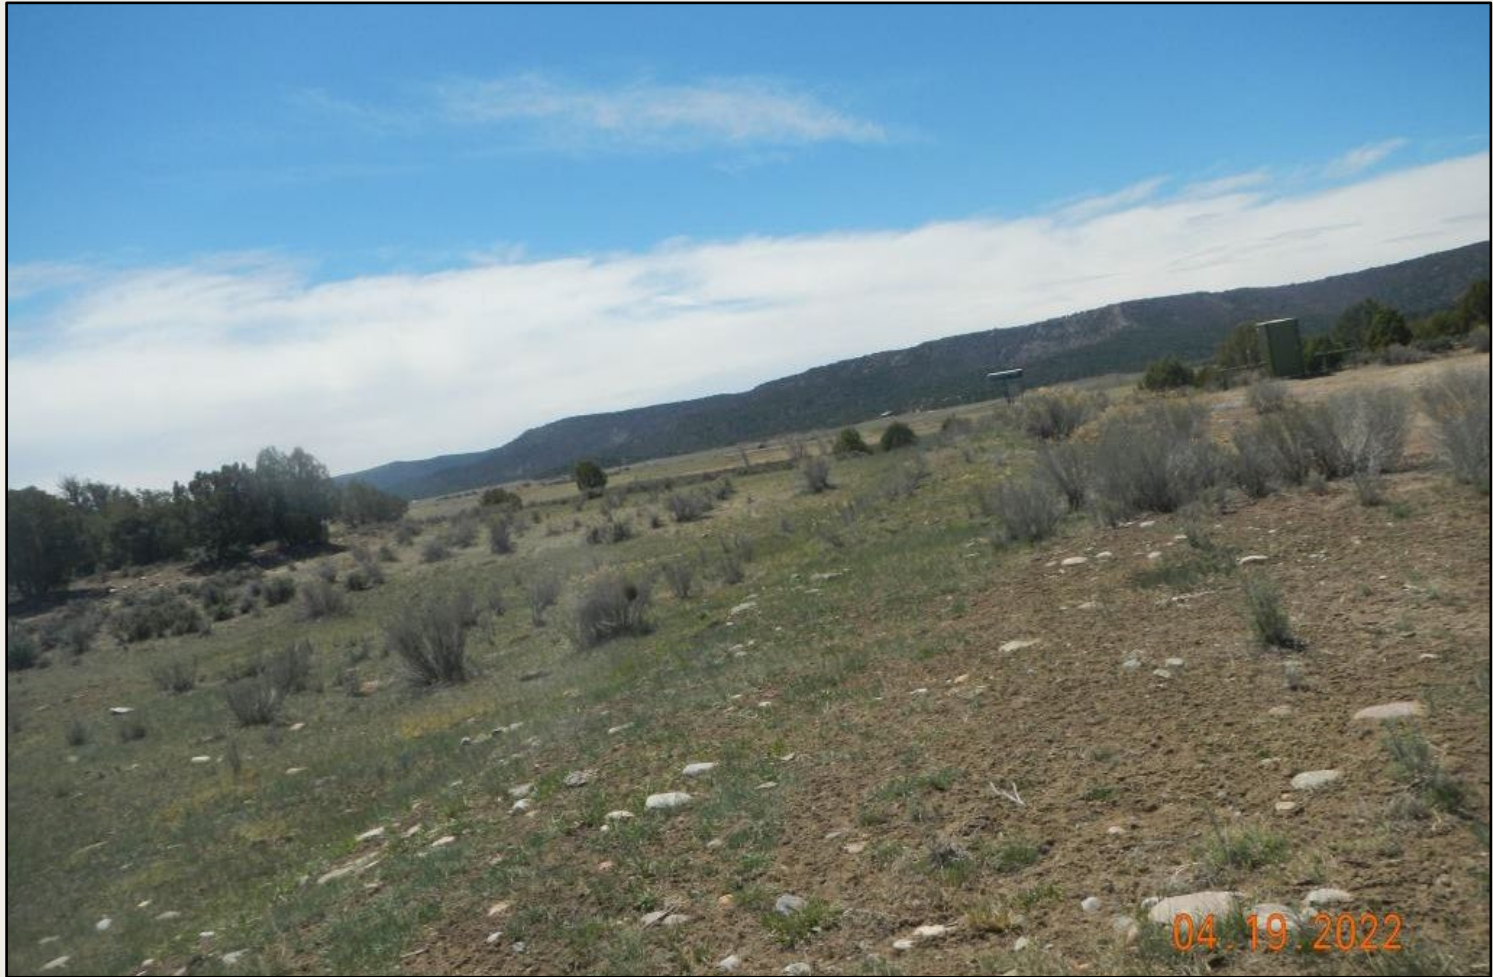
Photo 2. View of the eastern project area from the northeastern corner facing southward. Revegetation is progressing with western wheatgrass and rubber rabbitbrush.

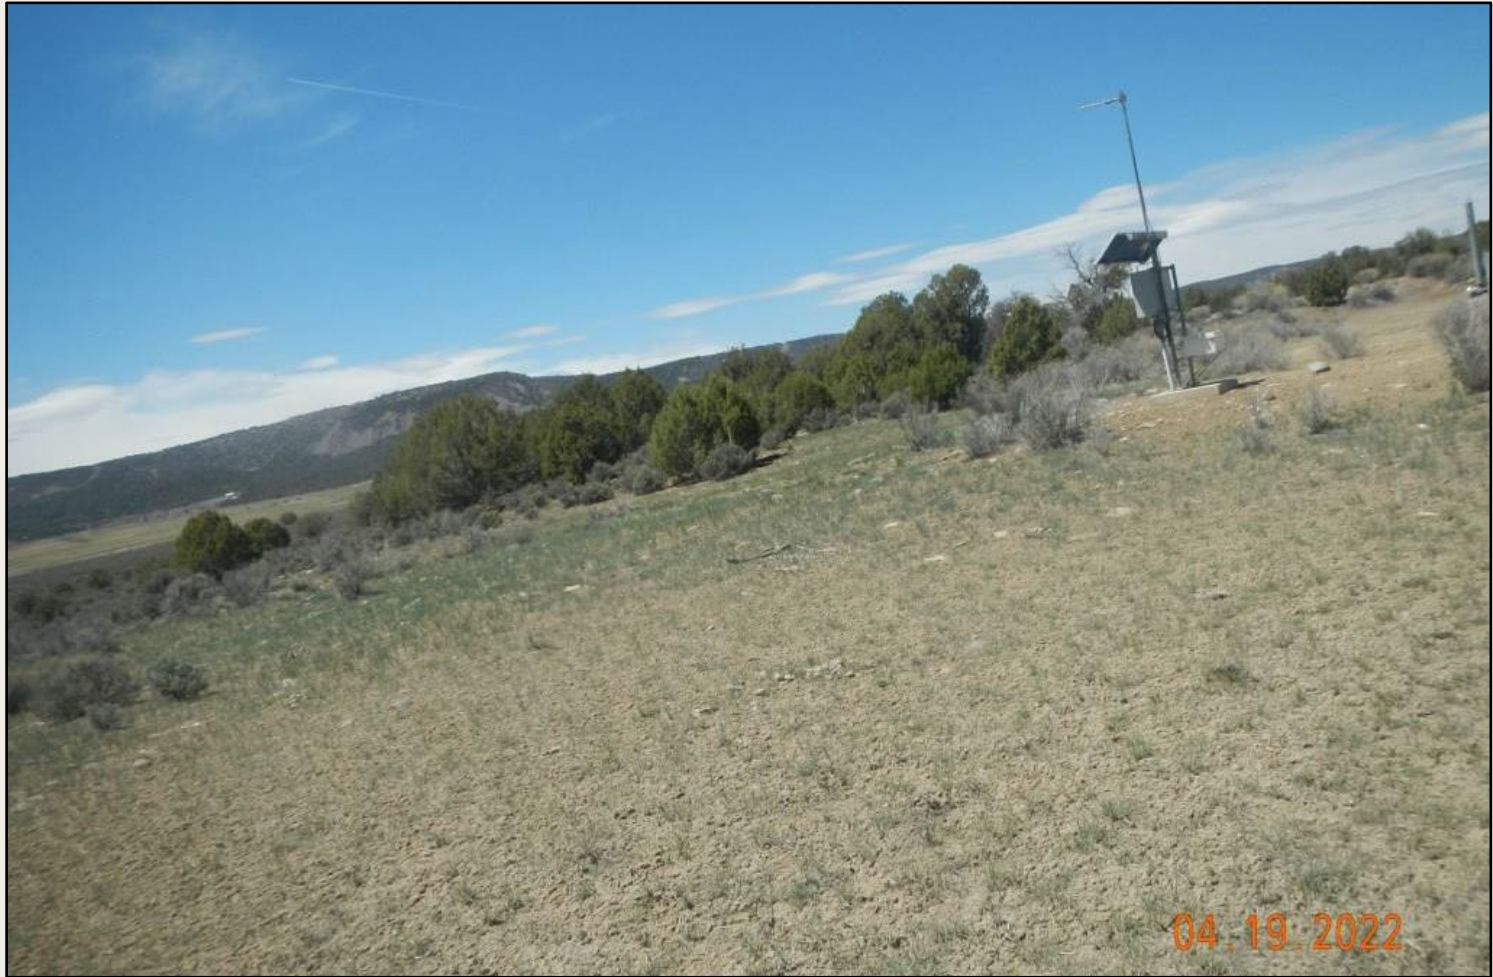
Photo 3. View of the southern project area from the southeastern corner facing westward.

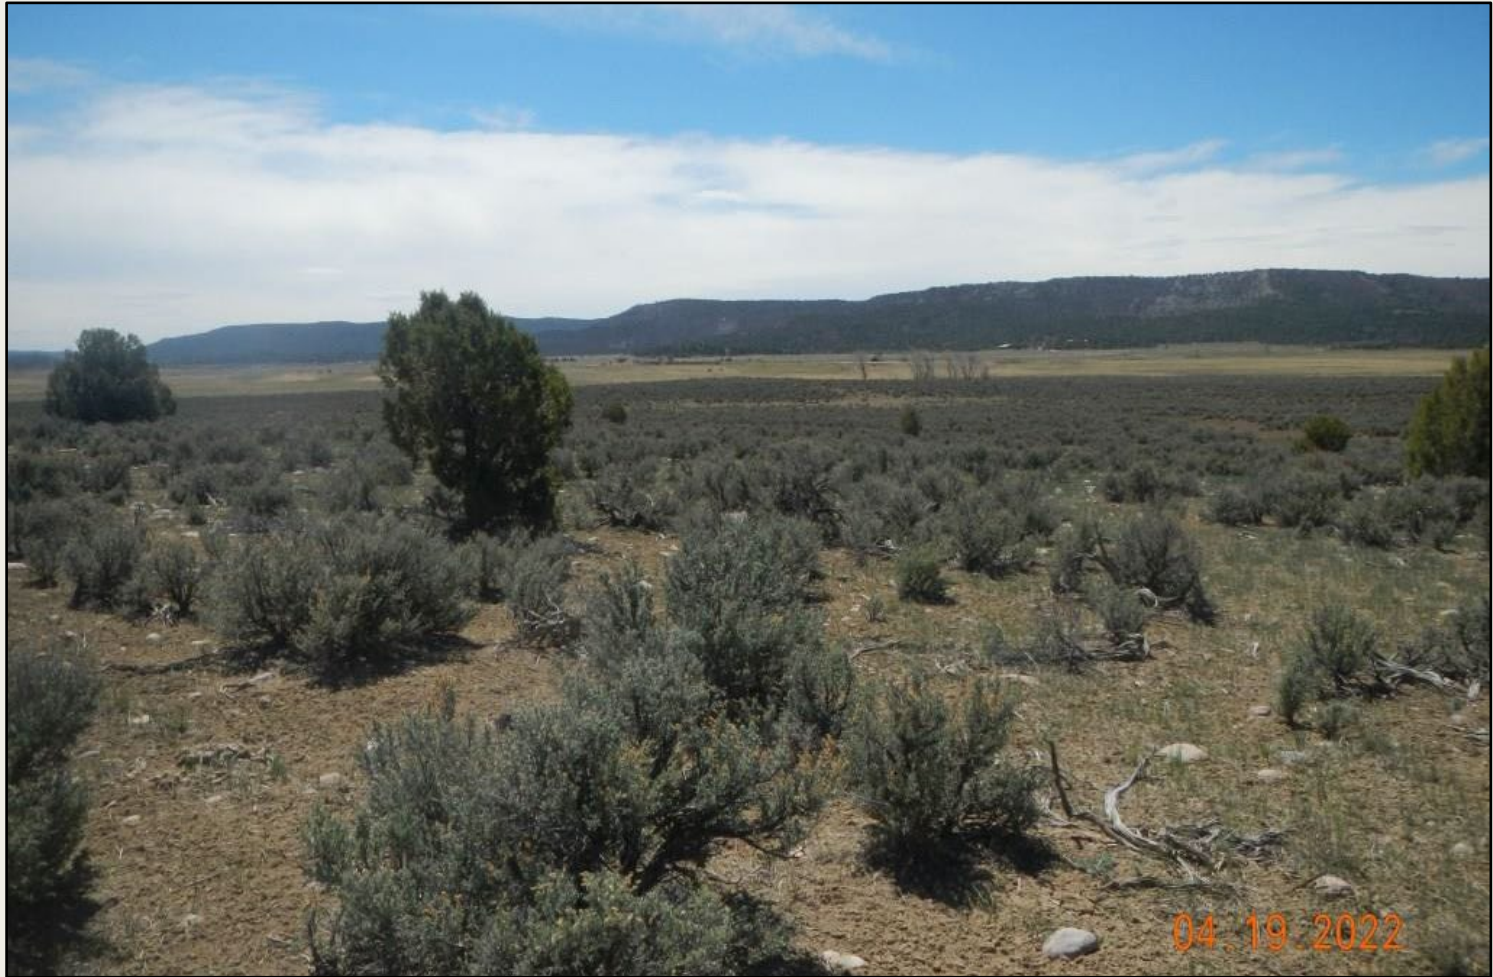
Photo 4. View of reference area comprised of sagebrush shrubland with and understory of James galleta, western wheatgrass, purplethreewain, yellow milkvetch, and Indian paintbrush.
