Inspection Photos
Operator: Rim Operating
API: 067-08071
Date: 4/19/2022

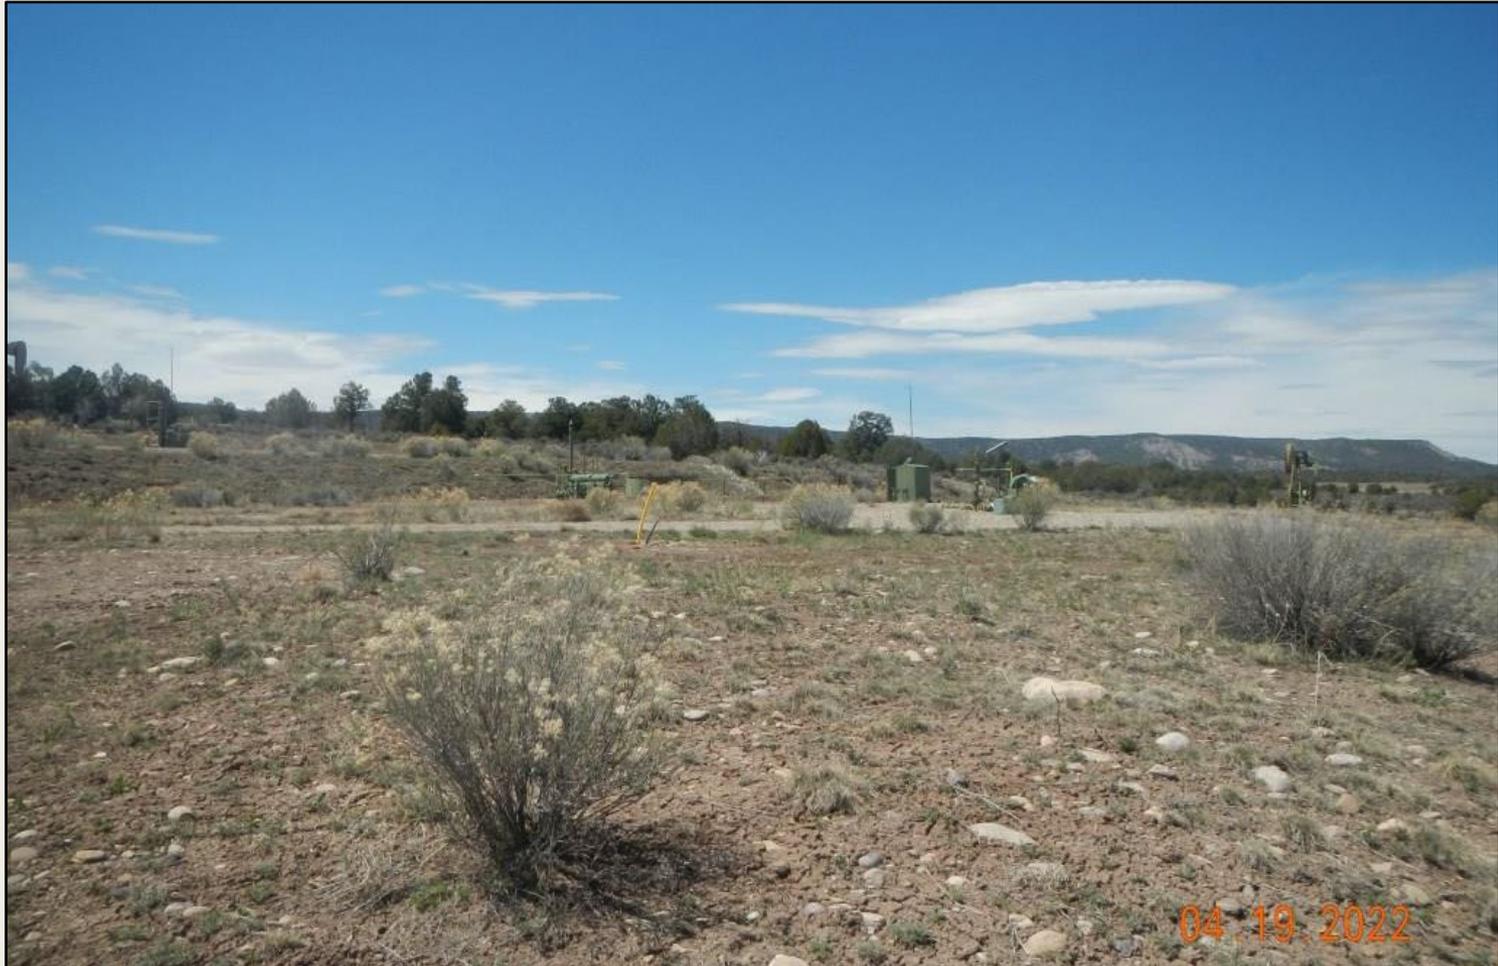
Photo 1. View of the project area from the northeastern corner facing center.

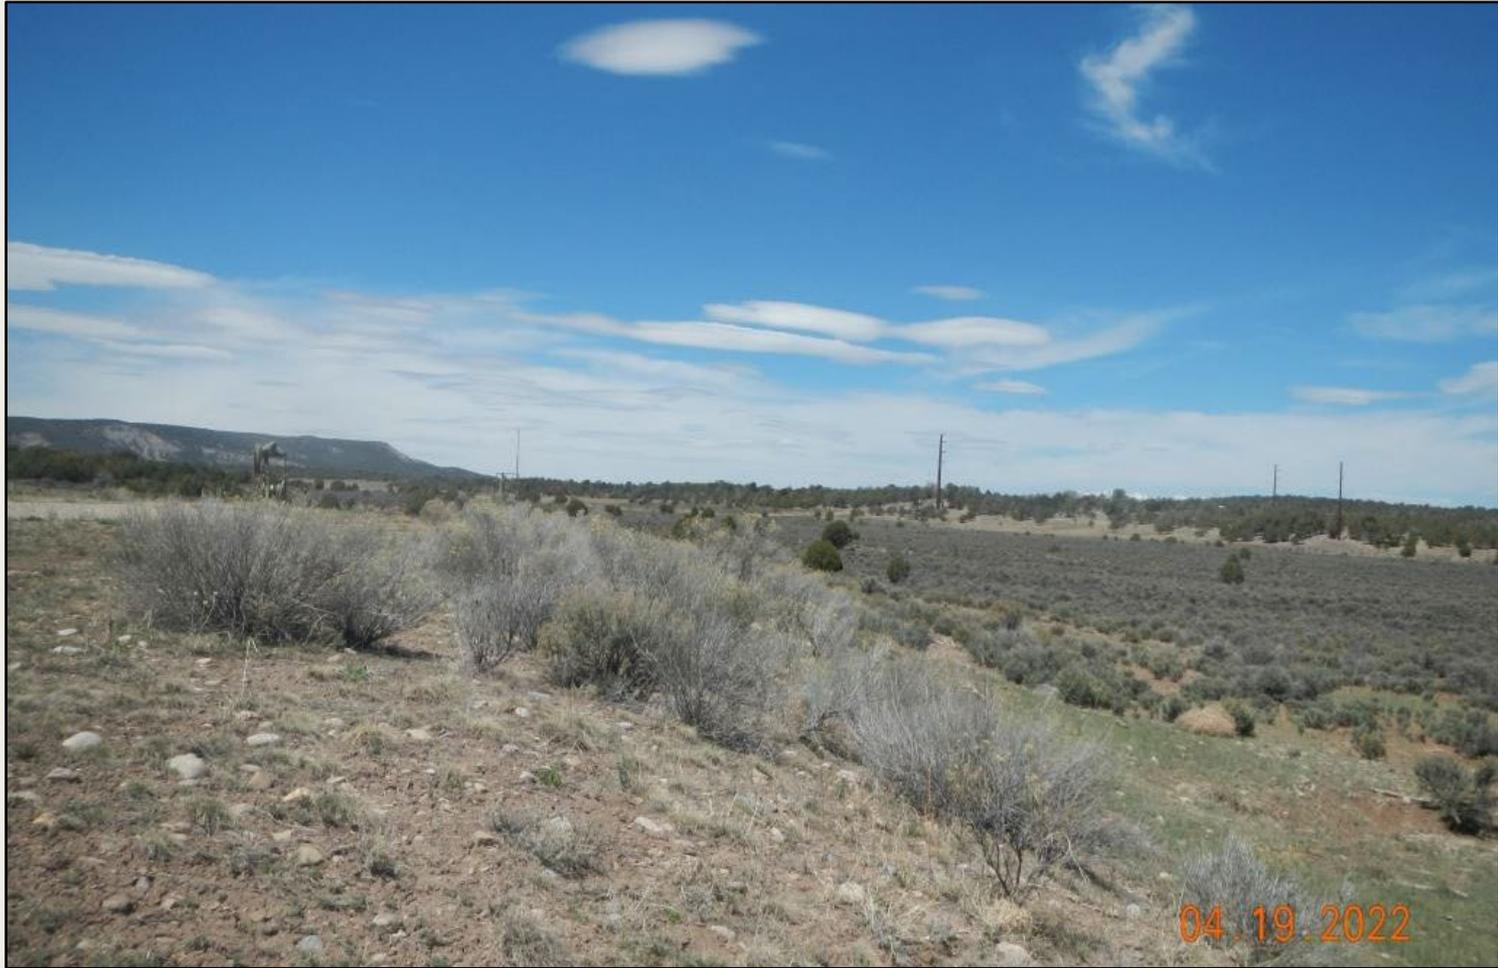
Photo 2. View of the northern project area from the northeastern corner facing westward. Revegetation is progressing largely with western wheatgrass rubber rabbitbrush, and purple threeawn.

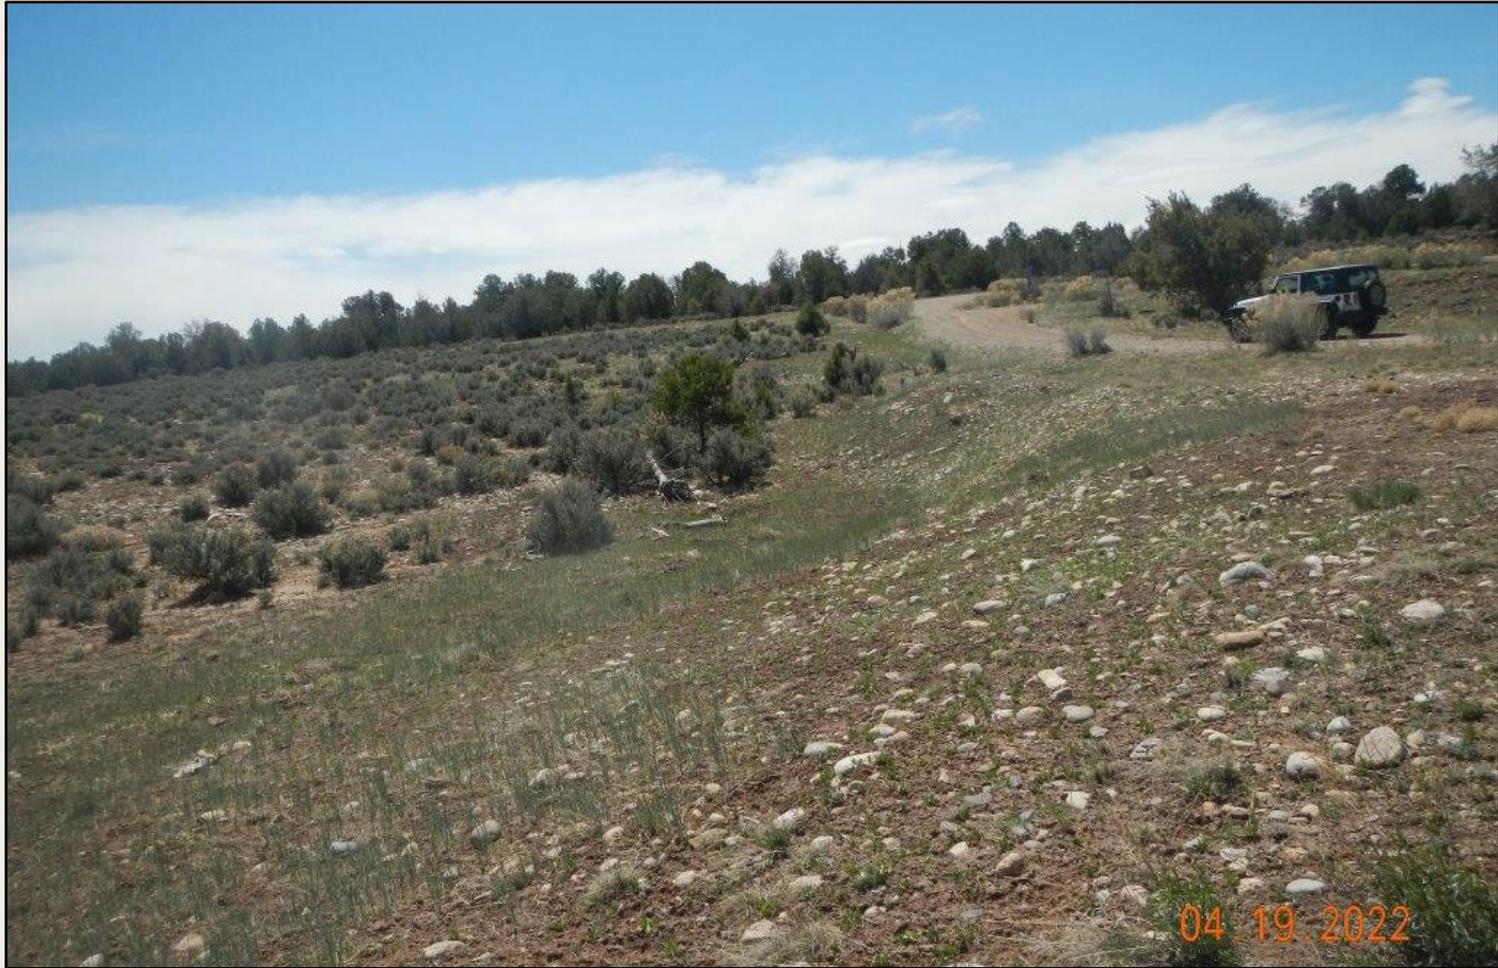
Photo 3. View of the eastern project area from the northeastern corner facing southward.

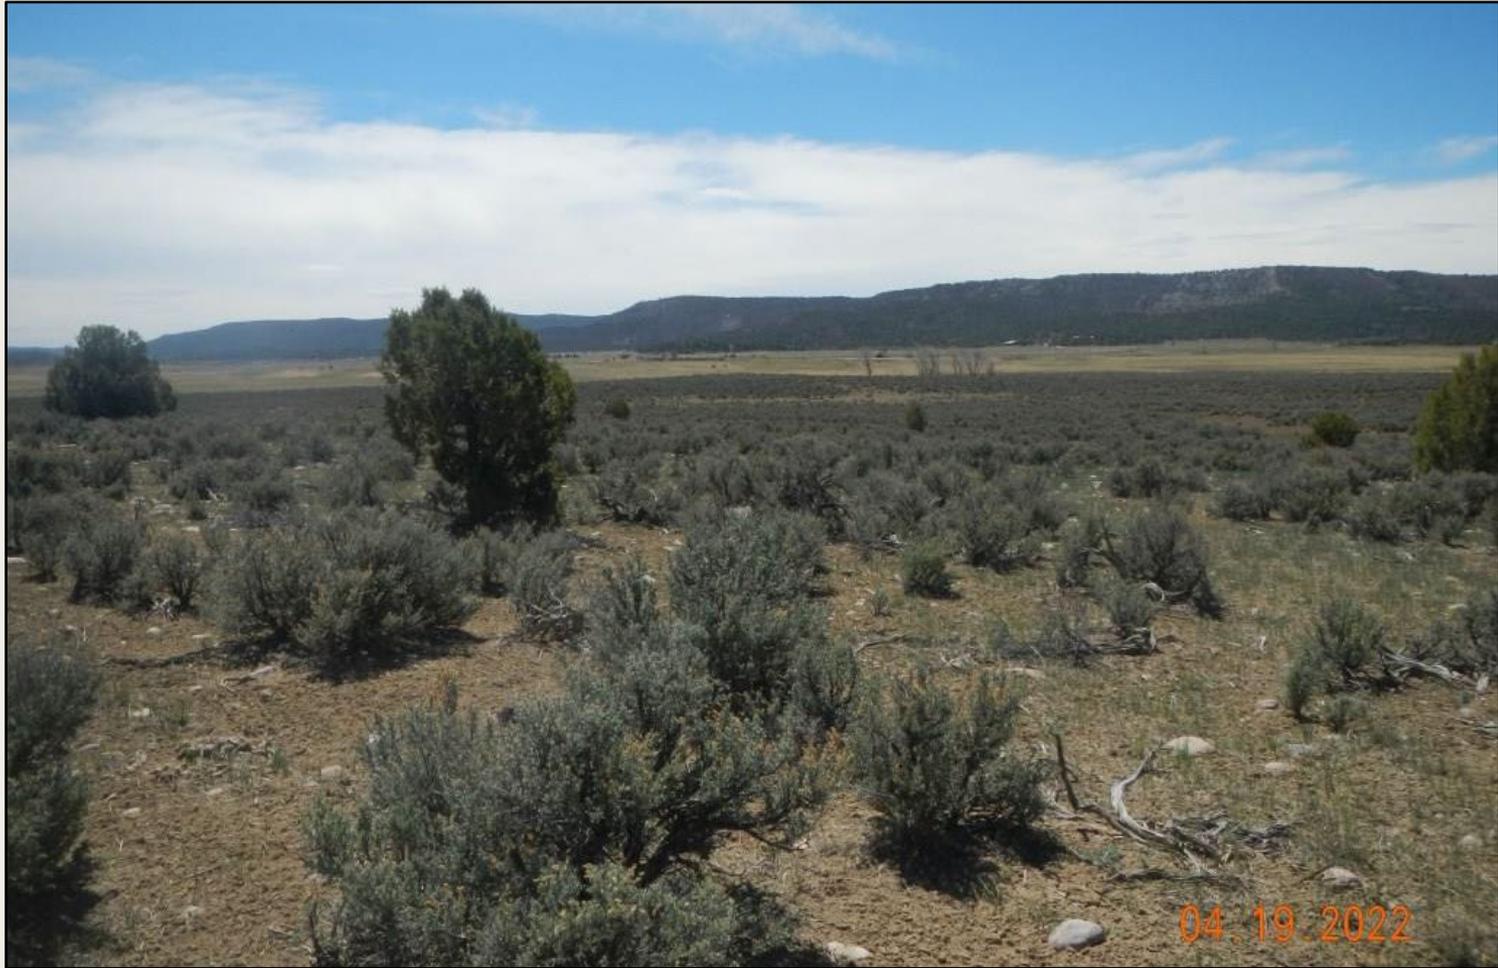
Photo 4. View of reference area comprised of sagebrush shrubland with and understory of James galleta, western wheatgrass, purplethreawn, yellow milkvetch, and Indian paintbrush.
