Inspection Photos

Operator: TEP Rocky Mountain- #96850

Location Name: Brynildson-66S92W /20SWSW

Inspection Document #: 702800139

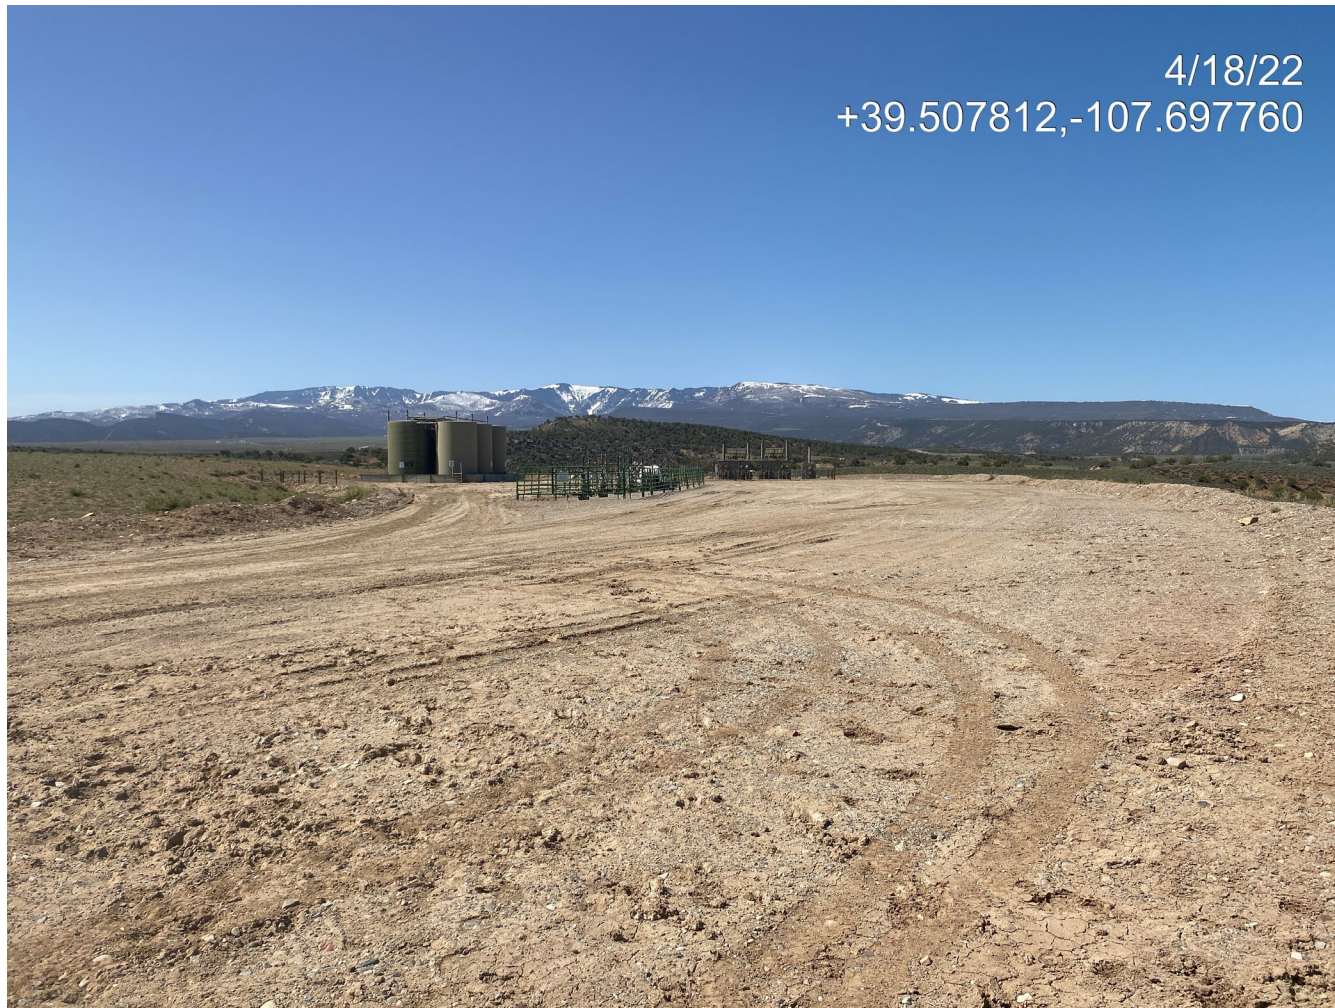
Photo 1. Photo taken from the Location entrance facing southwest shows an overview of the Location.

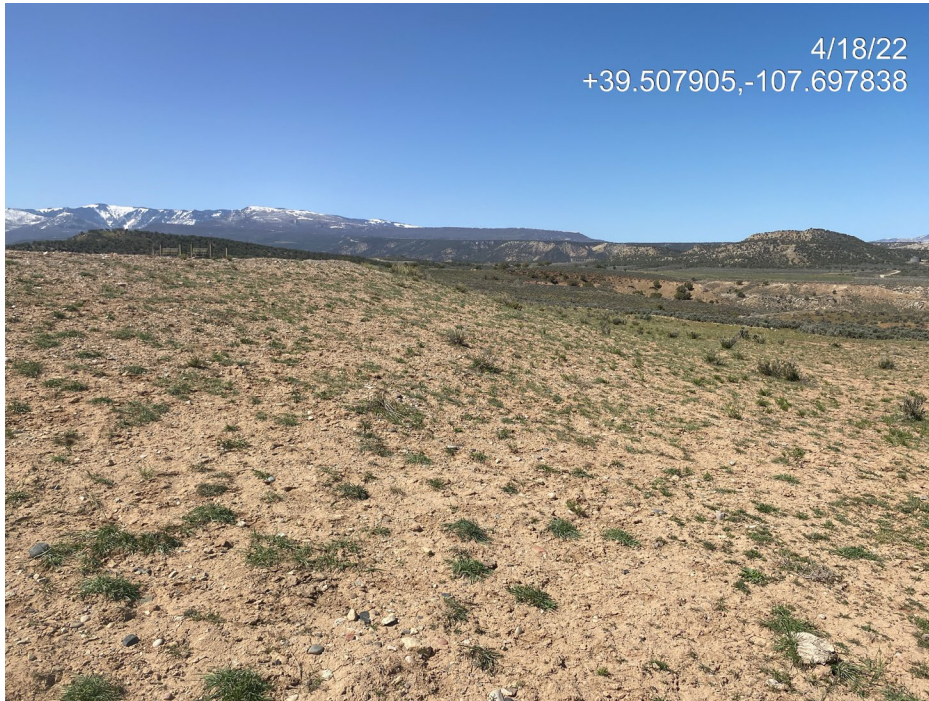
Photo 2. Photo taken from the north of the Location facing southwest shows the northwestern interim area colonized by seeded perennial grasses, occasional rabbitbrush and sagebrush, and undesirable plant species/weeds.

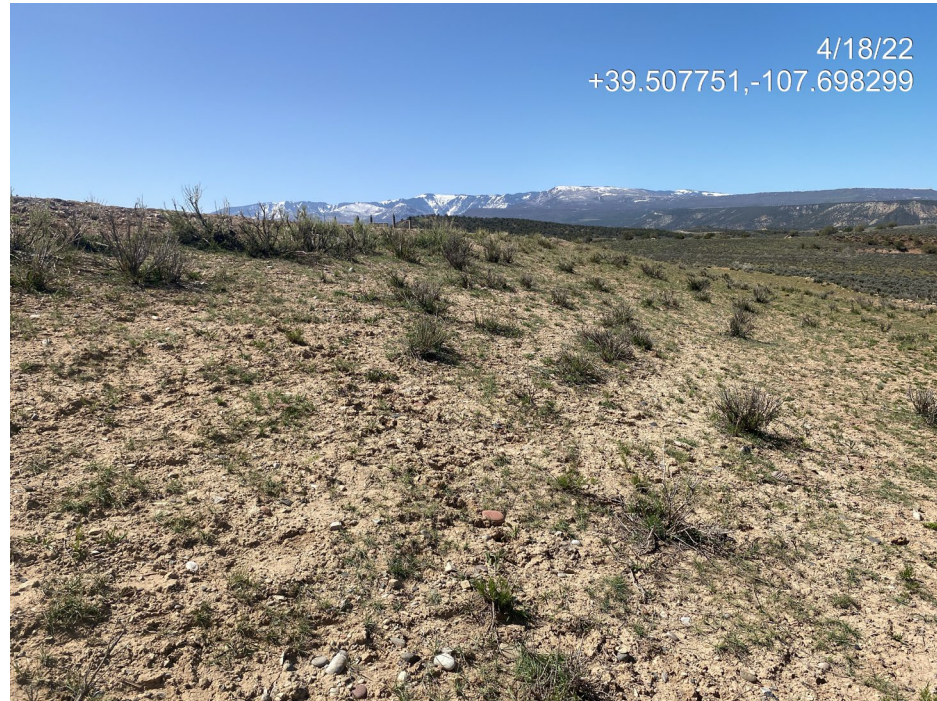
Photo 3. Refer to Photo 2 comment.

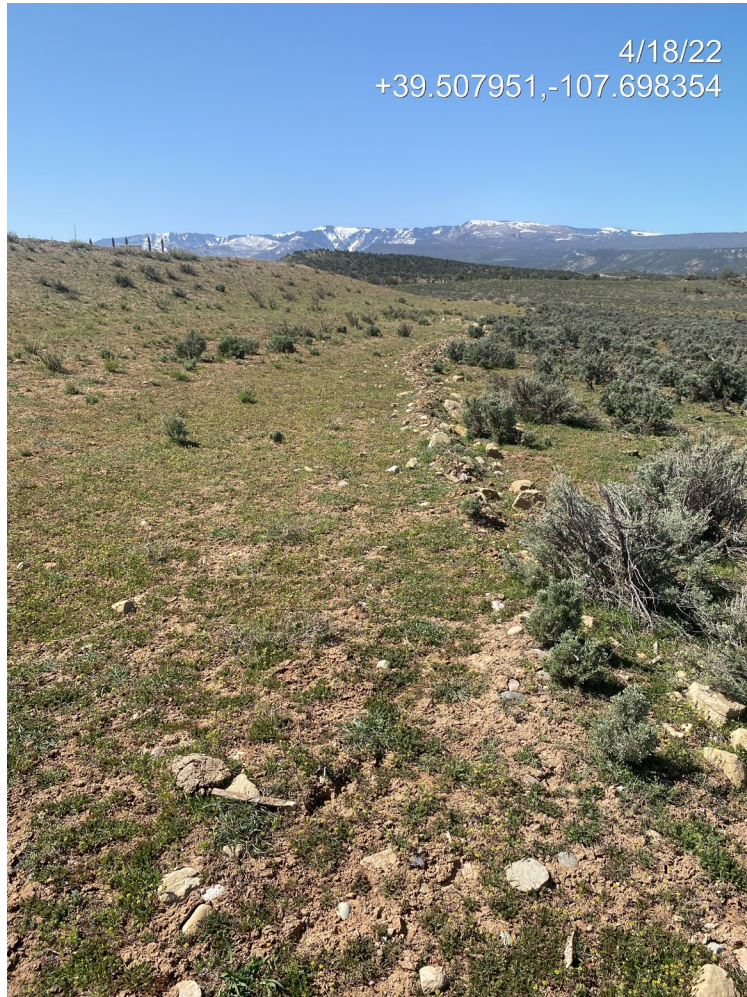
Photo 4. Photo taken from the north of the Location facing southwest shows interim areas (left) and undisturbed areas (right).

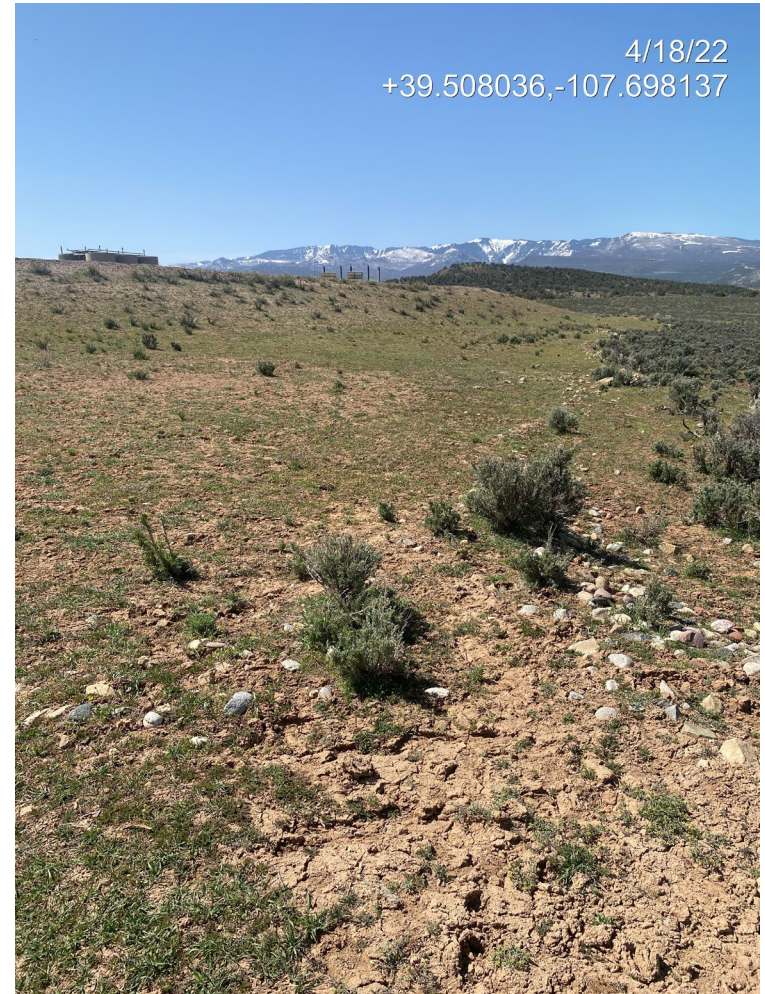
Photo 5. Refer to Photo 4 comment.

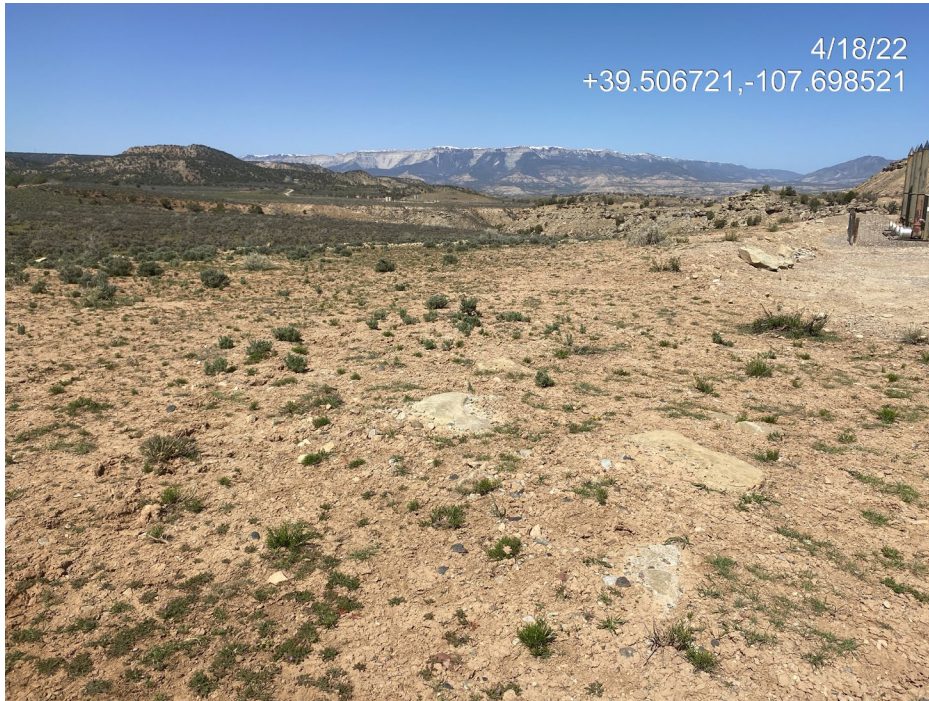
Photo 6. Photo taken from the southeast of the Location facing northwest shows the interim area colonized by seeded perennial grasses, occasional rabbitbrush and sagebrush, and undesirable plant species/weeds.

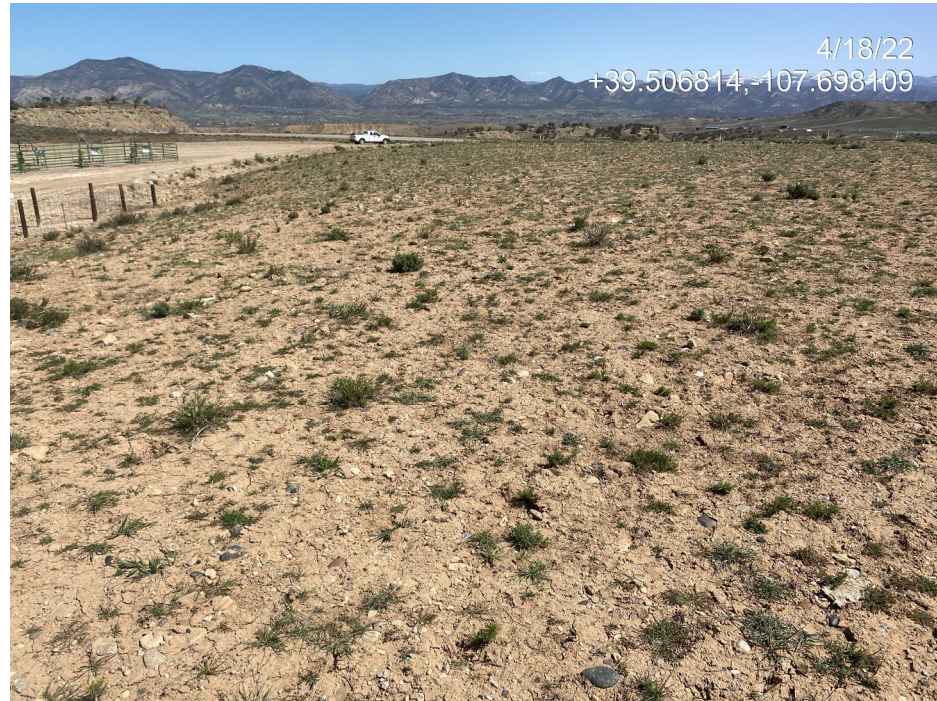
Photo 7. Photo taken from the southeast of the Location facing north. Refer to additional comments under Photo 6.

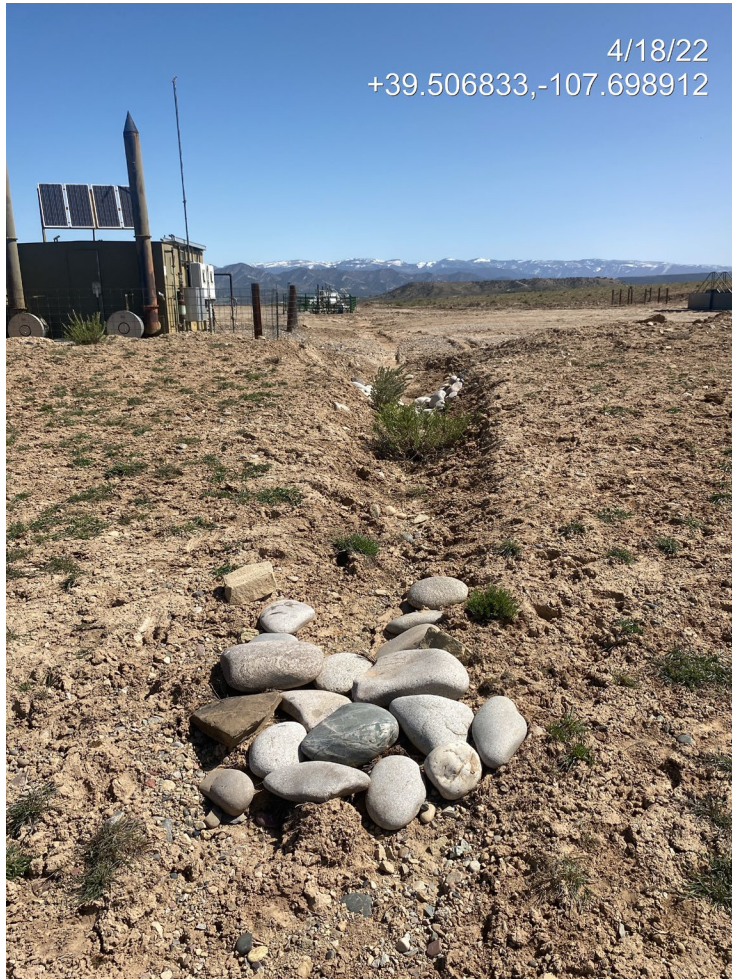
Photo 8. Photo taken from the south of the Location facing northeast shows a river rock lined sediment trap outlet.

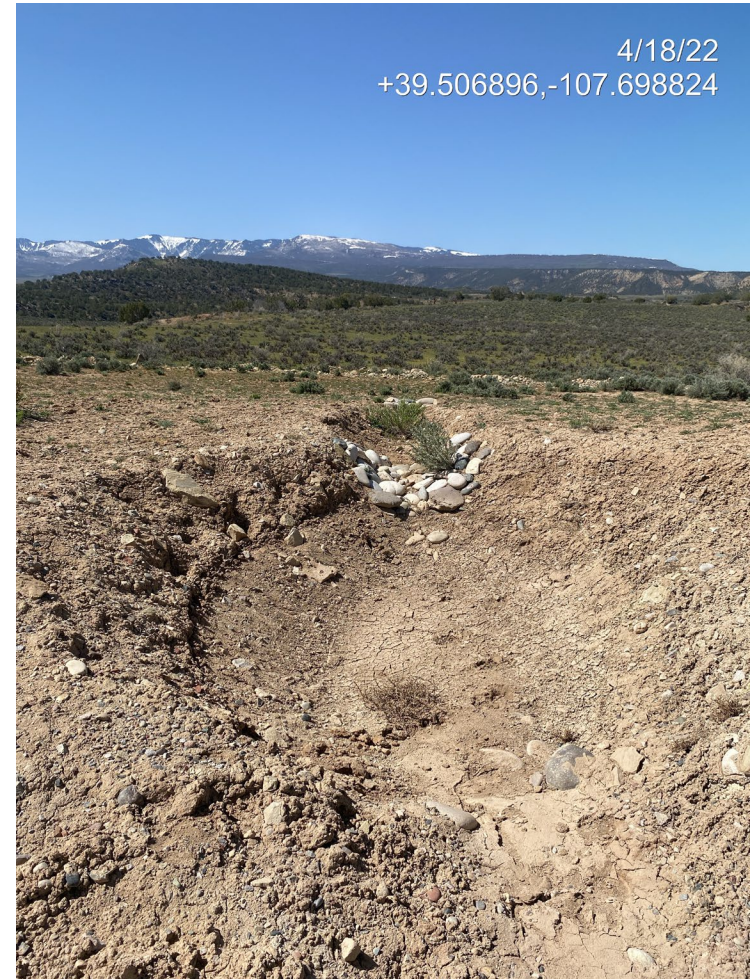
Photo 9. Photo taken from the south of the Location facing southwest shows a sediment trap which leads into a river rock lined outlet.

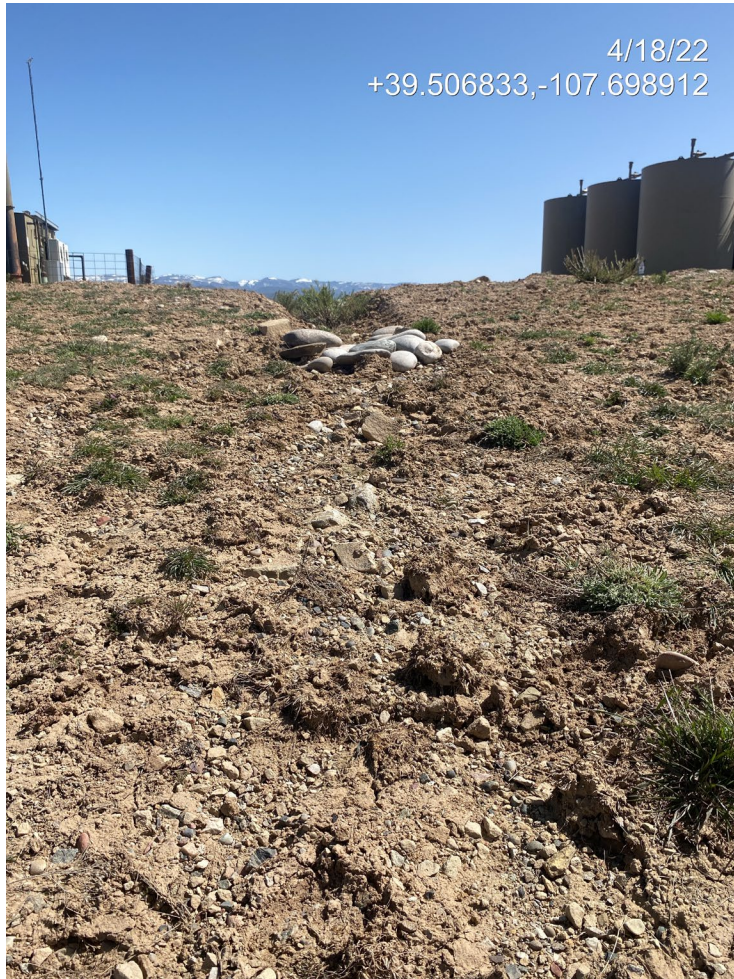
Photo 10. Photo taken from the south of the Location facing northeast shows pedestal formations due to stormwater degradation at a sediment trap outlet.

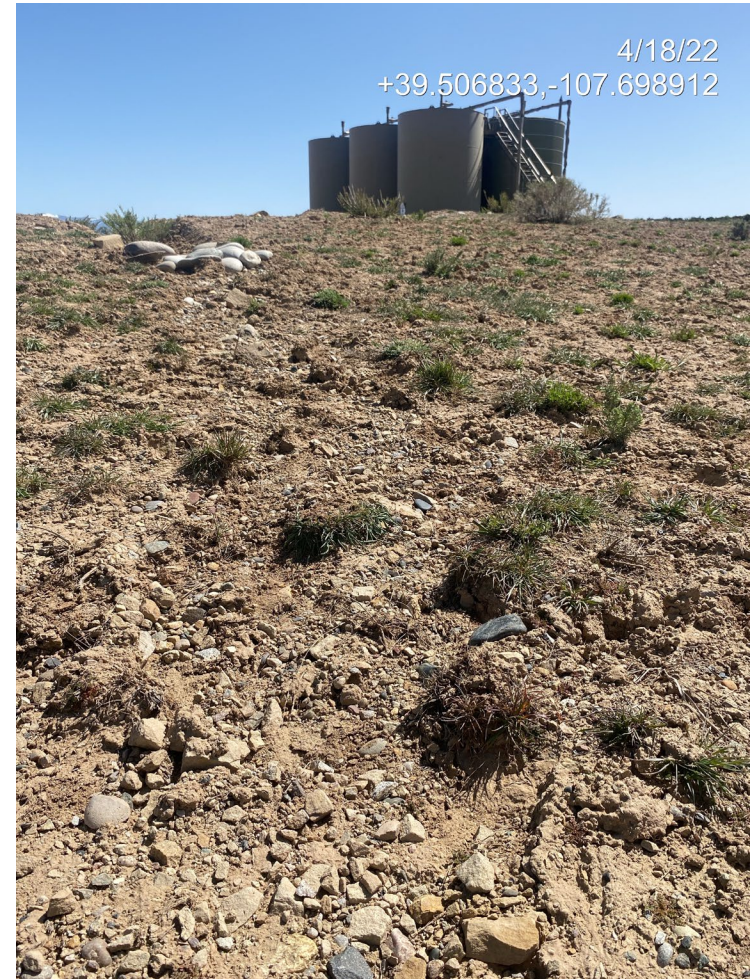
Photo 11. Refer to Photo 10 comment.

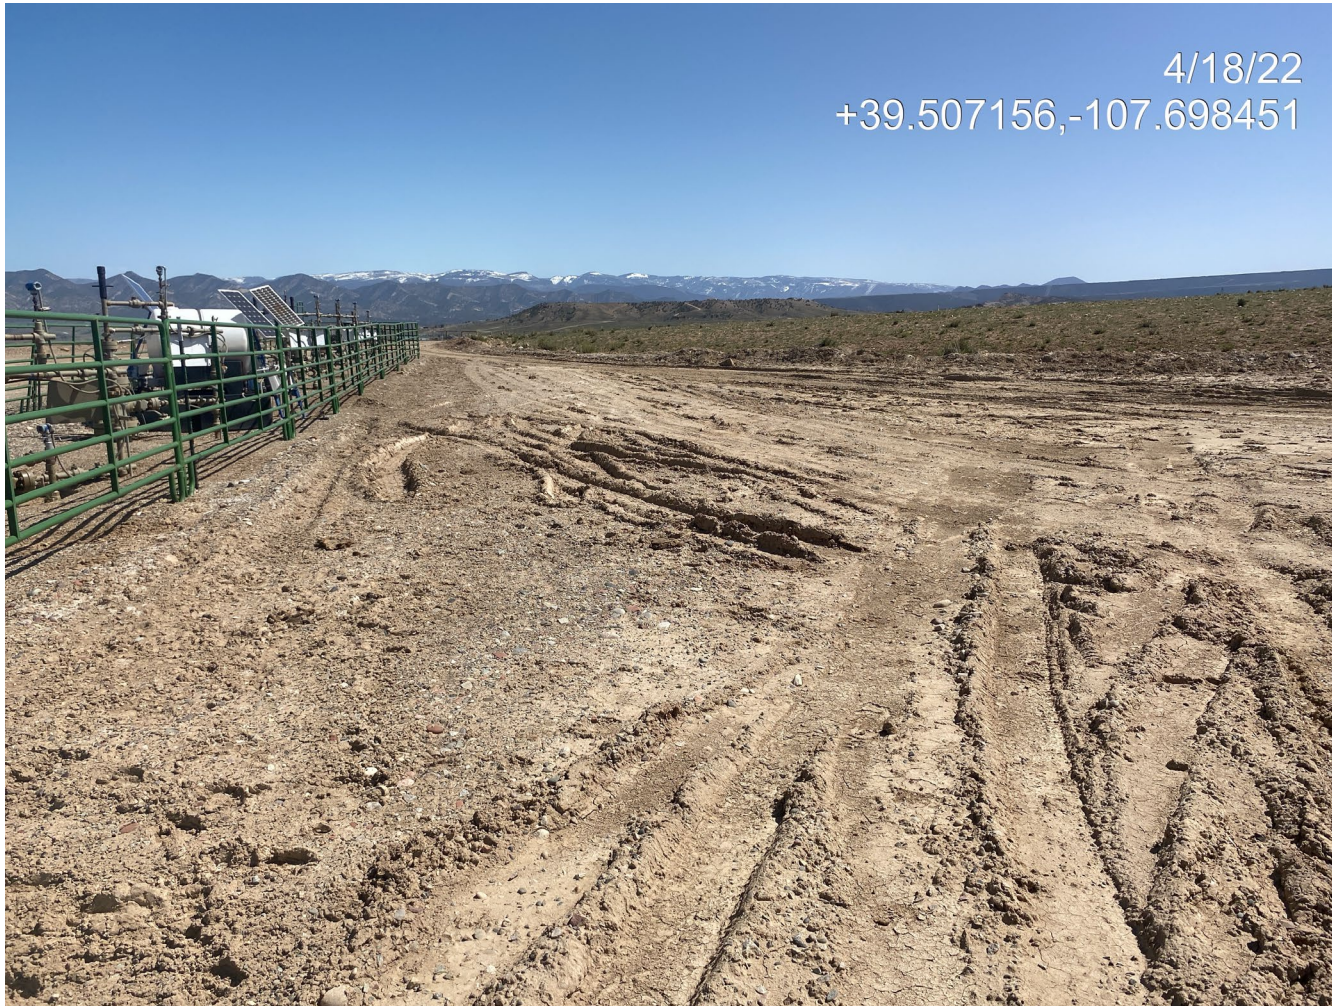
Photo 12. Photo taken from the south of the working pad area facing north shows signs of lack of stabilization BMPs in some areas (rutting is present) .
