Site Inspection Report

Site: MORGAN A #1
04/20/2022

SITE/LOCATION	DATE	TIME	INSPECTOR
MORGAN A #1	04/20/2022	02:06 PM	COGCC Contractor
Comments			
Work Activity Notes	Active removal and transportation of stockpiled soils offsite.		
Changes since previous inspection?	Yes	Drive by inspection	No
Actively being worked?	Yes		
Fieldwork Oversight Performed?	No	Oversight Type	N/A
Were Oversight Samples Collected?	No	Sample Details	N/A

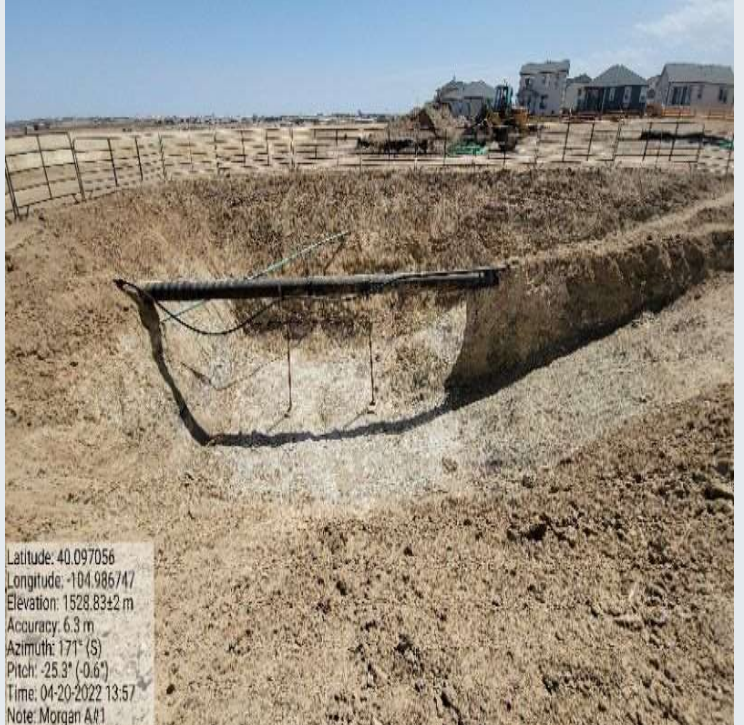
Remediation Activity Checklist	
	Photo
Question: Open excavation? Response: Yes Notes: Flowline exposed and supported. Adequate fencing surrounding excavation.

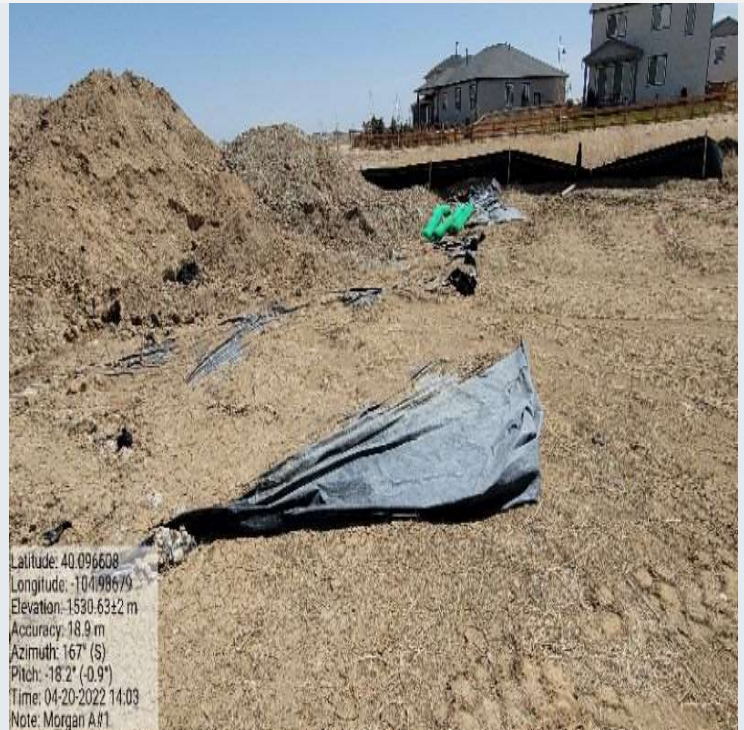
Question: Stockpiled waste?**Response:** Yes**Notes:** Actively being removed and transported offsite. Liners present under stockpiles (One partially torn). Silt fence failing – Other BMPs removed to allow excavator access.

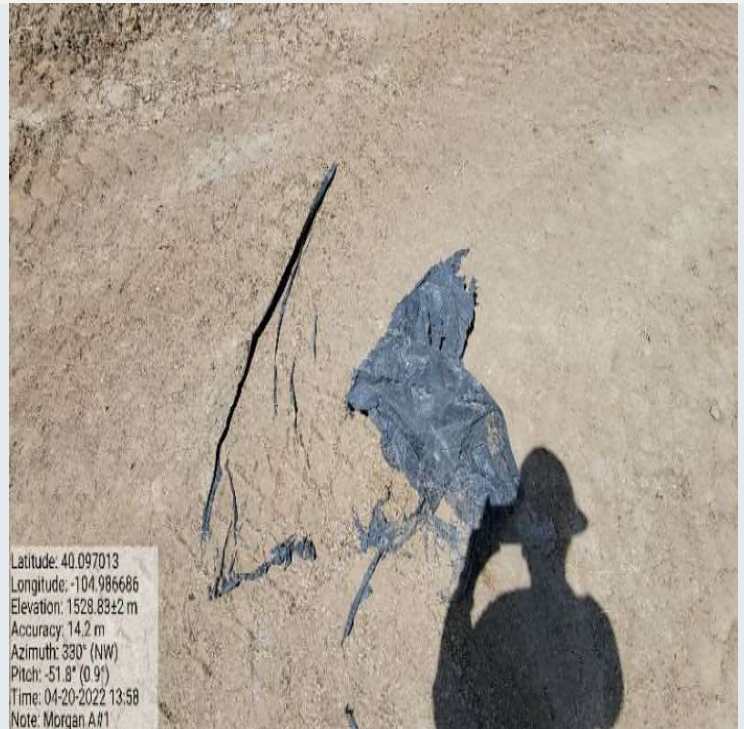
**Question:** Stockpiled waste?**Response:** Yes**Notes:** Actively being removed and transported offsite. Liners present under stockpiles (One partially torn). Silt fence failing – Other BMPs removed to allow excavator access.

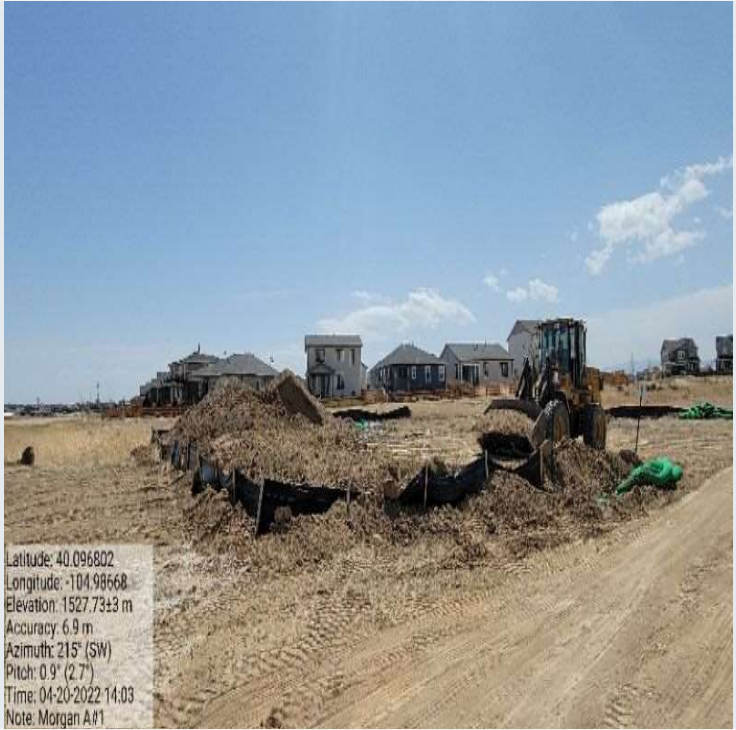
Photo
Question: Stockpiled waste? Response: Yes Notes: Actively being removed and transported offsite. Liners present under stockpiles (One partially torn). Silt fence failing – Other BMPs removed to allow excavator access.

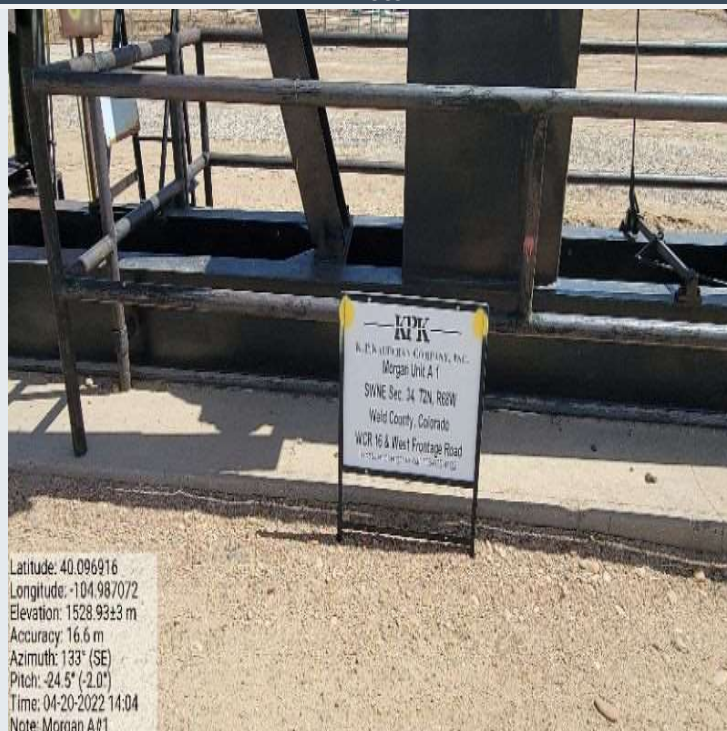
Question: Emergency sign in compliance with 605.g?

Response: Yes

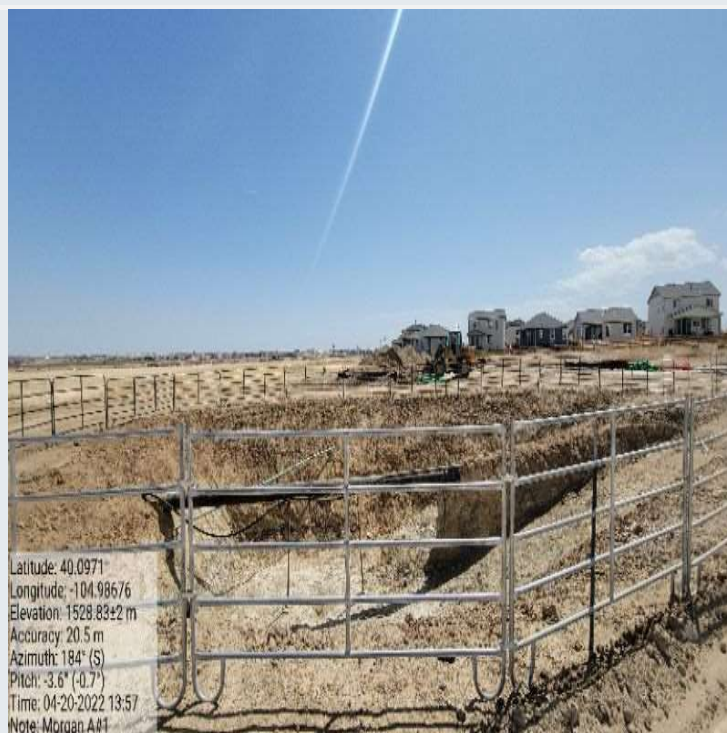
Question: Site properly fenced (in accordance with rule 913.b.(5)B.i)?

Response: Yes

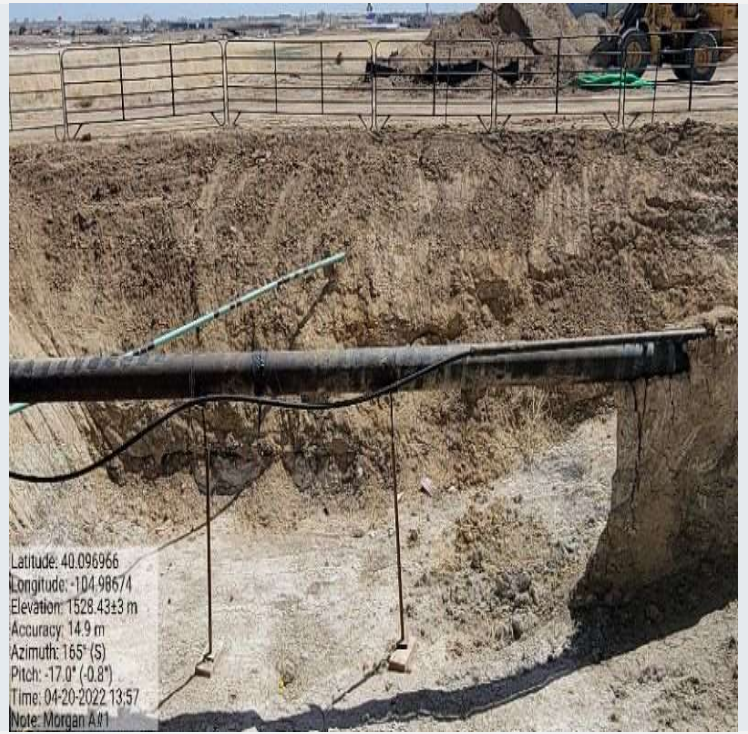
Site Condition Checklist	
Question: Is fencing adequate/appropriate for site and well maintained? Response: Yes Notes:	Photo No Photo
Question: Exposed buried/underground flowlines? Response: Yes Notes:

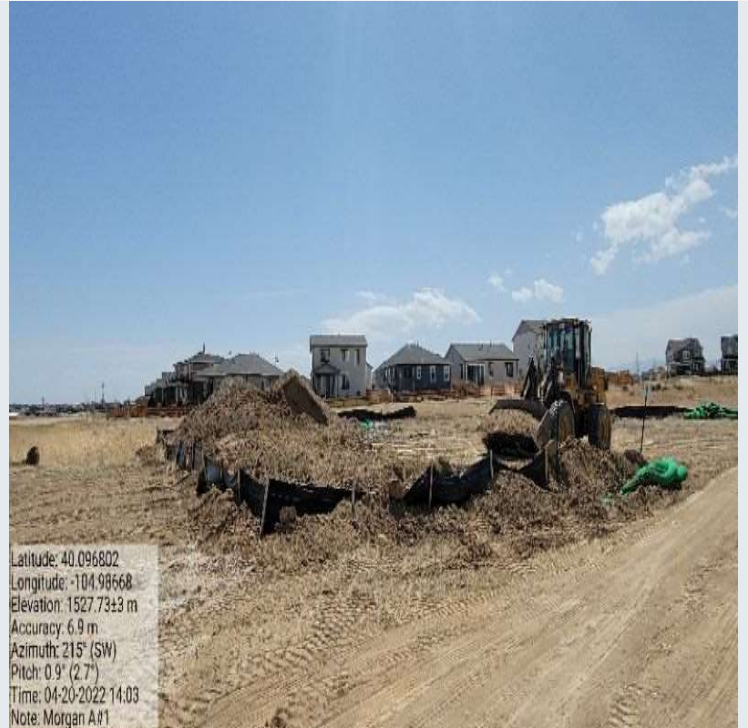
Question: Evidence of pollutants being discharged off-site?

Response: Yes

Notes: Inadequate silt fence installation.

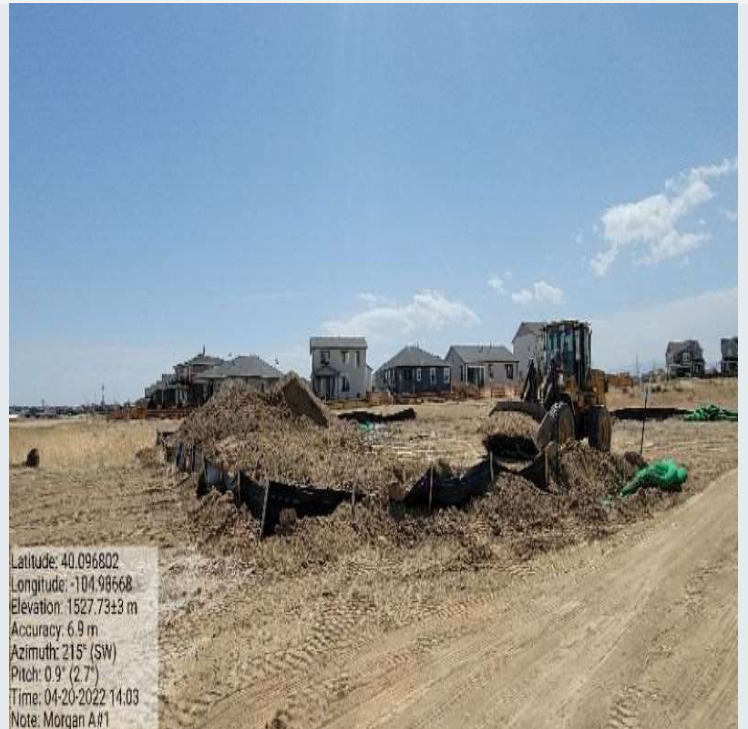
Question: All stormwater erosion control measures and BMPs are present and in good/working condition?

Response: No

Notes: Silt fences are failing – Other BMPs removed to allow excavator access.

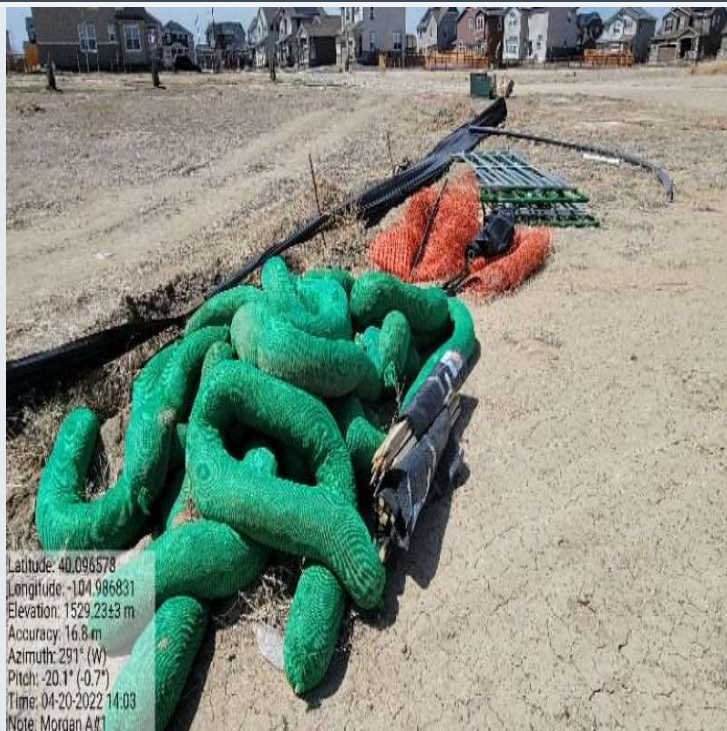
Question: Site is free of debris/trash?

Response: No

Notes: Unused fencing and debris stored onsite.

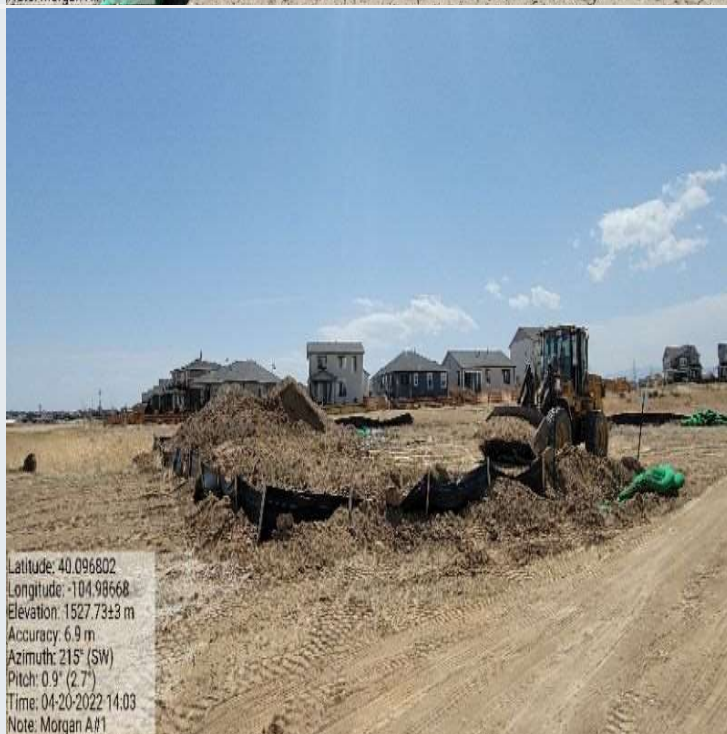
Question: Potential pollutants (trash, material stockpiles) are properly contained?

Response: No

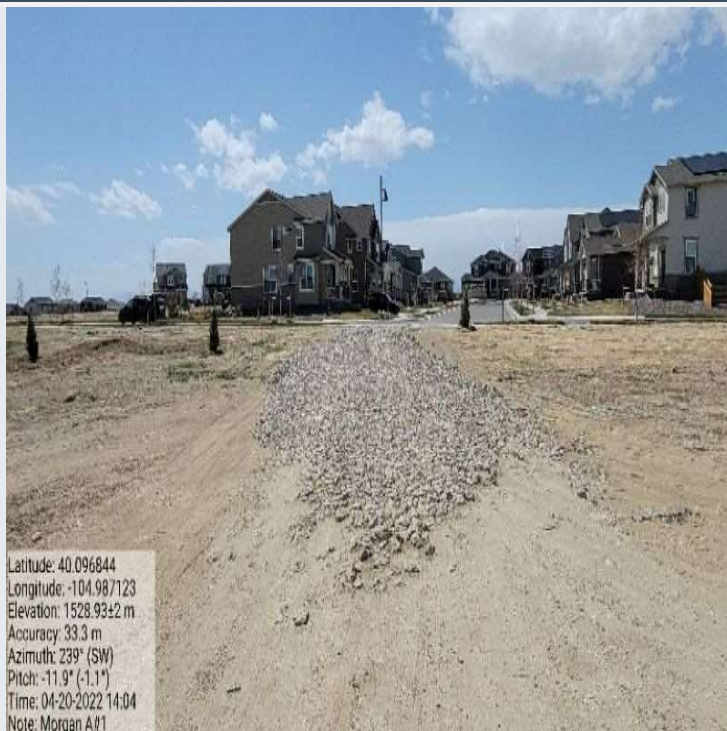
Question: Evidence of sediment/debris observed on adjacent roads? (If yes, is note tracking control BMP presence/conditions)

Response: No

Notes: Trackout control in place.

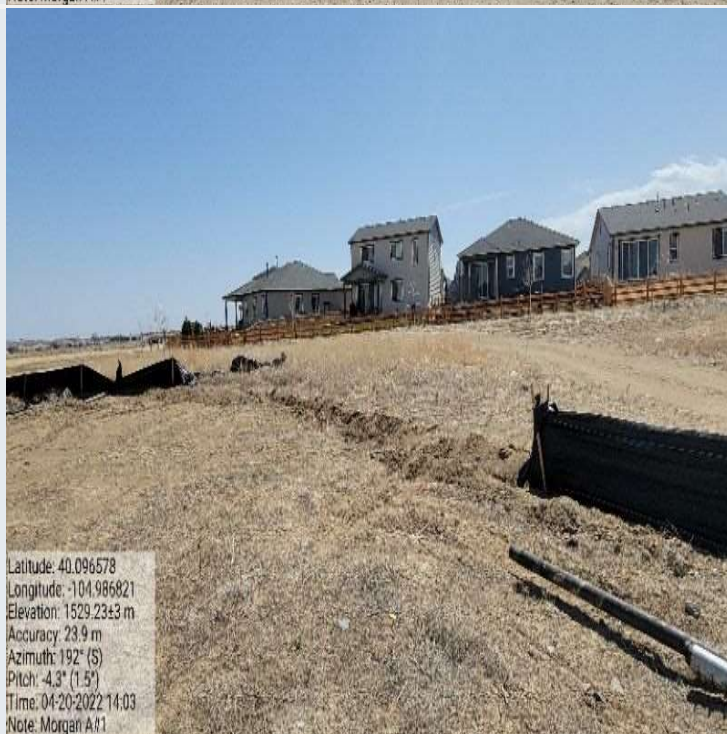
Question: Additional stormwater control measures/maintenance recommended?

Response: Yes

Notes: Repair and/or reinstall all silt fencing surrounding perimeter.

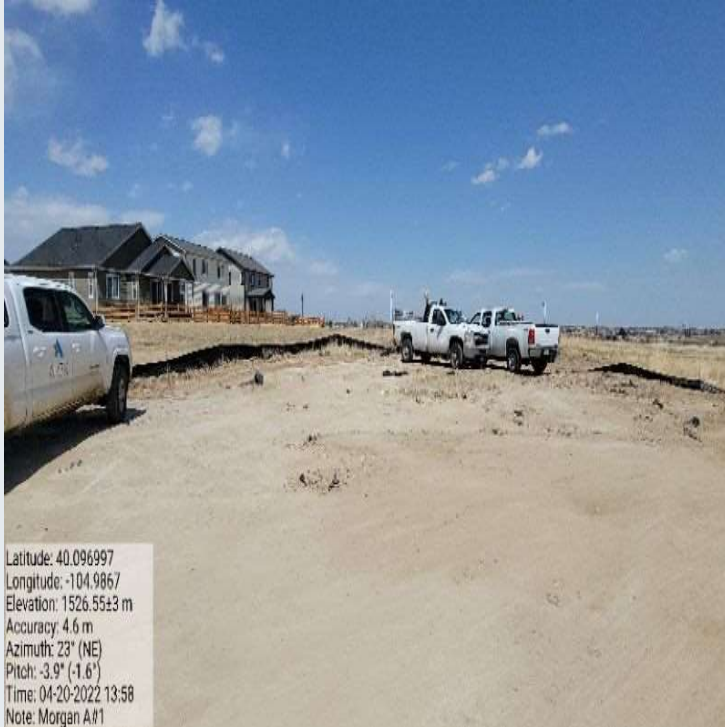
General Site - 1 Northern stockpile
