Inspection Photos
Location Name: Federal Wildhorse #15-31
Location ID: 322954

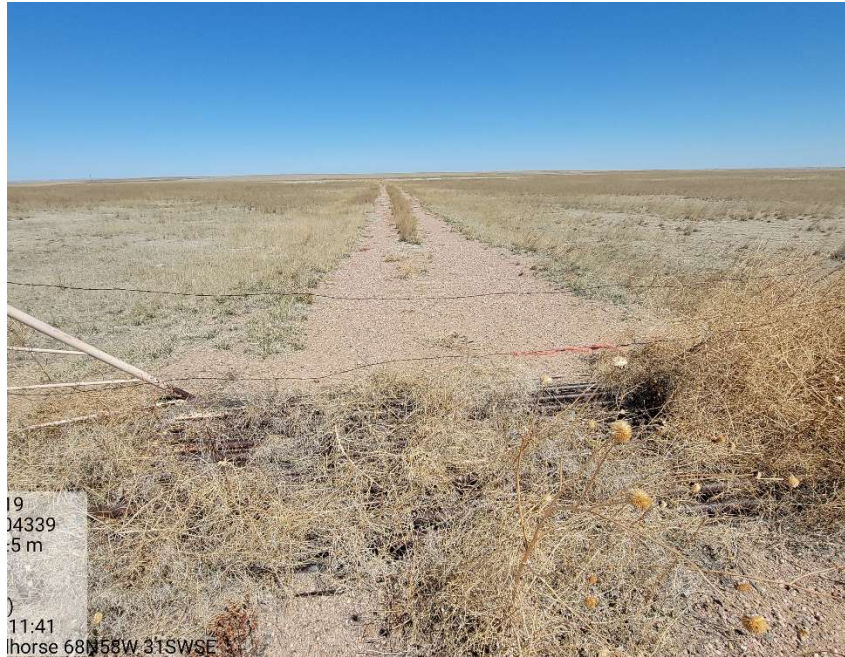
Photo 1 – Photo taken from the entrance of the well location, facing North. Photo illustrates the Operator has failed to perform final reclamation activities.

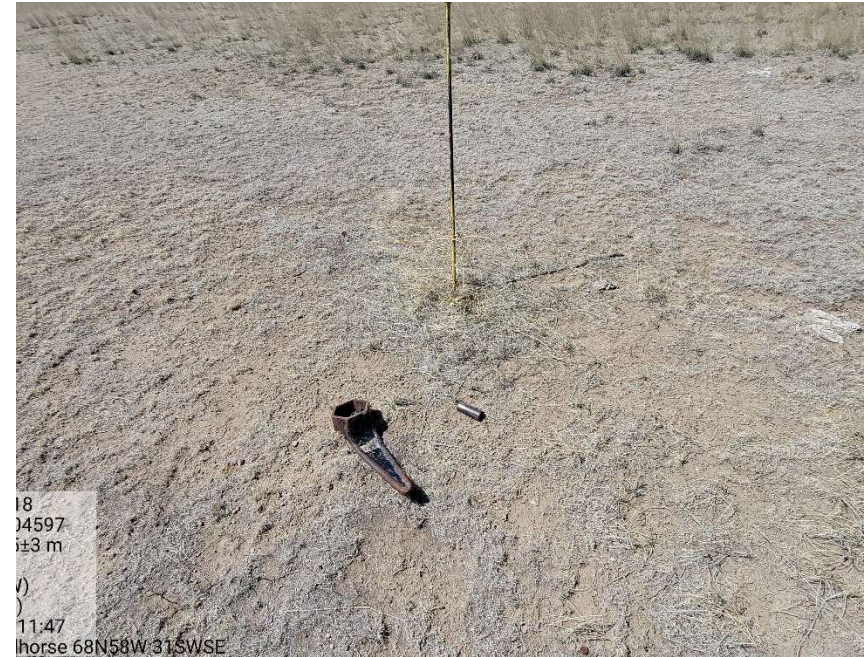
Photo 2 – Photo taken from the well location. Photo illustrates the Operator has failed to perform final reclamation activities and failed to respond to the previous corrective action inspection.

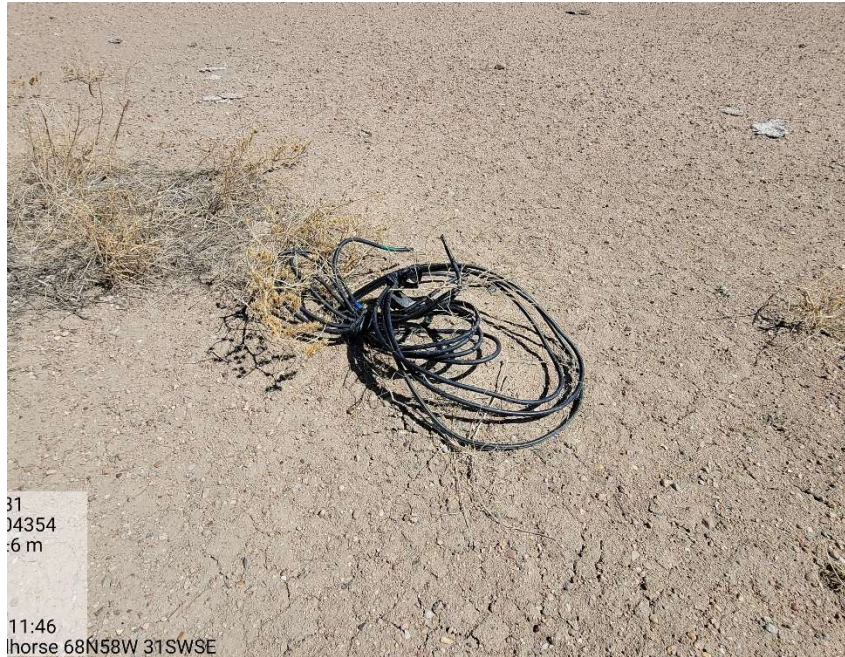
Photo 3 – Photo taken from the well location. Photo illustrates the Operator has failed to perform final reclamation activities and failed to respond to the previous corrective action inspection.

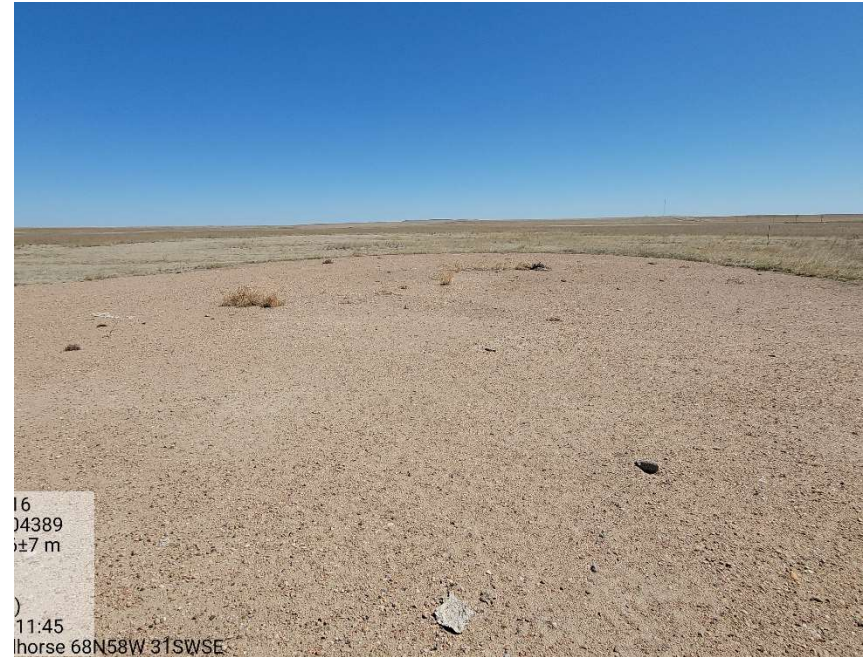
Photo 4 – Photo taken from the well location, facing East. Photo illustrates the Operator has failed to perform final reclamation activities.

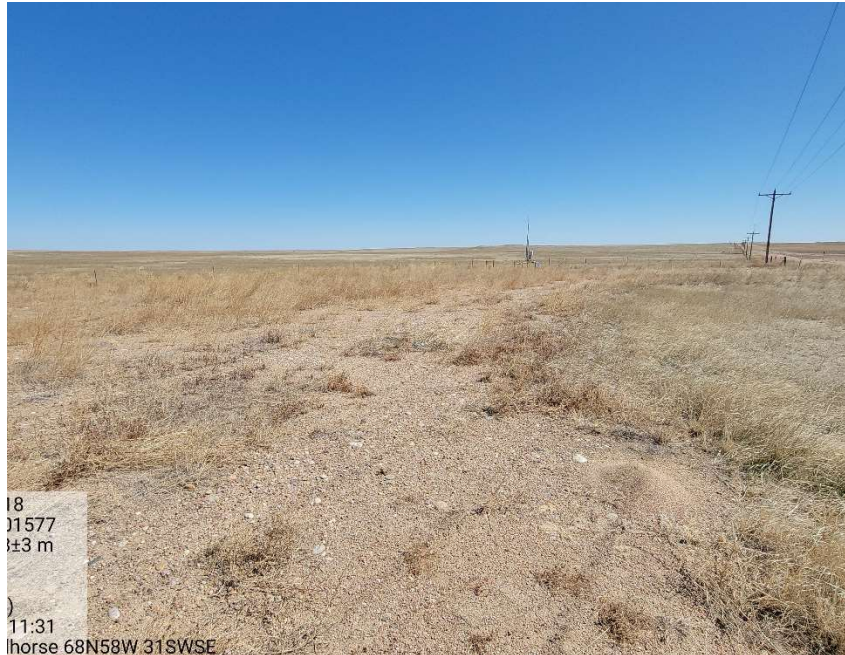
Photo 5 – Photo taken from the associated offsite tank battery, facing North. Photo illustrates the Operator has failed to perform final reclamation activities.

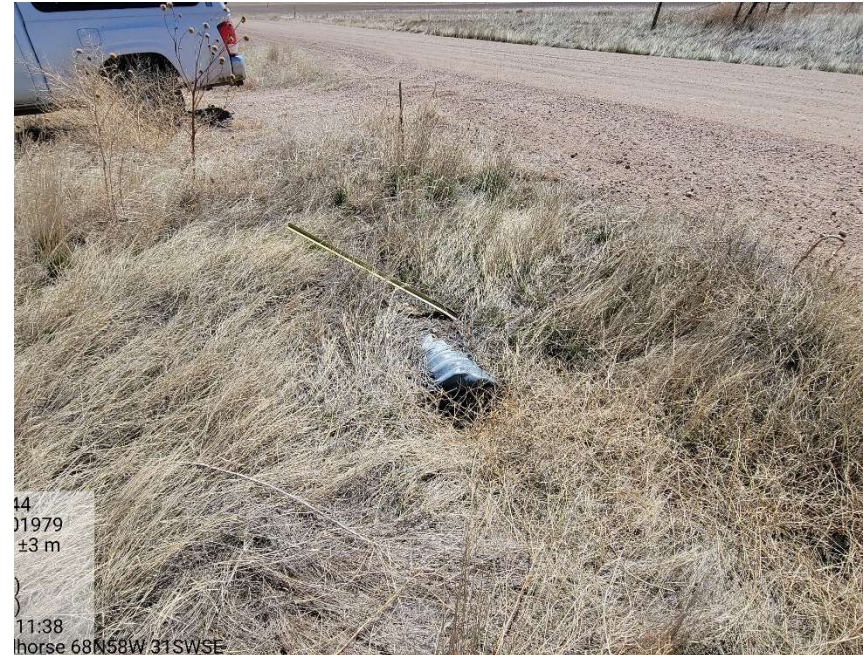
Photo 6 – Photo taken from the associated offsite tank battery. Photo illustrates the Operator has failed to perform final reclamation activities to remove all culverts.

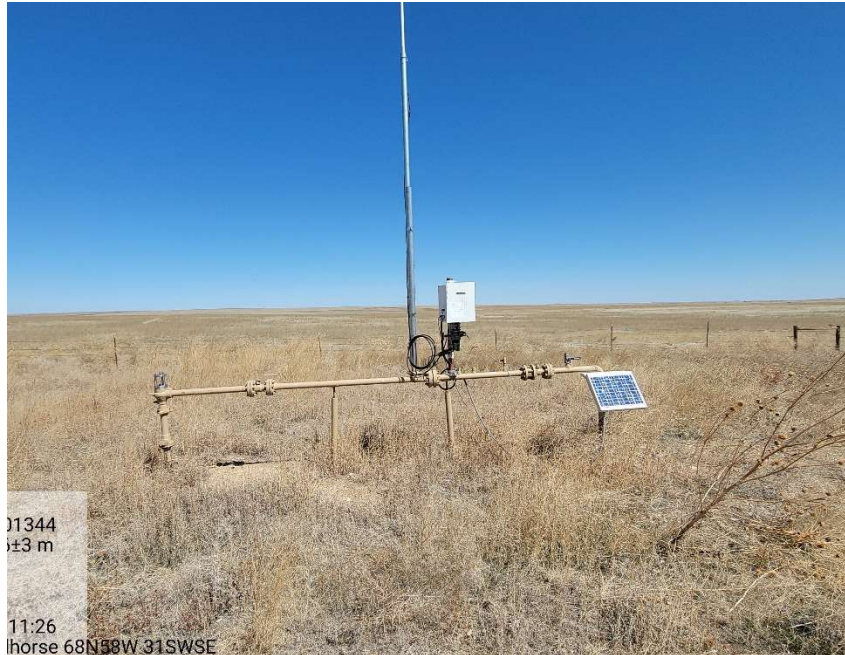
Photo 7 – Photo taken from the associated offsite tank battery, facing North. Photo illustrates the Operator has failed to perform final reclamation activities to remove all equipment.
