**CHEVRON USA INC
FEE-62N102W 17SWSE
Location # 316644**

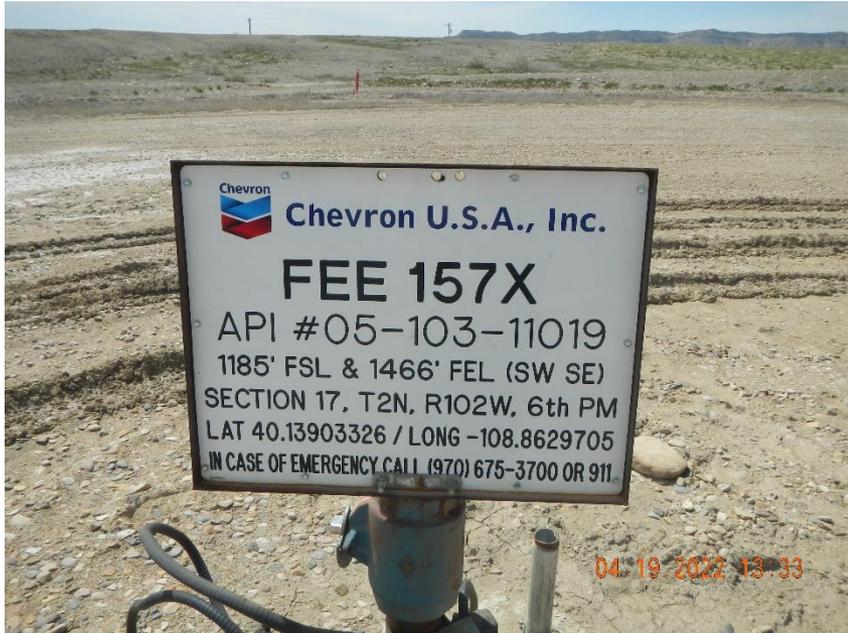
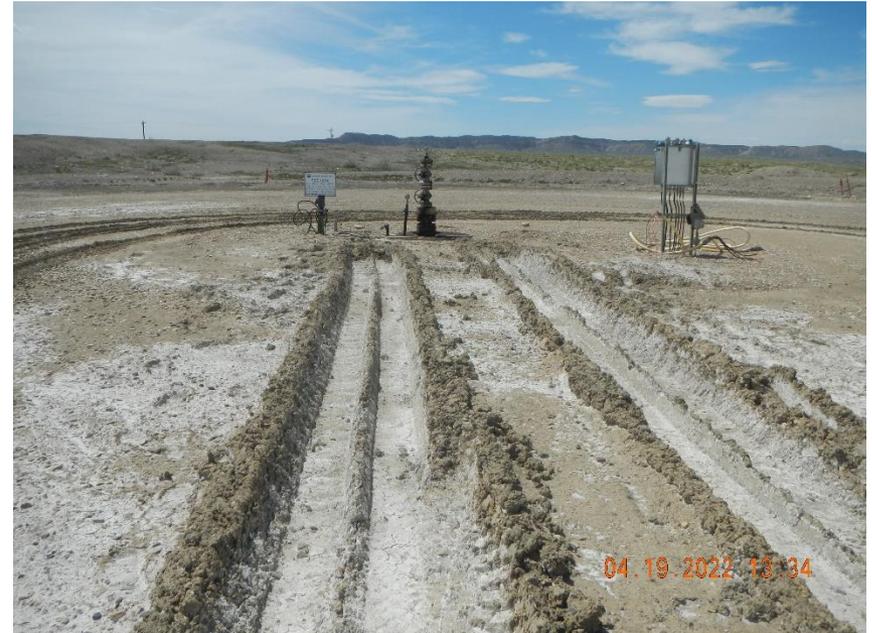
Deep ruts on location are sign of lack of compaction

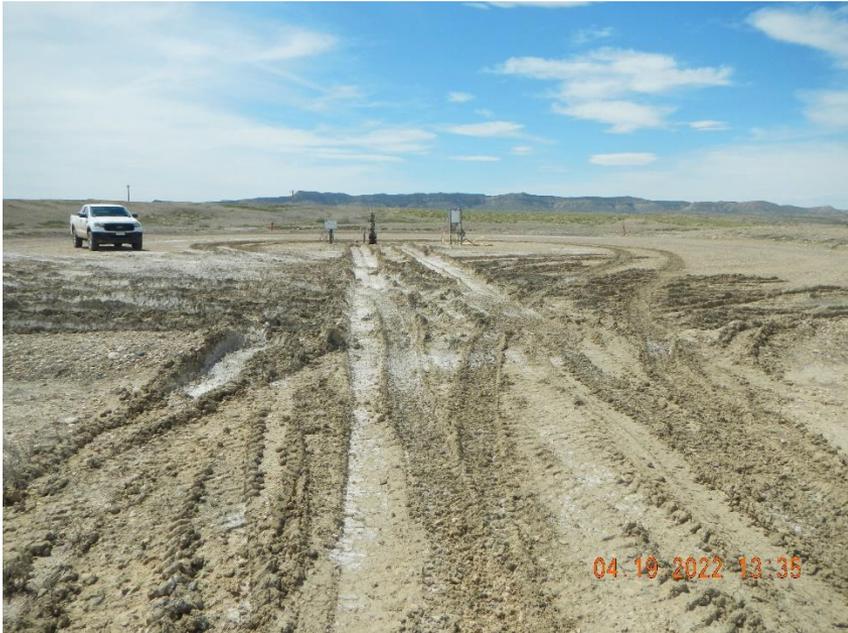
Deep ruts on location are sign of lack of compaction

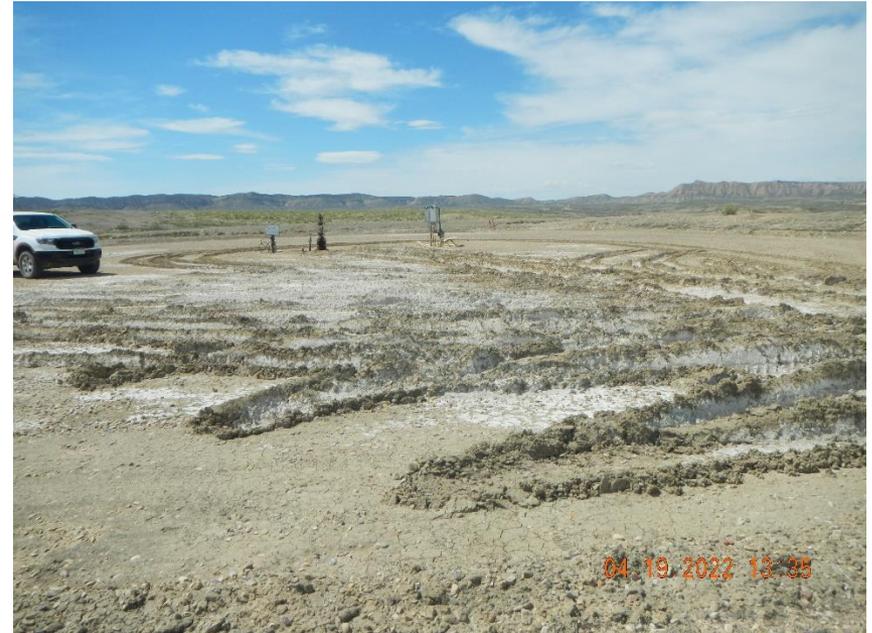
Deep ruts on location are sign of lack of compaction
