## Inspection Photos

Location Name: CAERUS PICEANCE LLC Mesa /N23-697

Location ID: 448427

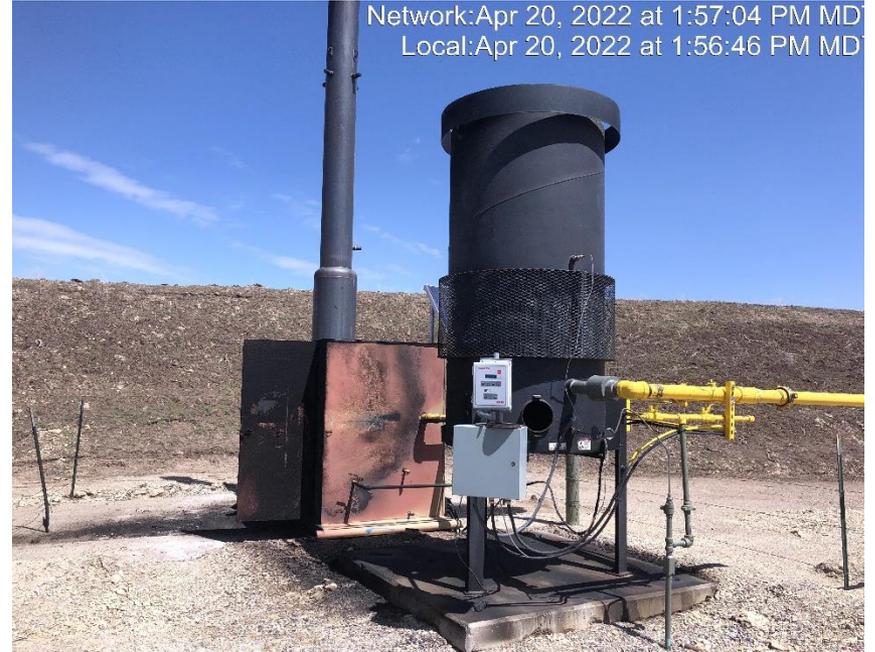
**Photo #6487 Combustor fire.**

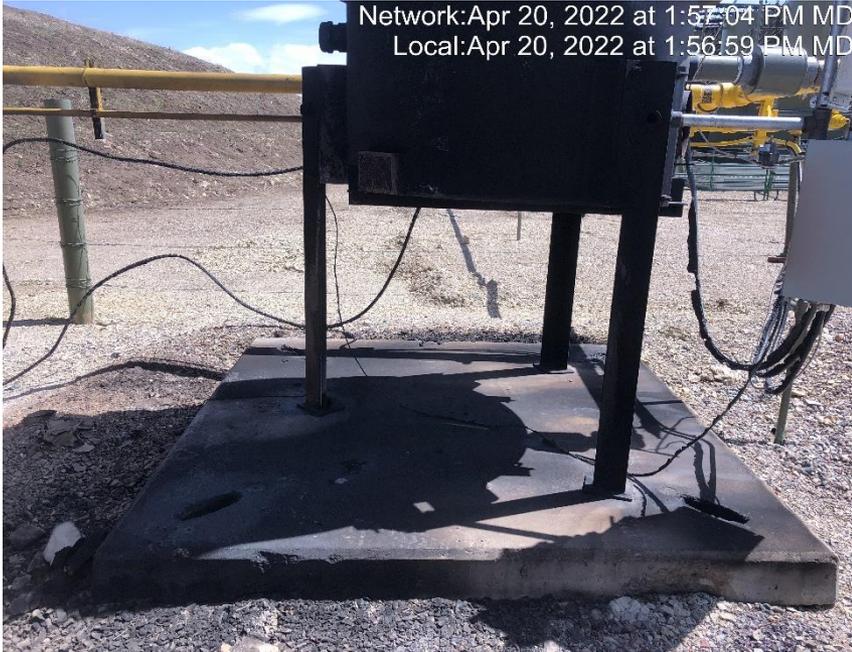
**Photo #6488 Charred combustor pad indicates the fire was caused by fluid carry over.**

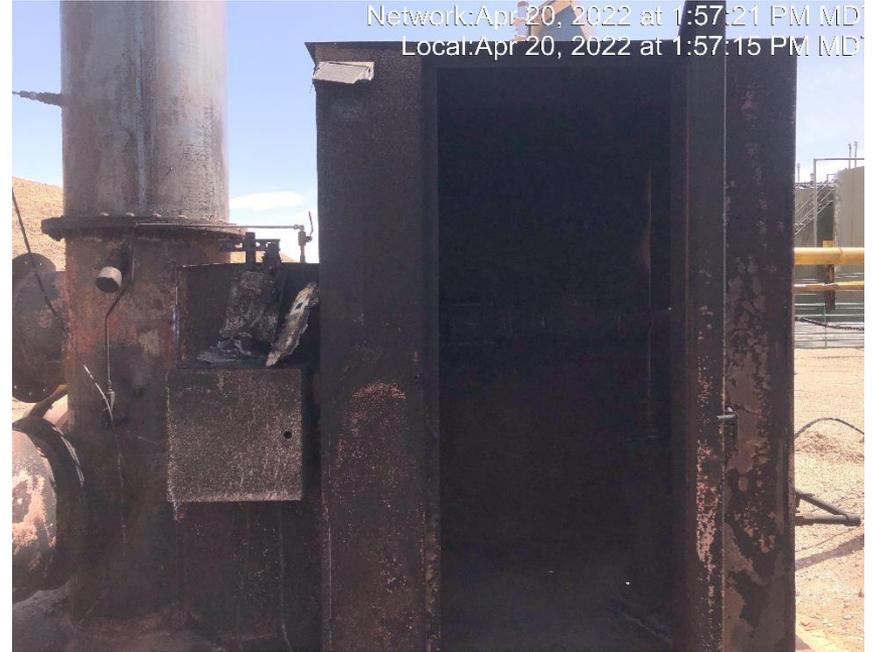
**Photo #6489 combustor fire.**

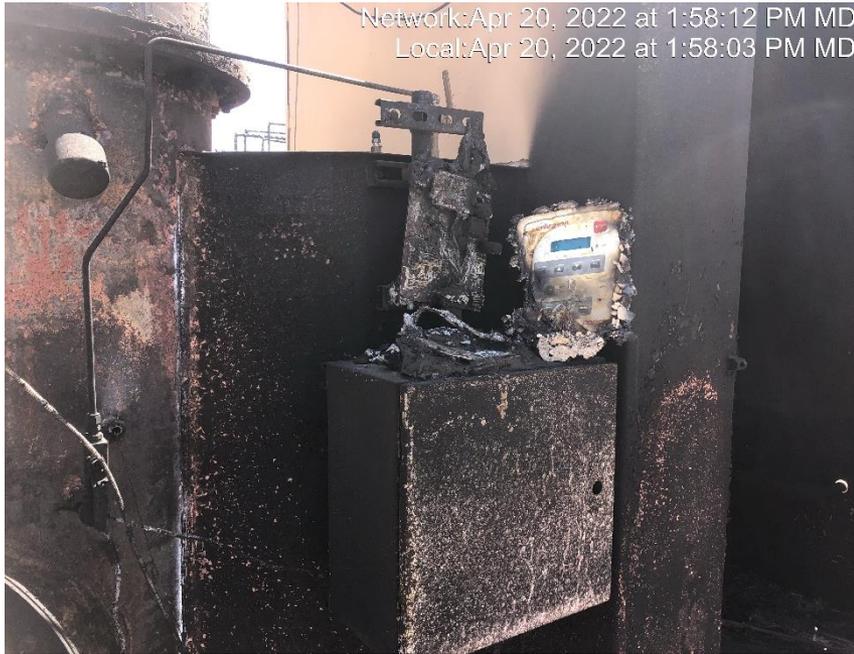
**Photo #6490 Burned Pro Fire ignition controller.**

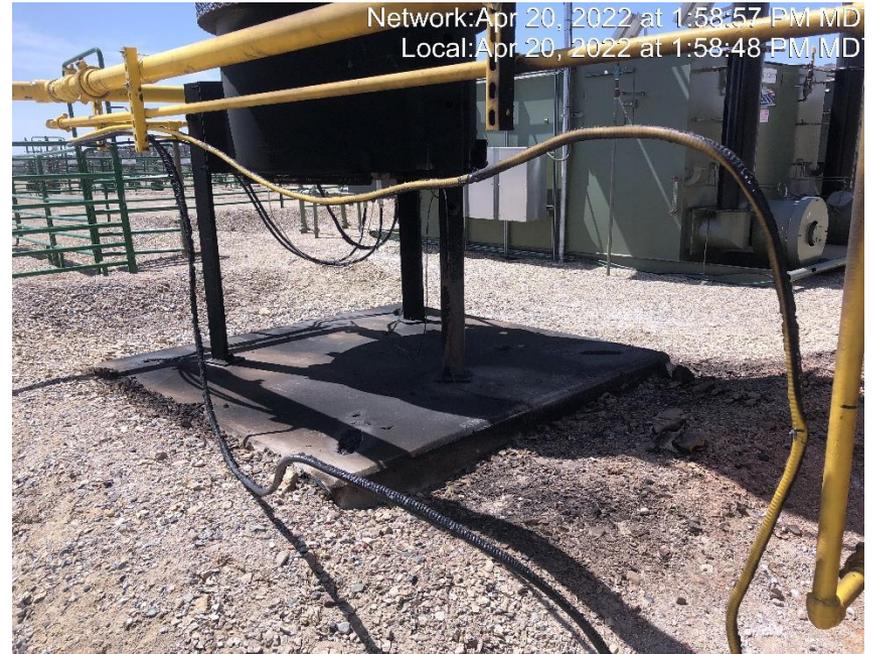
**Photo #6491 Melted automation lines.**

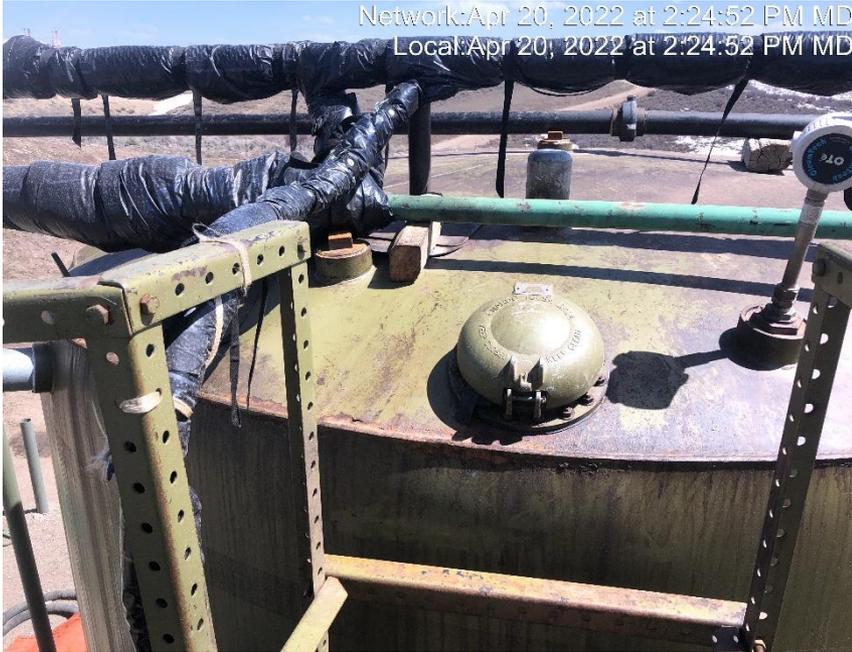
**Photo #6525 Tank appears to have been over pressured and is disconnected.**

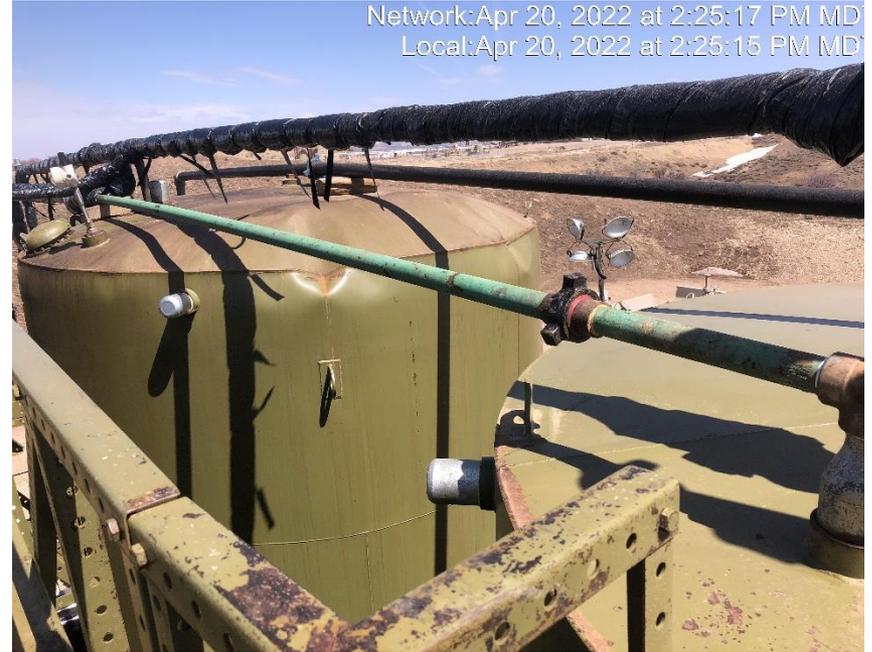
**Photo #6526 Tank appears to have been over pressured and is disconnected.**

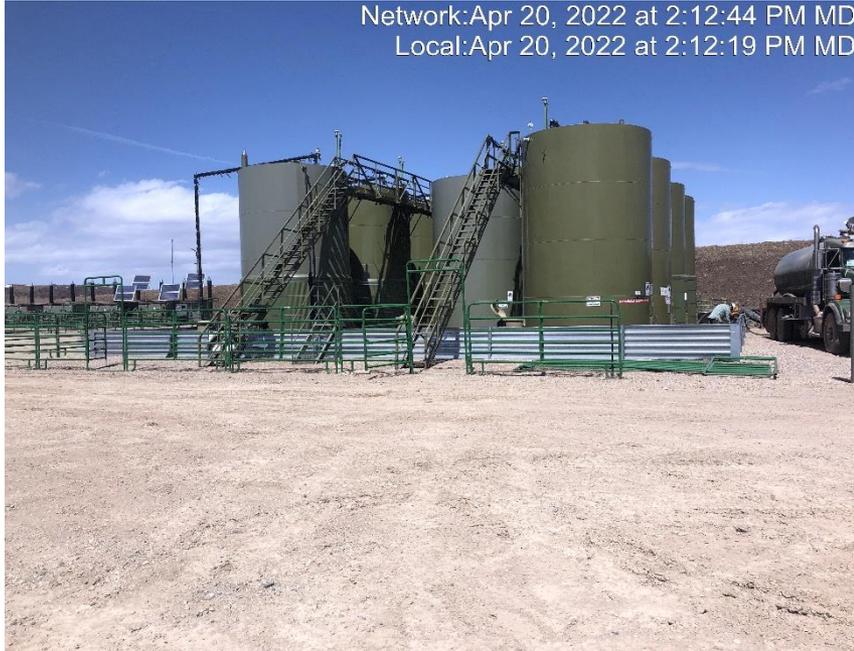
Photo #6519 No battery sign located at the tank battery.

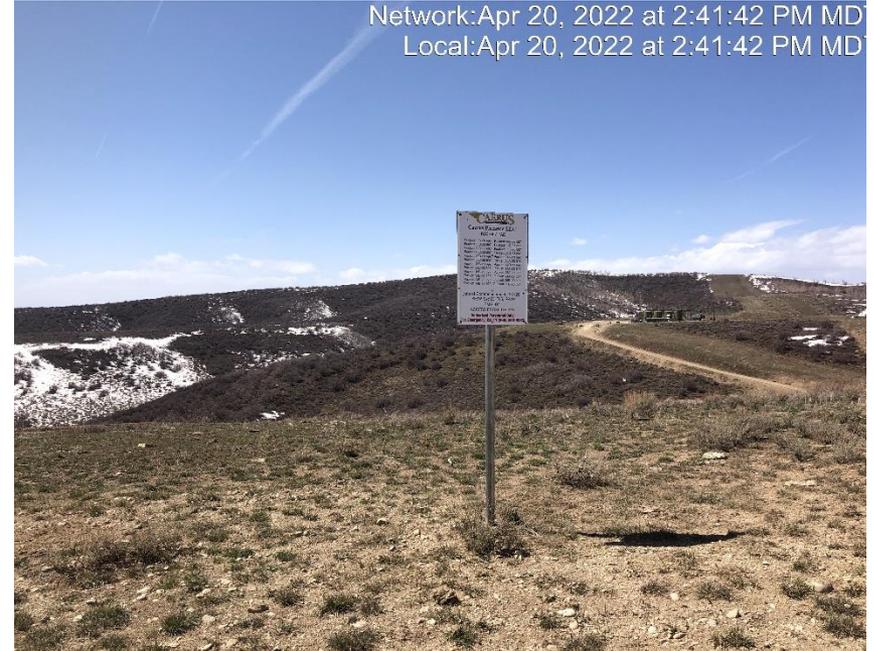
Photo #6530 Nearest sign to location located approximately 400 yards form location.

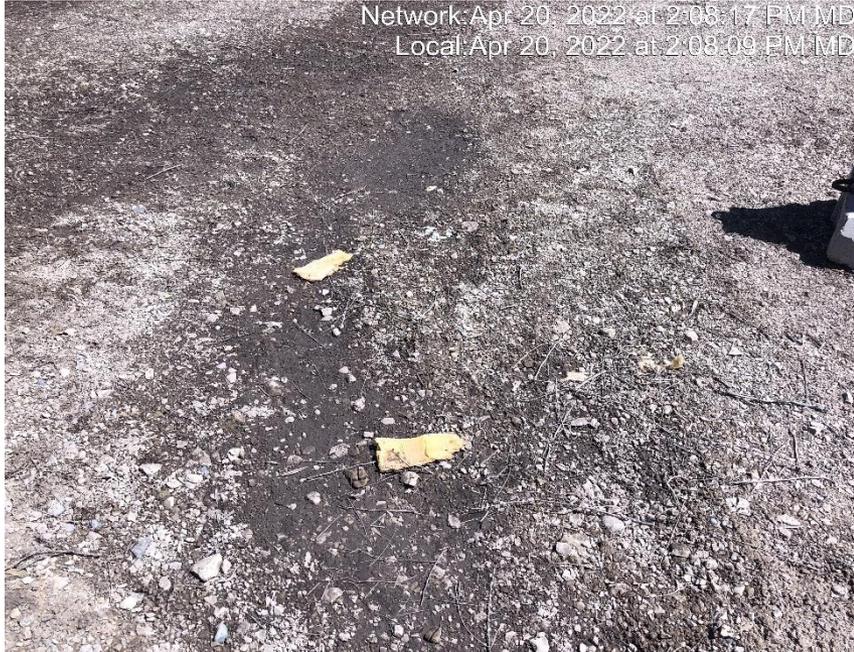
**Photo #6512 Multiple places with trash on location.**

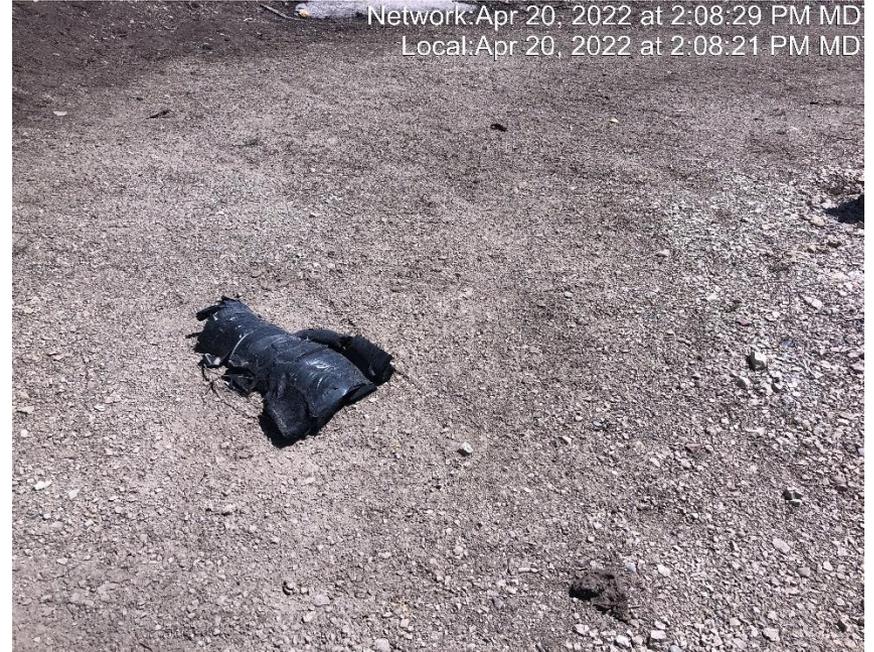
**Photo #6513 Multiple places with trash on location.**

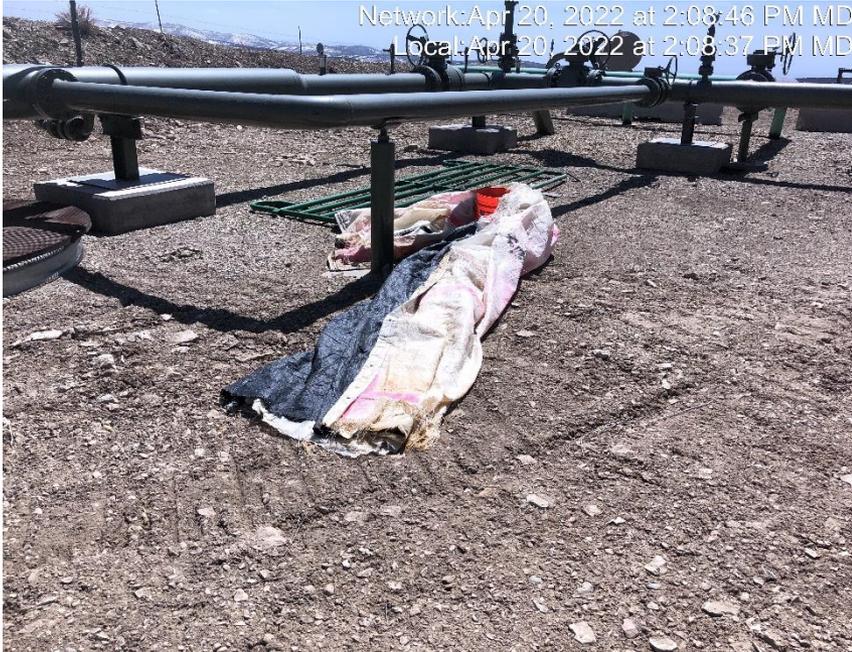
Photo #6514 Multiple places with trash on location.

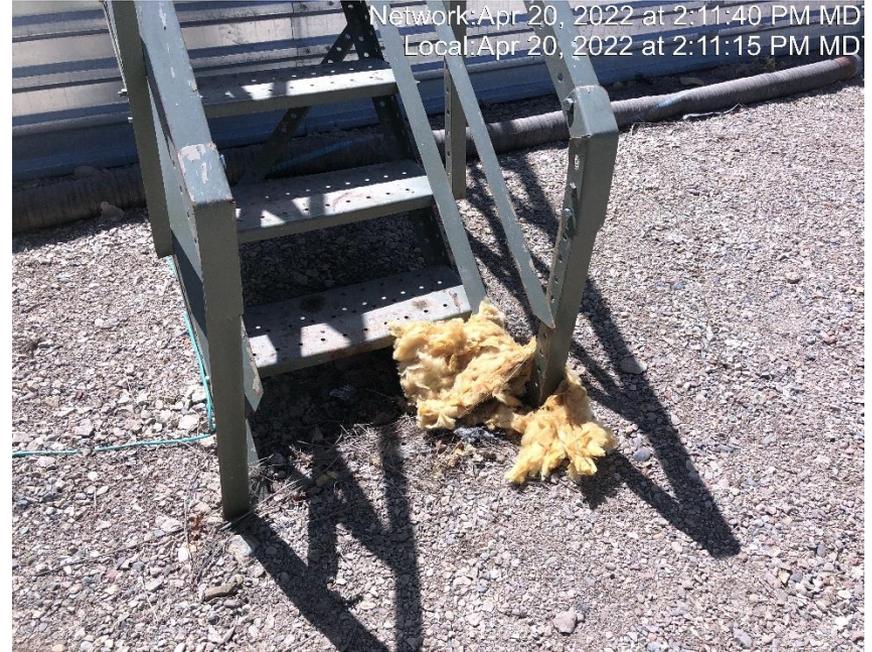
Photo #6518 Multiple places with trash on location.

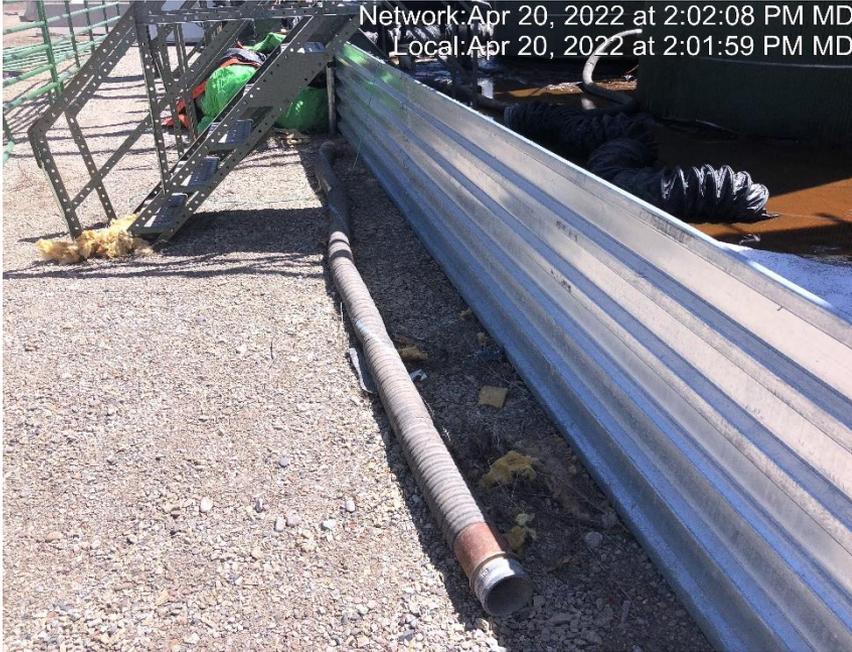
**Photo #6492 Multiple places with stored and unused equipment.**

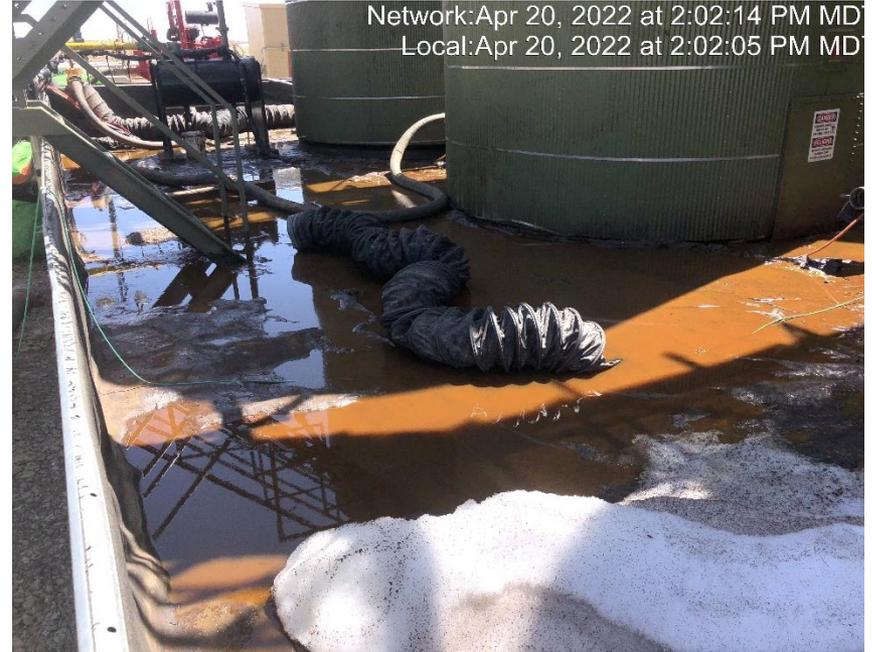
**Photo #6493 Multiple places with stored and unused equipment.**

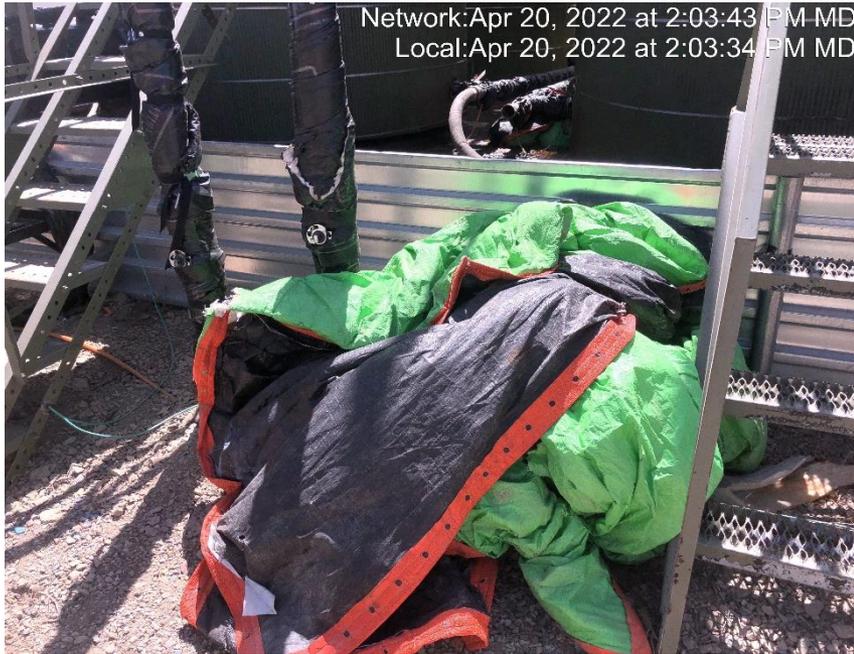
**Photo #6496 Multiple places with stored and unused equipment.**

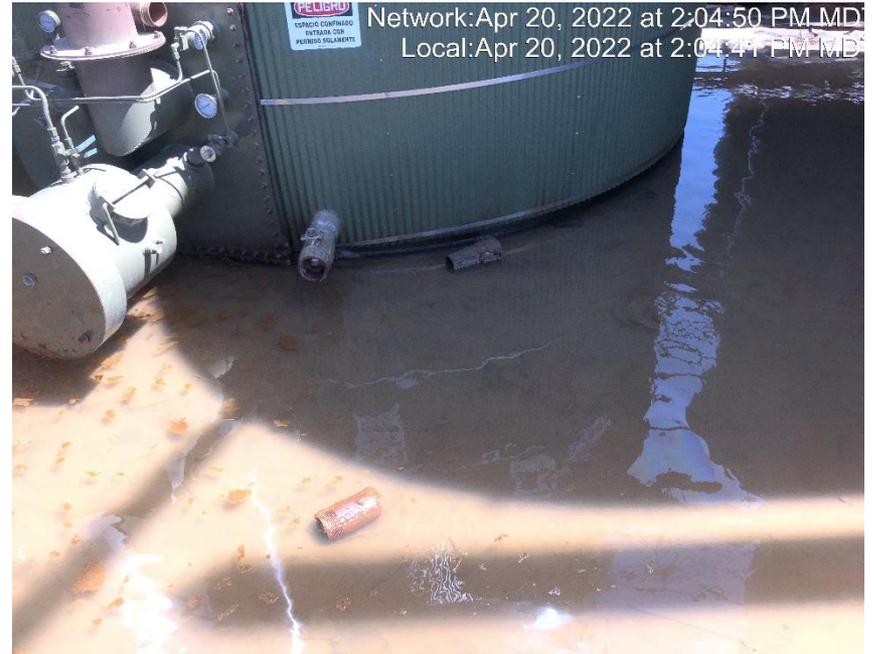
**Photo #6501 Multiple places with stored and unused equipment.**

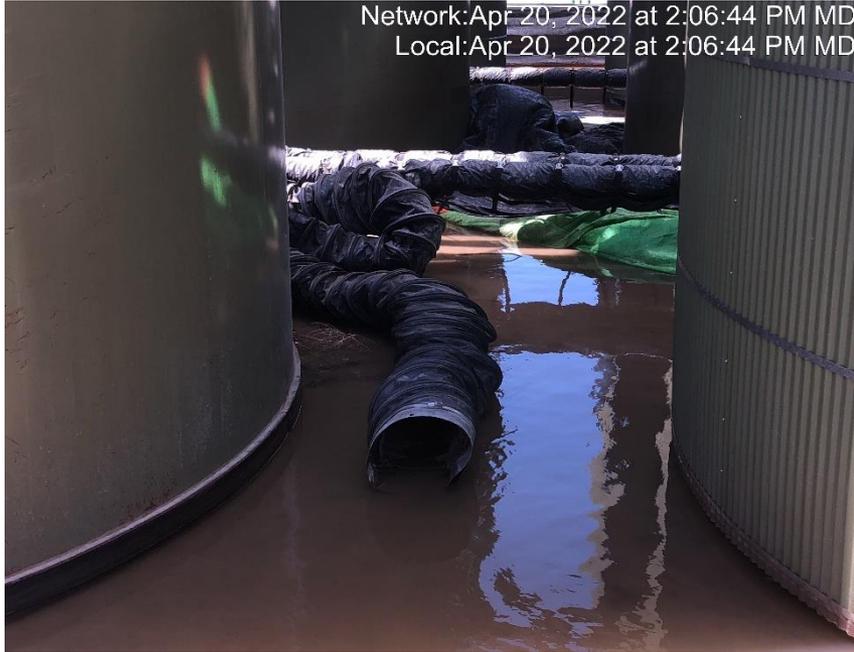
**Photo #6508** Multiple places with stored and unused equipment.

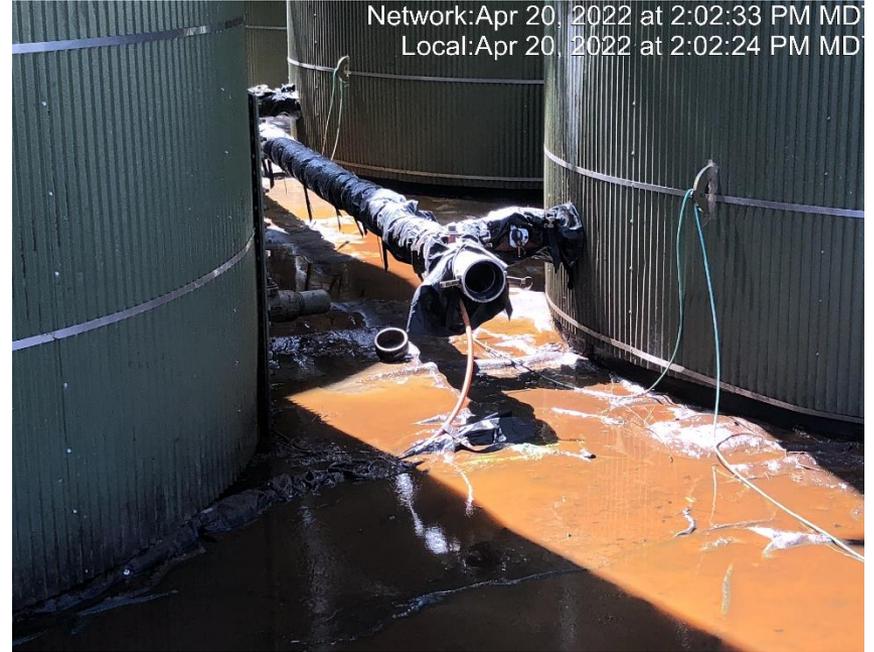
**Photo #6494** Loadline open ended.

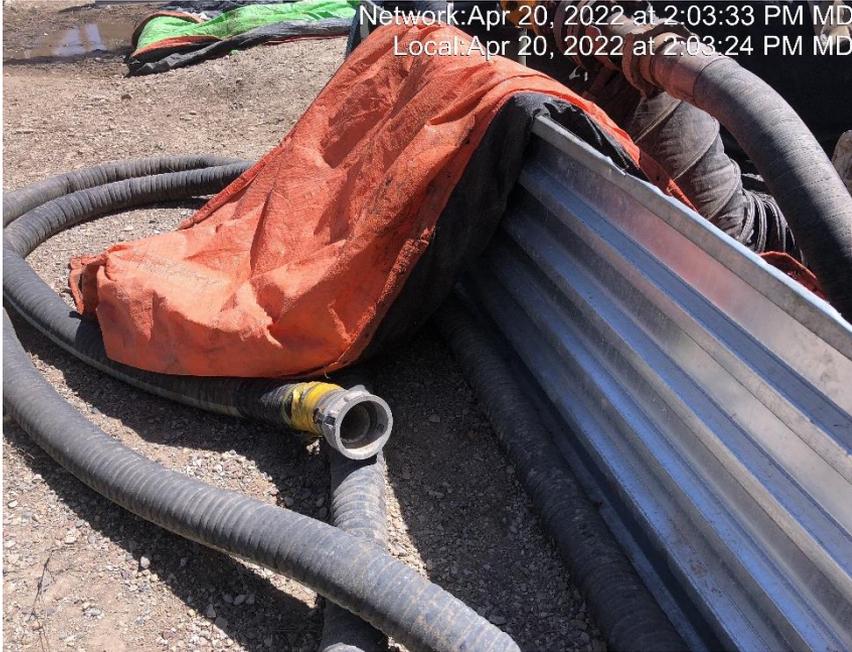
Photo #6495 Loadline open ended.

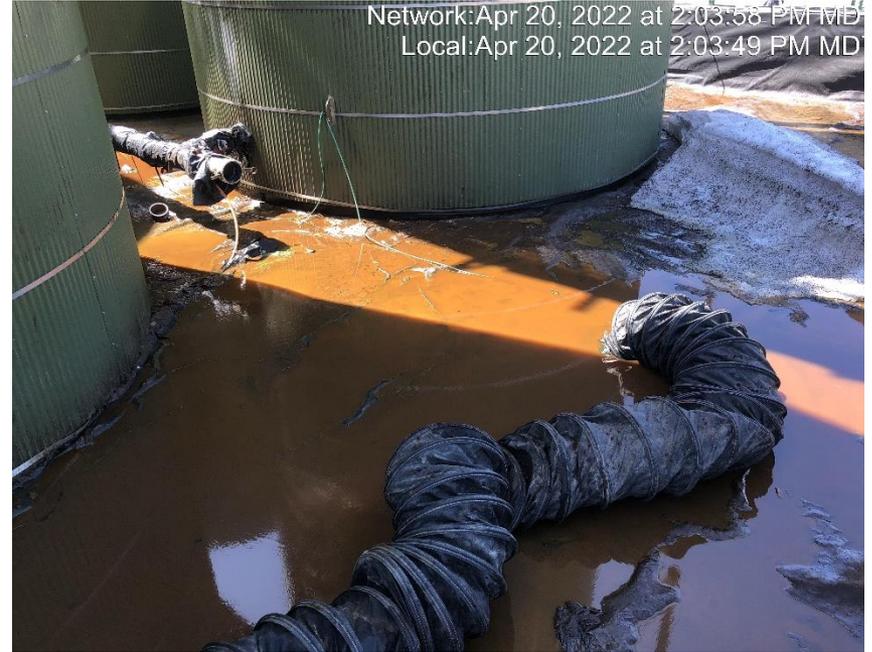
Photo #6497 Loadline open ended.

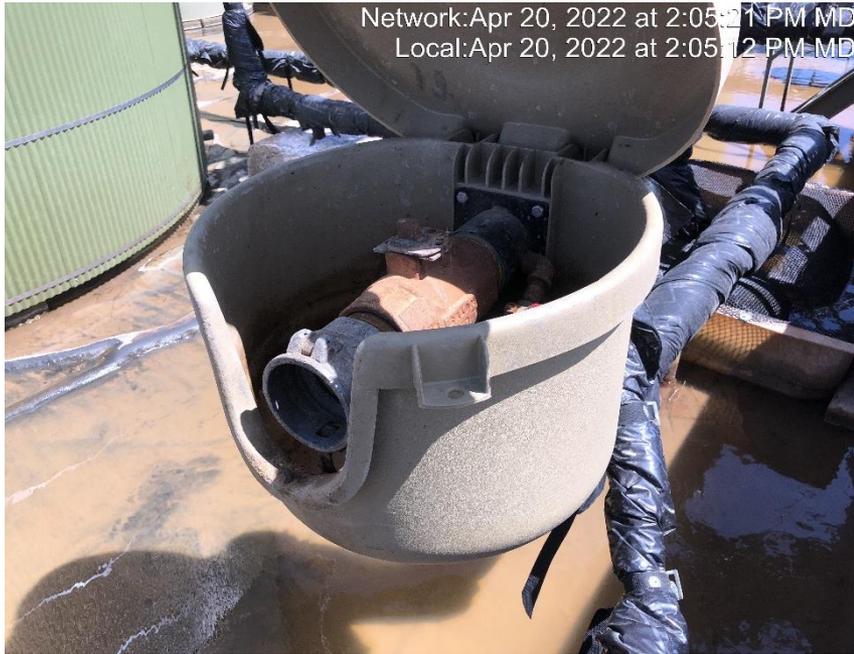
Photo #6503 Loadline open ended.

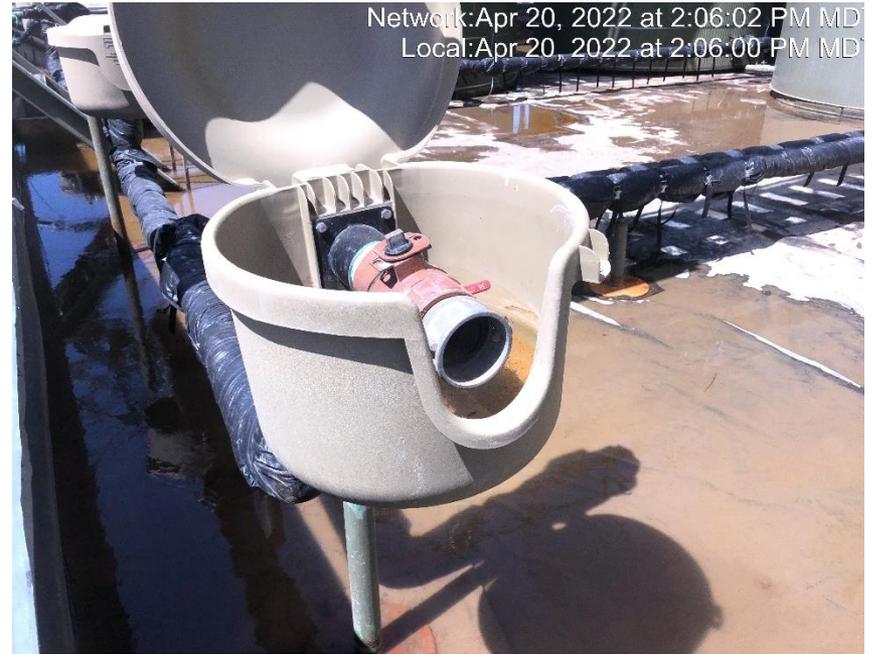
Photo #6505 Loadline open ended.

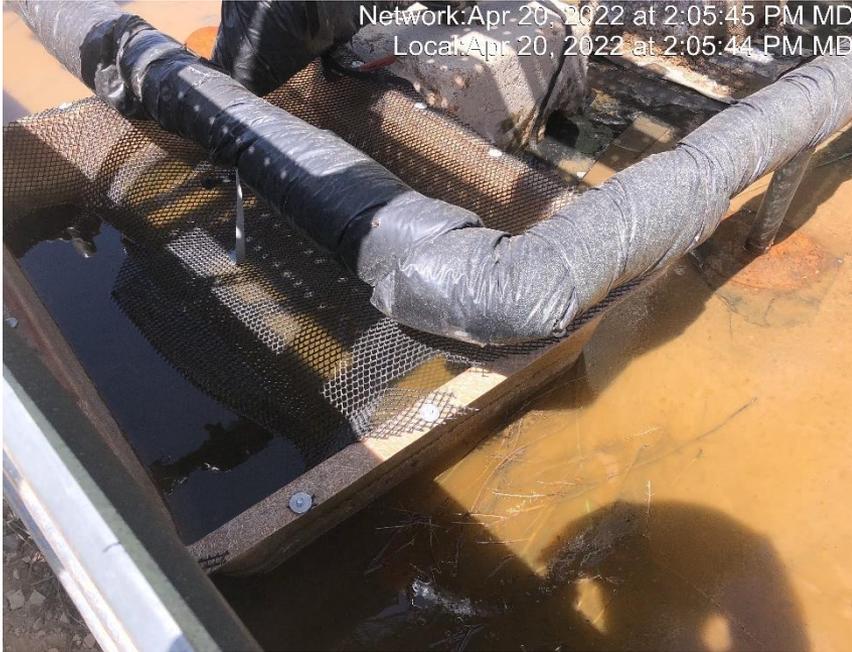
**Photo #6504 Bird protector insufficient.**

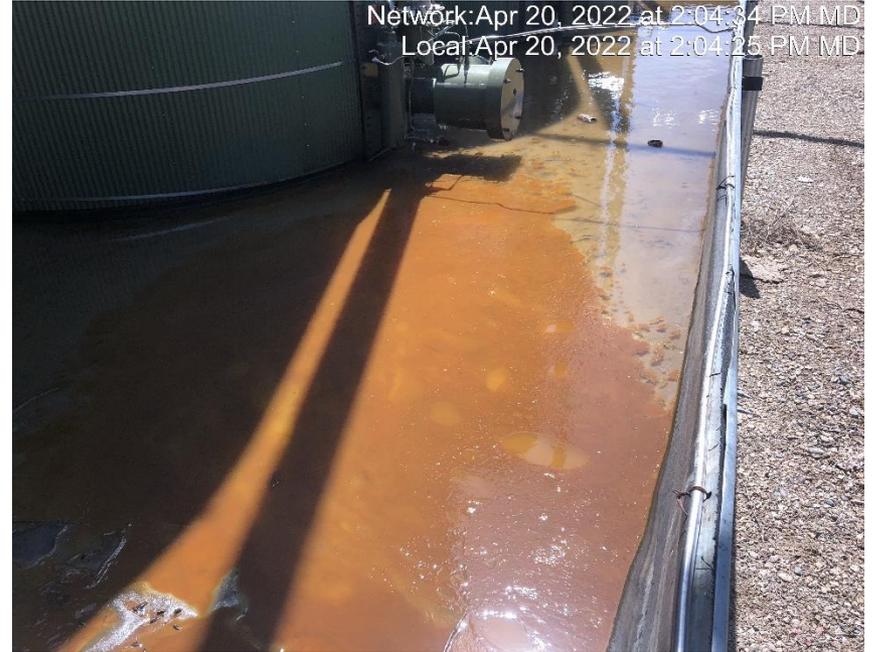
**Photo #6499 Oily fluid located throughout containment.**

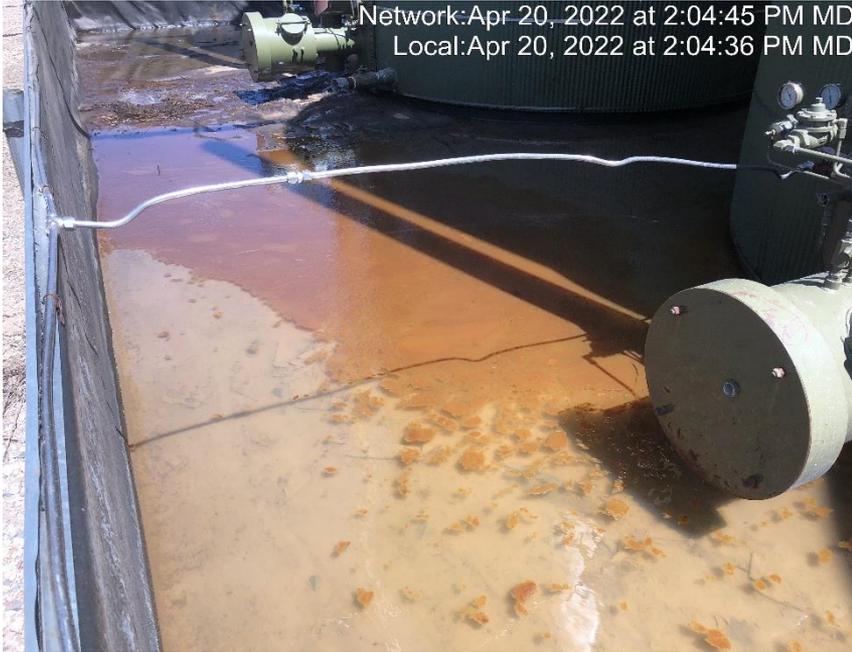
**Photo #6500 Oily fluid located throughout containment.**

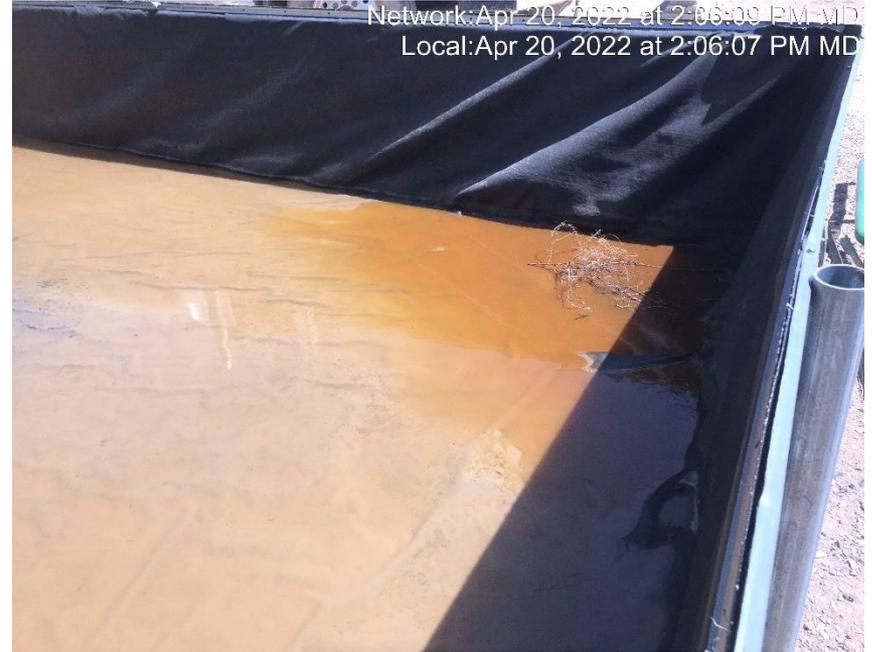
**Photo #6506 Oily fluid located throughout containment.**

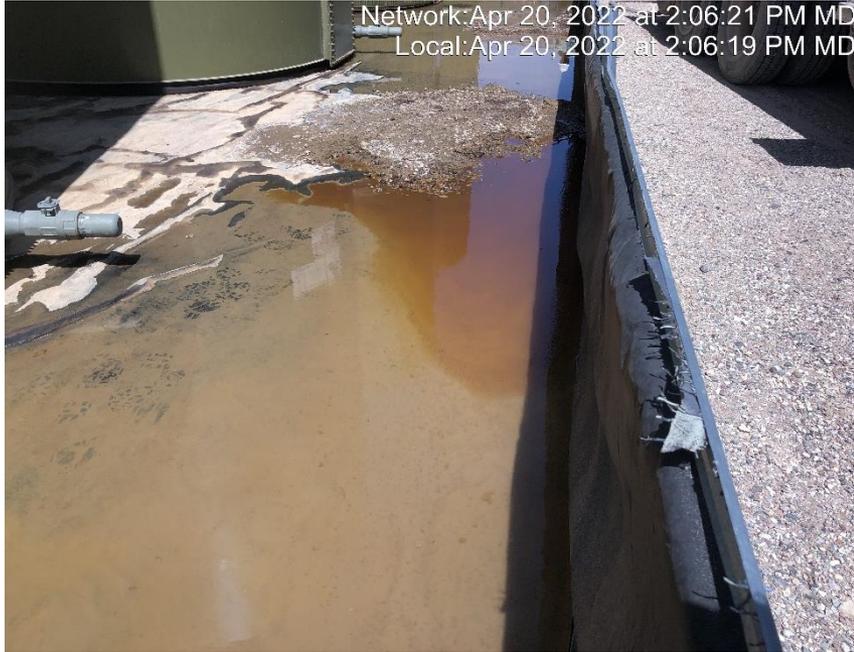
**Photo #6507 Oily fluid located throughout containment.**

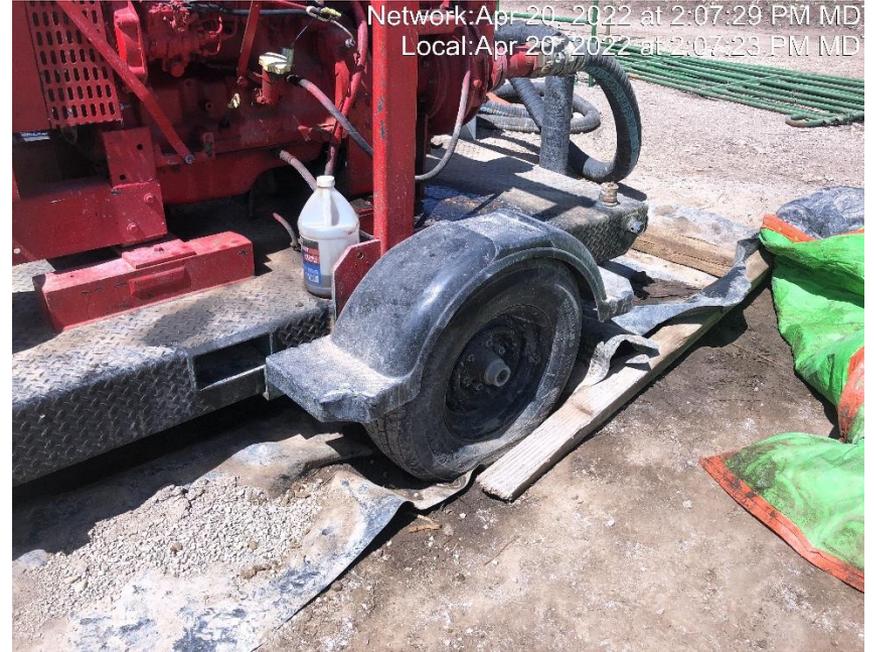
**Photo #6509 Insufficient spill prevention BMP.**

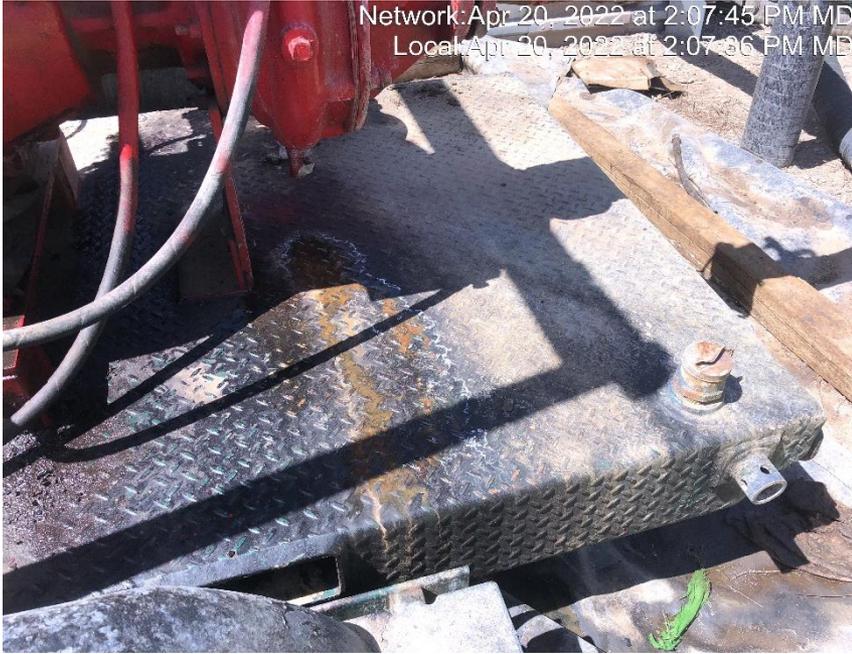
**Photo #6510 Drain valve on produced water transfer pump appears to be leaking.**

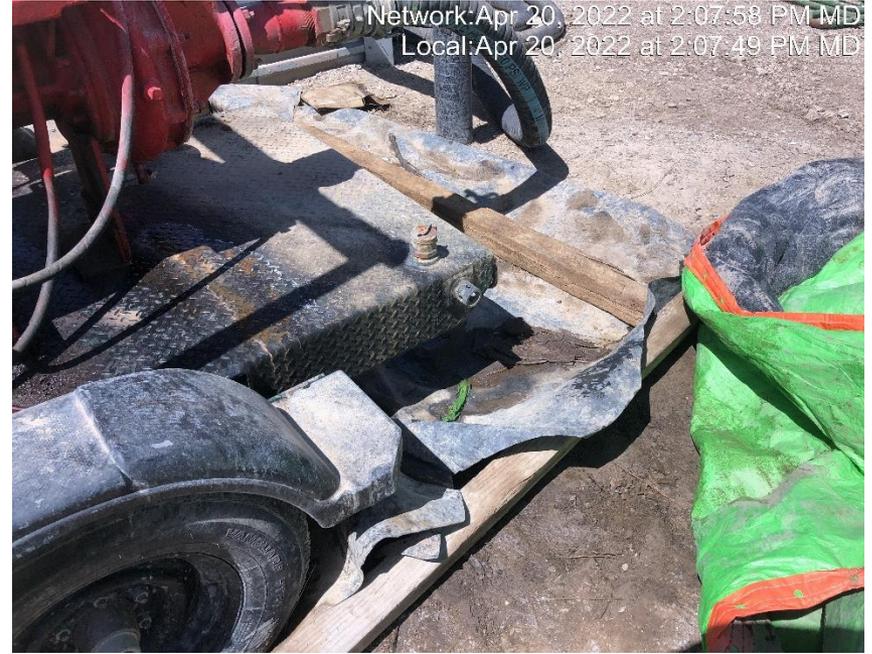
**Photo #5611 Insufficient secondary containment and potentially impacted soil under tarp.**

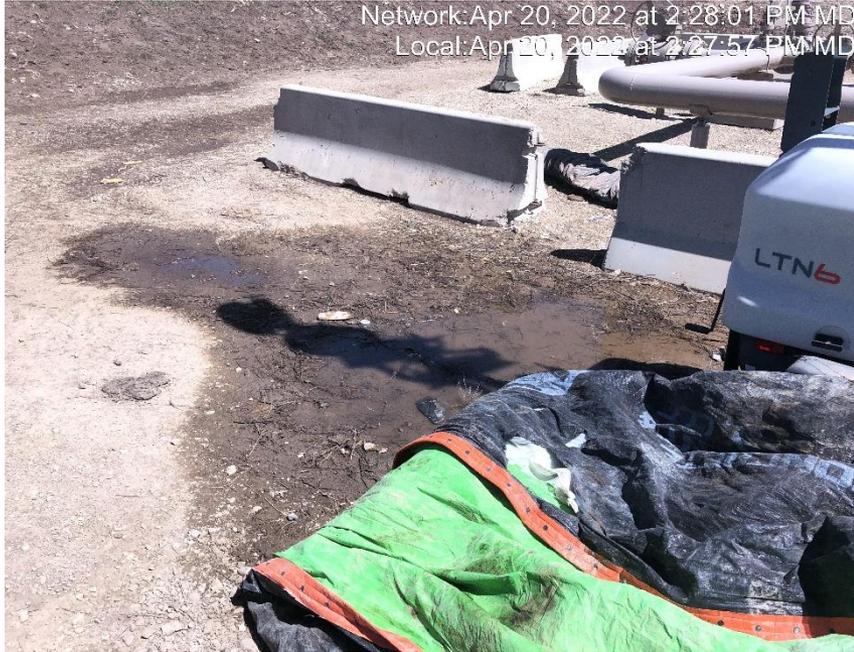
**Photo #6527 Potentially impacted soils continued.**

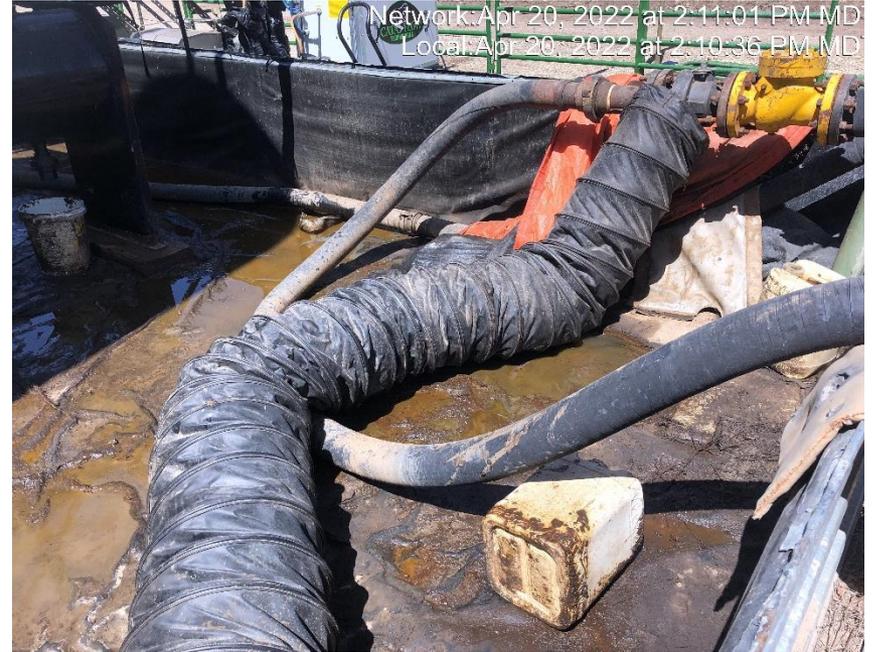
**Photo #6515 Multiple places with debris.**

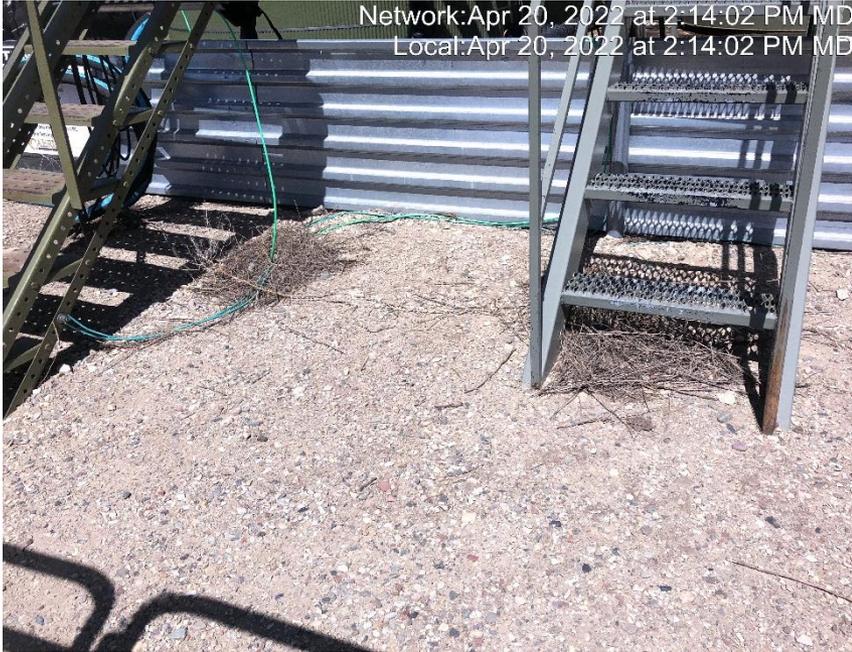
**Photo #6521 Multiple places with debris.**

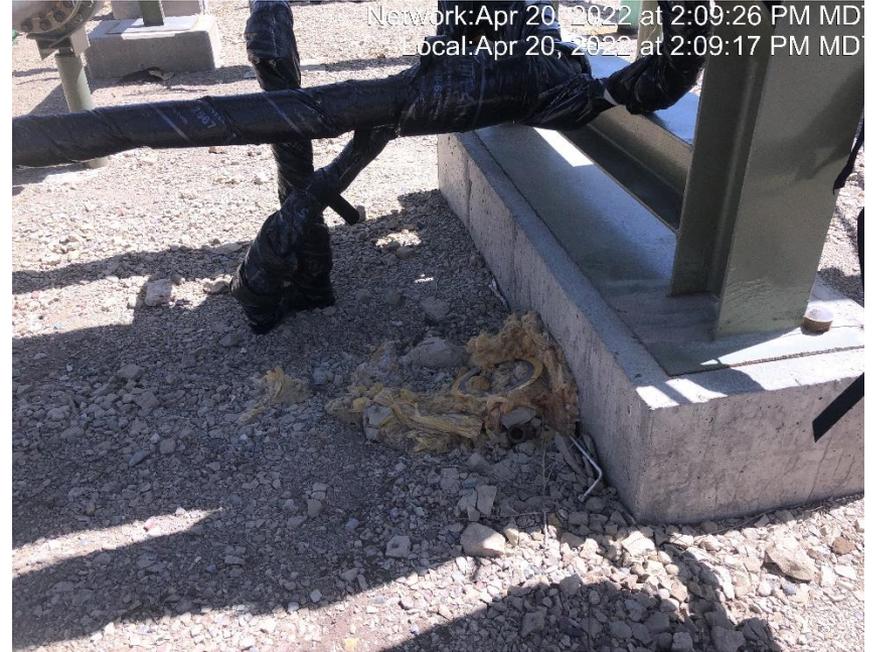
**Photo #6516 Multiple places with trash and debris on location.**

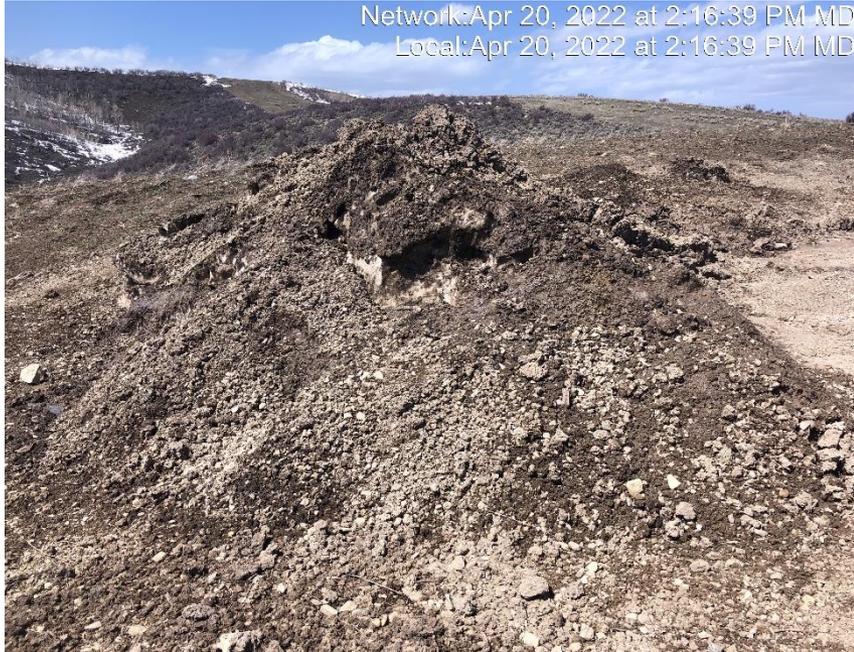
**Photo #6522 Multiple piles of sediment without BMP implementation.**

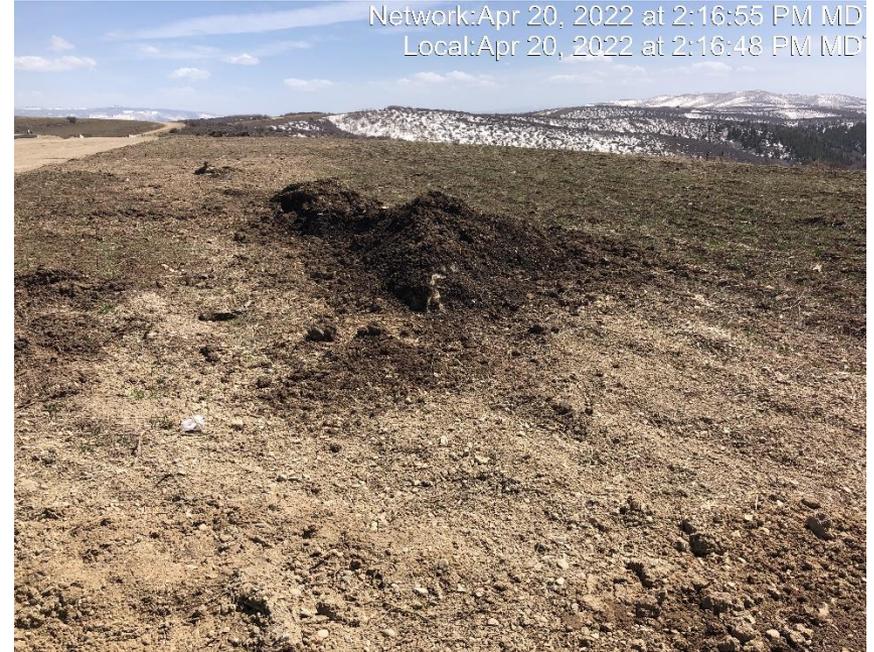
**Photo #6523 Sediment has been transported on to reclaimed area.**

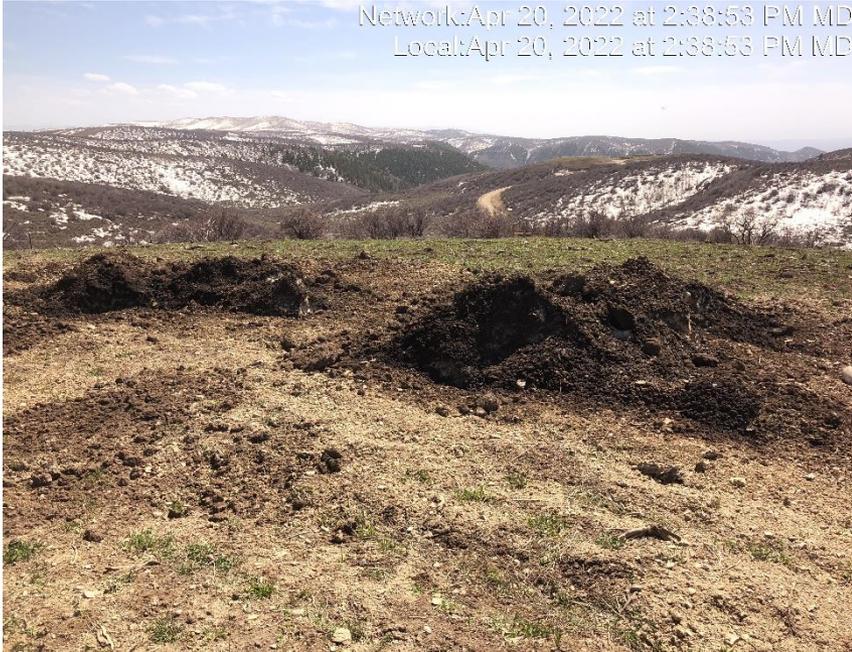
**Photo #6528** Sediment has been transported on to reclaimed area.

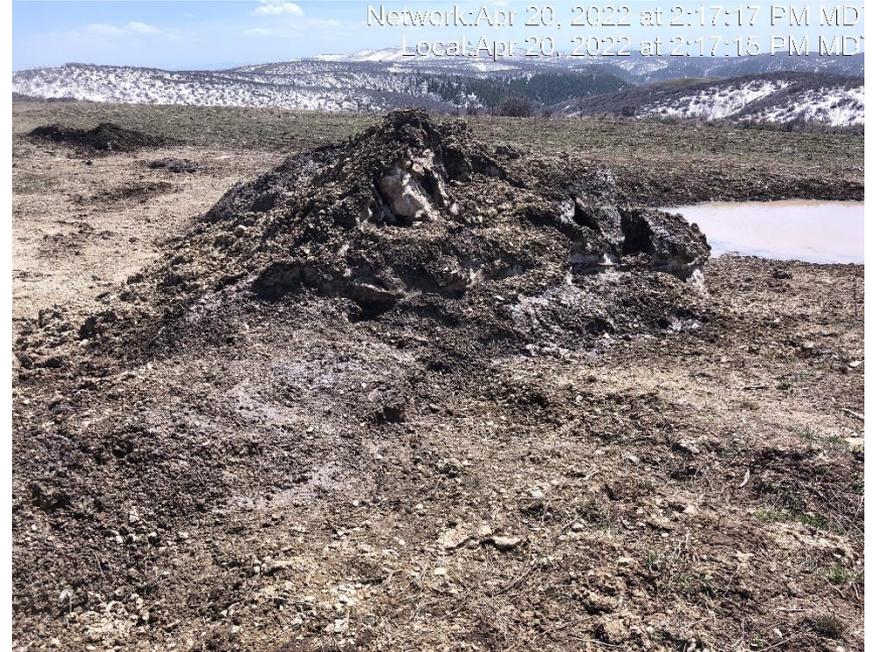
**Photo #6524** Sediment has been transported on to reclaimed area.
