Inspection Photos
Location Name: Knight B #1
API: 05-067-07842

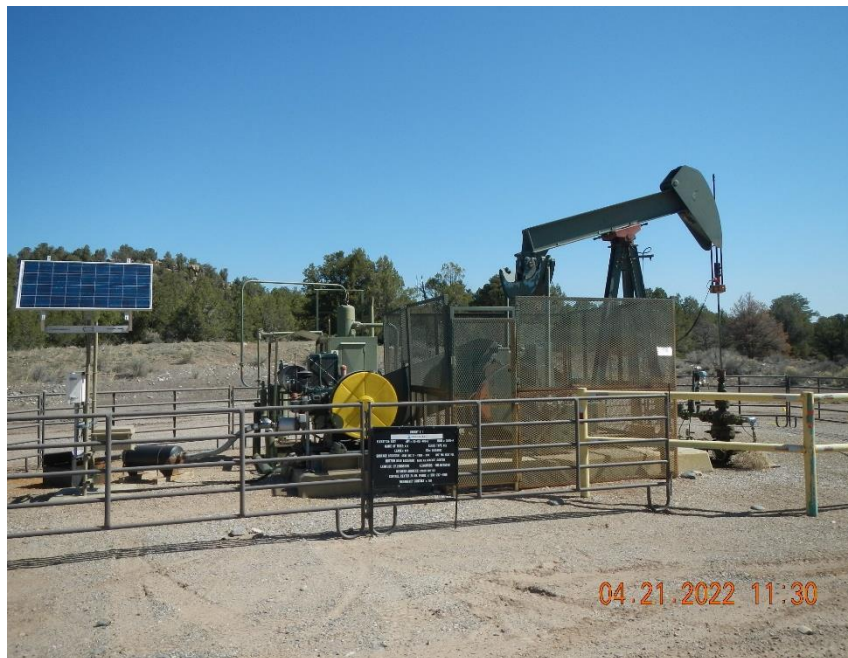
Knight B #1 pump jack and well head.

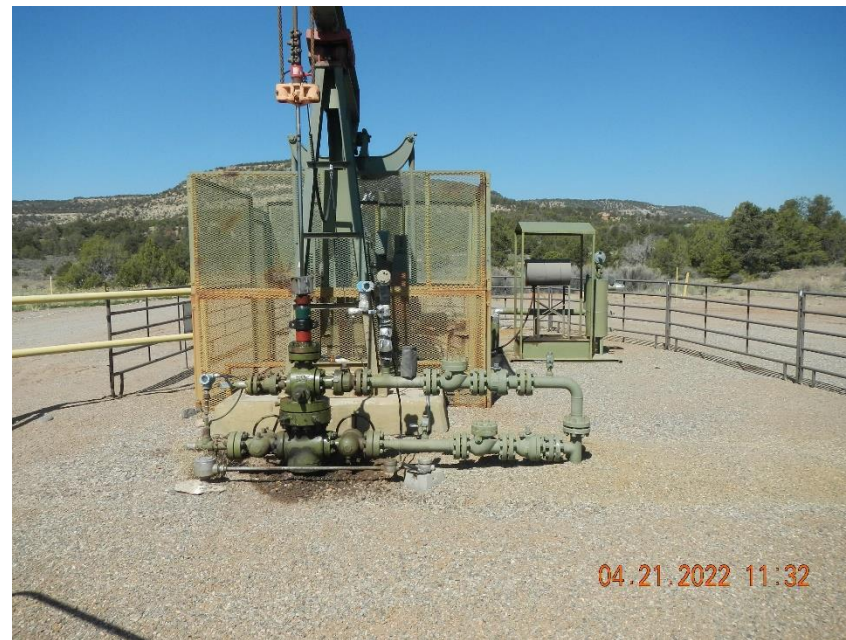
Well head is stained and wet. Surrounding gravel is stained.

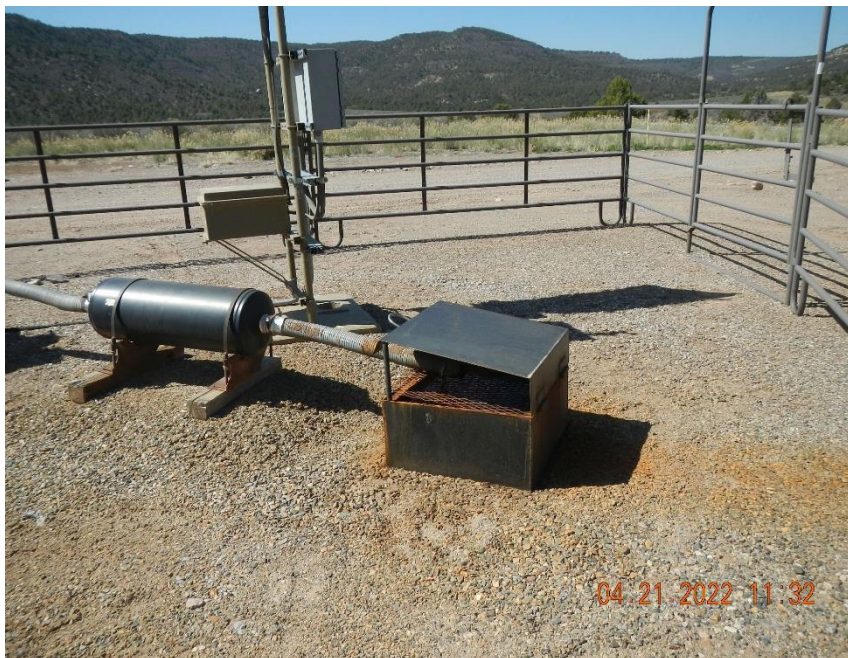
Containment for prime mover exhaust is almost full of fluids.

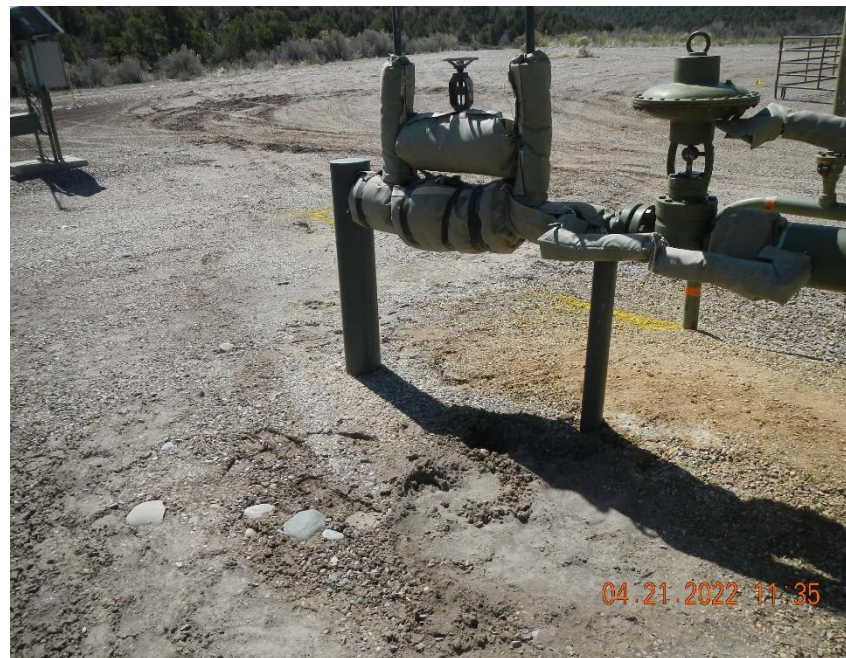
Apparent point source of Spill/Release Point ID #481990.

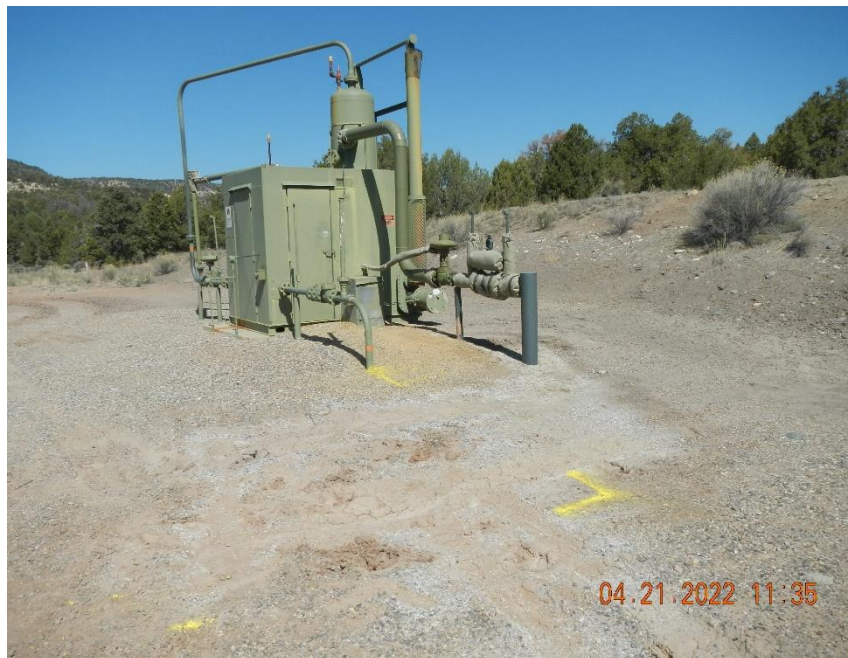
**Leaking water line valve on separator resulting in
Spill/Release Point ID #481990.**

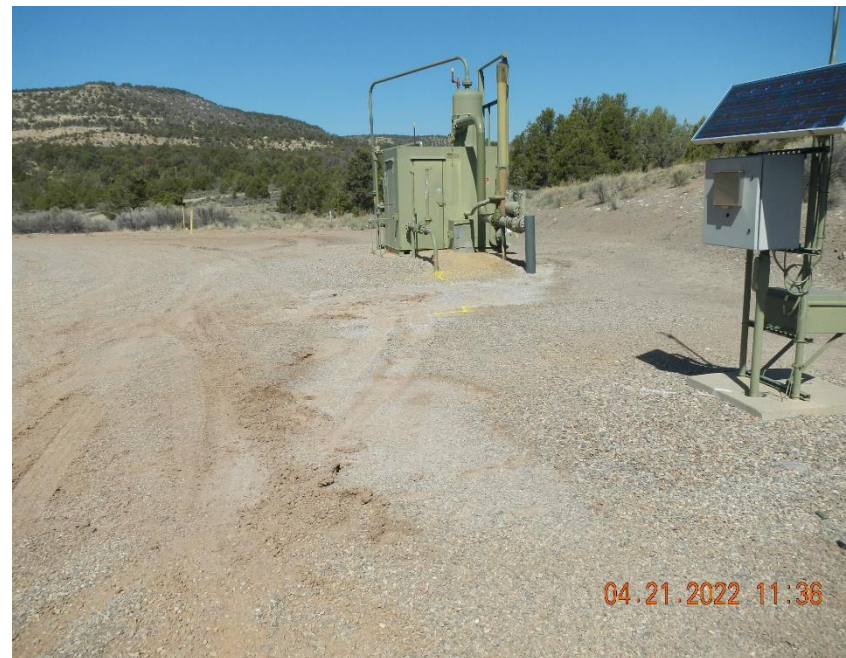
**Terminus of observable impacts from Spill/Release Point ID
#481990.**
