Inspection Photos
Location Name: Knight D #2M
API: 05-067-06325

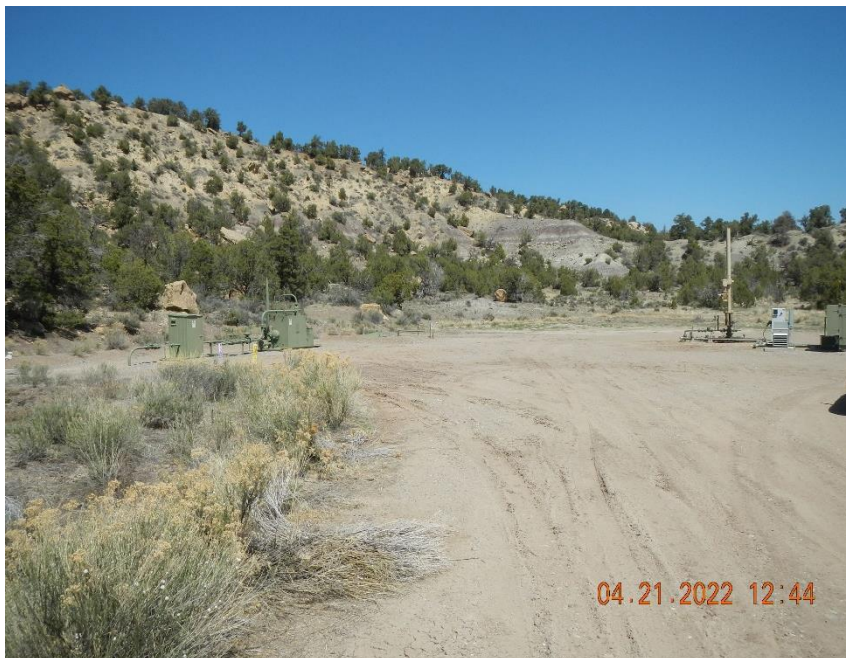
Knight D #2M location photo.

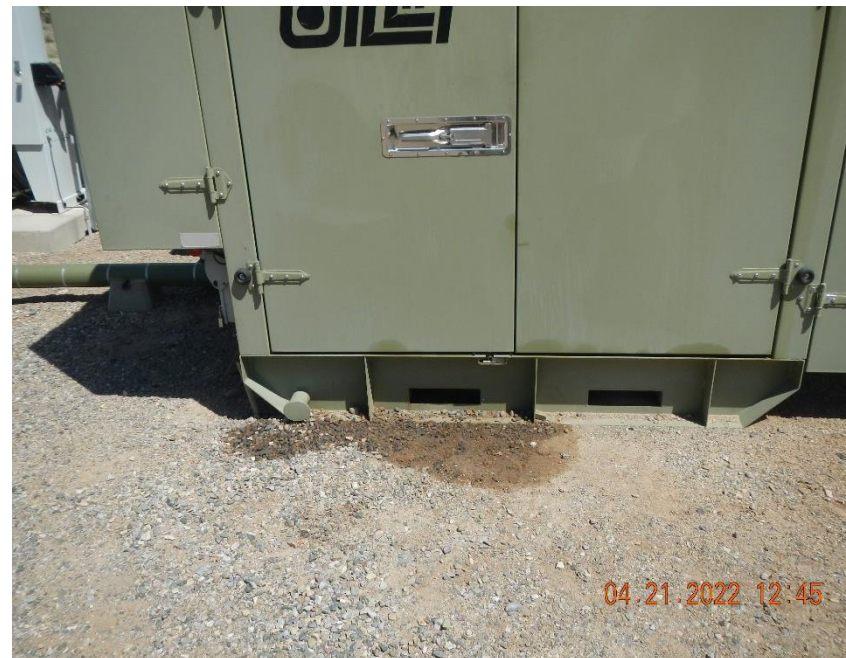
Stained soil next to OilLift pump controller.

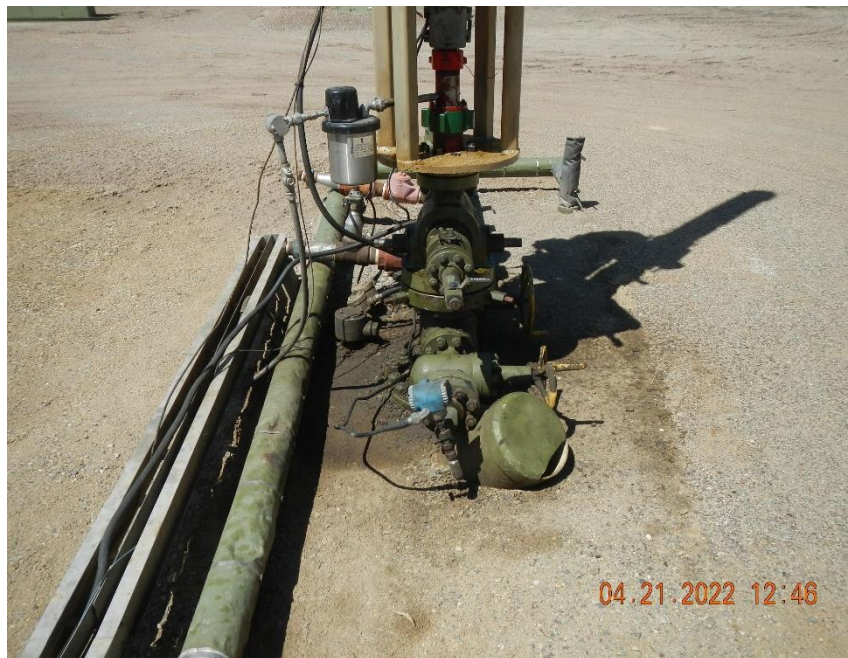
Well head and surrounding area are wet and stained.

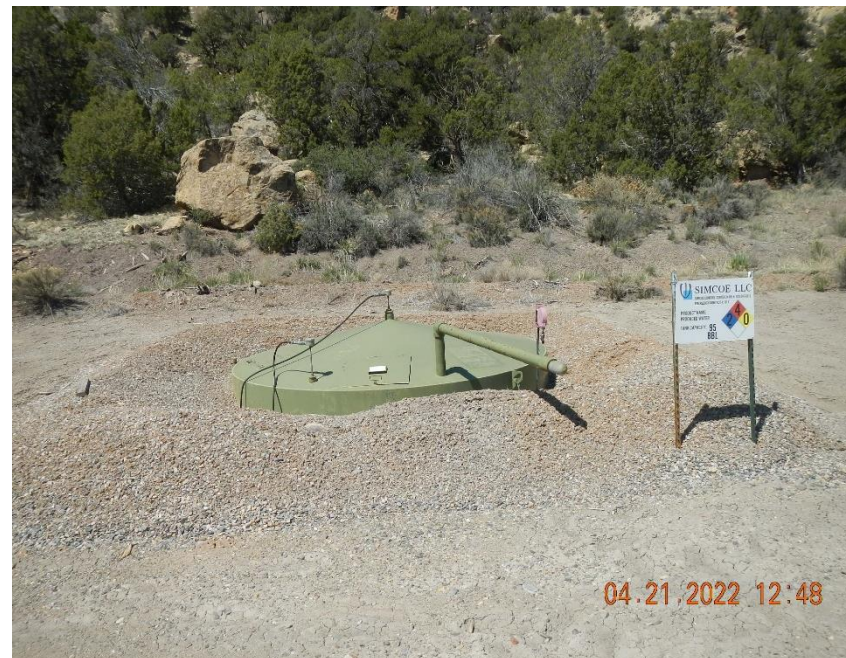
95 bbl. produced water PBV.
