Well Name: Carpenter 32-6-3 2/Carpenter 32-6-3 15 **Location ID** 438700
Document Number: 693904074
Inspector: Catherine Roy
Revegetation is progressing within portions of the interim reclamation areas, and remains sparse/bare in other portions. Specifically areas on well pad berms, down-slope from eastern berms, and cut-slopes support little desirable vegetation.

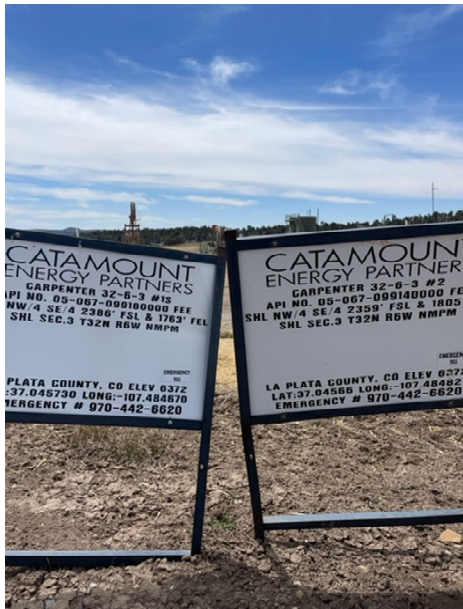
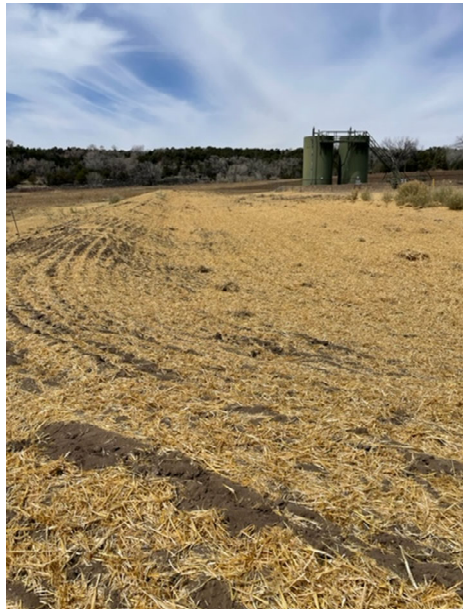
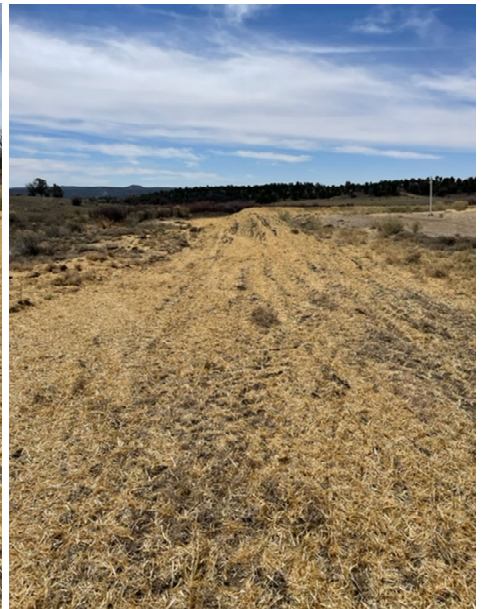
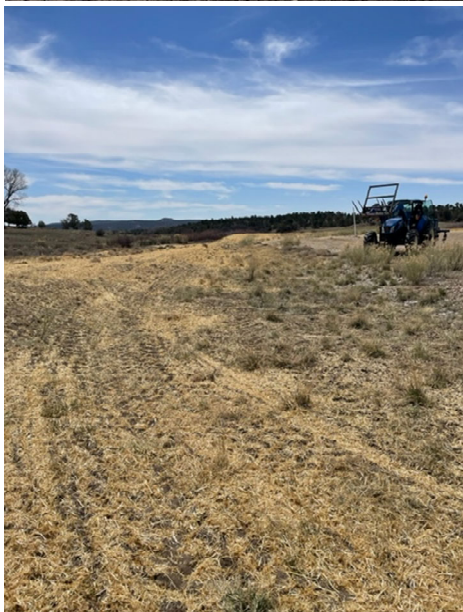
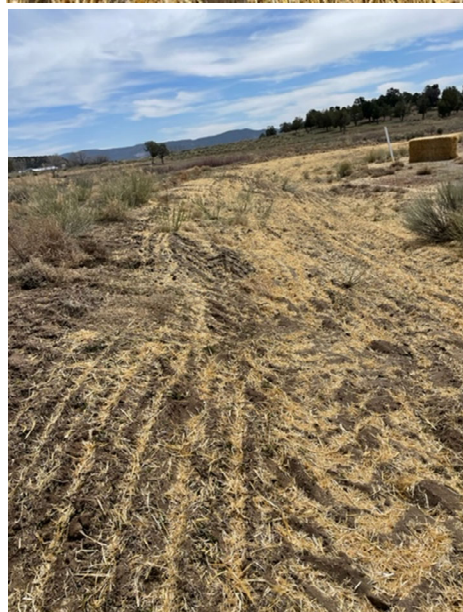
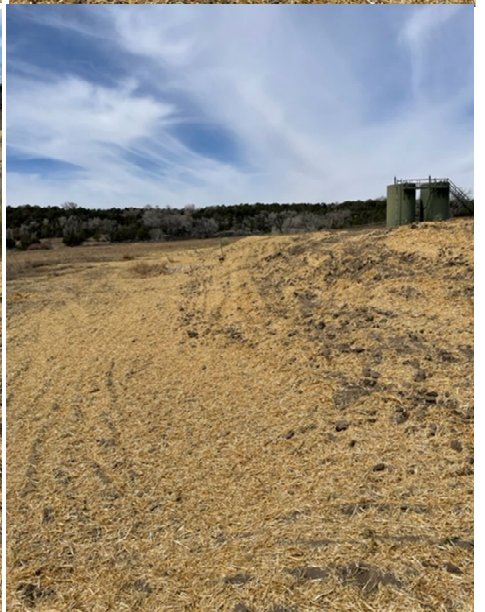
Corrective Action: Bare soils in the project area are not stabilized. Stormwater BMPs (wattles) are degraded and no longer functioning.

Correction Action Due: 4/14/2022
Action Taken: Seeded and hydromulched berms and cut slopes

Correction Action Due: 5/1/2022
Action Completed: 4/14/2022
Corrective Action: Seeded and hydromulched berms and cut slopes/bare soil areas
