Inspection Photos  
Operator: Kinder Morgan  
API: 083-06574  
Date: 4/21/2022

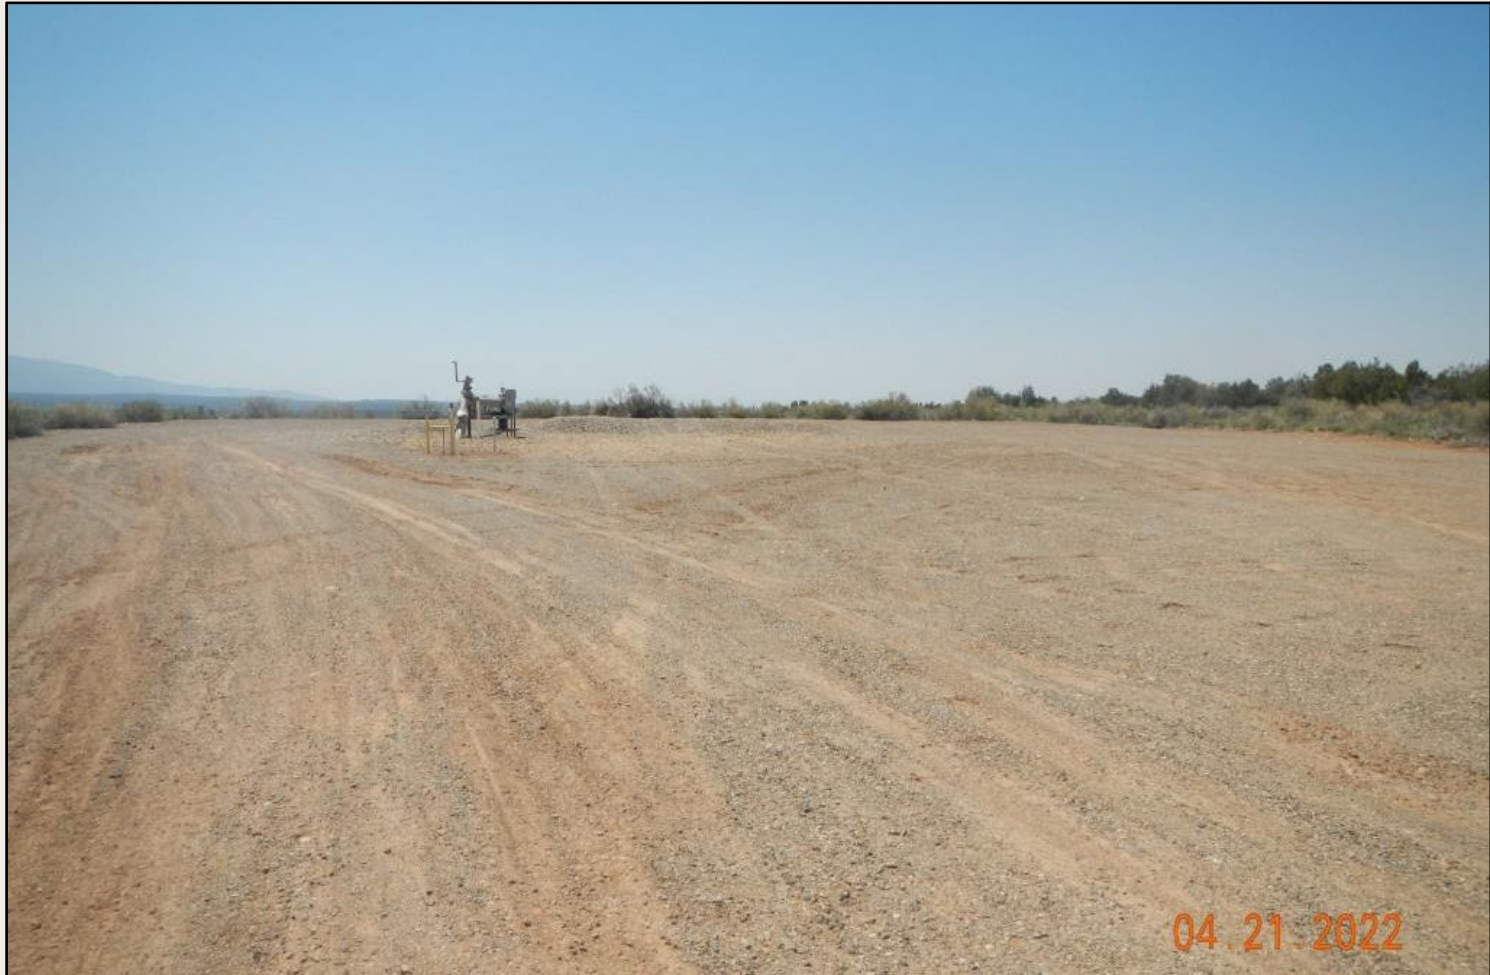
Photo 1. View of the project area from the well pad entrance facing center.

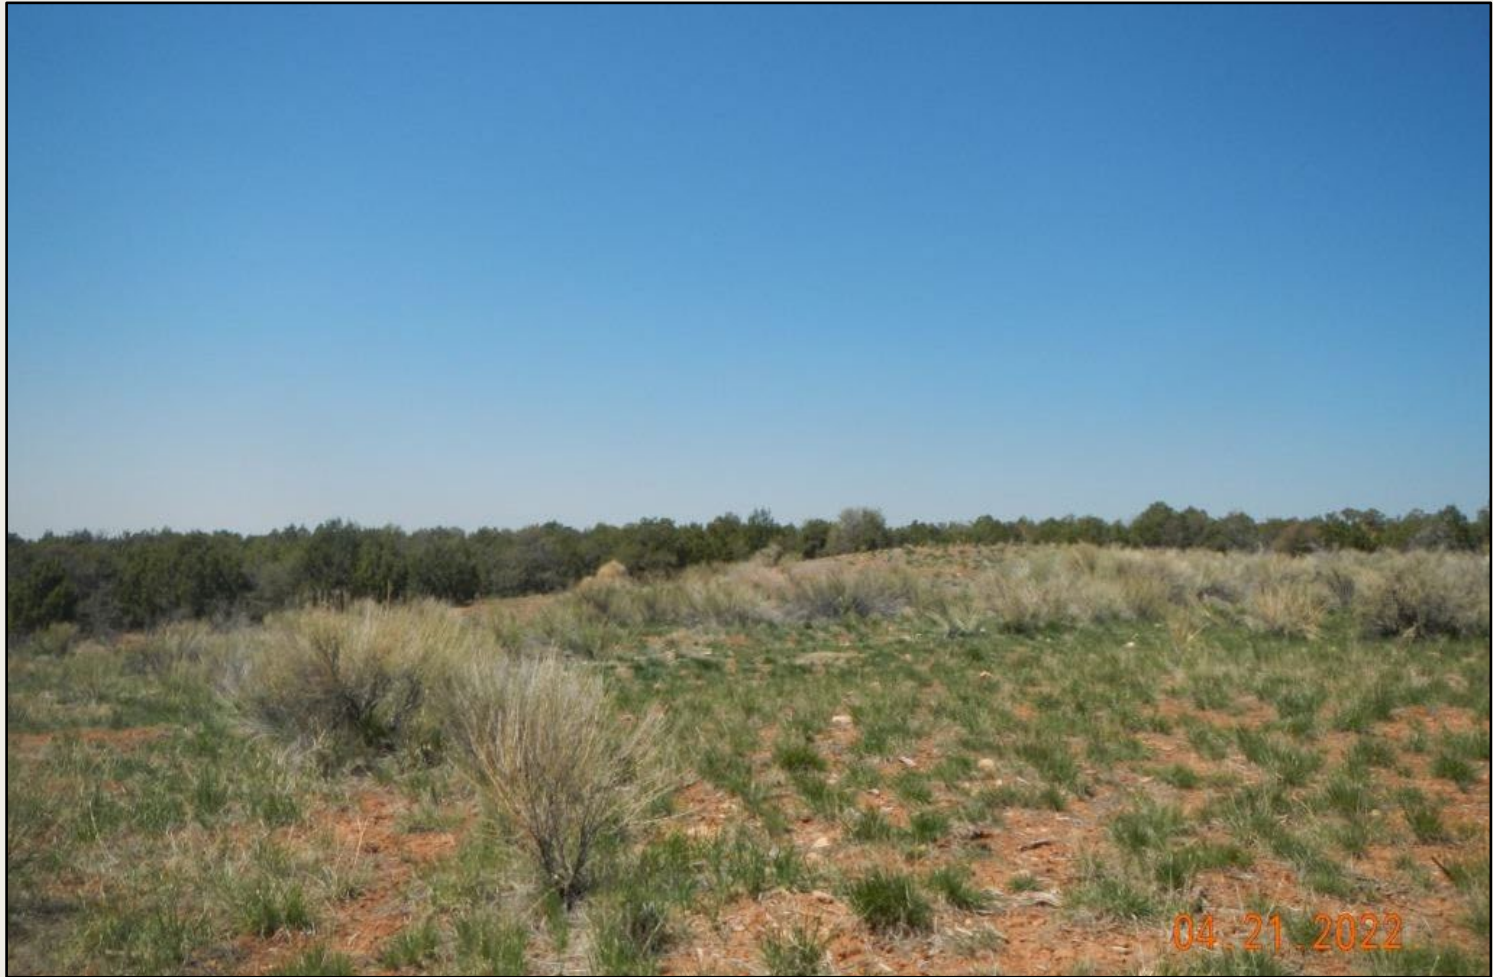
Photo 2. View of the southern project area from the southeastern corner facing westward. Revegetation is progressing with rubber rabbitbrush (*Chrysothamnus nauseosus*), crested wheatgrass (*Agropyron smithii*), western wheatgrass (*Pascopyrum smithii*), and sand dropseed (*Sporobolus cryptandrus*).

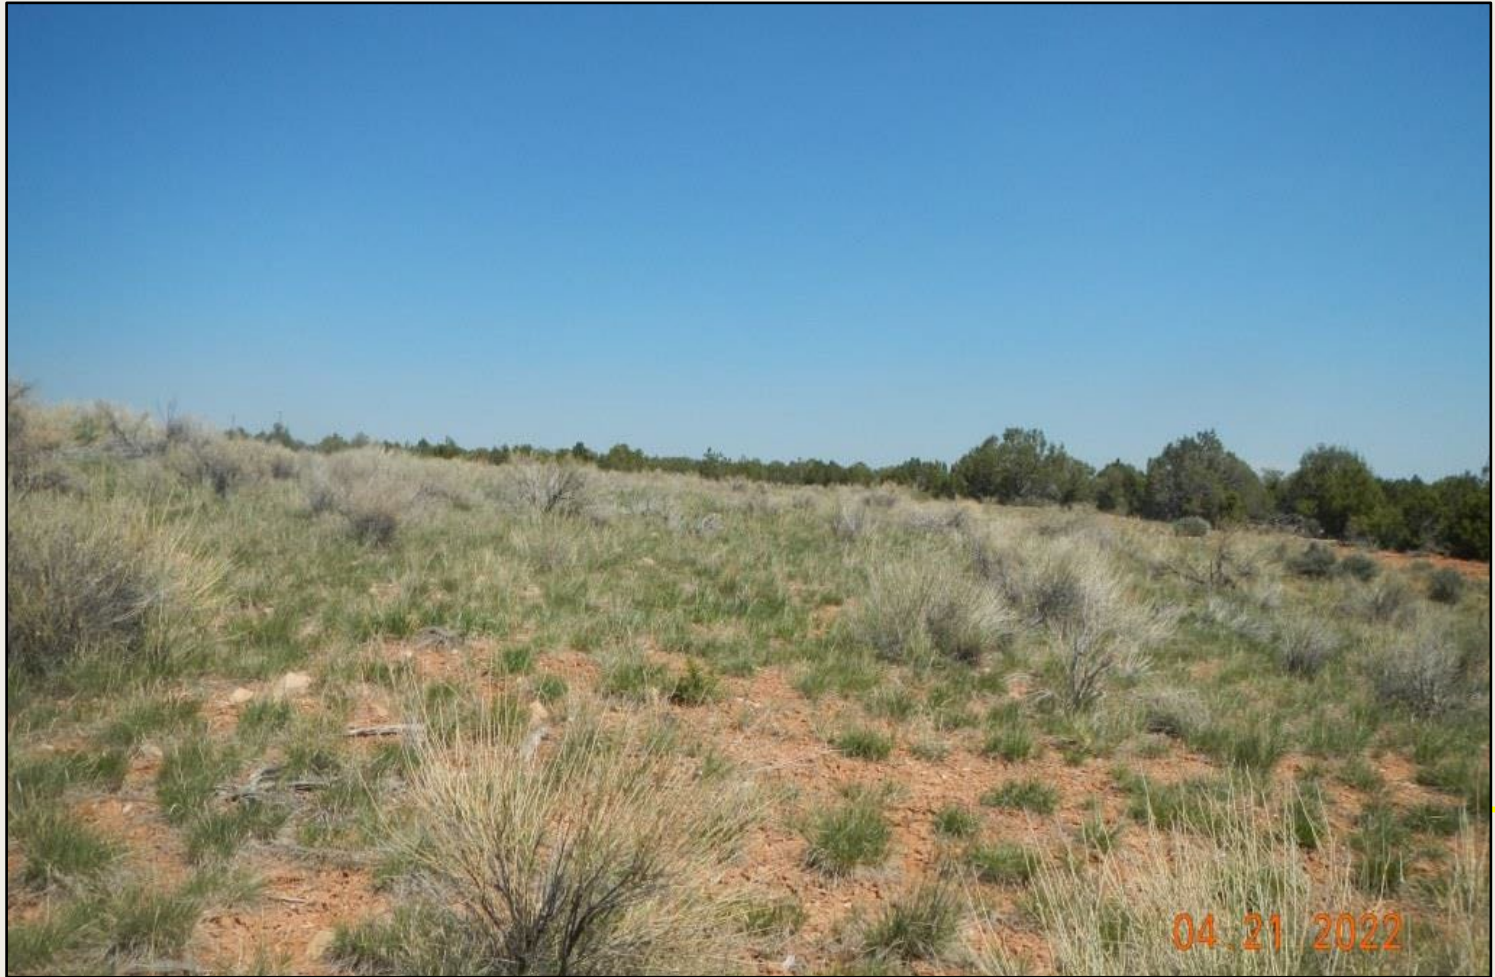
Photo 3. View of the eastern project area from the southeastern corner facing northward.

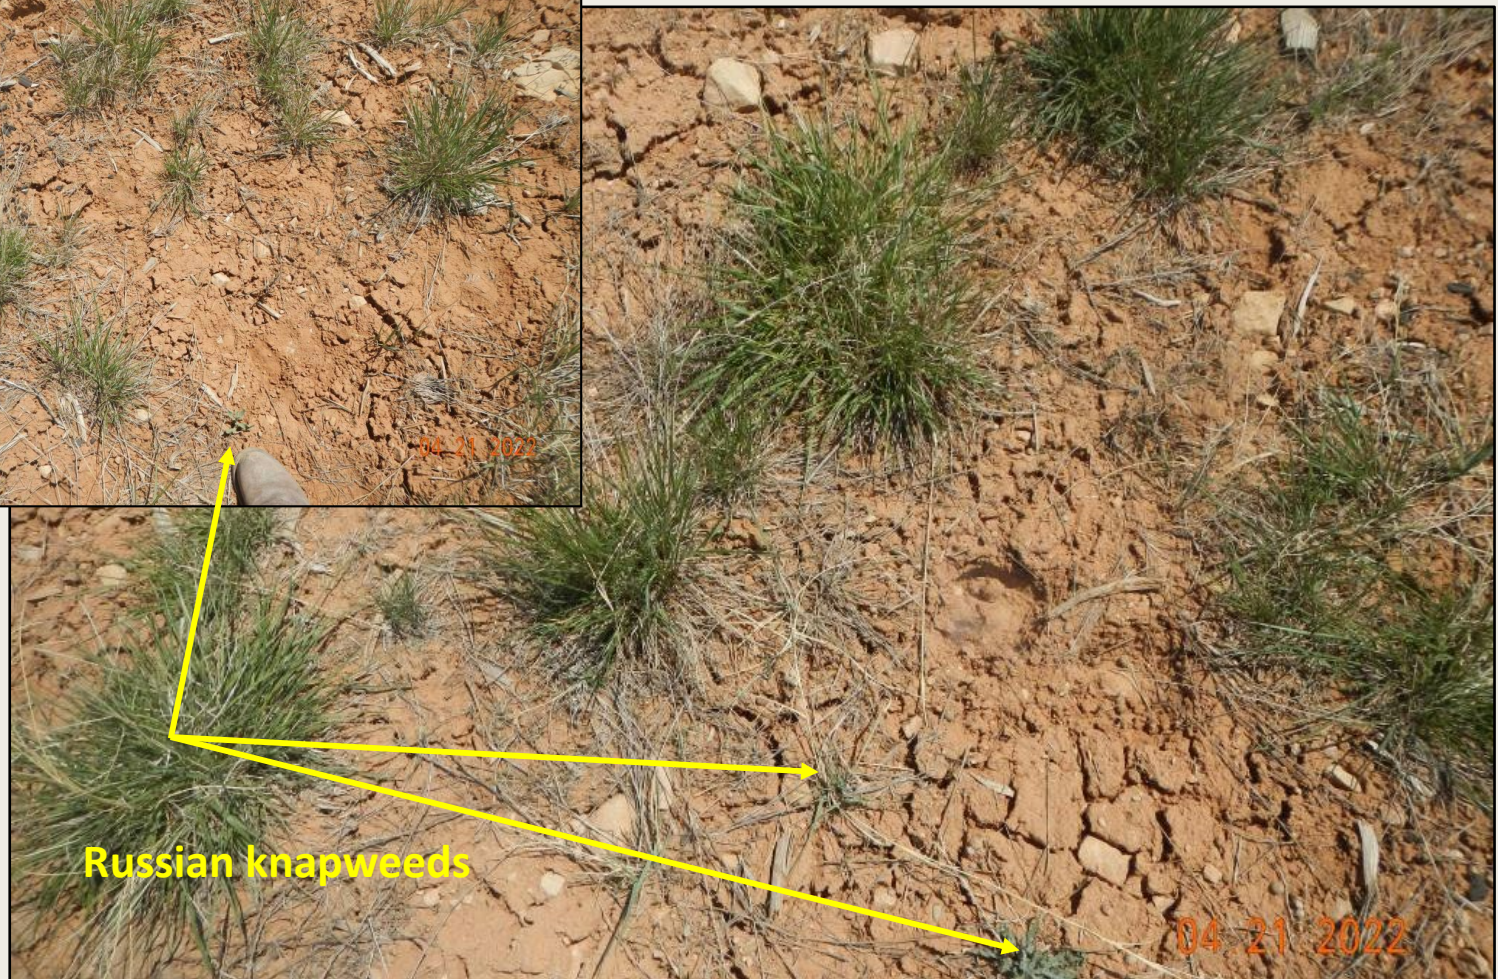
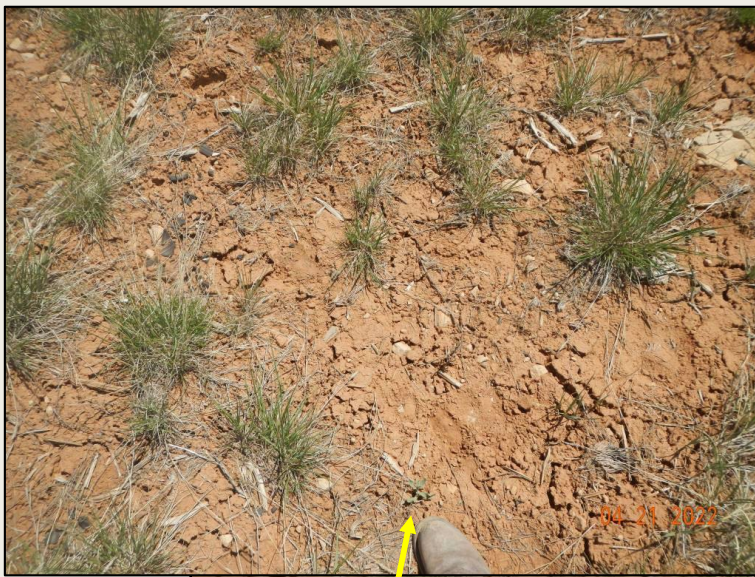
**Russian knapweeds**

Photo 4. View of Russian knapweeds within the interim reclamation area. Scattered individuals observed, (~25) additional weeds may be present as it is early in the growing season.

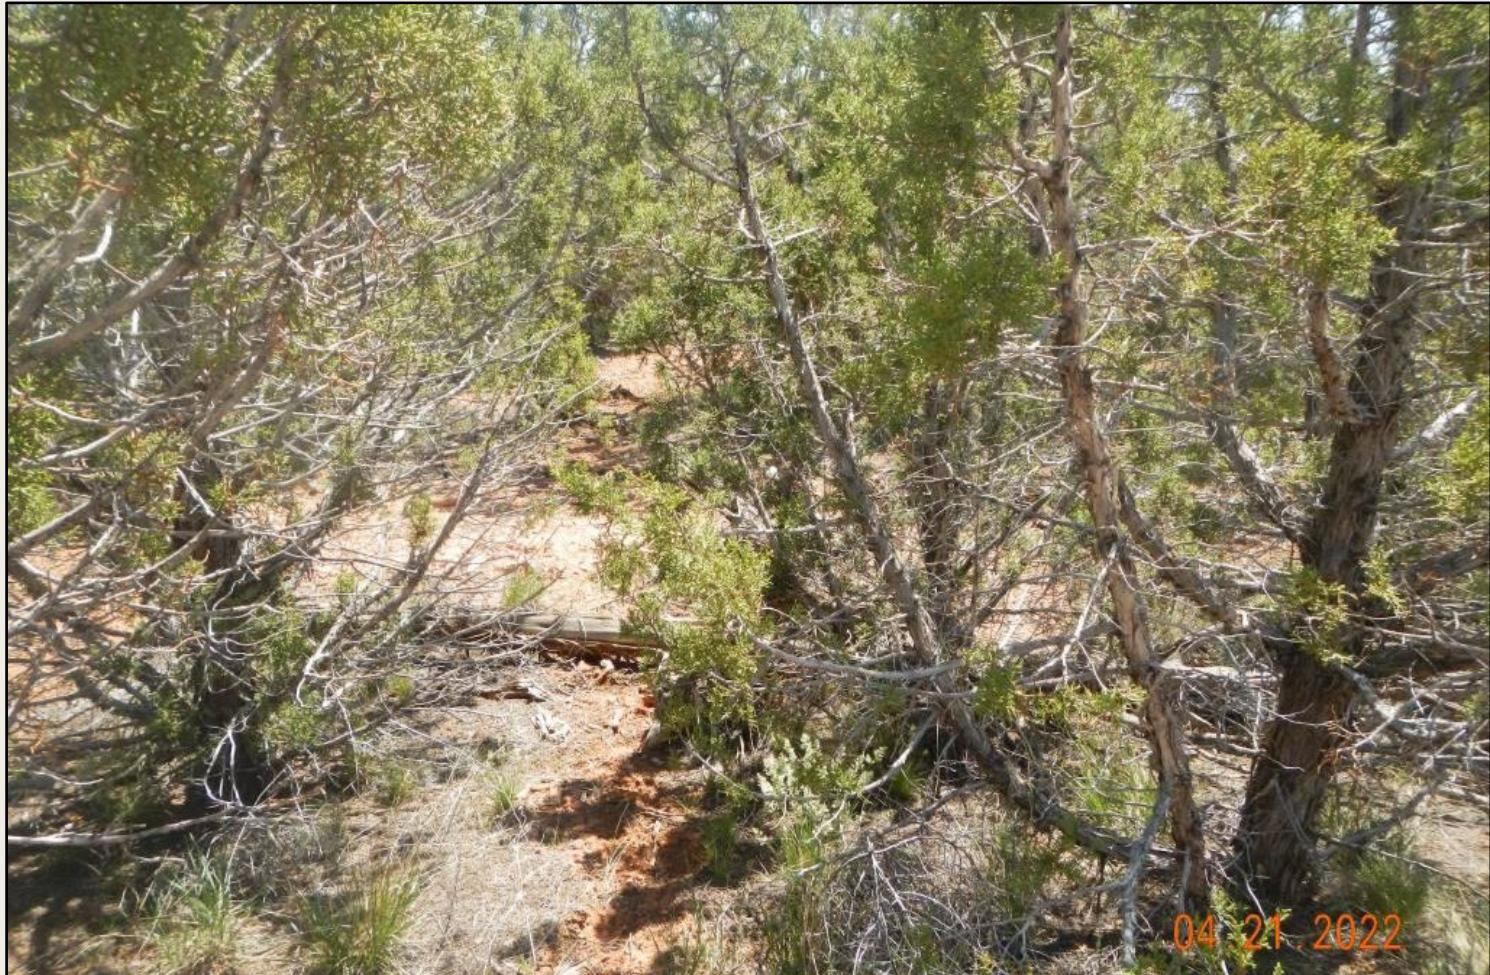
Photo 5. View of reference area comprised of pinyon and juniper woodland with sagebrush (*Artemisia tridentata*), snakeweed (*Guiterrezia sarothrae*), Indian ricegrass (*Achnatherum hymenioides*), and muttongrass (*Poa fendleriana*).
