Inspection Photos

Operator: Caerus Piceance LLC- #10456

Location Name: Shideler-66S92W /32SWNE

Inspection Document #: 702800148

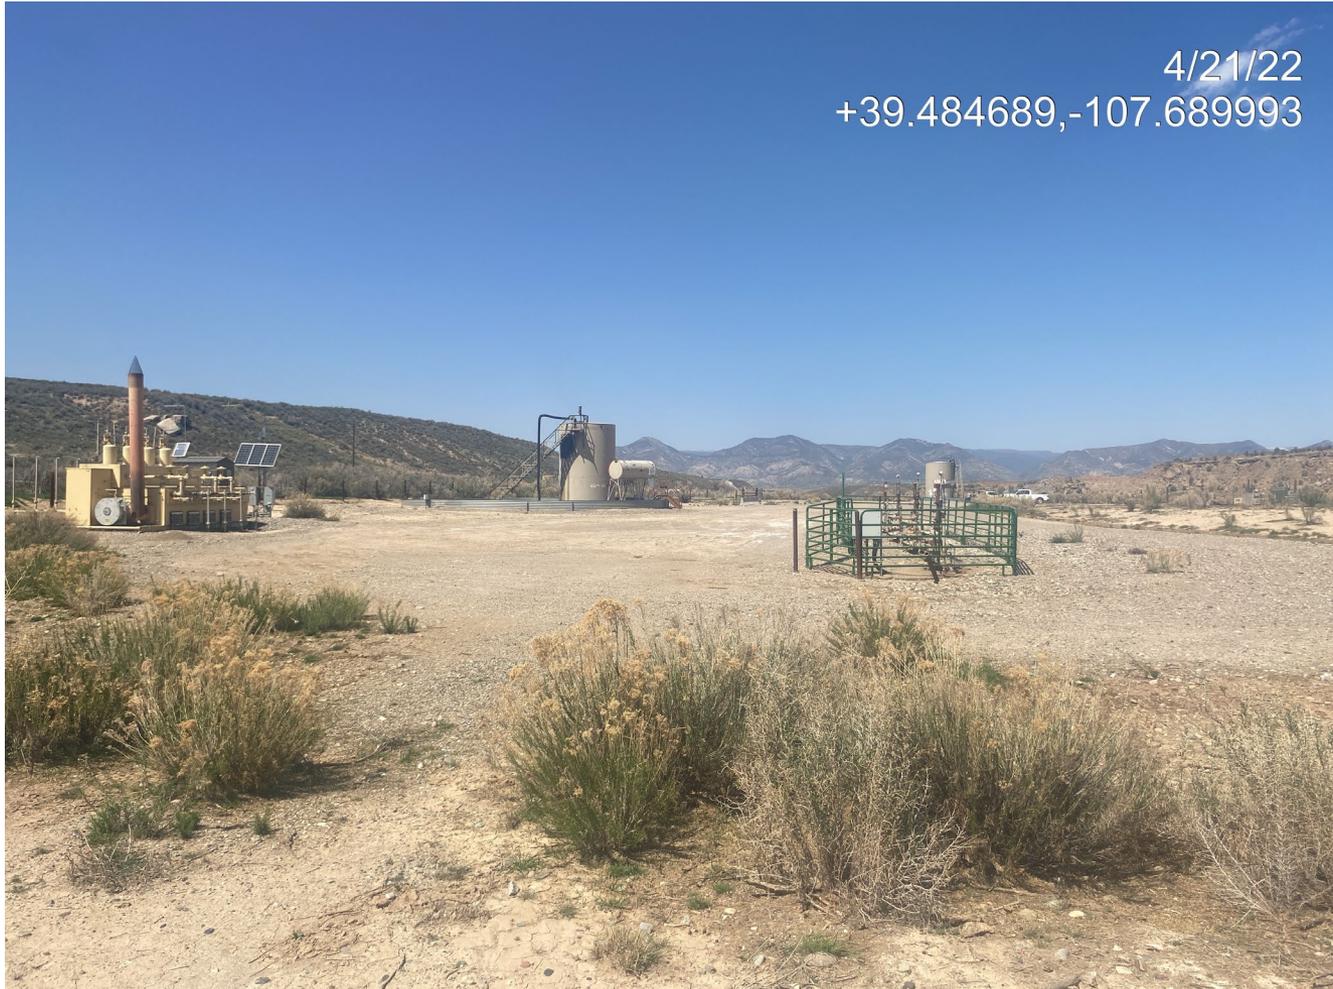
Photo 1. Photo taken from the south of the Location shows an overview of the Location.

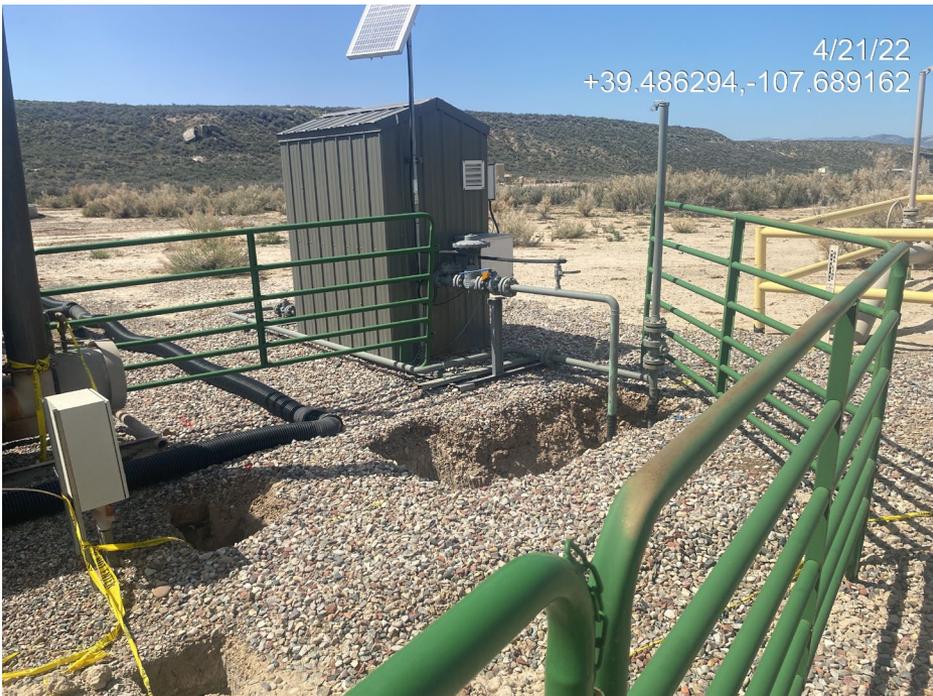
Photo 2. Photo taken from the separator at the northeast of the Location shows inadequate protection of an excavated area from entrance by wildlife, livestock or personnel.

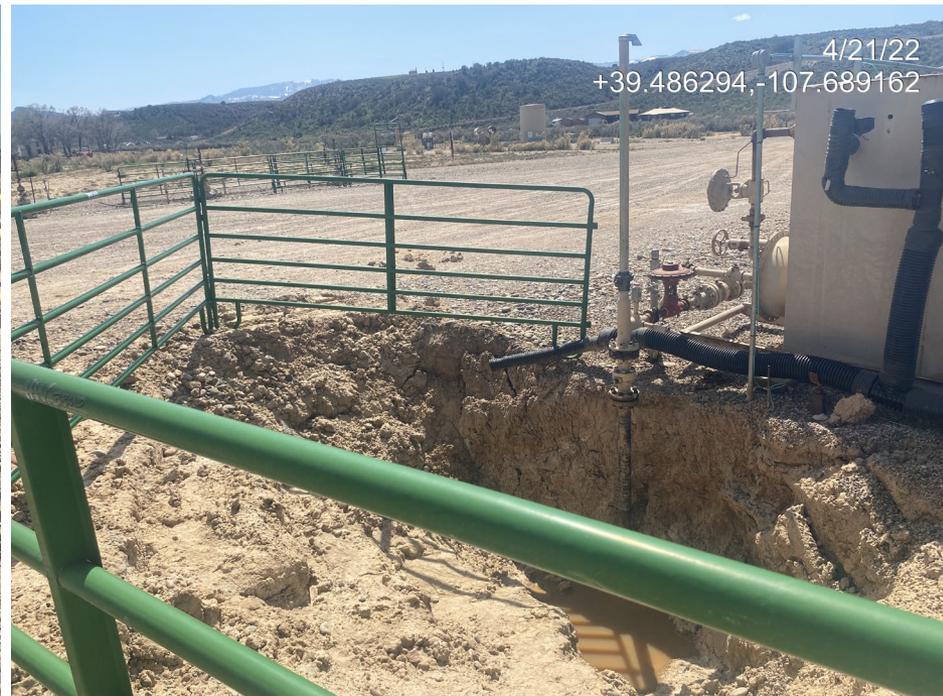
Photo 3. Refer to Photo 2 comments.

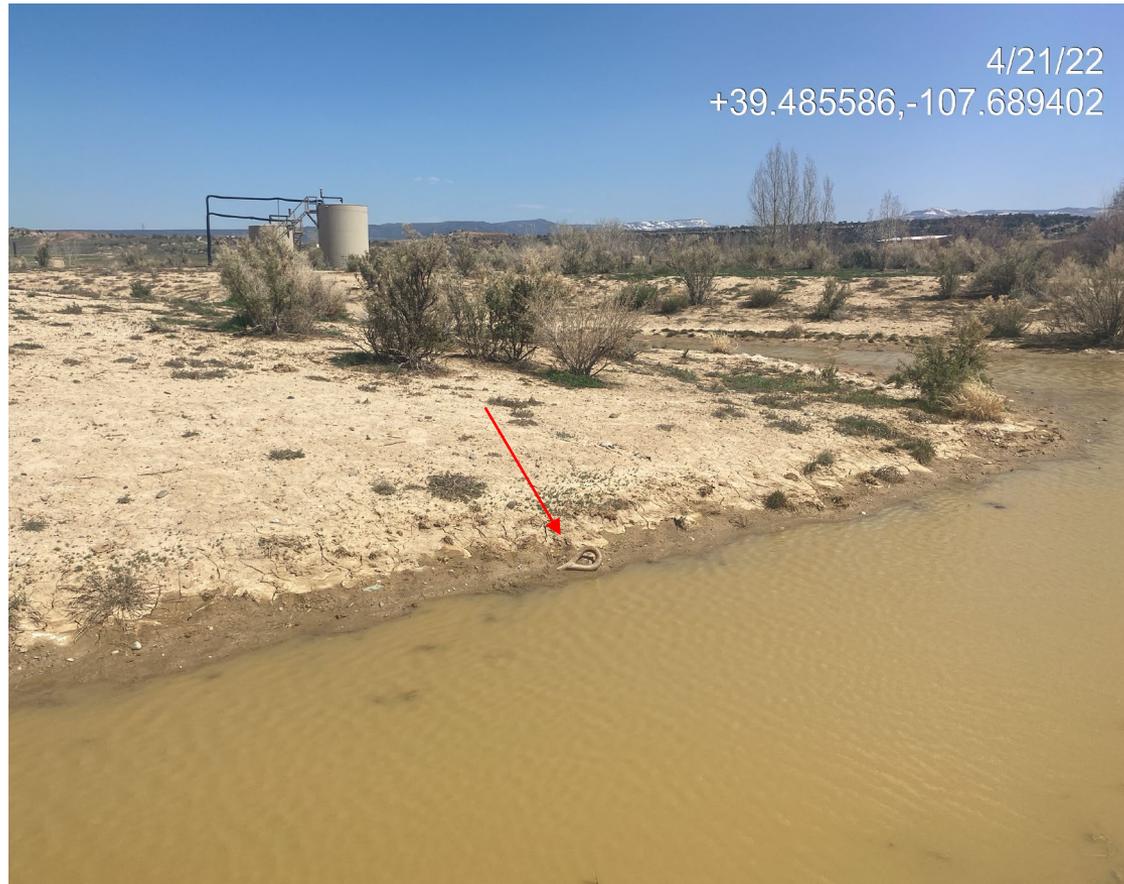
Photo 4. Photo taken from the southeast of the Location facing east shows an unmarked anchor. Photo also shows interim areas dominated by bare ground, undesirable plant species/weeds and shrubs which are not uniform in distribution. Note: GPS coordinates in the photo are slightly off due to phone GPS malfunction/inaccuracy. This photo was taken standing on the southeast of the working pad area.

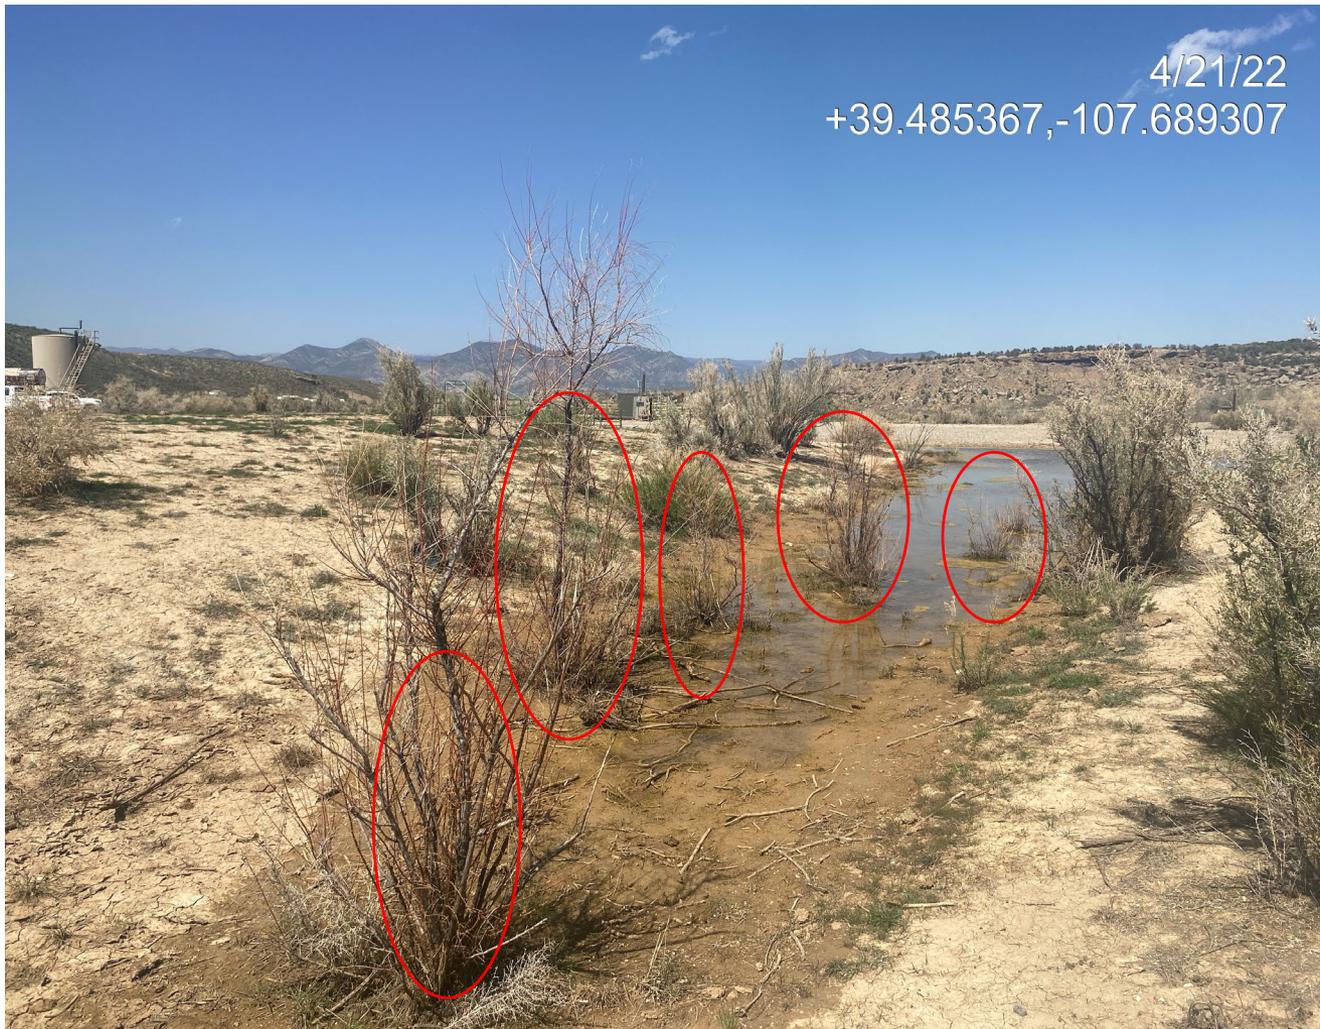
Photo 5. Photo taken from the ditch to the east of the Location shows the establishment of salt cedar, a CO list B Noxious Weed.

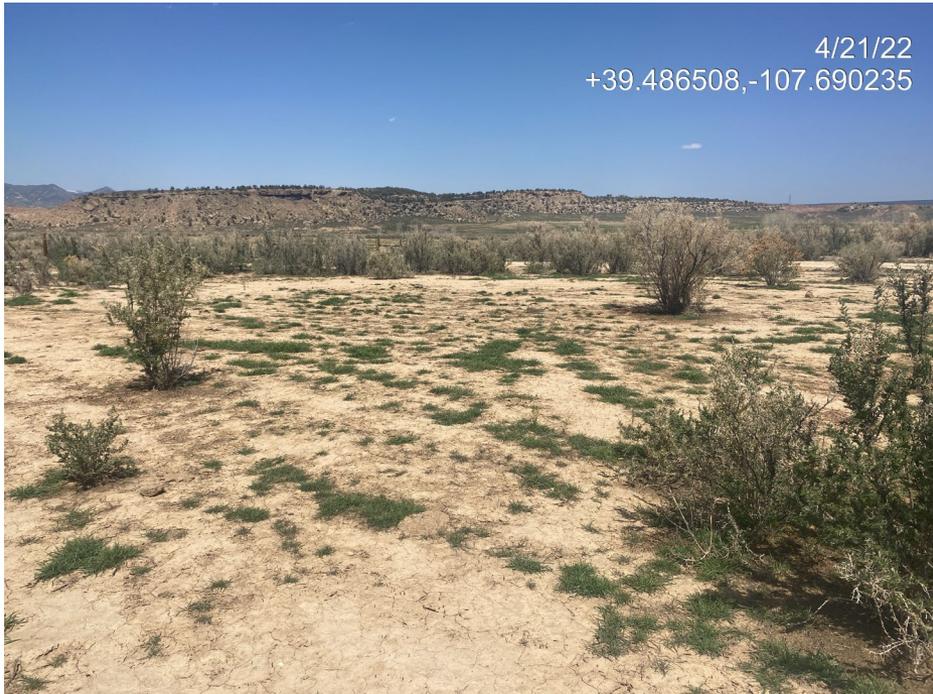
Photo 6. Photo taken from the northwest of the Location shows interim areas dominated by shrubs, bare ground and undesirable plant species/weeds. The grass in the photo is annual wheatgrass, an introduced weed.

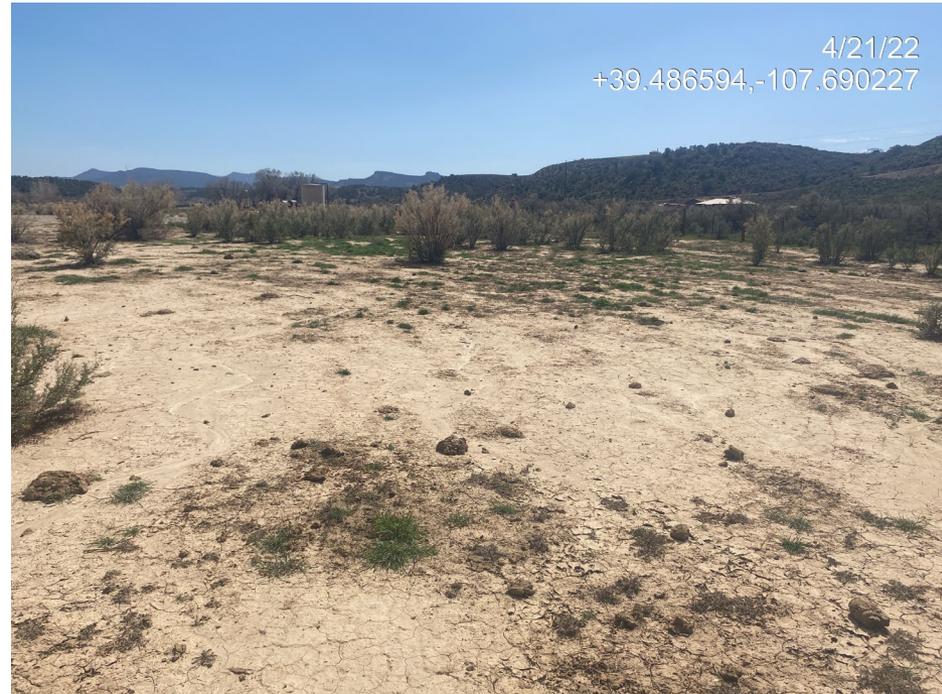
Photo 7. Refer to Photo 6 comment.

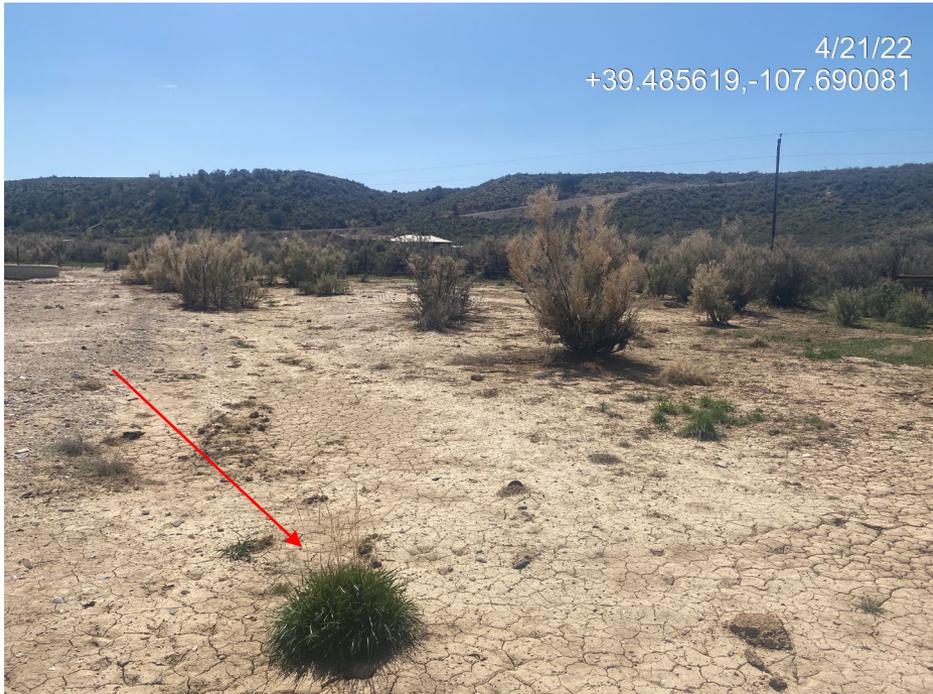
Photo 8. Photo taken from the southwest of the Location shows interim areas dominated by shrubs, bare ground and undesirable plant species/weeds. The grass in the foreground is intermediate wheatgrass, a commonly seeded species which is very rare in the interim areas.

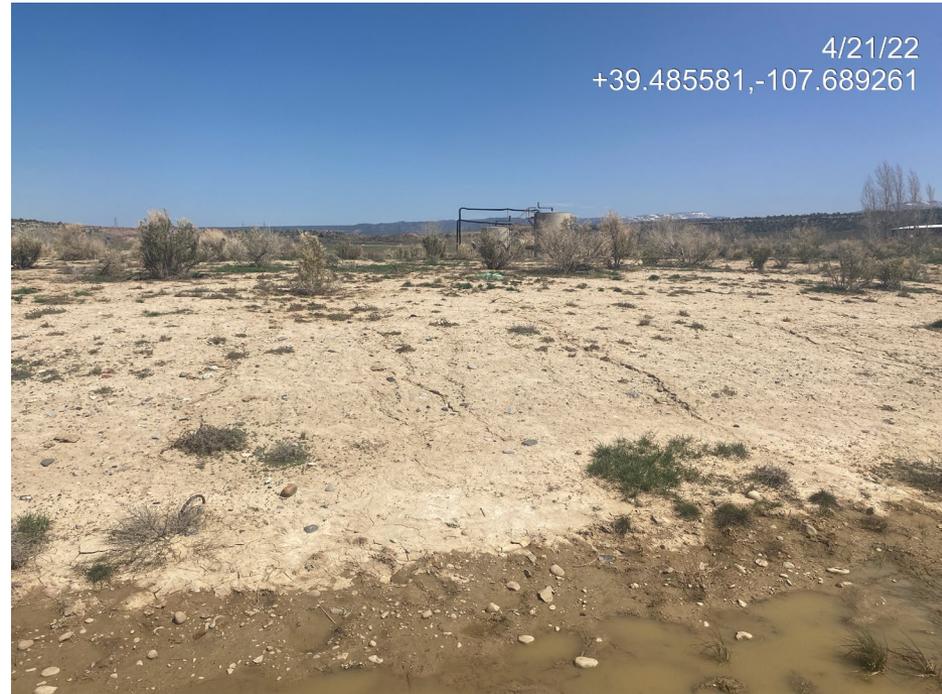
Photo 9. Photo taken from the southeast of the Location facing west shows rill erosion occurring in interim areas dominated by bare ground. Shrubs present do not appear sufficient to stabilize soils. Note: GPS coordinates in the photo are slightly off due to phone GPS malfunction/inaccuracy. This photo was taken standing on the southeast of the working pad area.

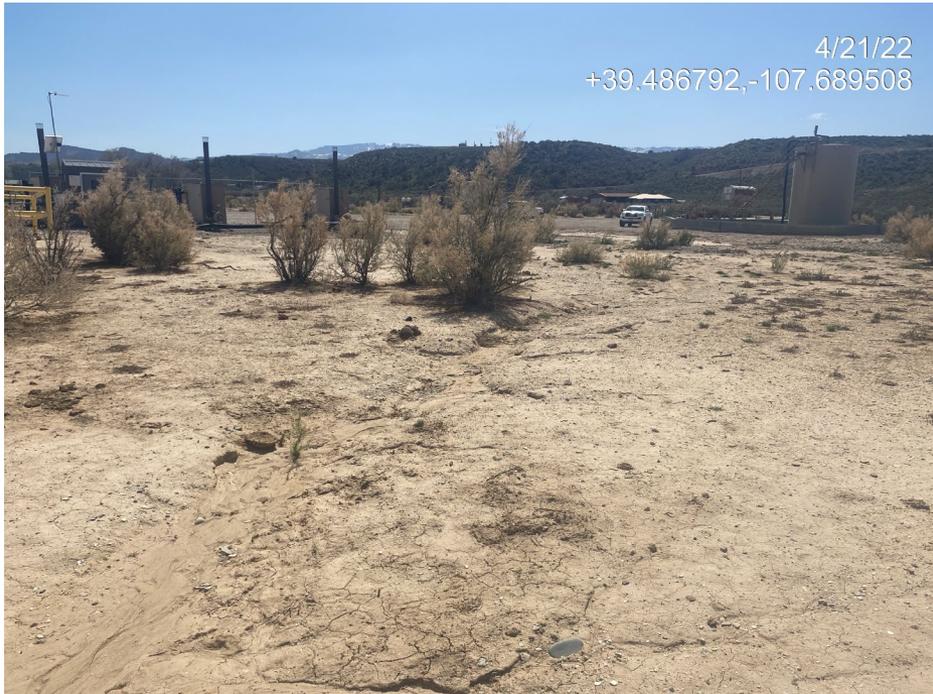
Photo 10. Photo taken from the north of the Location facing south shows erosion occurring in interim areas dominated by bare ground. Shrubs present do not appear sufficient to stabilize soils.

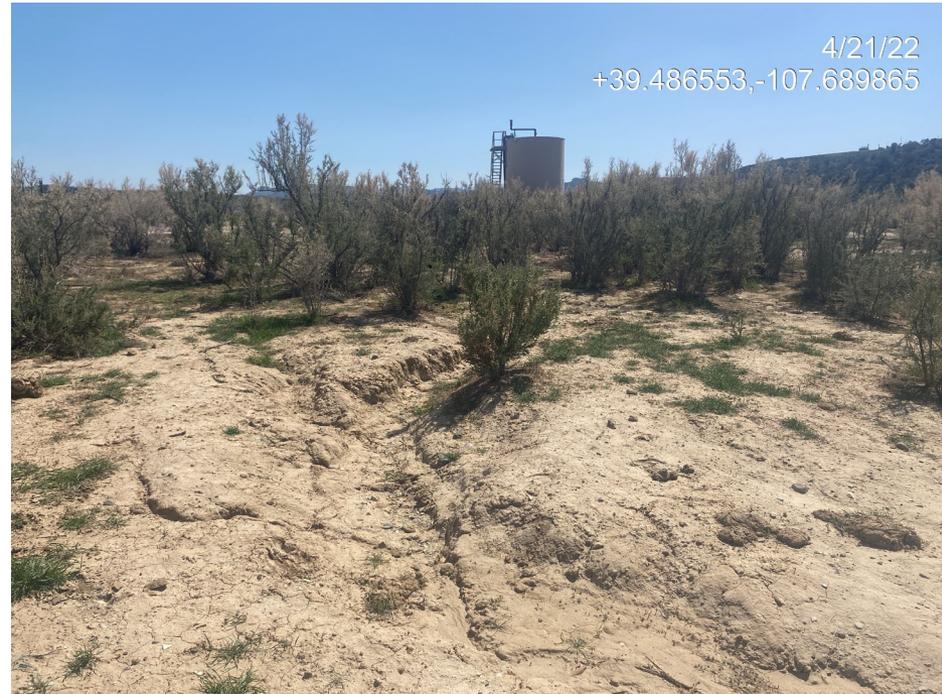
Photo 11. Refer to Photo 10 comment. The grass in the photo is annual wheatgrass, an introduced weed.

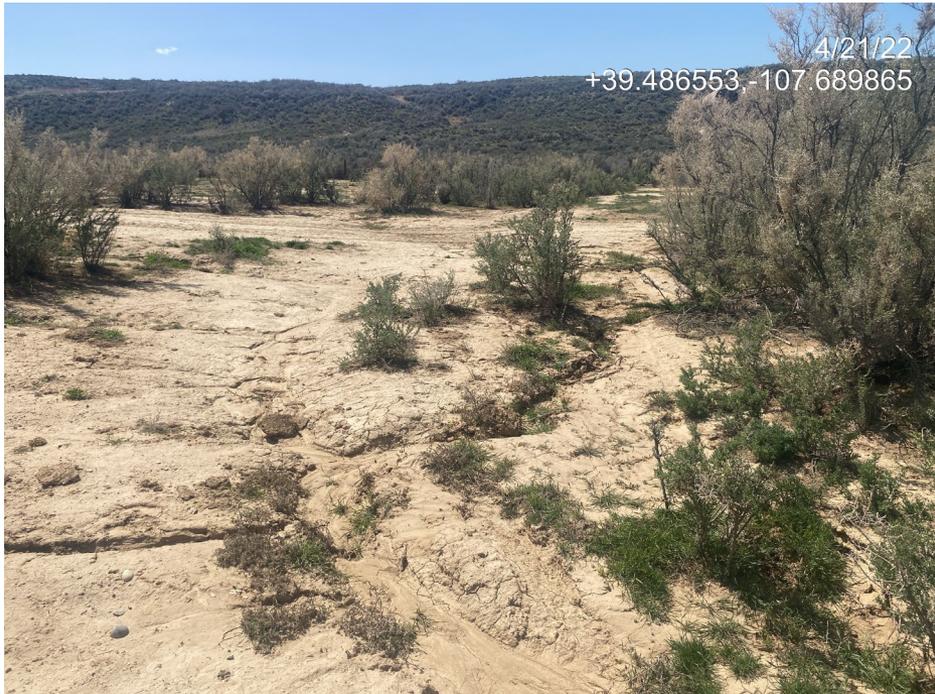
Photo 12. Photo taken from the north of the Location facing east shows erosion occurring in interim areas dominated by bare ground. Shrubs present do not appear sufficient to stabilize soils. The grass in the photo is annual wheatgrass, an introduced weed.

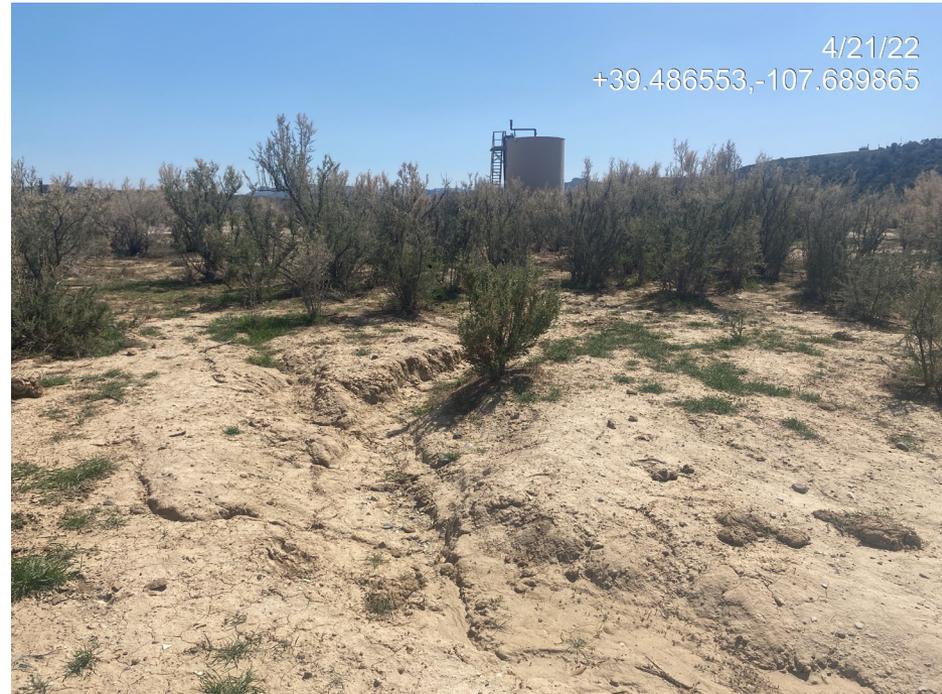
Photo 13. Refer to Photo 12 comment.
