Inspection Photos

API: 061-06433

Operator: STRACHAN EXPLORATION

Inspection Date: 4/25/2022

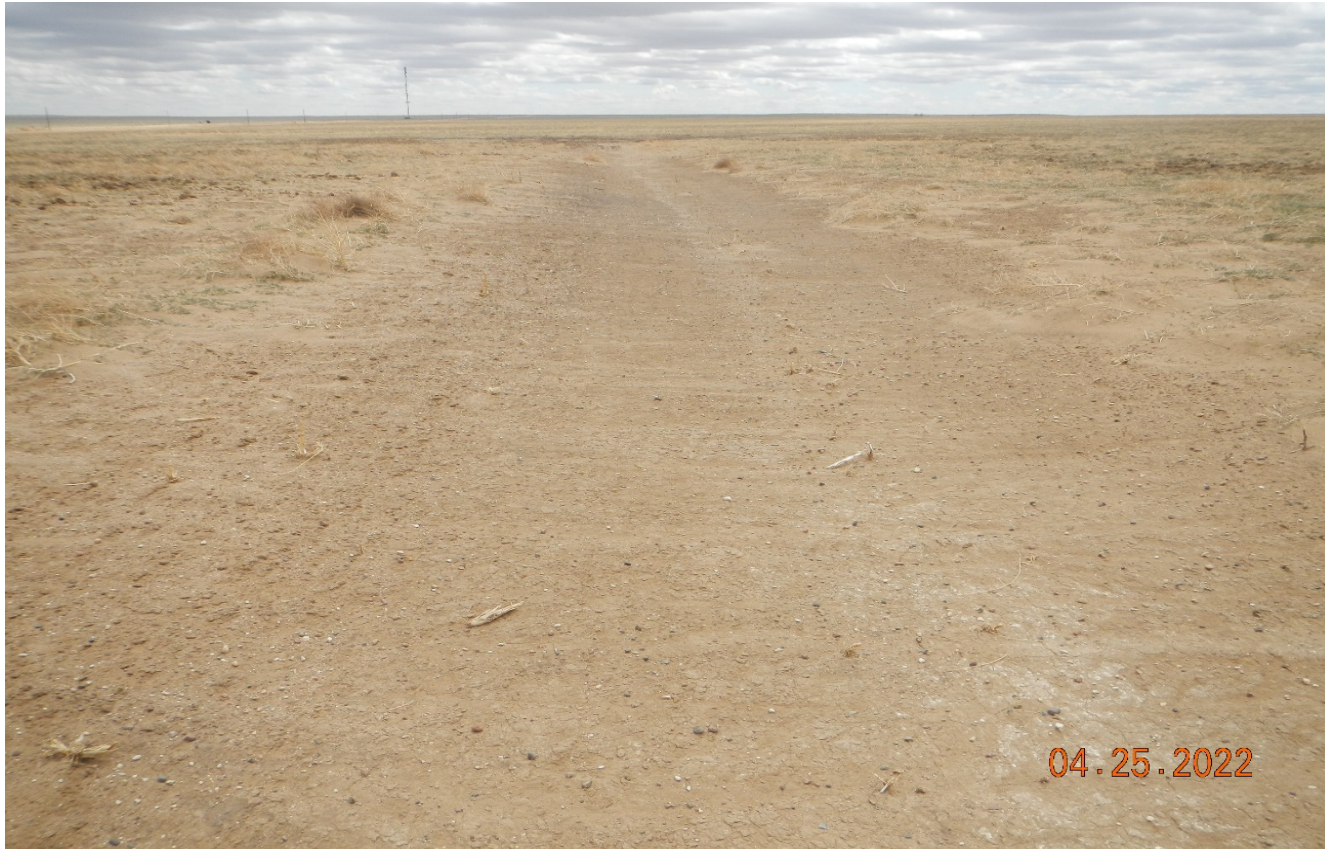
Photo 1. Facing south along the former access road. The road has not been recontoured and soils remain compacted.

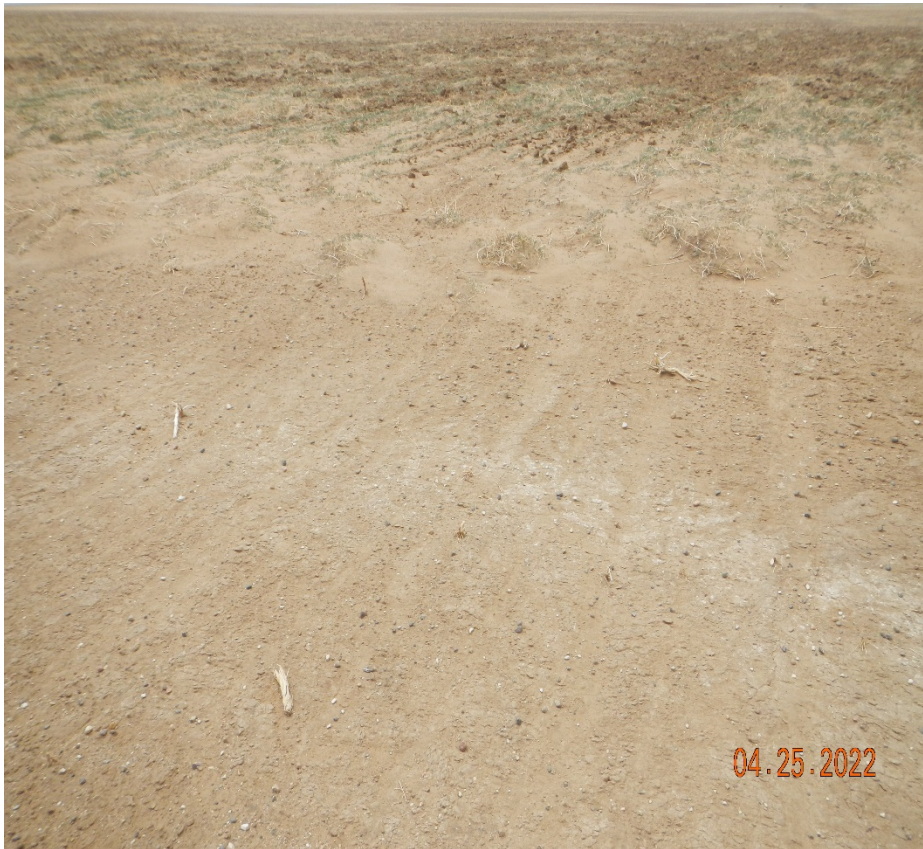
Photo 2. The ag equipment scrap over the compacted soils on the access road. Soils must be decompacted by cross ripping to at least 18 inches.

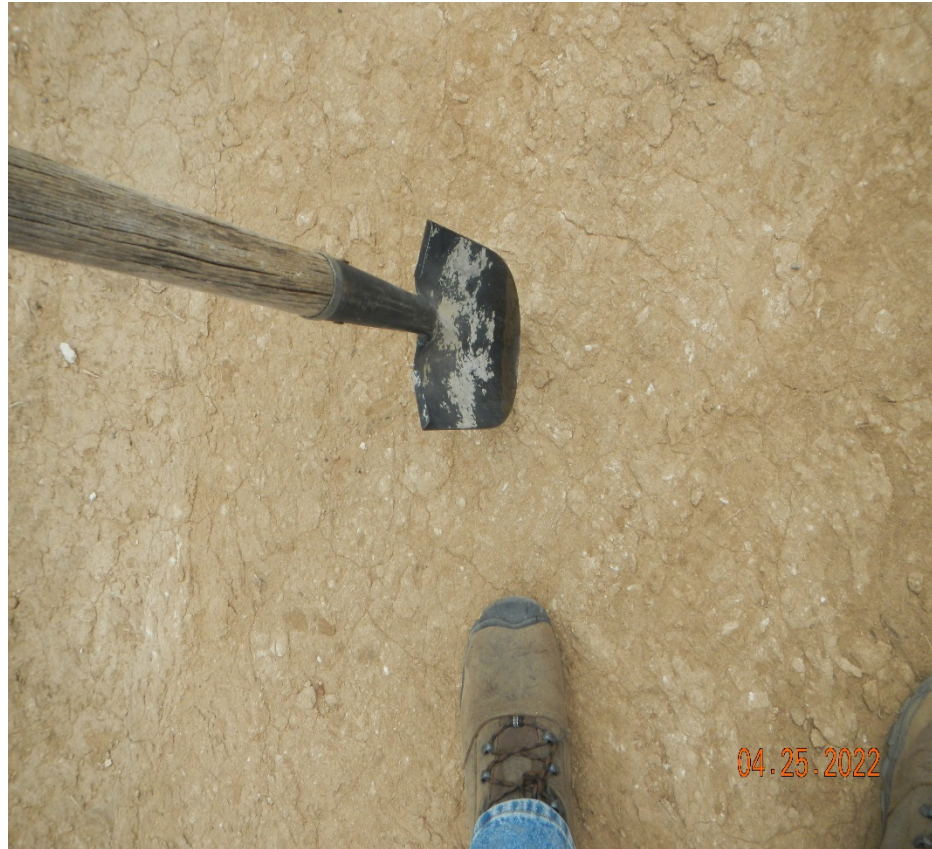
Photo 3. The shovel could not penetrate the soils along the access road. Soils must be decompacted by cross ripping to at least 18 inches.

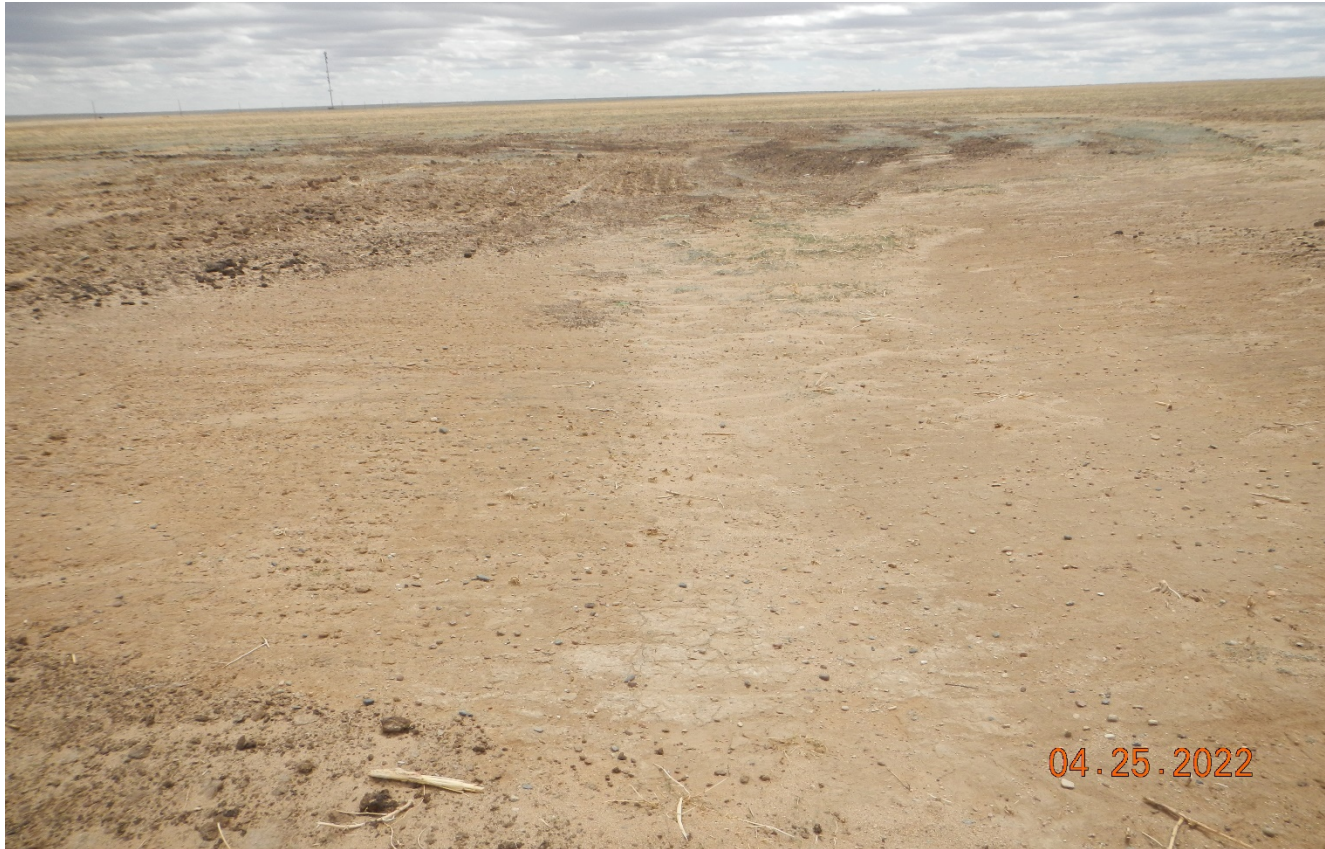
Photo 4. Facing south toward the abandoned well site located in cropland. There were some areas where soils were ripped and other area that were not.

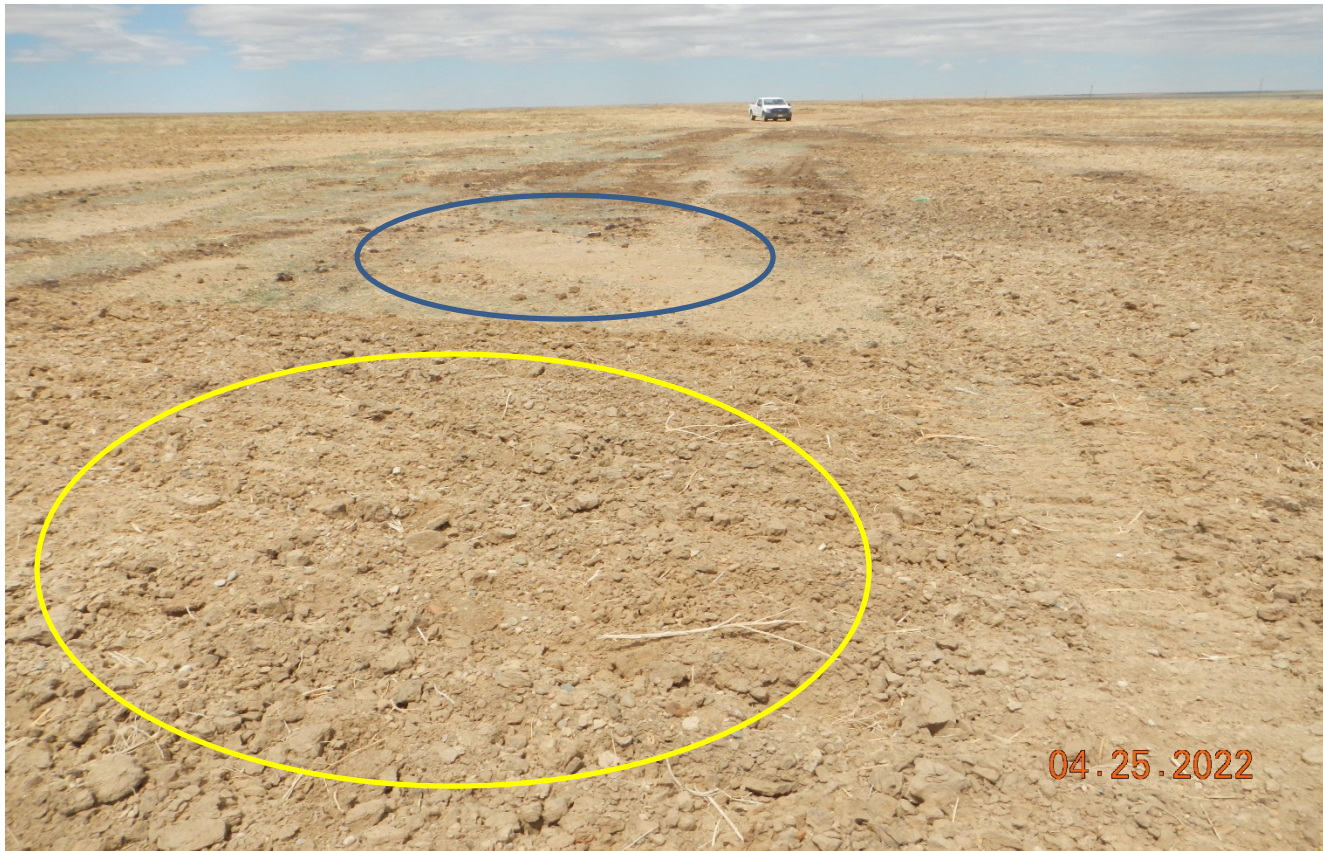
Photo 5. Facing north at the location. Soils were ripped in one direction at some areas (yellow circle) however, other areas remain compacted (blue circle).

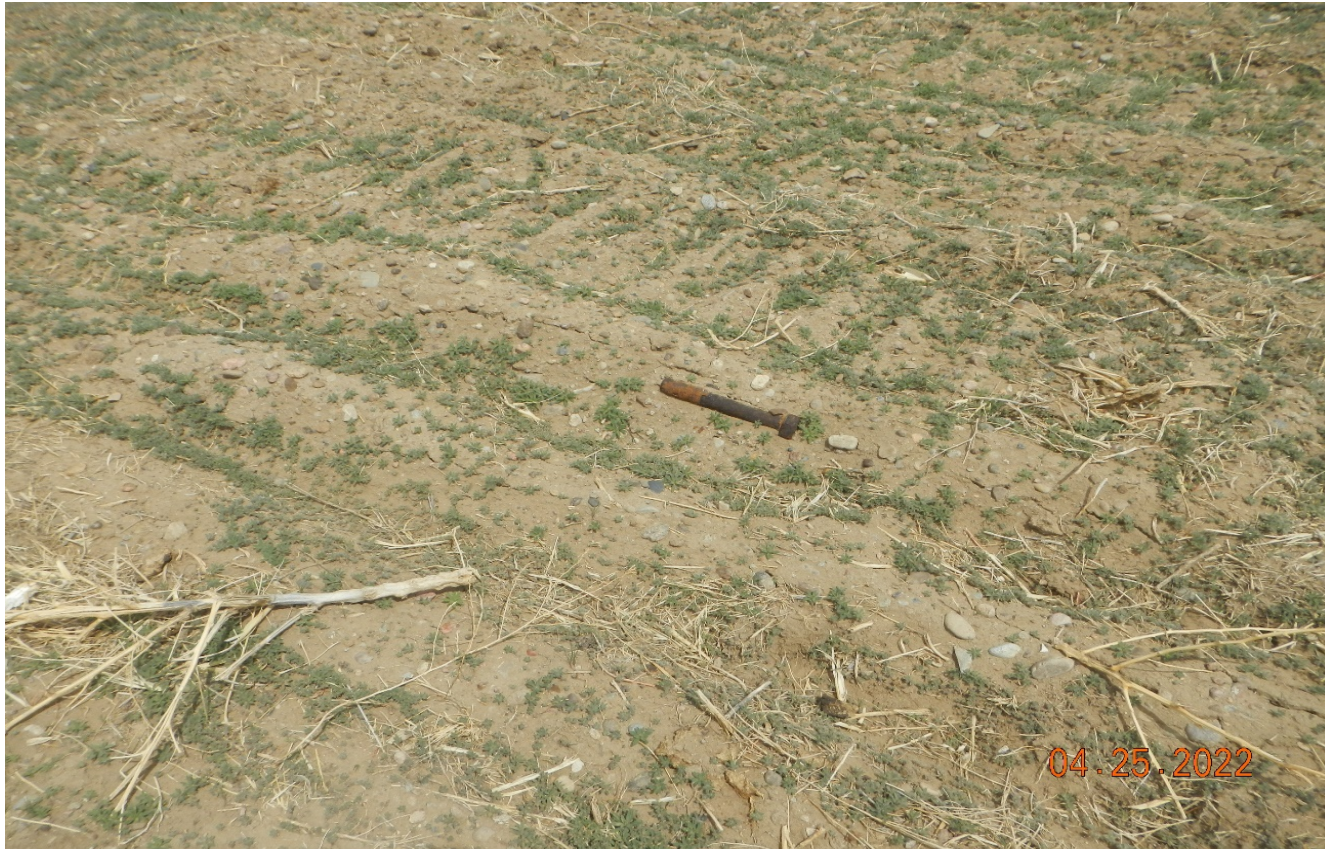
Photo 6. There are undesirable weeds sprouting up at the location. All undesirable weeds need to be controlled.

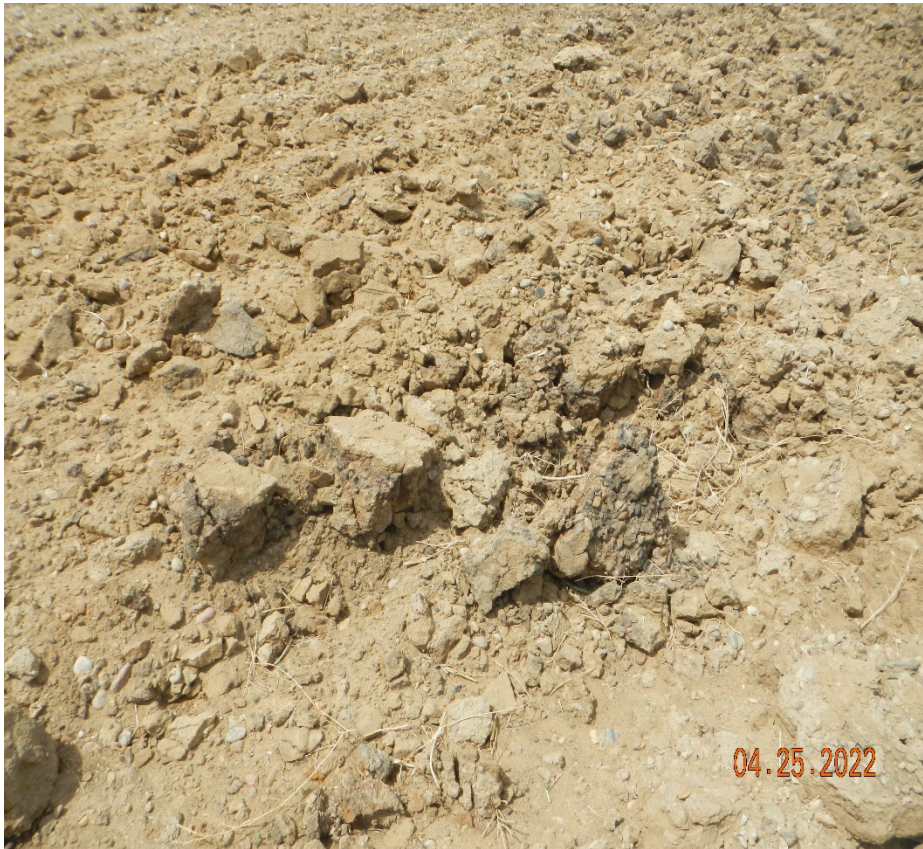
Photo 7. There are chunks of soil that have not been adequately tilled to establish a proper seed bed.

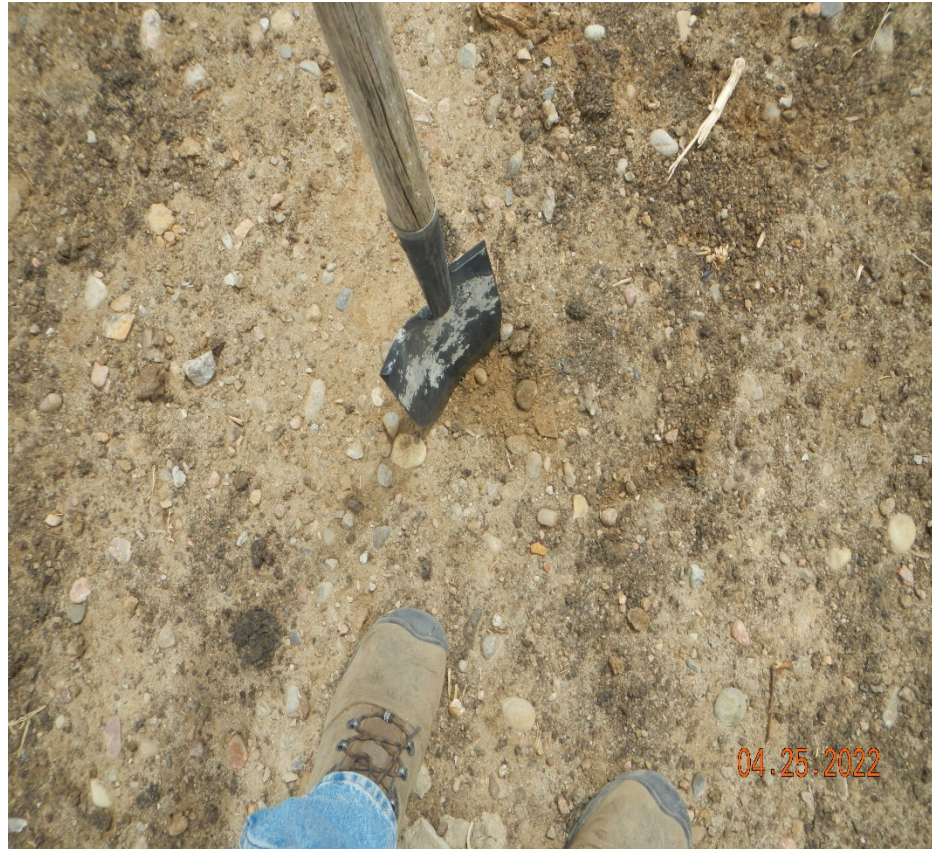
Photo 8. The shovel could not penetrate some areas of soil at the location. Soils must be decompacted by cross ripping to at least 18 inches.
