Inspection Photos

4/22/2022

Operator: CAERUS PICEANCE LLC # 10456

Location ID: 335822

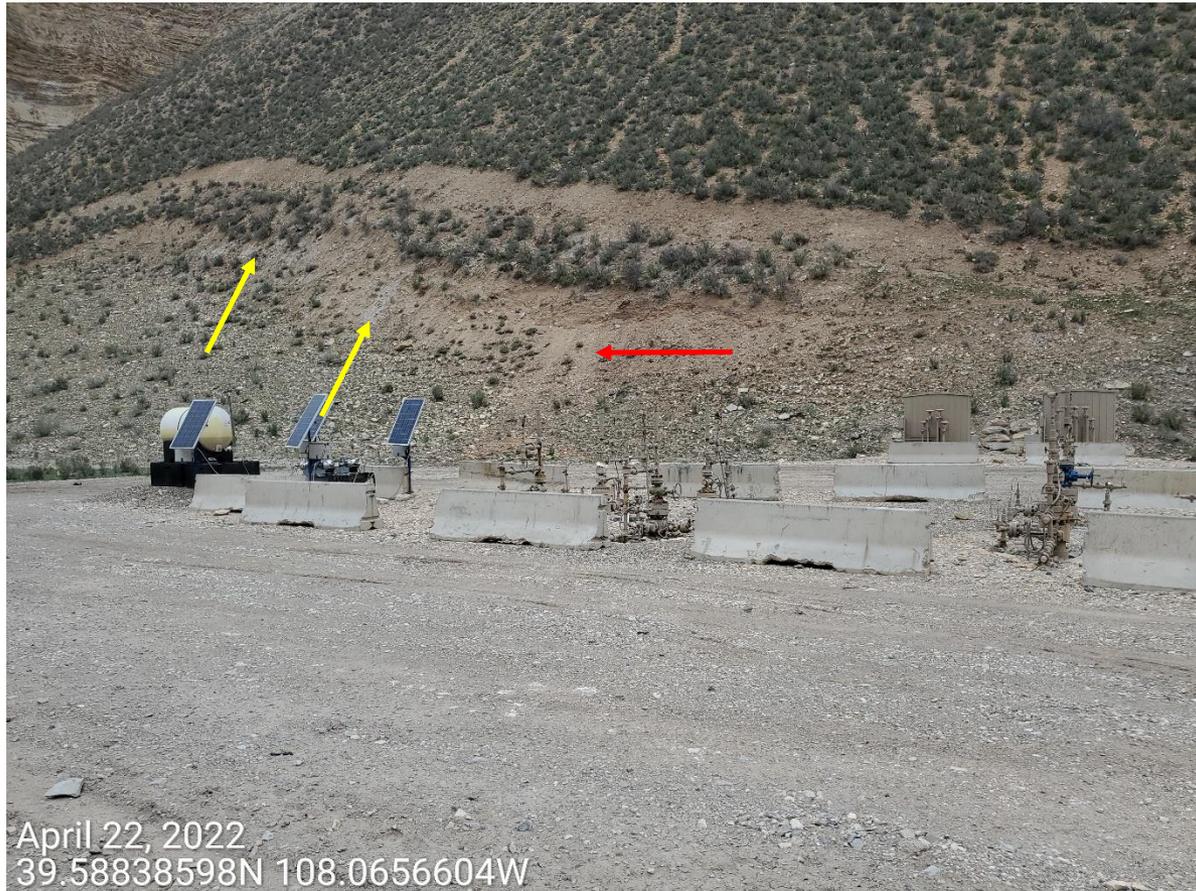
Photo 1: Photo taken from the location, facing north. Photo provides overview of the northern interim areas of the Location and the perimeter stormwater ditch. Operator appears to have implemented hydromulch (yellow arrow) at slopes, however BMP has not been maintained in a proper functioning condition to minimize erosion, degradation, and to stabilize the slopes; erosion and degradation to the slopes have persisted (red arrow example).

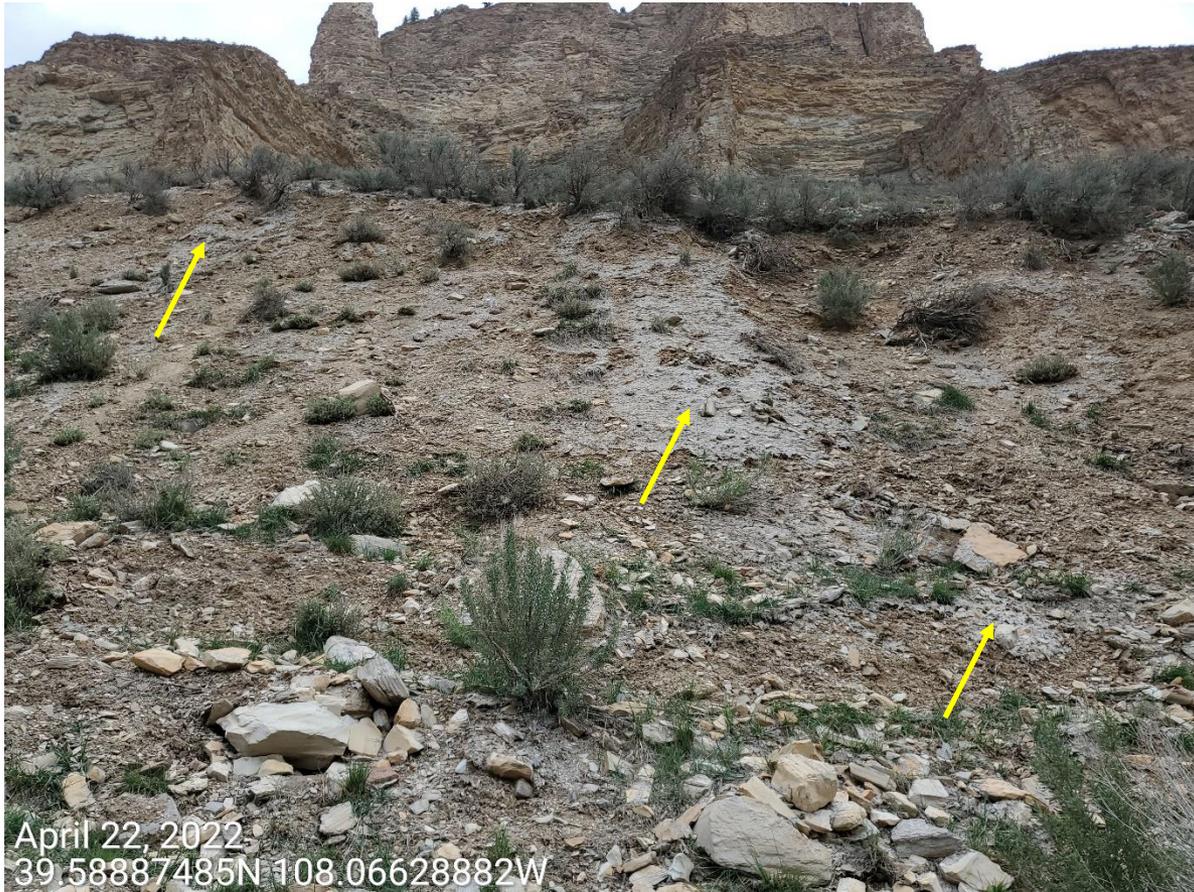
Photo 2: Photo taken from the northern interim areas of the Location. Photo example showing hydromulch (yellow arrow) that appears to have been implemented by Operator; BMP has not been maintained in a proper functioning condition to minimize erosion, degradation, and to stabilize the slopes; erosion, degradation and stabilization issues have persisted.

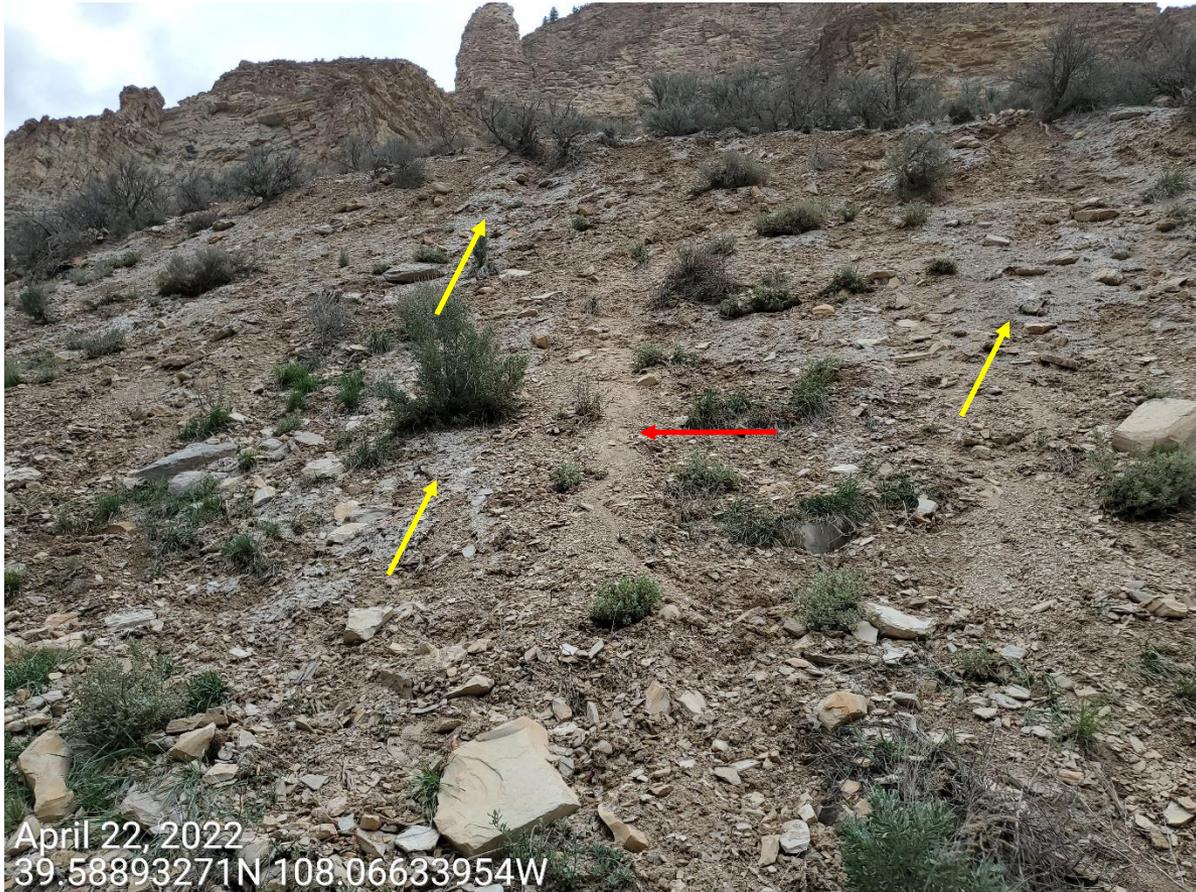
Photo 3: Photo taken from the northern interim areas of the Location. Photo example showing hydromulch (yellow arrow) that appears to have been implemented by Operator; BMP has not been maintained in a proper functioning condition to minimize erosion, degradation, and to stabilize the slopes; erosion, degradation and stabilization issues have persisted (red arrow).

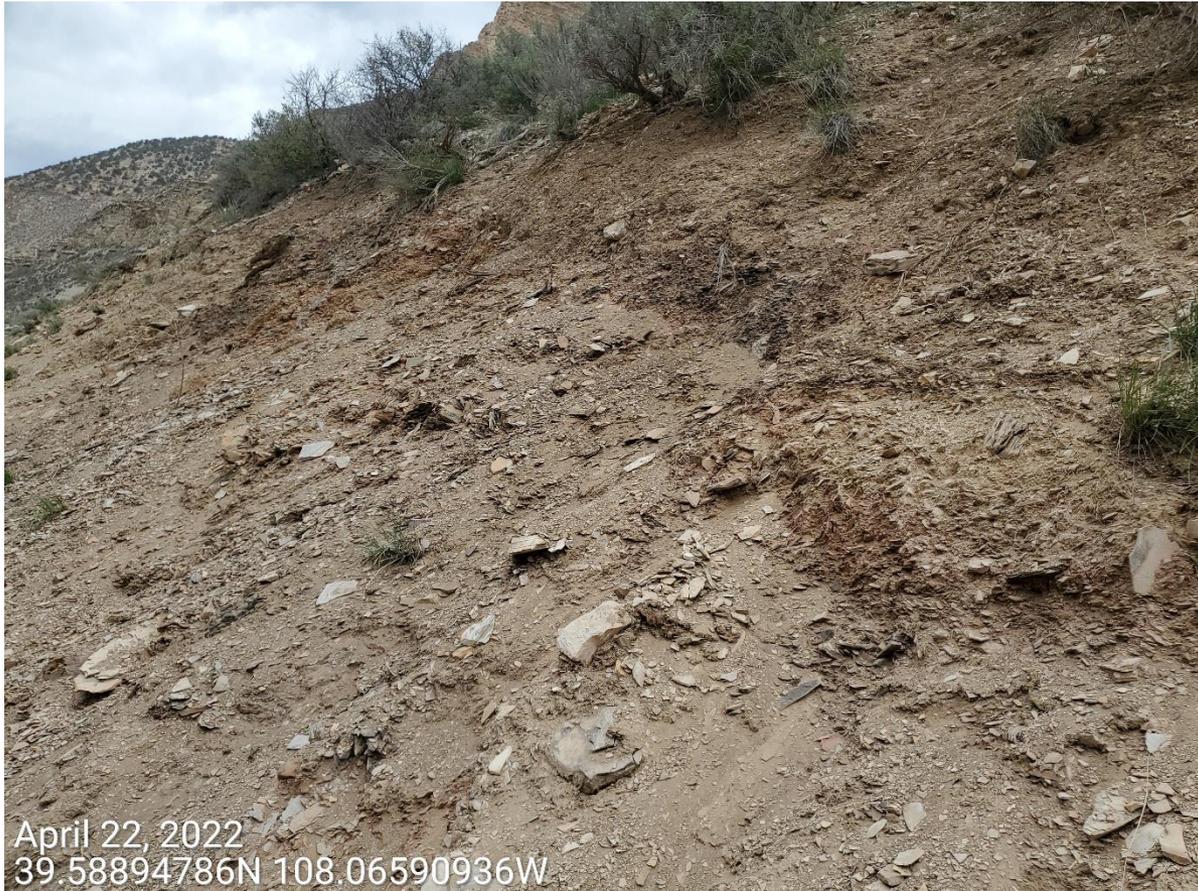
Photo 4: Photo taken from the northern interim areas of the Location. Photo example showing BMPs along slopes have not been maintained in a proper functioning condition to minimize erosion, degradation, and to stabilize the slopes; erosion, degradation and stabilization issues have persisted.

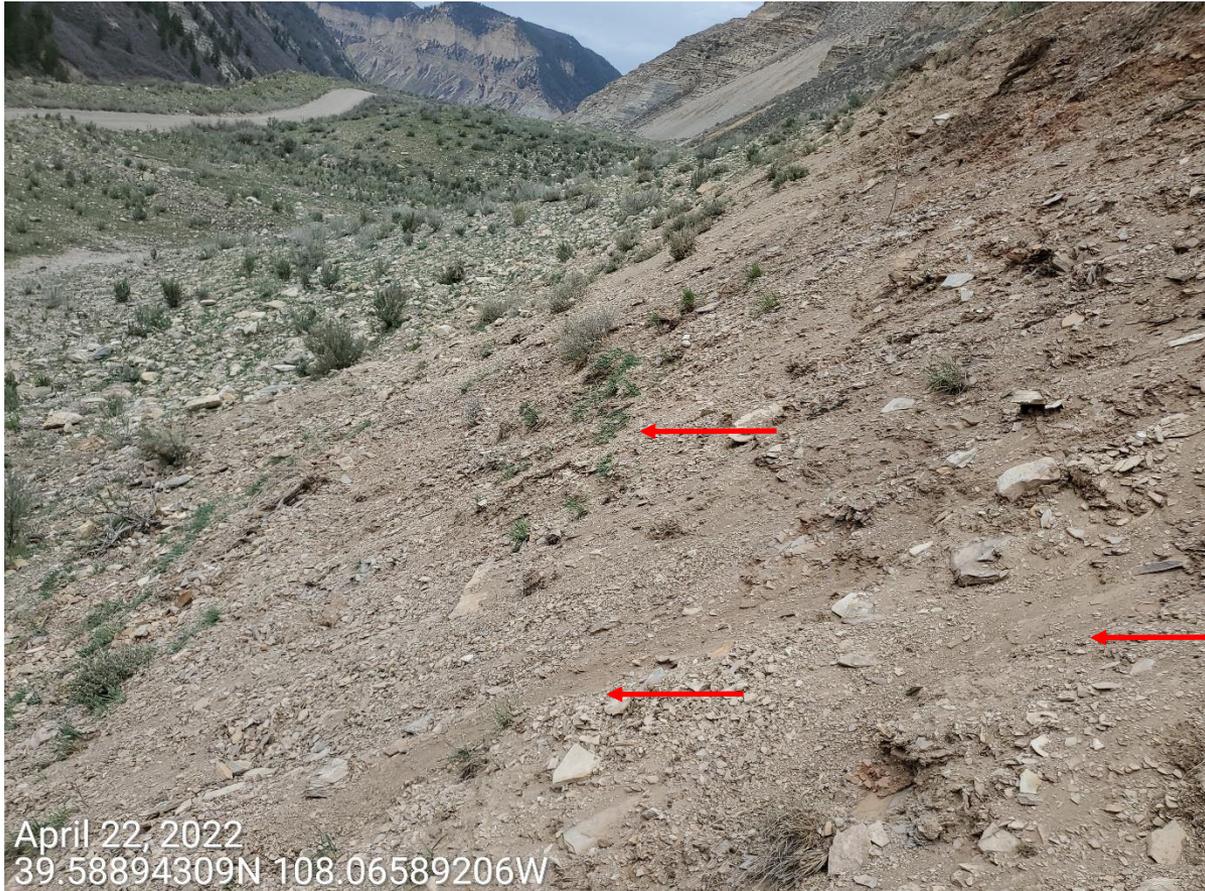
Photo 5: Photo taken from the northern interim areas of the Location. Photo example showing BMPs along slopes have not been maintained in a proper functioning condition to minimize erosion, degradation, and to stabilize the slopes; erosion, degradation and stabilization issues have persisted.

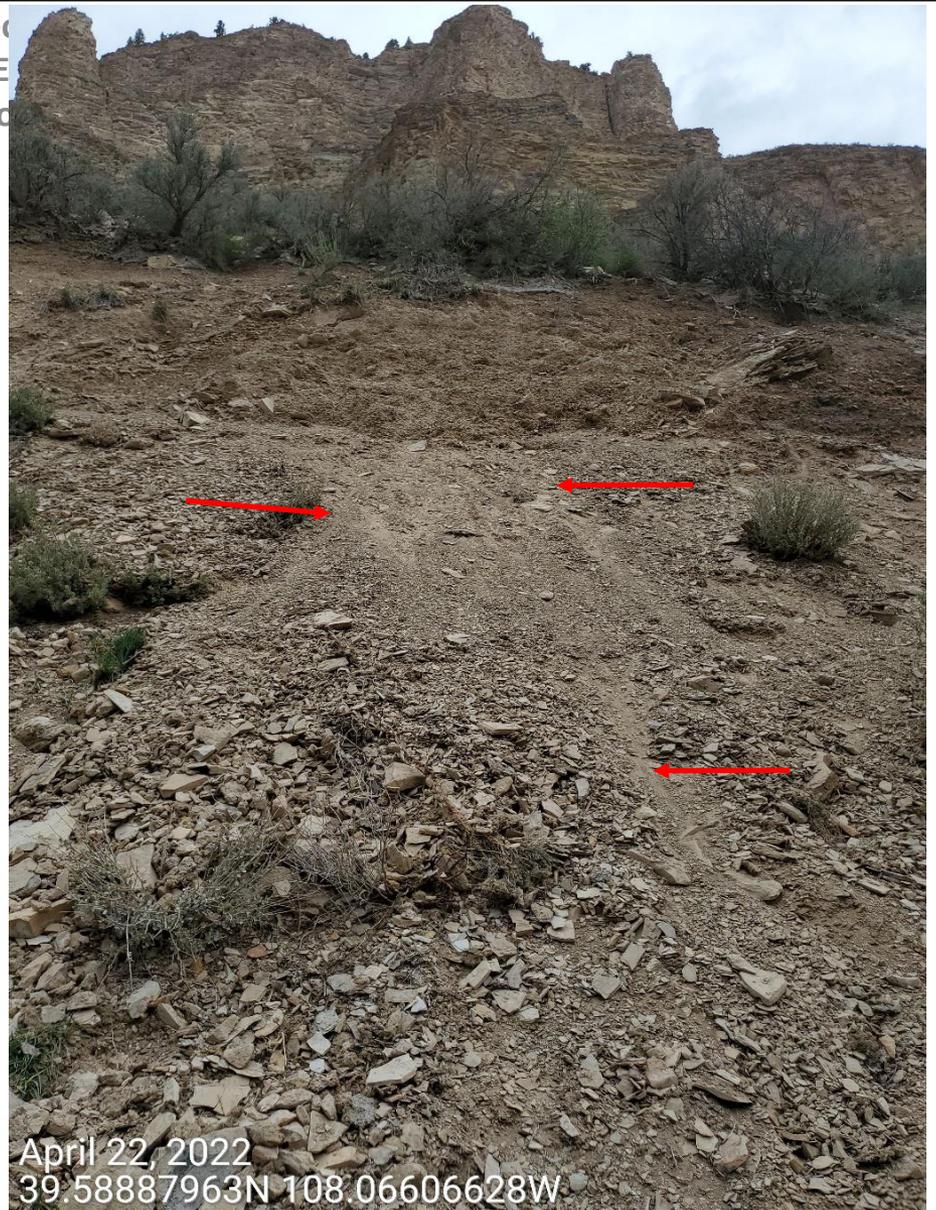
Photo 6: Photo taken from the northern interim areas of the Location. Photo example showing BMPs along slopes have not been maintained in a proper functioning condition to minimize erosion, degradation, and to stabilize the slopes; erosion, degradation and stabilization issues have persisted.

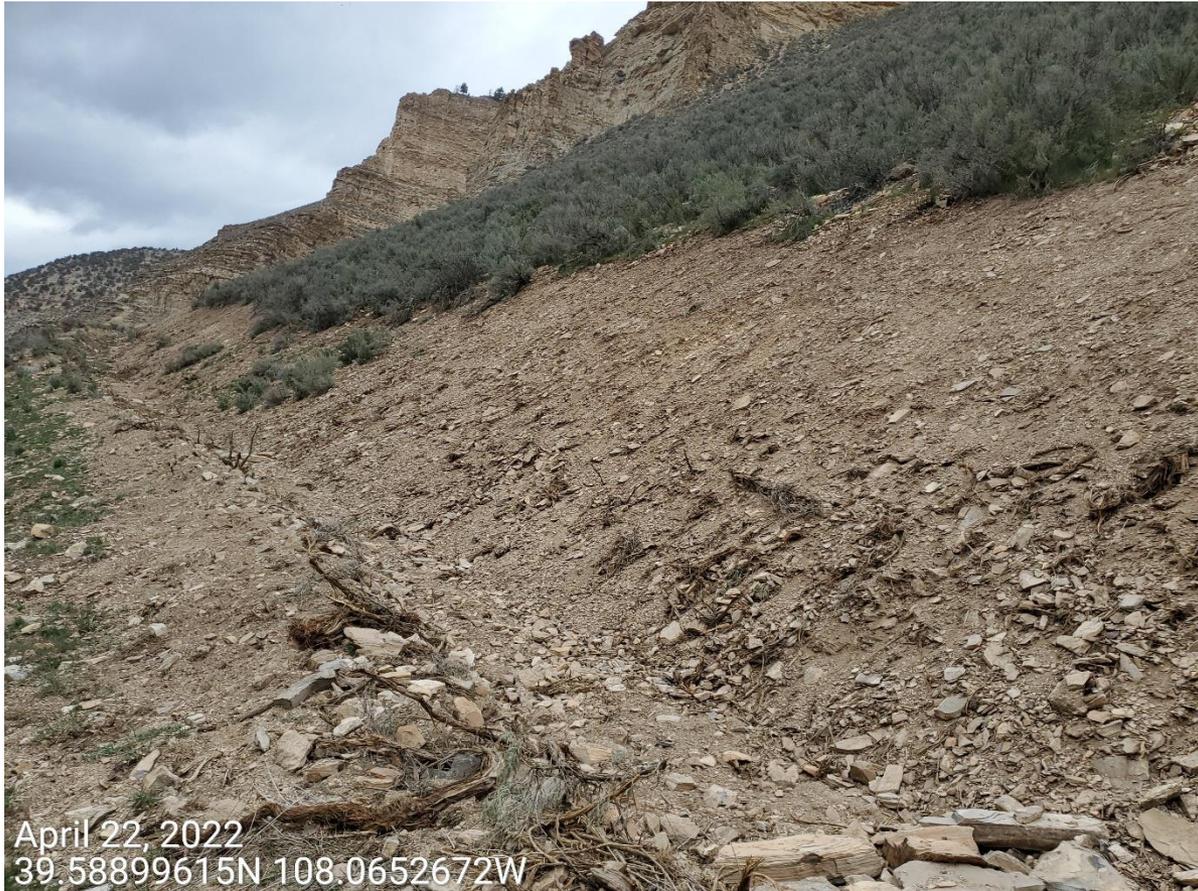
Photo 7: Photo taken from the stormwater diversion ditch along the north end of the Location. Photo shows Operator appears to have regraded to match the adjacent upslope areas. Photo shows that control measures to minimize erosion, degradation, and to stabilize the slopes of the ditch are missing or insufficient.

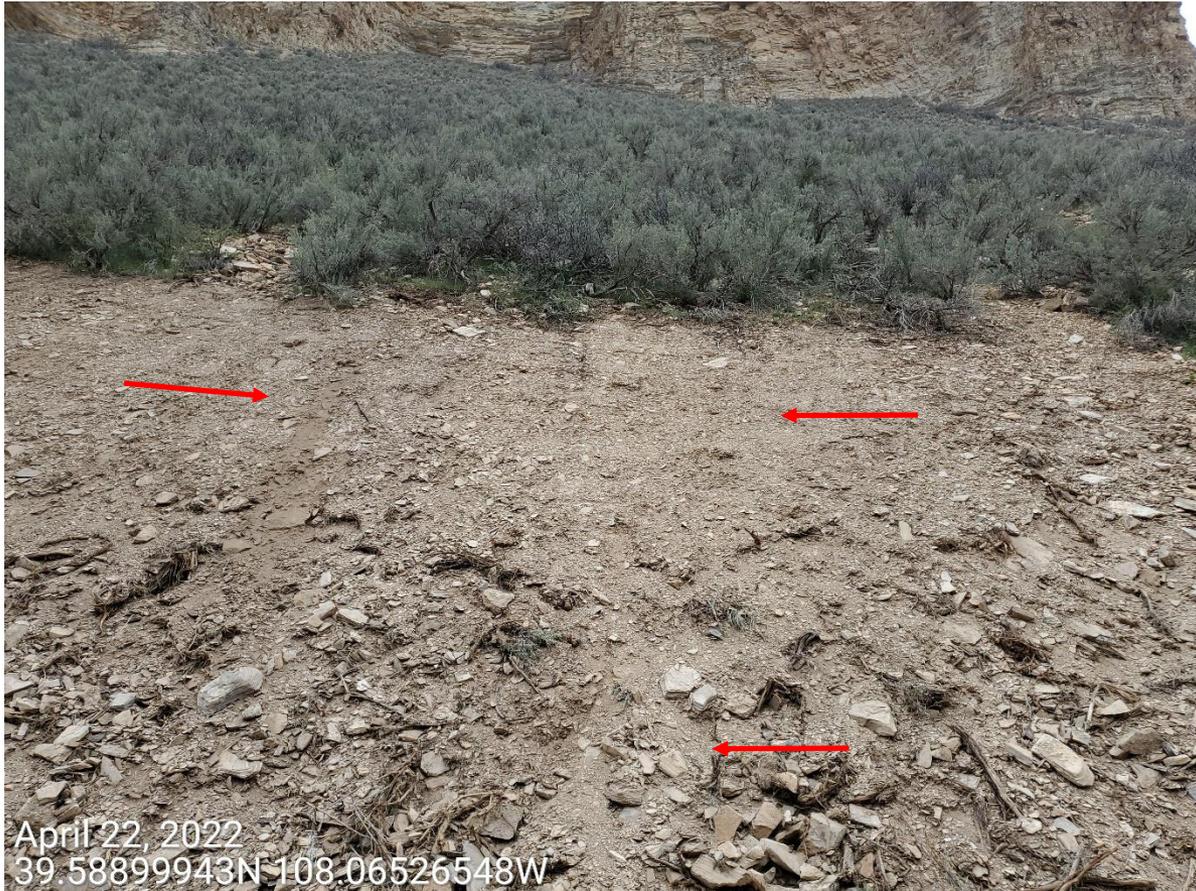
Photo 8: Photo taken from the stormwater diversion ditch along the north end of the Location. Photo example showing BMPs along slopes are missing or insufficient to minimize erosion, degradation, and to stabilize the slopes of the ditch; erosion, degradation and stabilization issues have persisted.

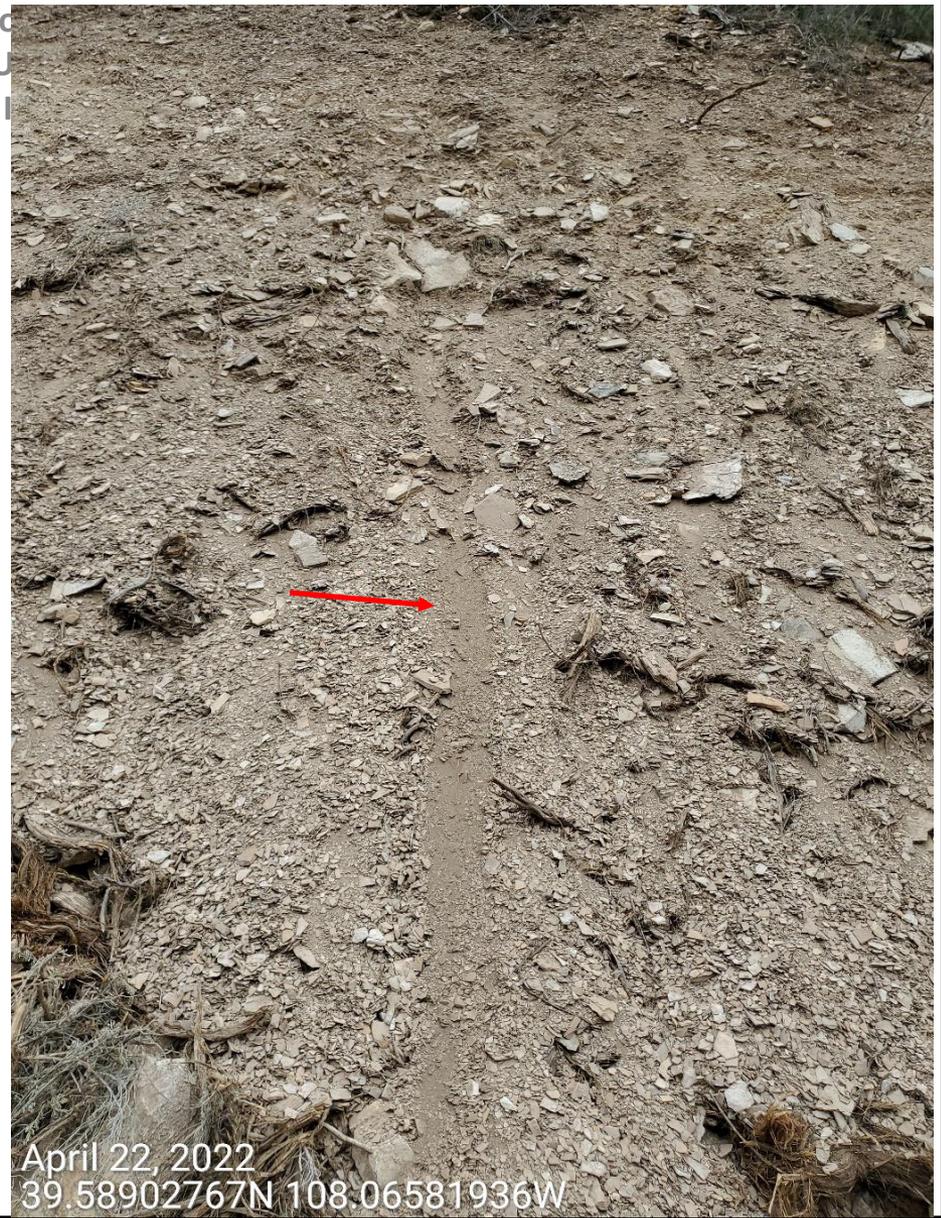
Photo 9: Photo taken from the stormwater diversion ditch along the north end of the Location. Photo example showing BMPs along slopes are missing or insufficient to minimize erosion, degradation, and to stabilize the slopes of the ditch; erosion, degradation and stabilization issues have persisted.
