Inspection Photos  
Operator: Simcoe  
API: 067-06921  
Date: 4/26/2022

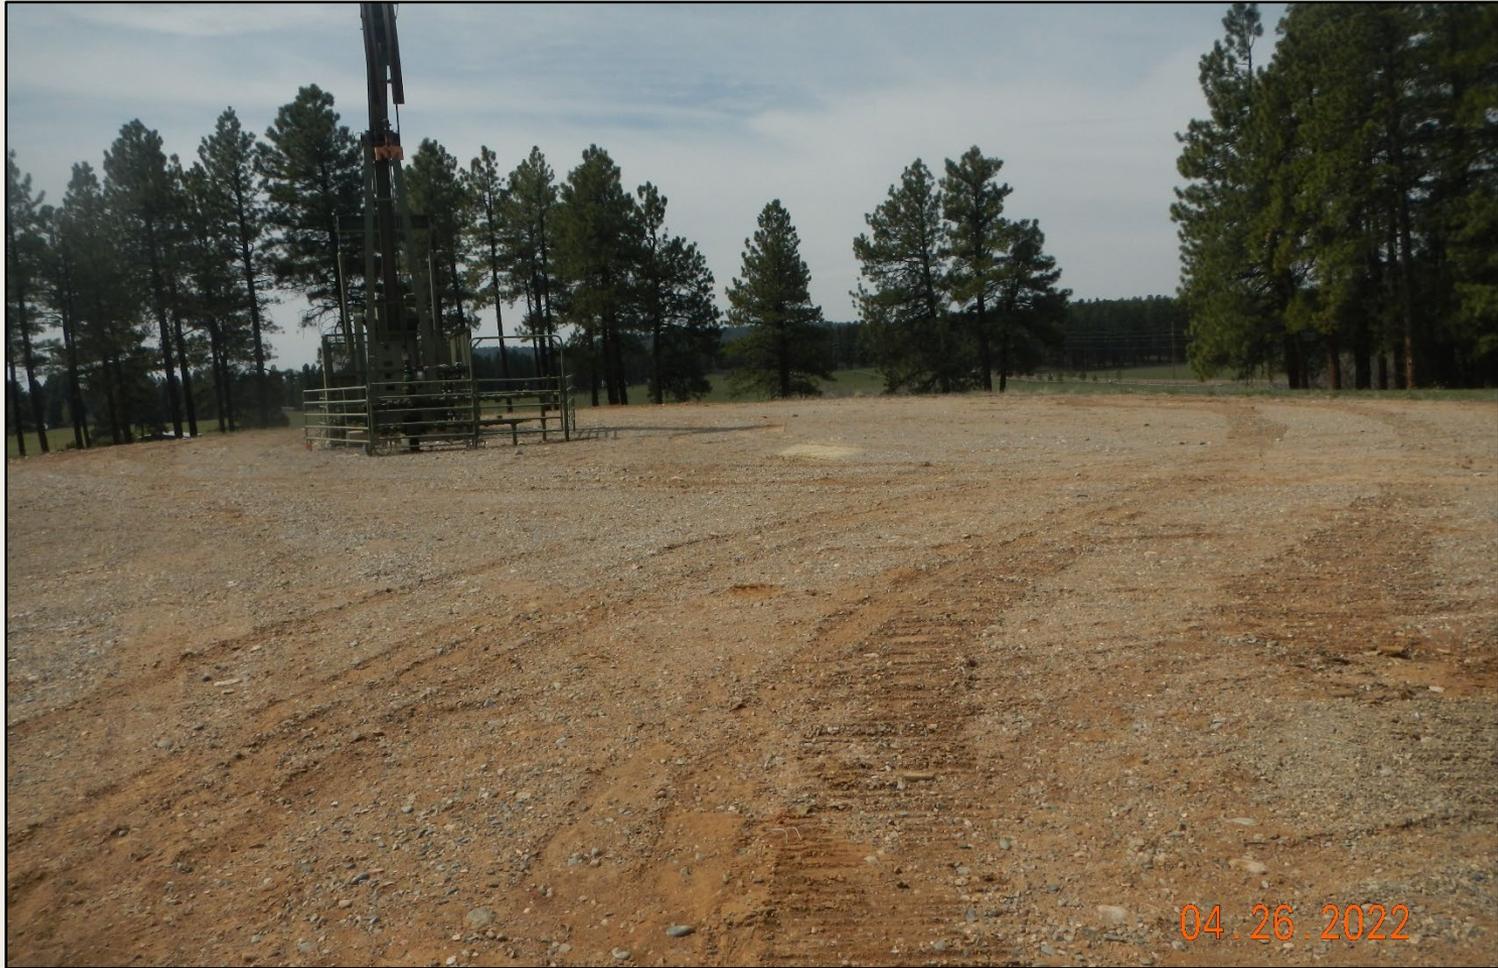
Photo 1. View of the project area from the well pad entrance facing center.

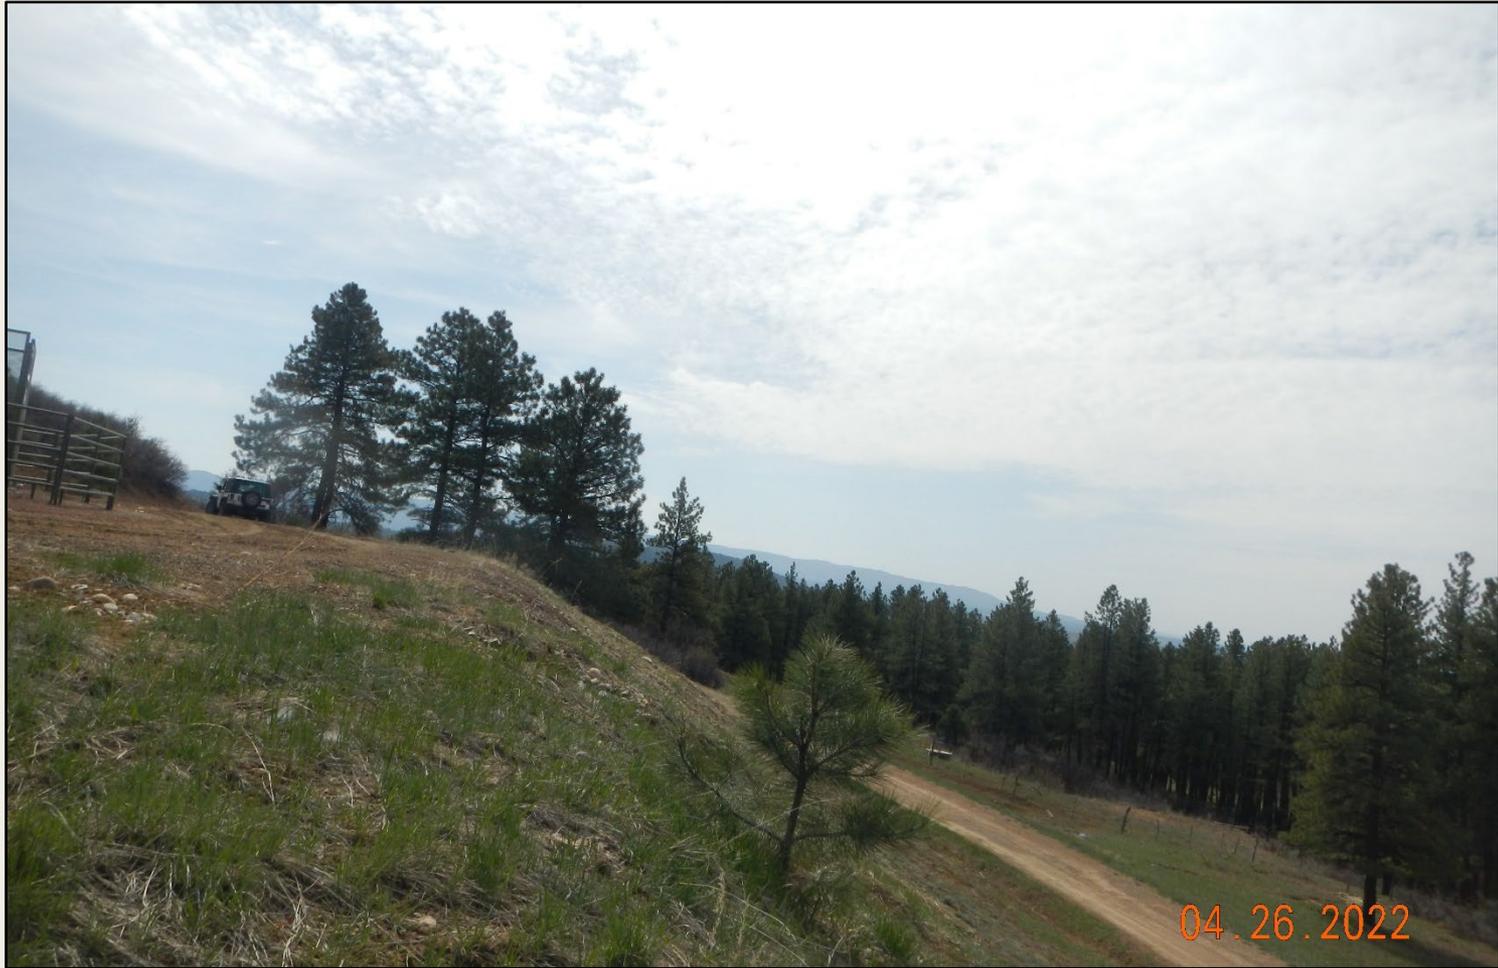
Photo 2. View of the southwestern project area from the northwestern corner facing southeastward. Revegetation is progressing with smooth brome (*Bromus inermis*), western wheatgrass (*Pascopyrum smithii*), and sand dropseed (*Sporobolus cryptandrus*).

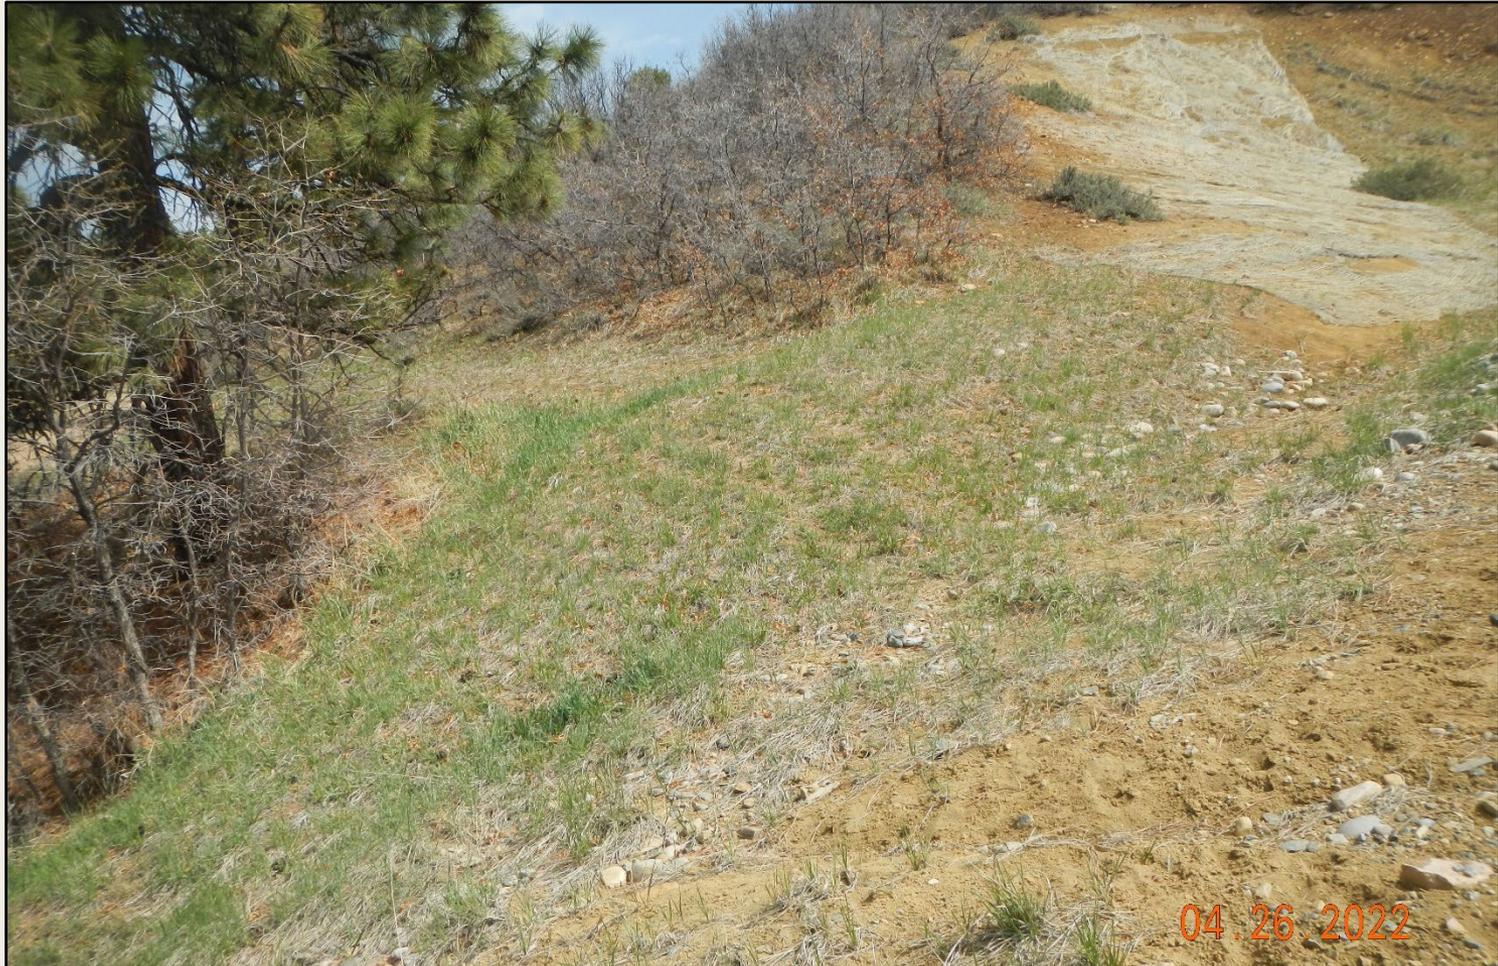
Photo 3. View of the northwestern project area facing eastward. Straw blanket needs maintenance.
