Inspection Photos  
Operator: Simcoe  
API: 067-07060  
Date: 4/26/2022

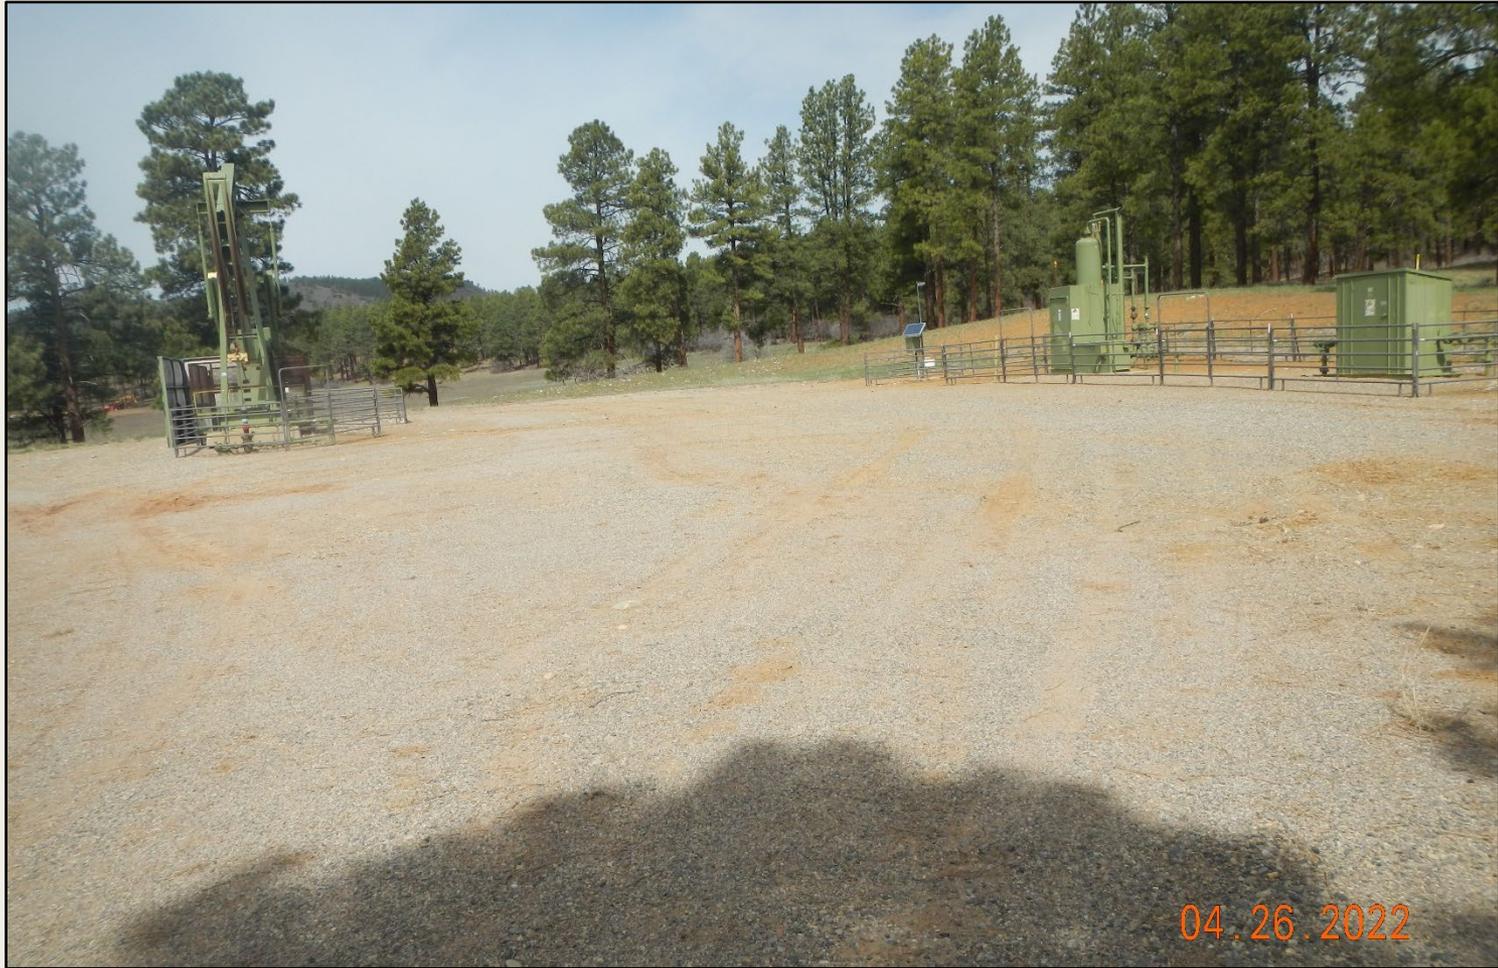
Photo 1. View of the project area from the well pad entrance facing center.

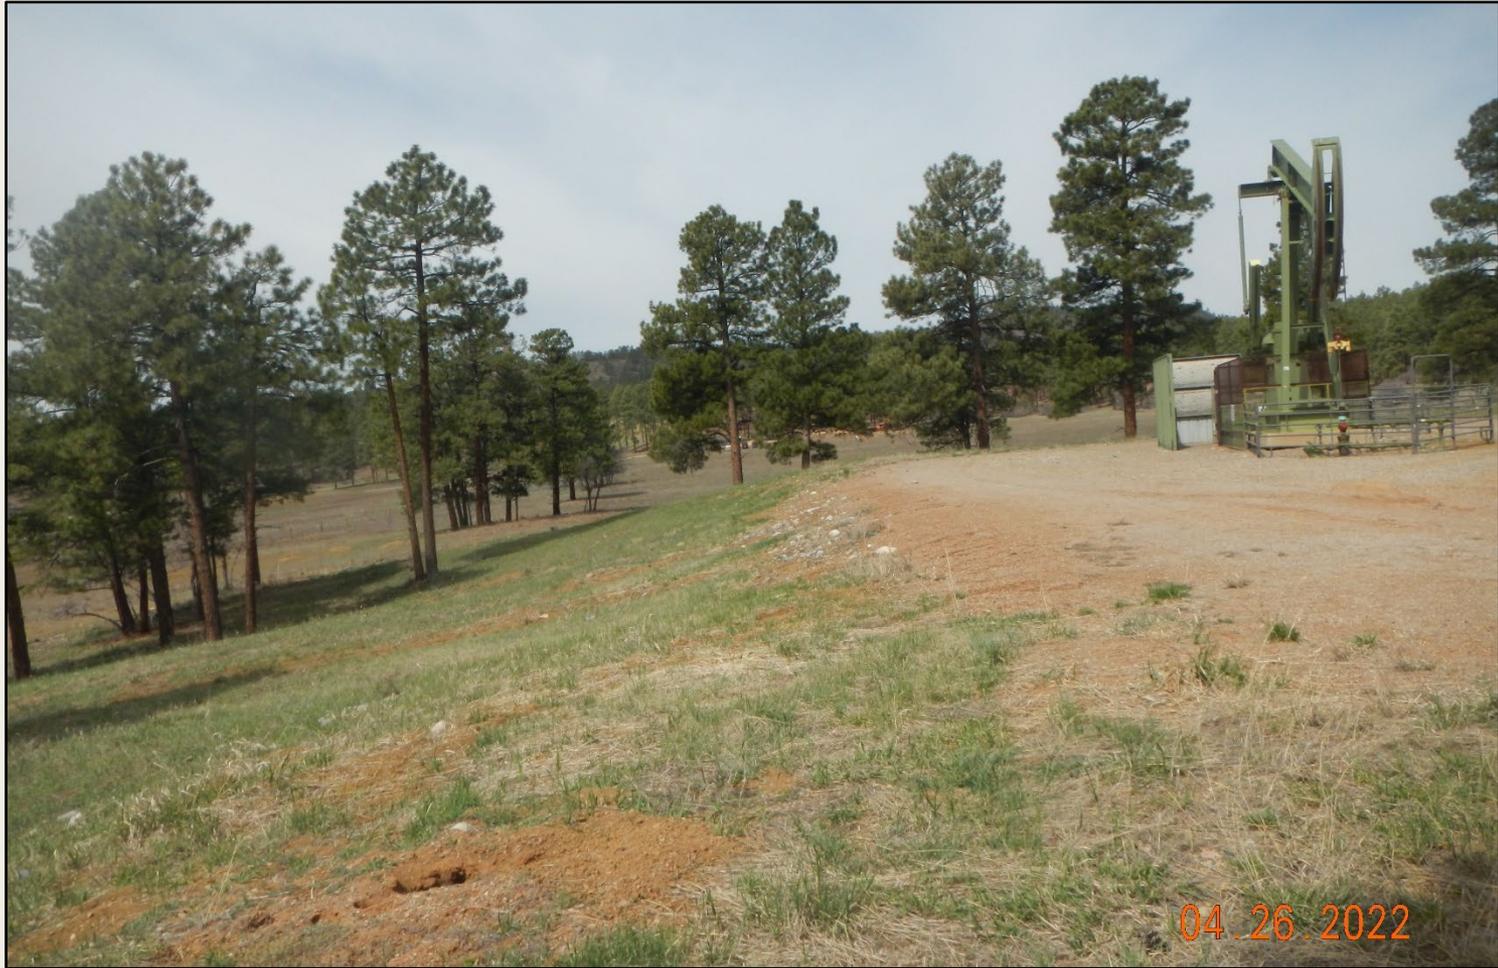
Photo 2. View of the southern project area from the southeastern corner facing westward. Revegetation is progressing with smooth brome (*Bromus inermis*), western wheatgrass (*Pascopyrum smithii*), and sand dropseed (*Sporobolus cryptandrus*).

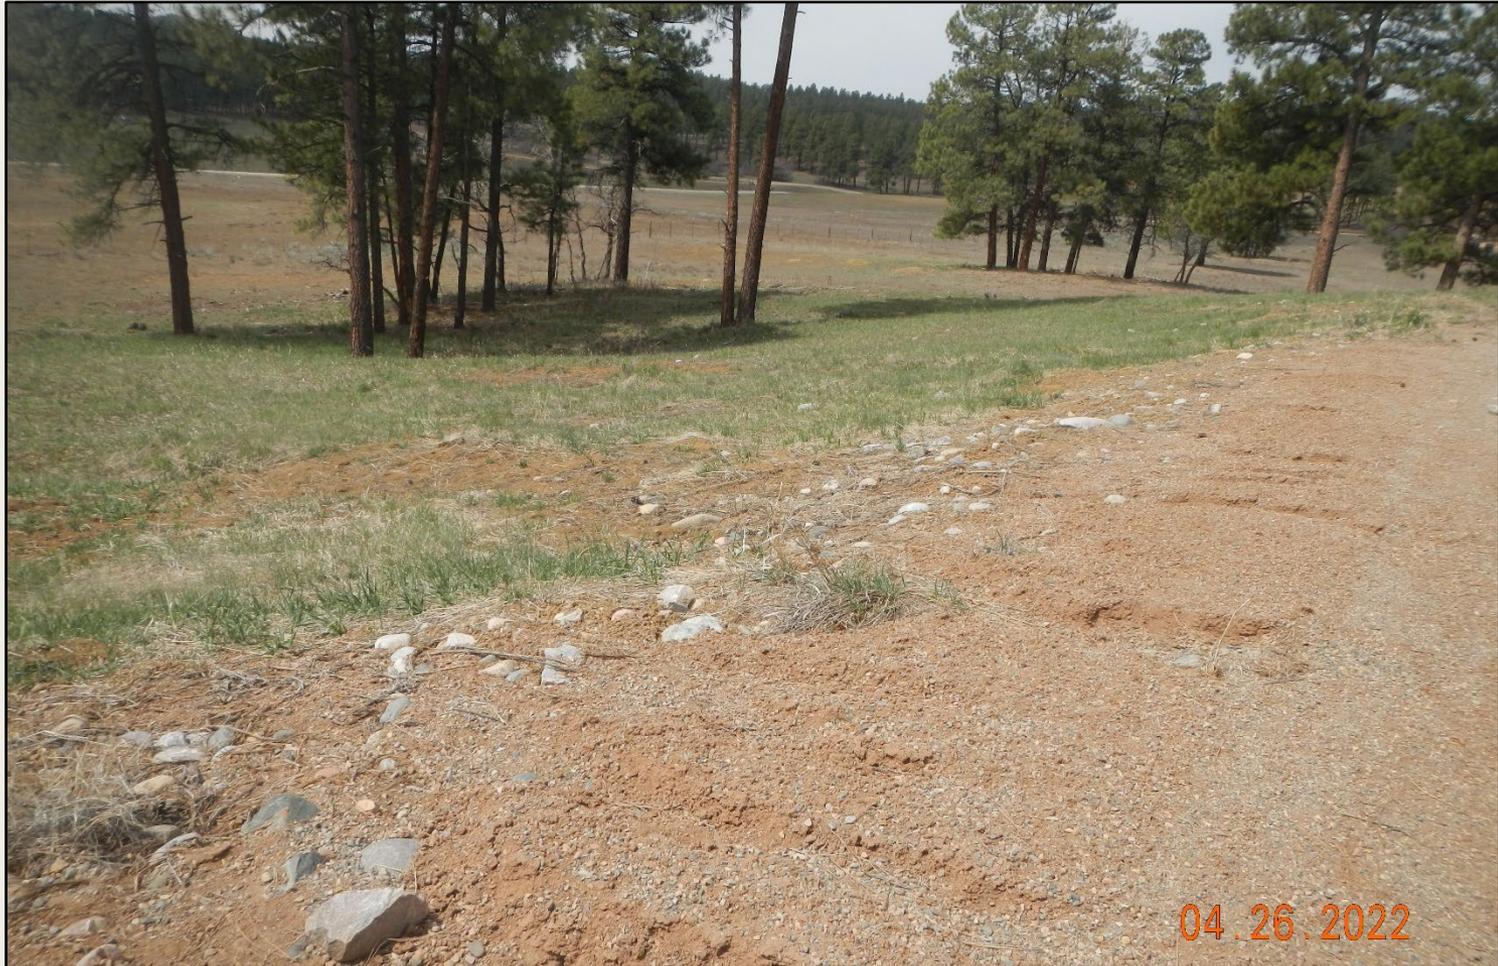
Photo 3. View of erosional rilling where concentrated stormwater flows off of the edge of the working area.

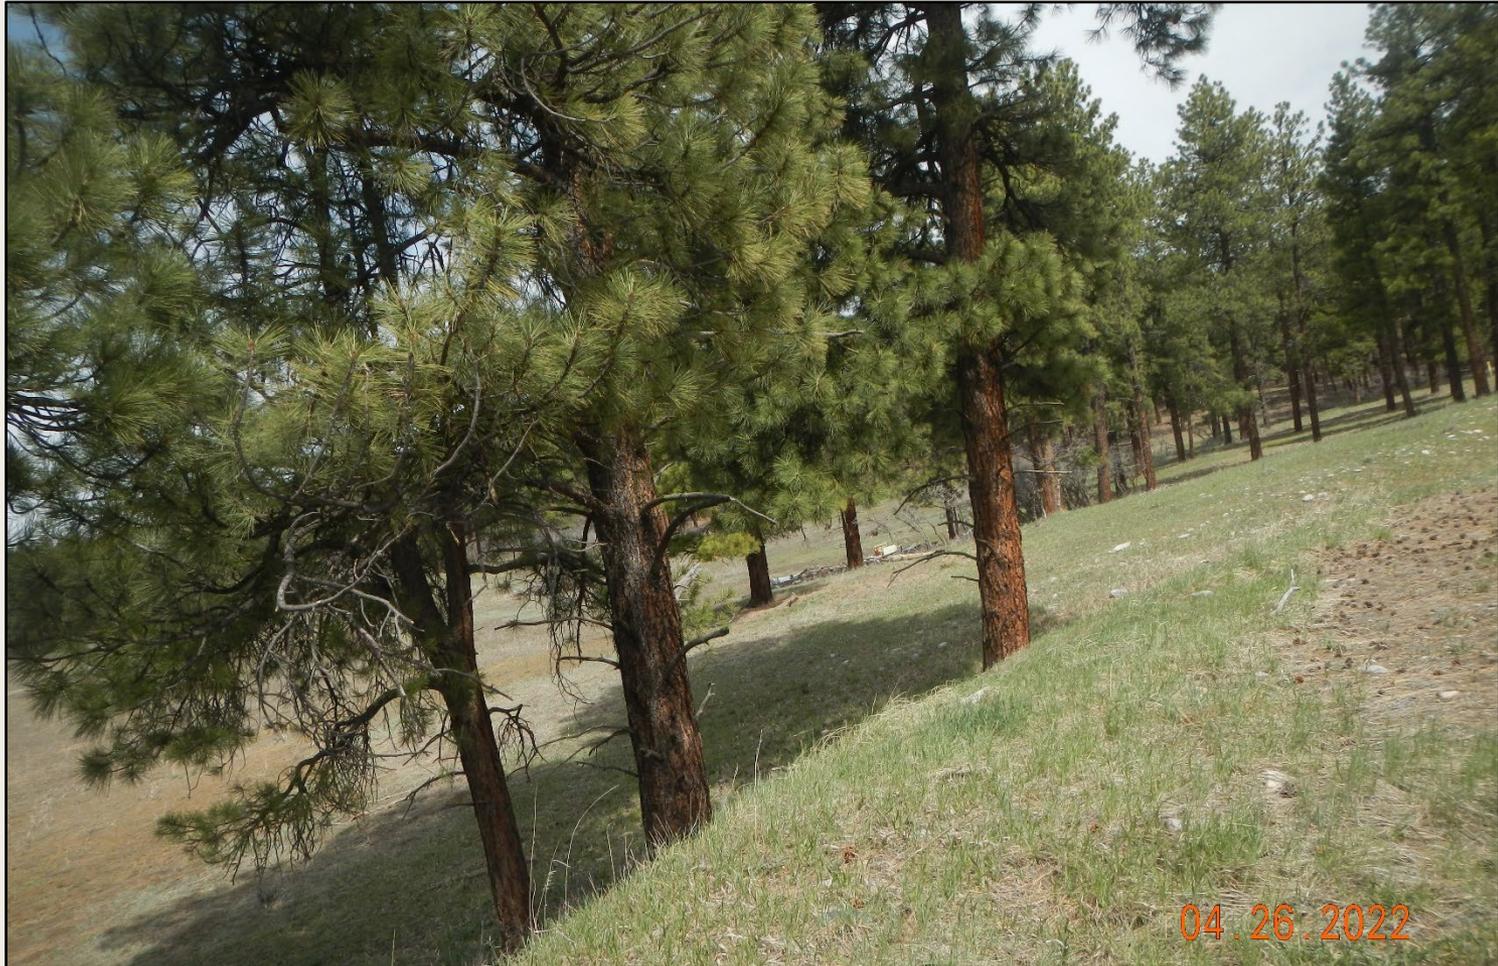
Photo 4. View of the western project area facing northward.

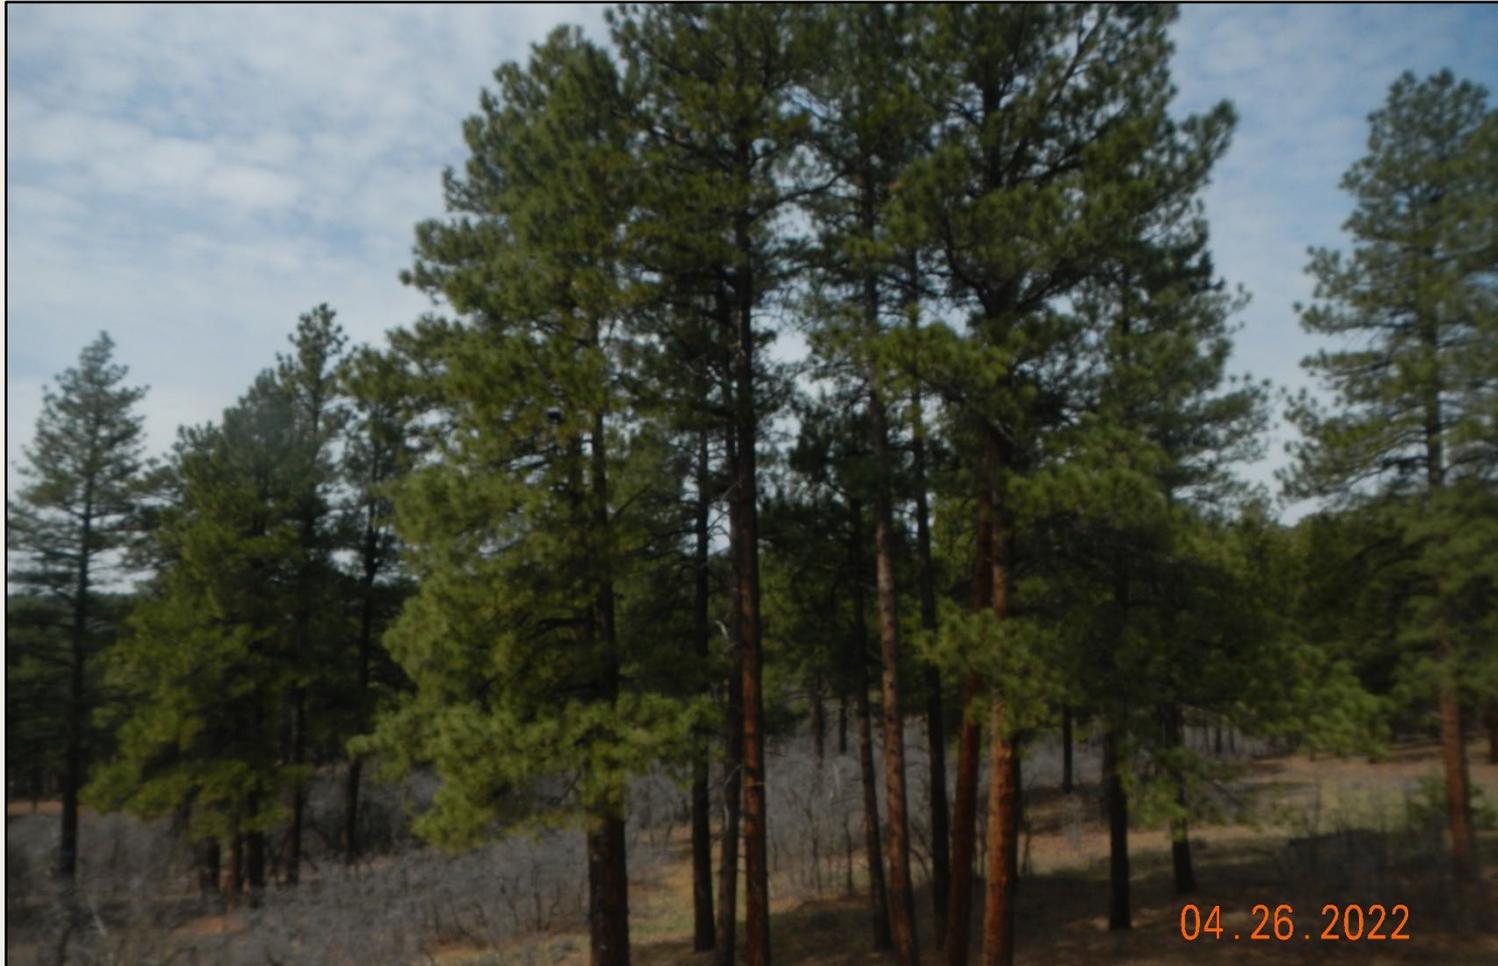
Photo 5. View of the reference area comprised of ponderosa pine forest with gambel oak (*Quercus gambelii*), Oregon grape (*Mahonia repens*), and Idaho fescue (*Festuca idahoensis*).
