Inspection Photos
Operator: Simcoe
API: 067-08991
Date: 4/26/2022

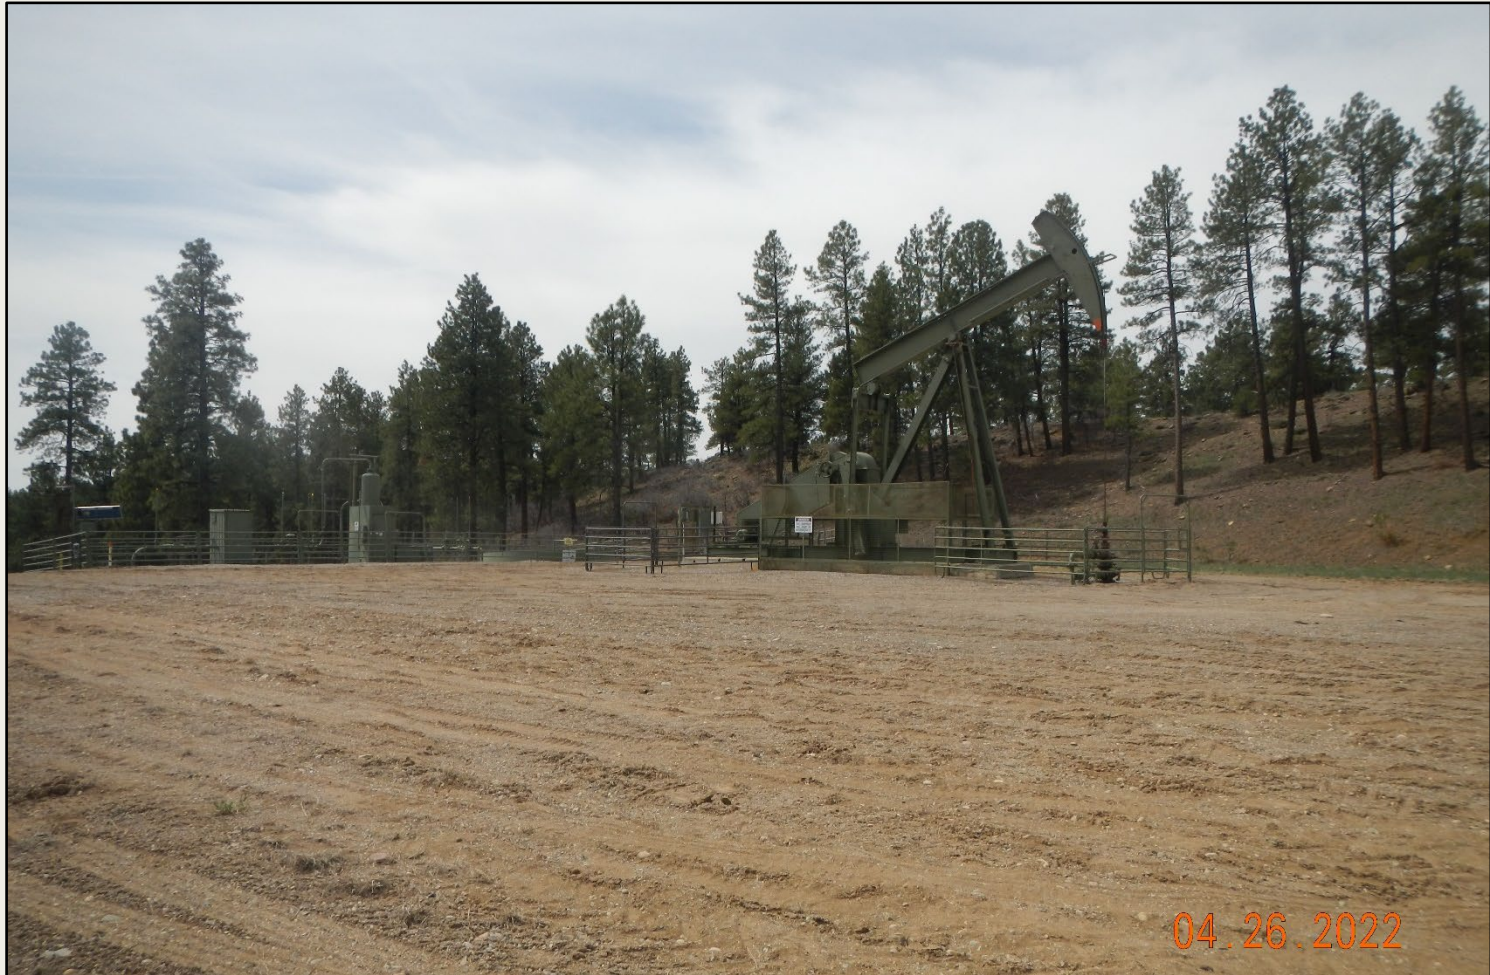
Photo 1. View of the project area from the northeastern corner facing center.

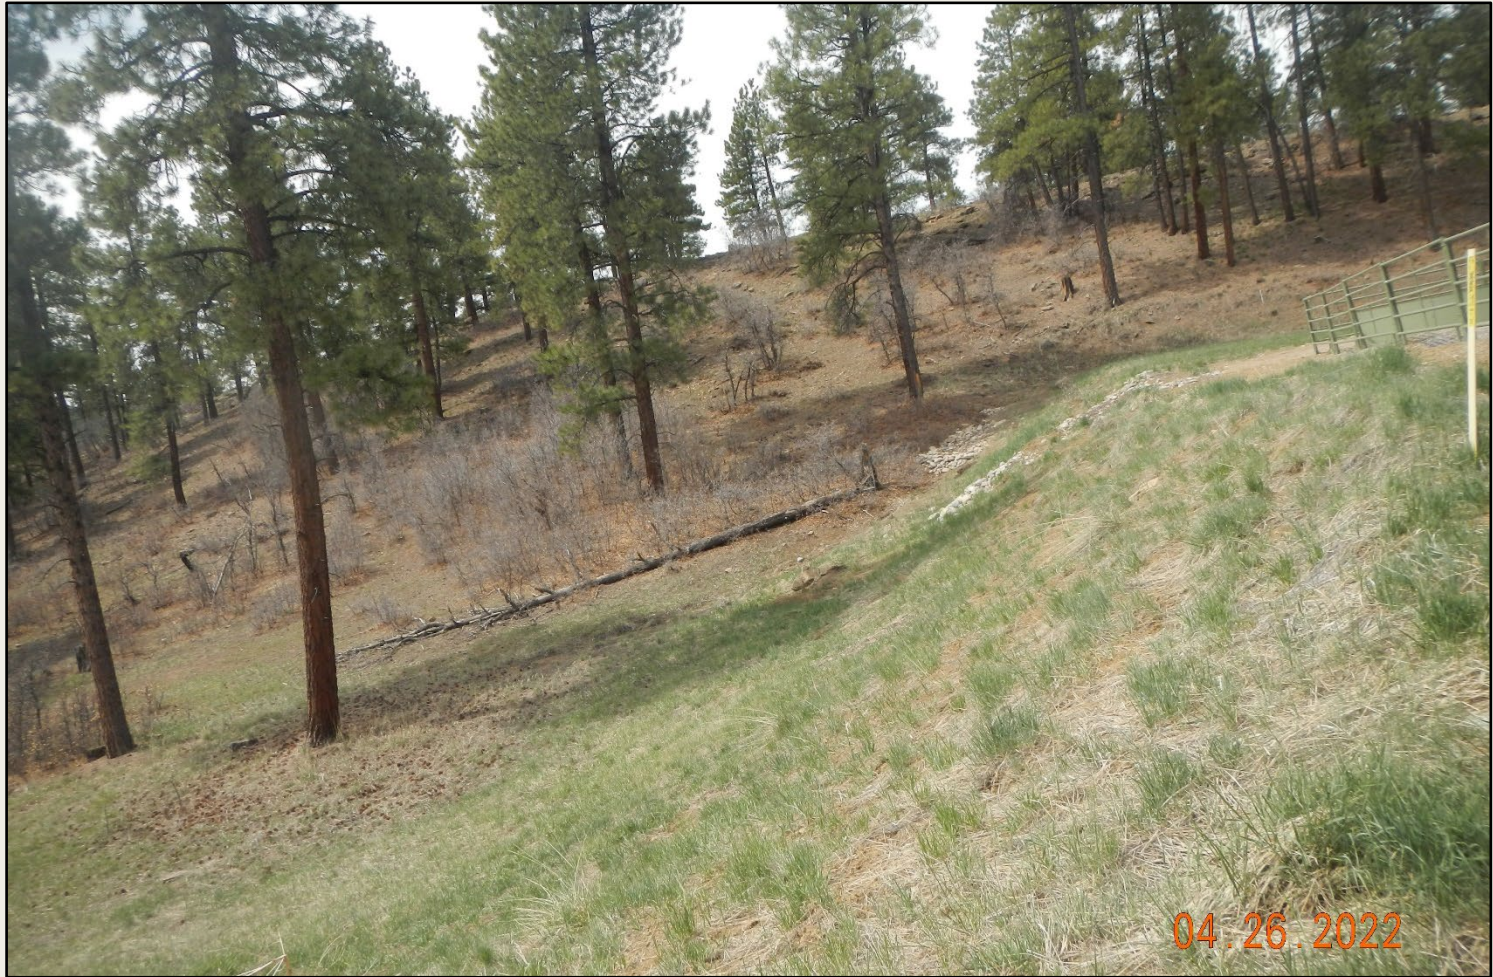
Photo 2. View of the southern project area from the southeastern corner facing westward. Revegetation is progressing with smooth brome (*Bromus inermis*), western wheatgrass (*Pascopyrum smithii*), and sand dropseed (*Sporobolus cryptandrus*).

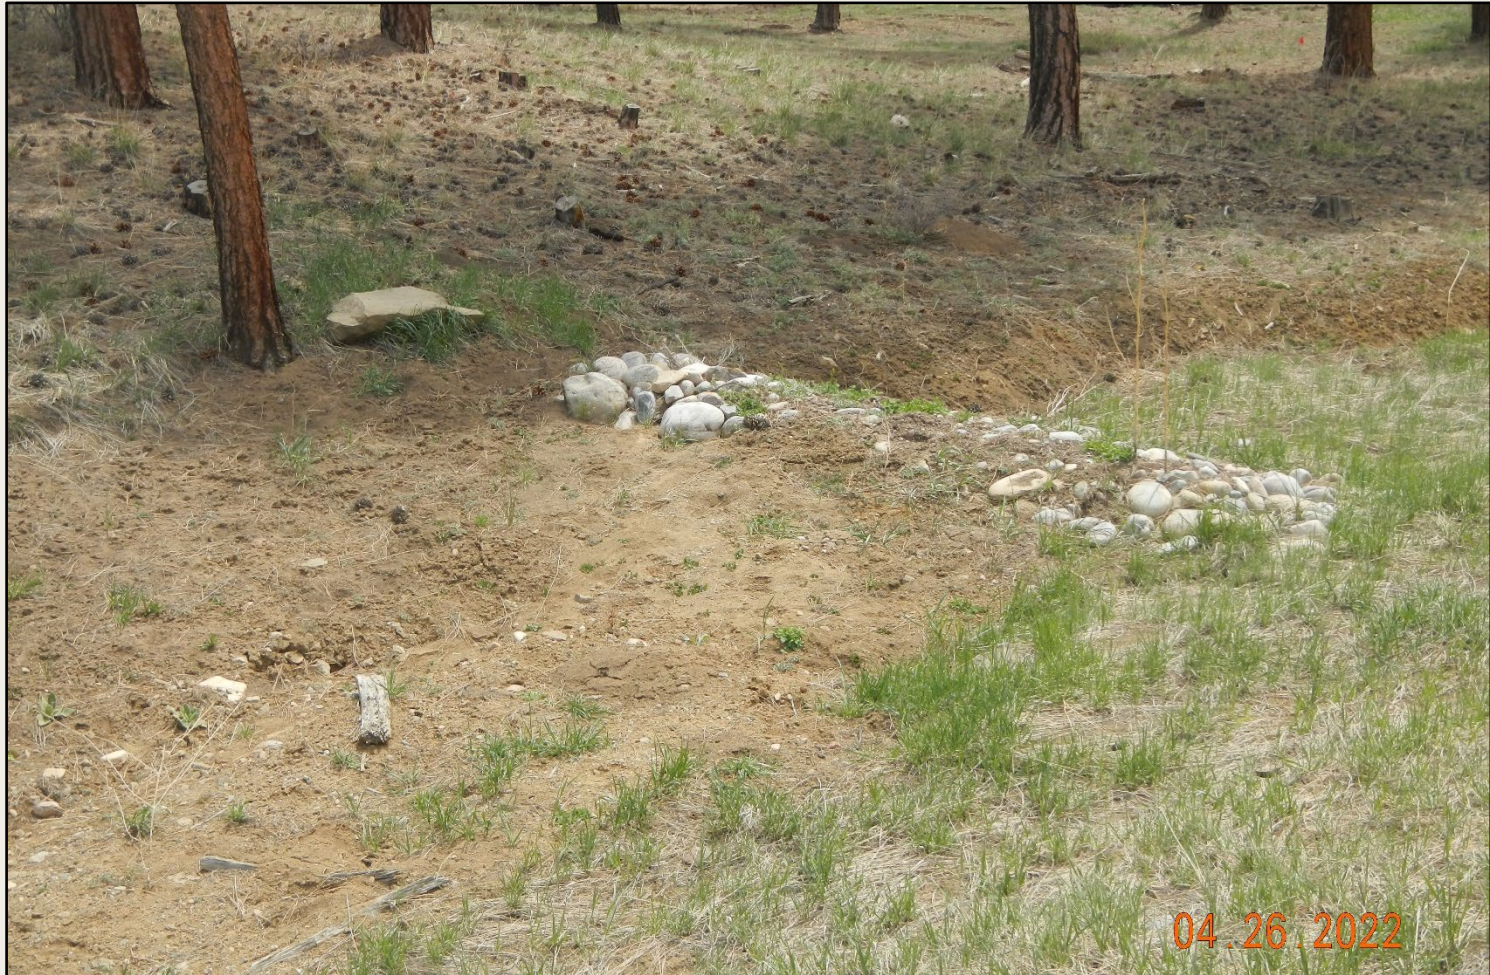
Photo 3. View of cobble BMP within the northeastern project area that is full of sediment and needs maintenance.

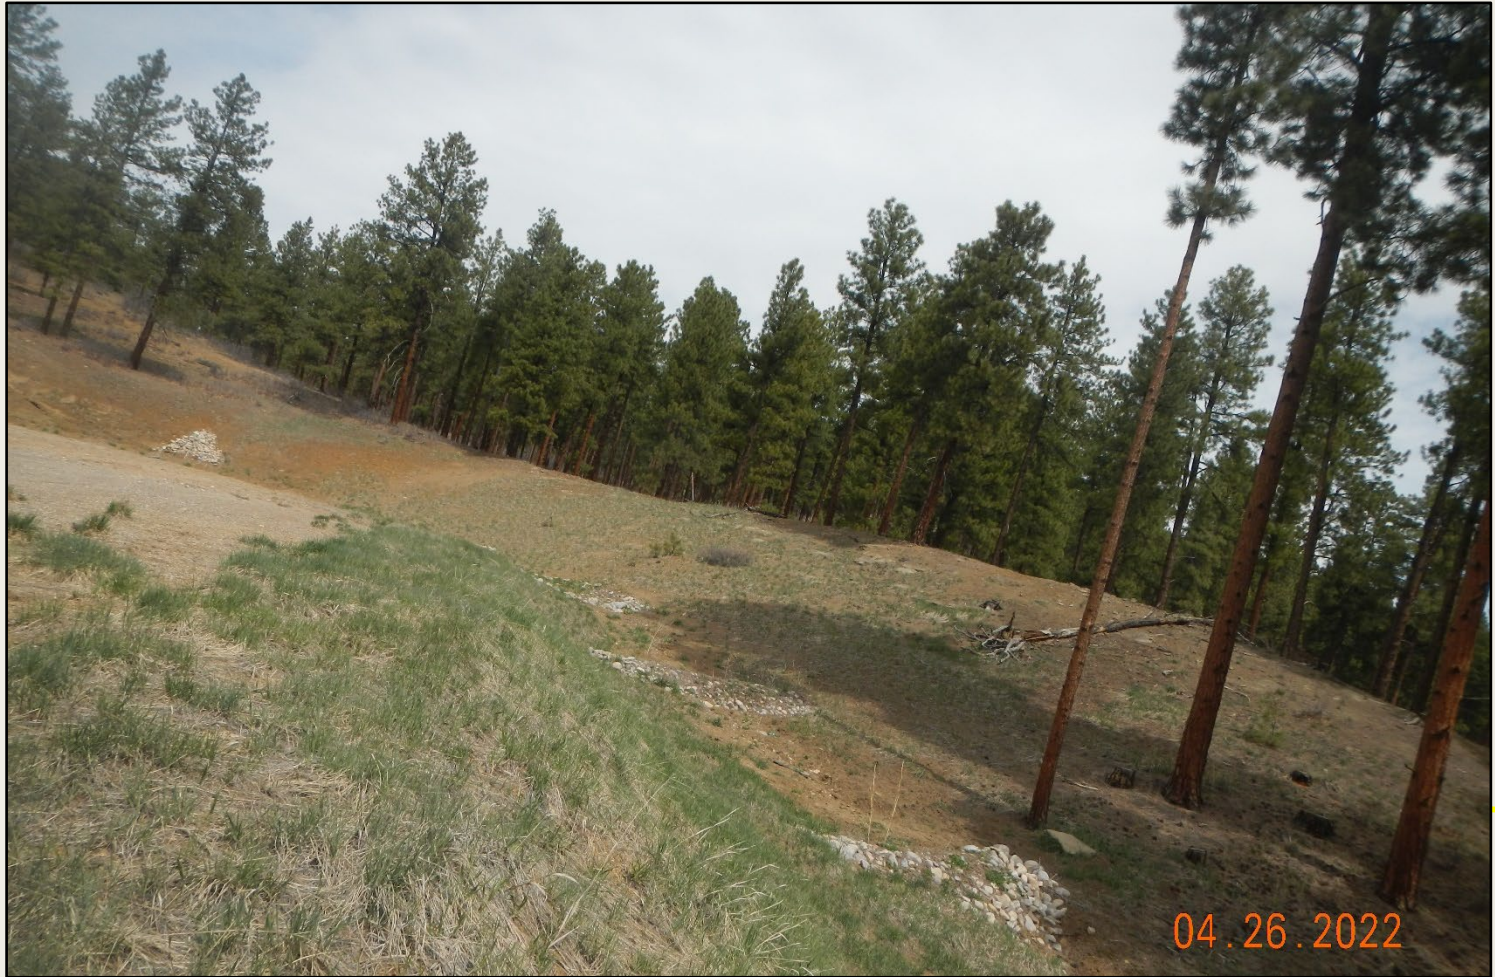
Photo 4. View of the northern project area facing westward.

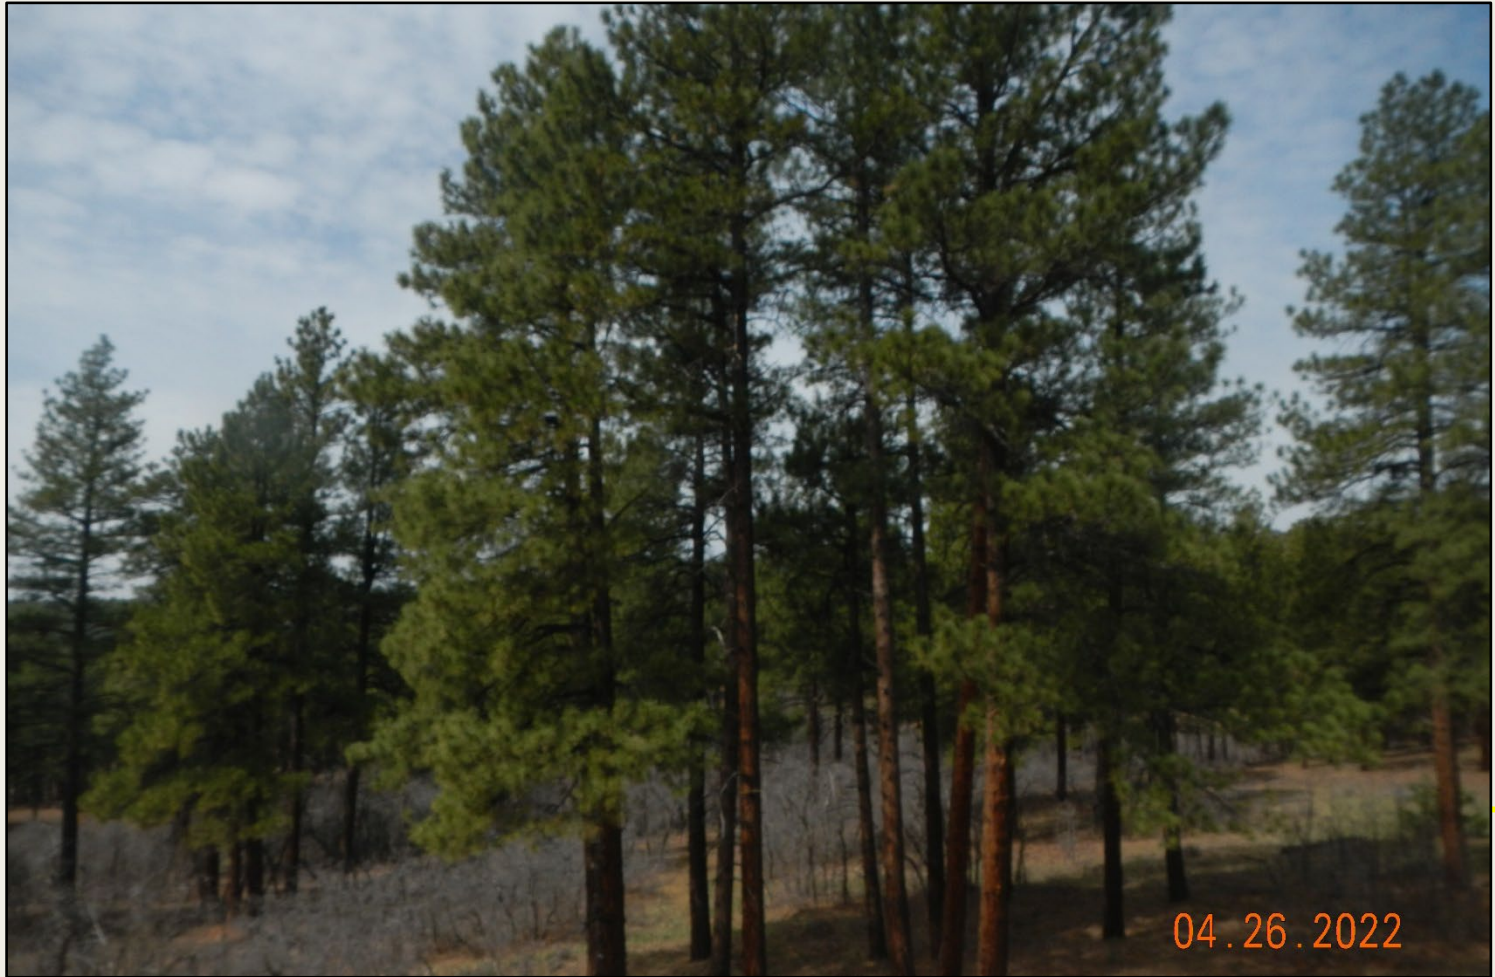
Photo 5. View of the reference area comprised of ponderosa pine forest with gambel oak (*Quercus gambelii*), Oregon grape (*Mahonia repens*), and Idaho fescue (*Festuca idahoensis*).
