Inspection Photos

API: 061-06287

Operator: CHEMCO INC

Inspection Date: 4/25/2022

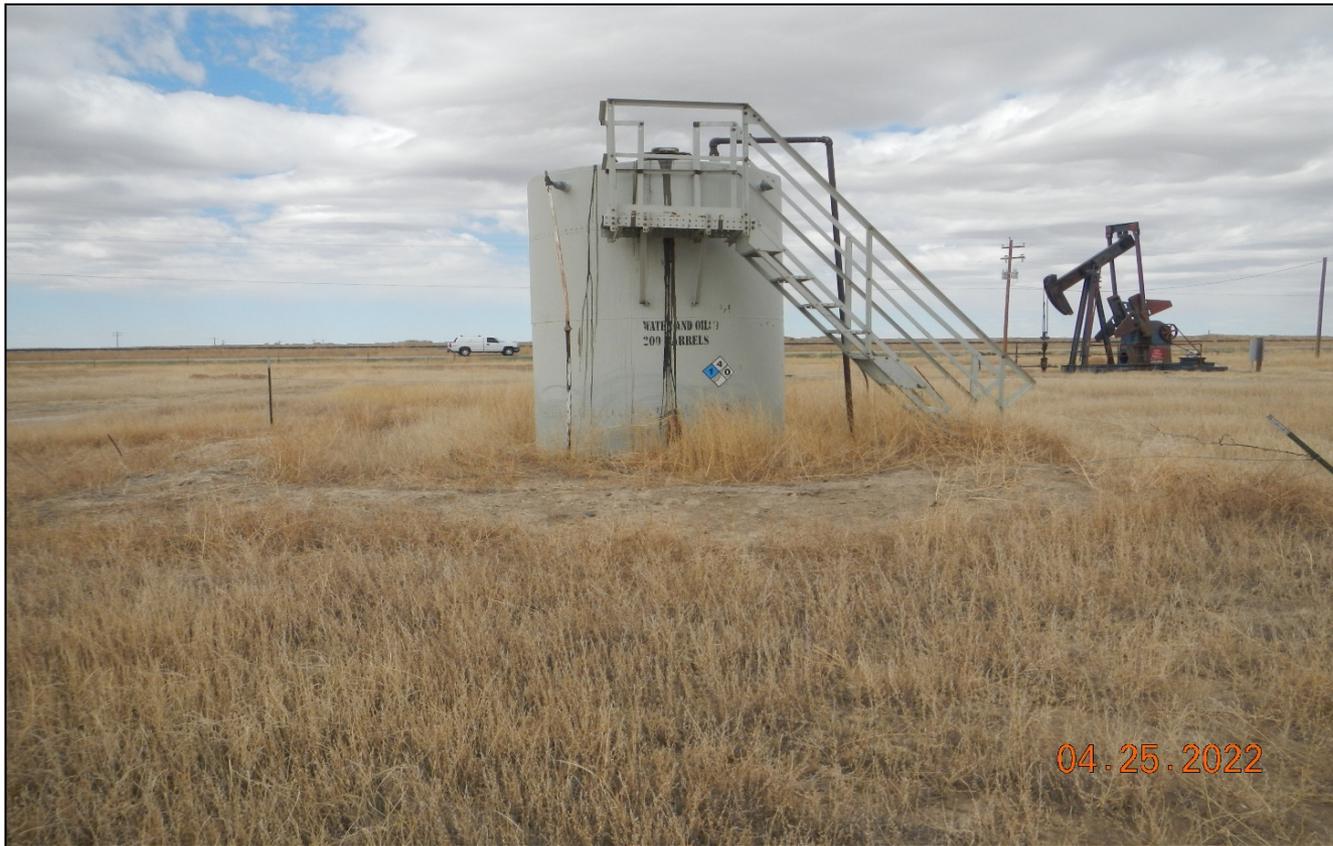
Photo 1. Facing toward the tank battery. The area inside the berm needs to be kept free of vegetation. The fence around the tank needs to be repaired to prevent livestock entry. The berm around the tank needs to be rebuilt to contain a spill.

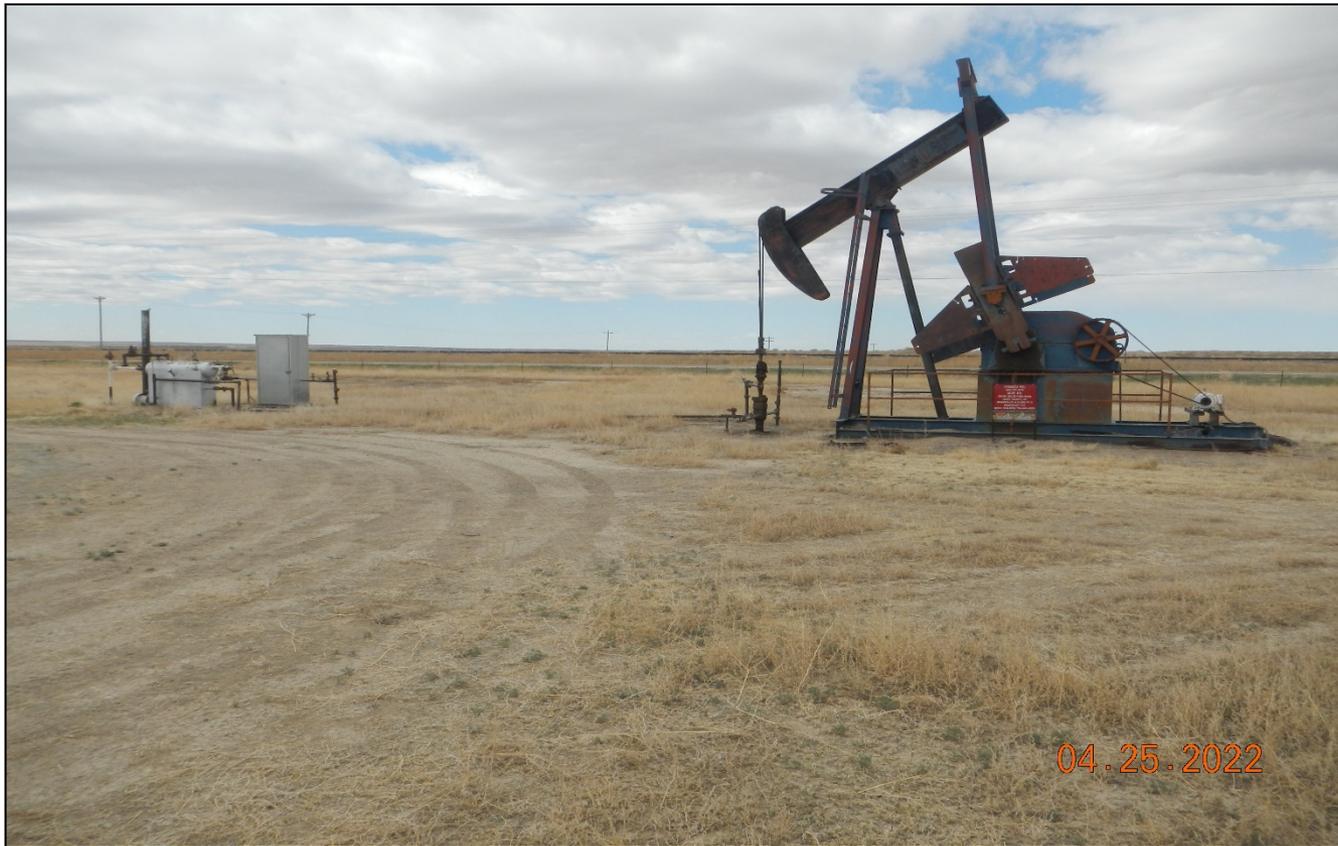
Photo 2. Facing toward the well site.

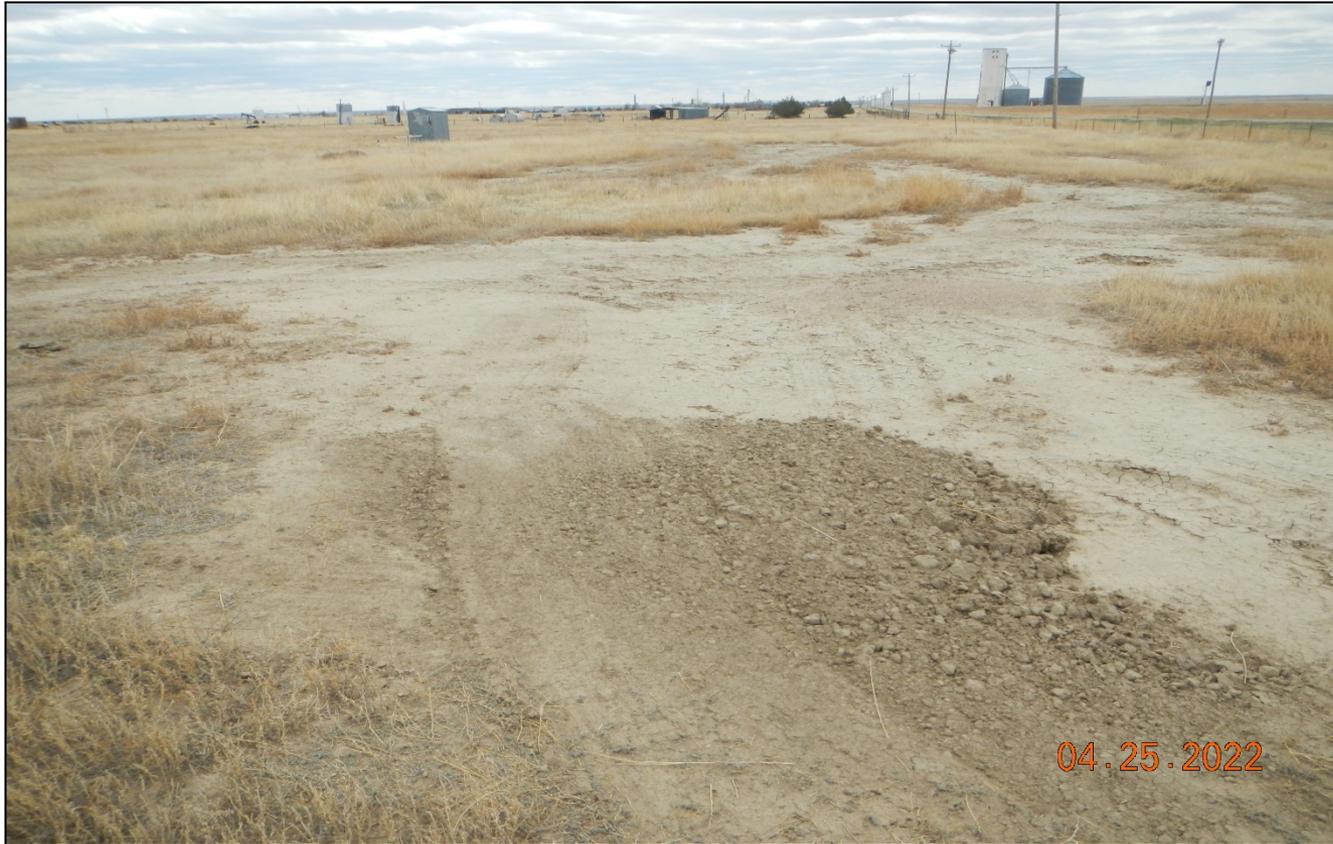
Photo 3. Facing west at the north side of the location. This is the area of impacted soils previously identified. A form 27 has been submitted for remediation.

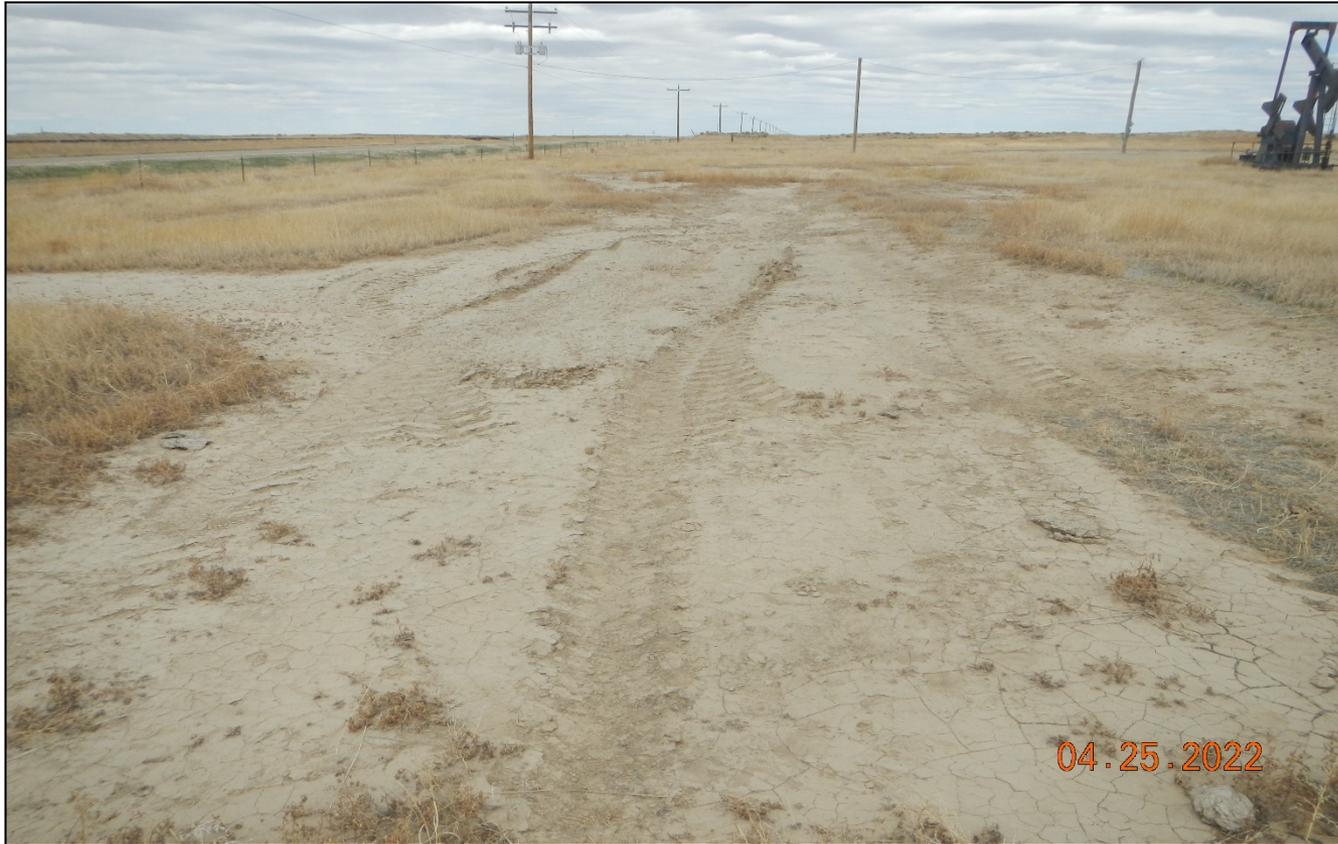
Photo 4. Facing east at the north side of the location. This is the area of impacted soils previously identified. A form 27 has been submitted for remediation.

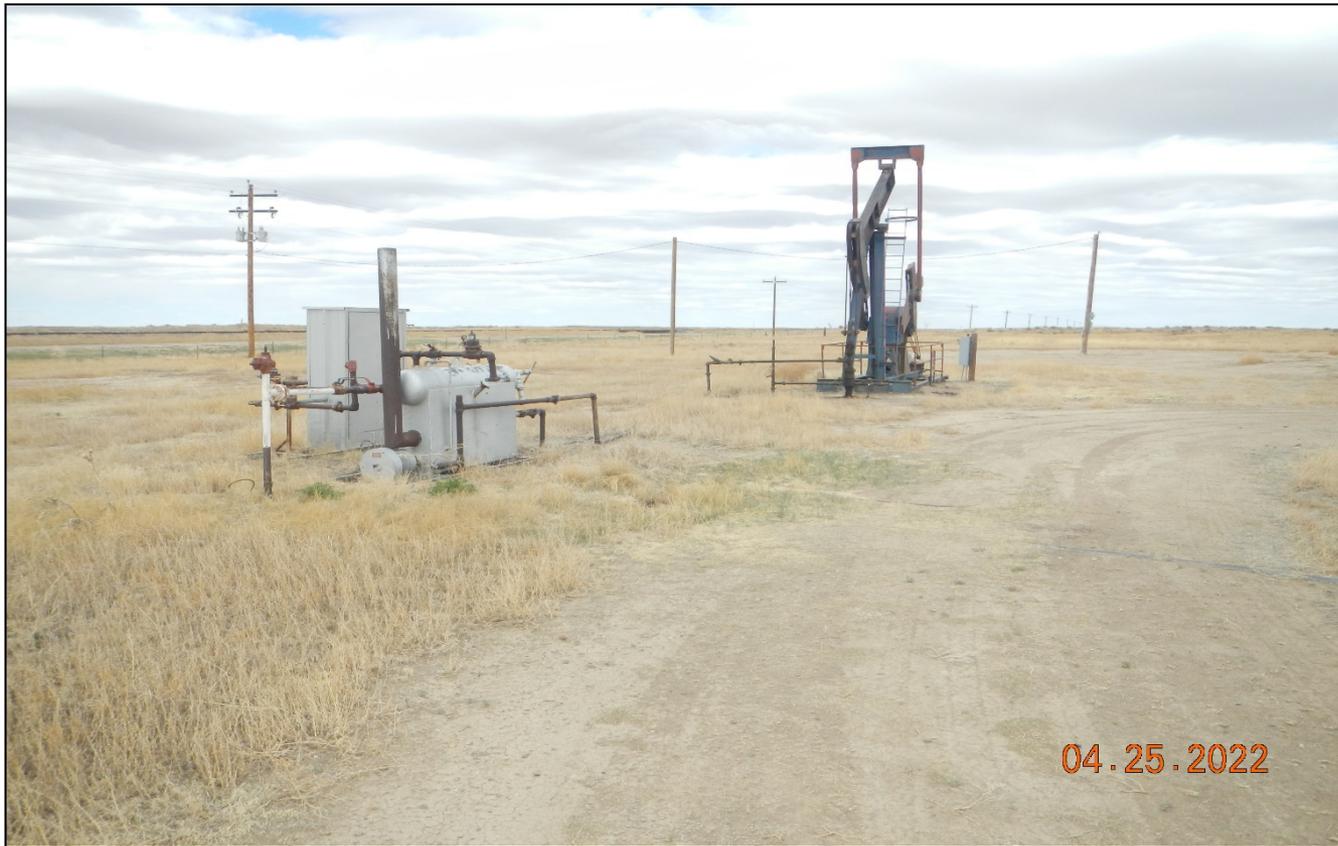
Photo 5. Facing northeast toward the well site.

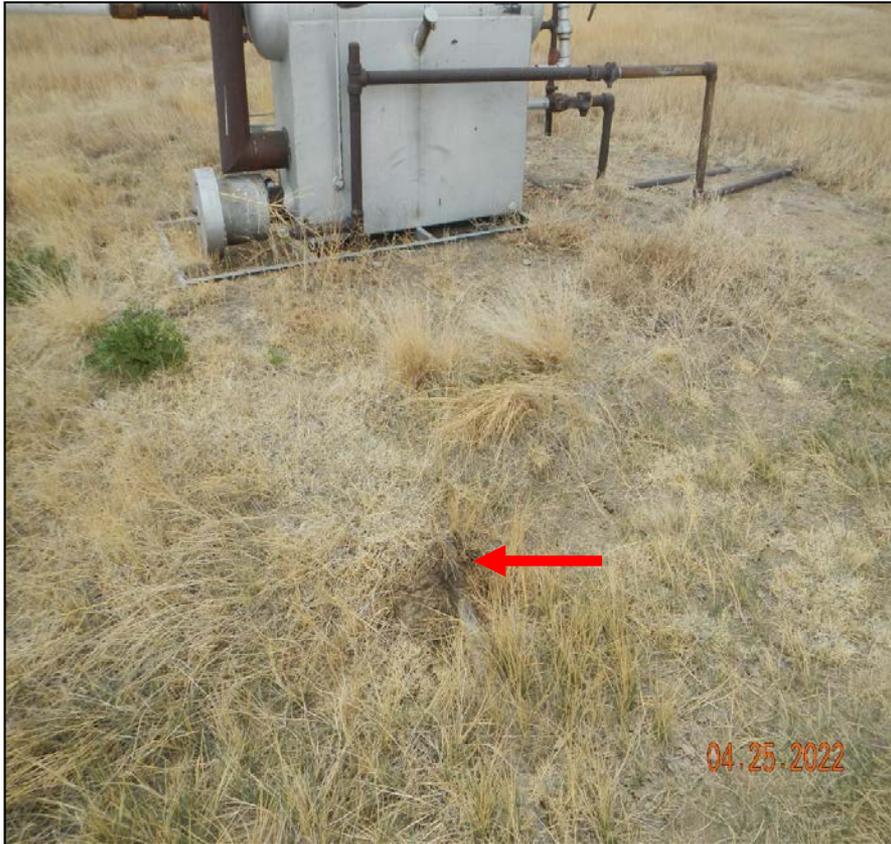
Photo 6. This flowline had previously leaked.

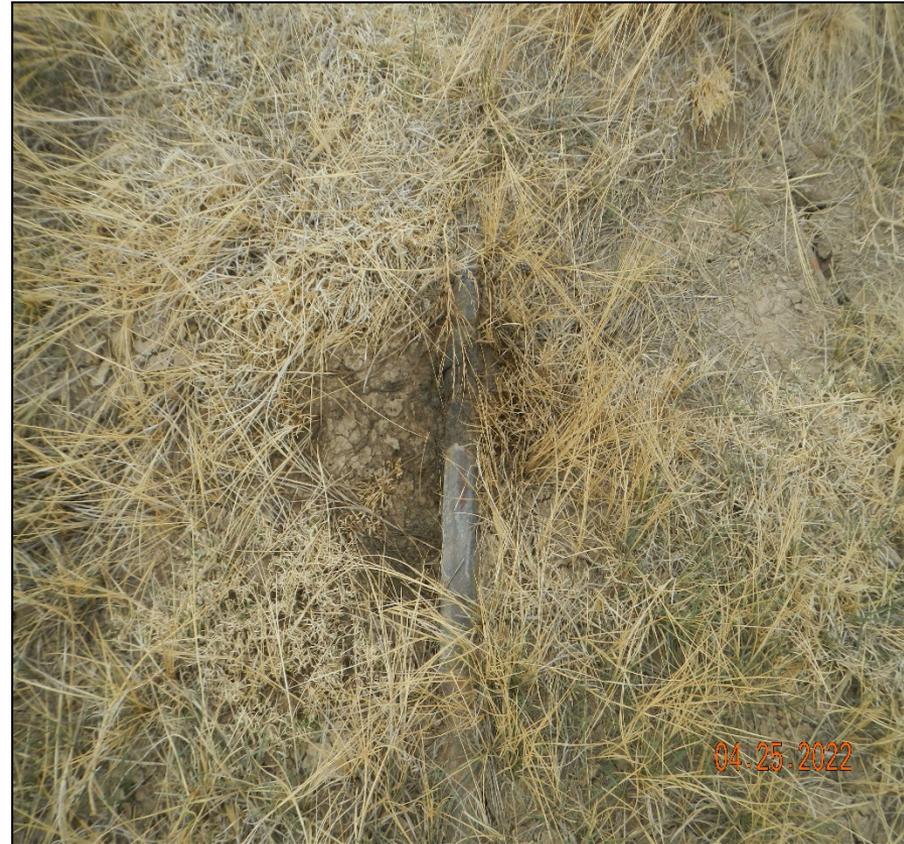
Photo 7. The impacted soils need to be cleaned up and the pipe inspected.
