Stormwater Inspection

Operator: K P KAUFFMAN COMPANY INC - 46290

Location ID: 465402

Location Name: John Weigandt Consolidation

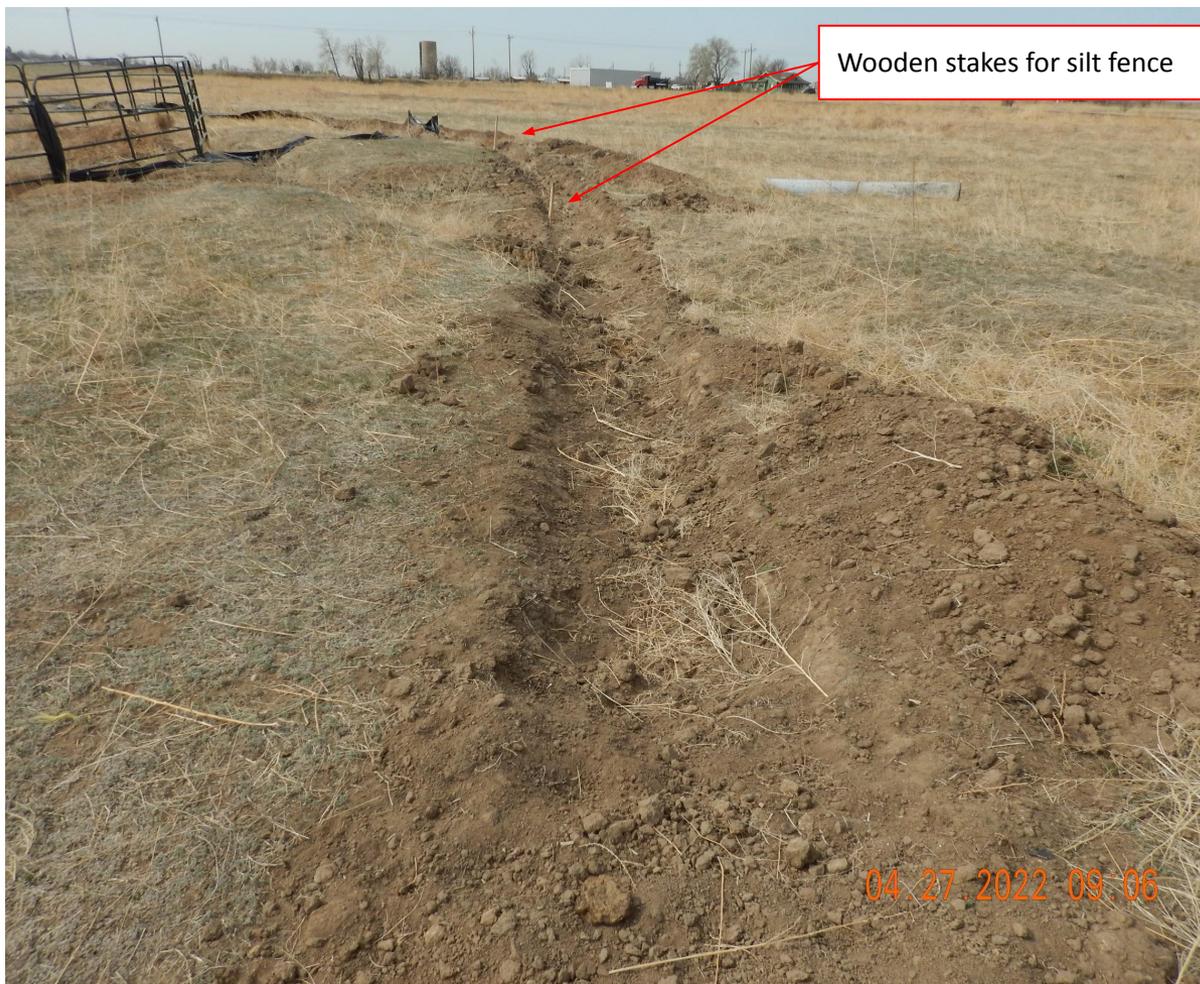
Photo 1. Photo taken north of the excavation, facing South. Photo illustrates Operator has either improperly installed a ditch BMP after the installation of silt fence BMP or has improperly installed the silt fence BMP. If this was intended to be a ditch BMP, Operator has failed stabilize soil material. If this was intended to be a silt fence BMP, Operator has failed to compact and backfill the trenched area. See Photos 2 and 3 regarding additional observations north and west of the excavation area.

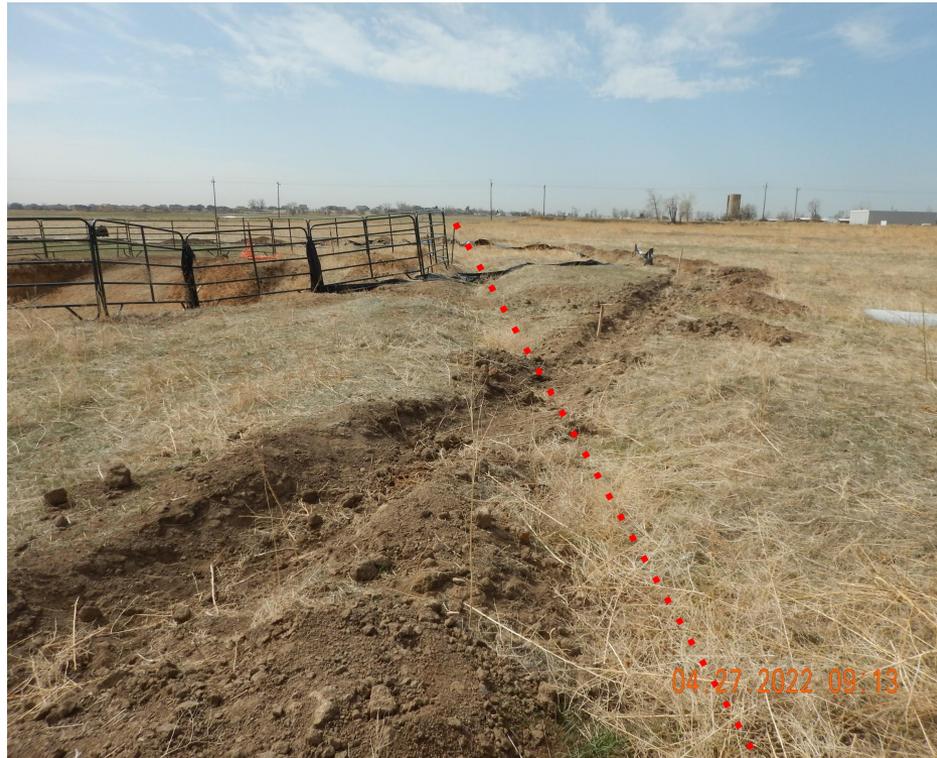
Photo 2. Photo taken north of the excavation, facing South. Photo highlights an existing vegetated ditch that the Operator could have considered as a BMP for run-on mitigation. Instead, the Operator created additional disturbances and failed to minimize disturbances.

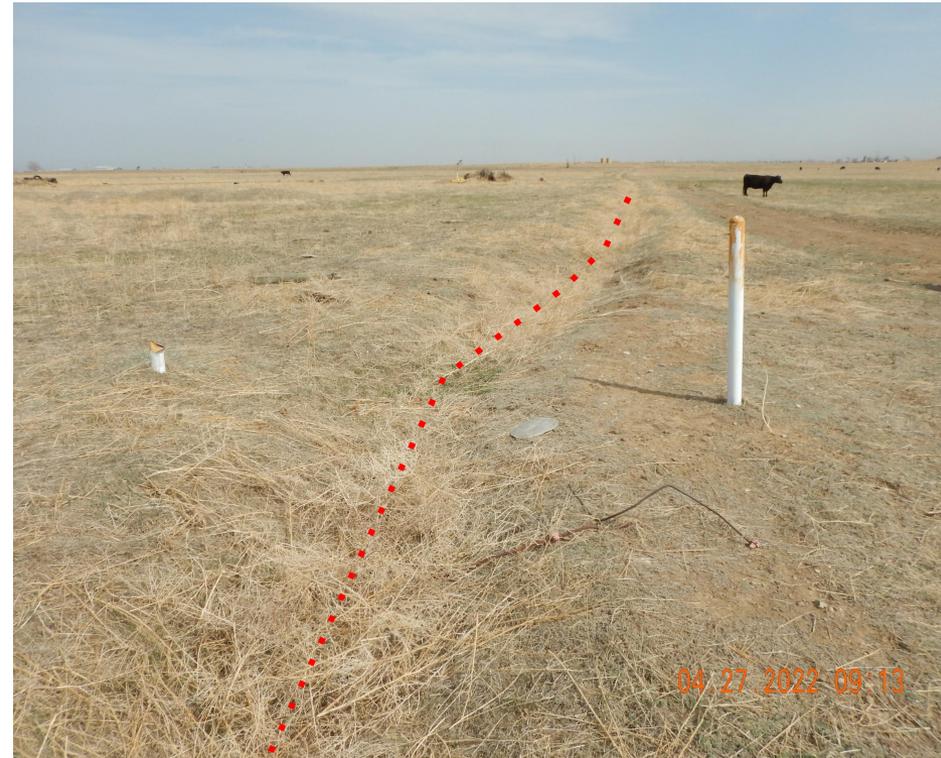
Photo 3. Photo taken north of the excavation, facing North. Photo highlights the existing vegetated ditch mentioned in Photo 2.

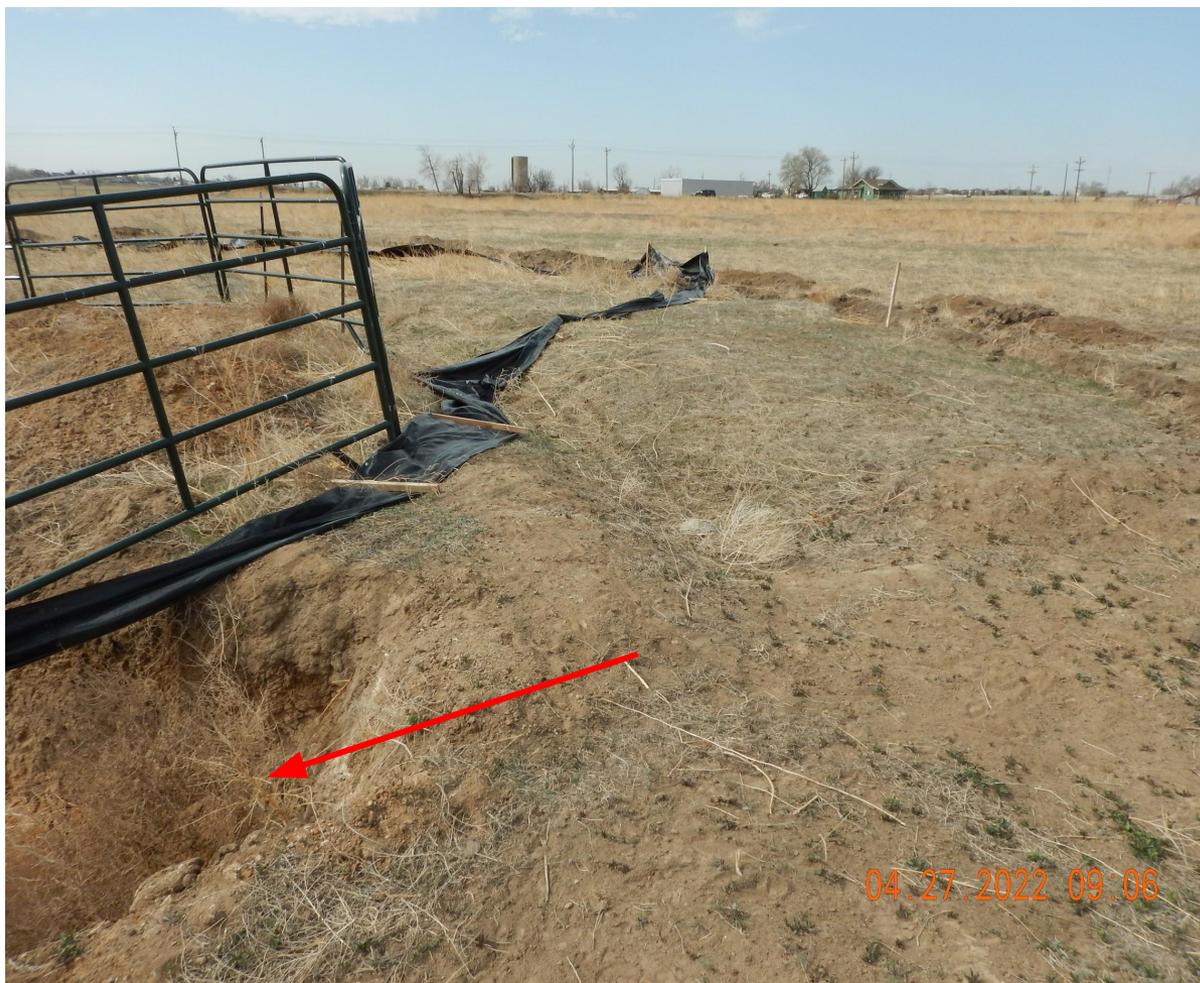
Photo 4. Photo taken from the northwestern excavation area, facing South. Photo illustrates silt fence material that is now considered debris and shall be removed. Also, this photo highlights fencing has not surrounded the excavation area to prevent livestock or wildlife entry.

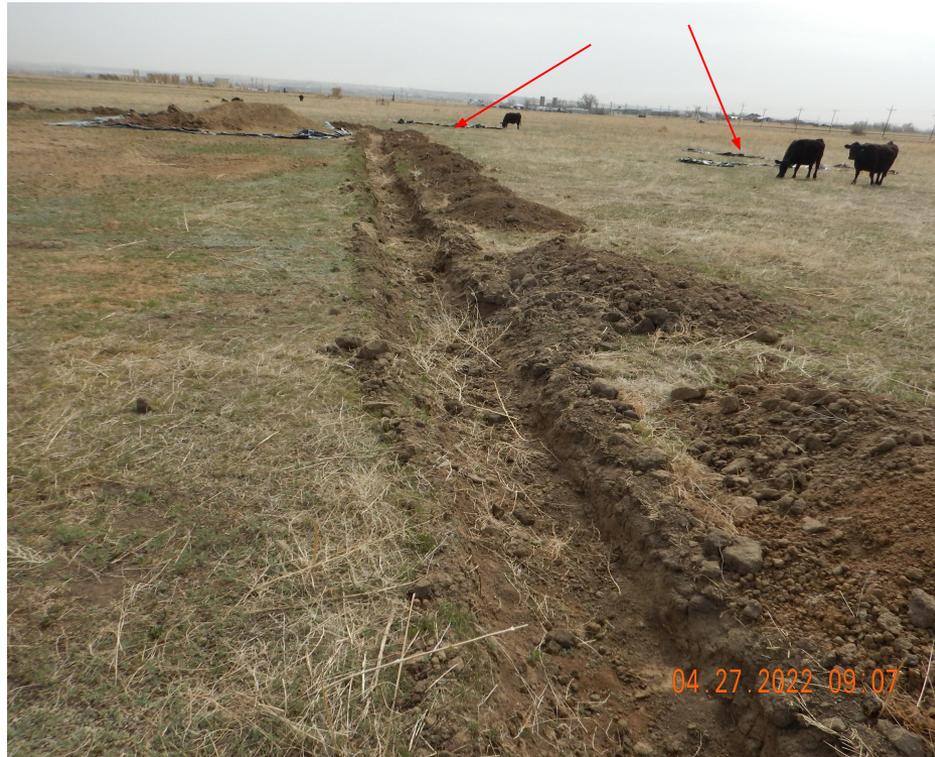
Photo 5. Photo taken south of the excavation area, facing East. Photo illustrates (red arrows) silt fence material off location that is now considered debris and shall be removed. Also, photo illustrates unconsolidated soil material that has not been properly stabilized.

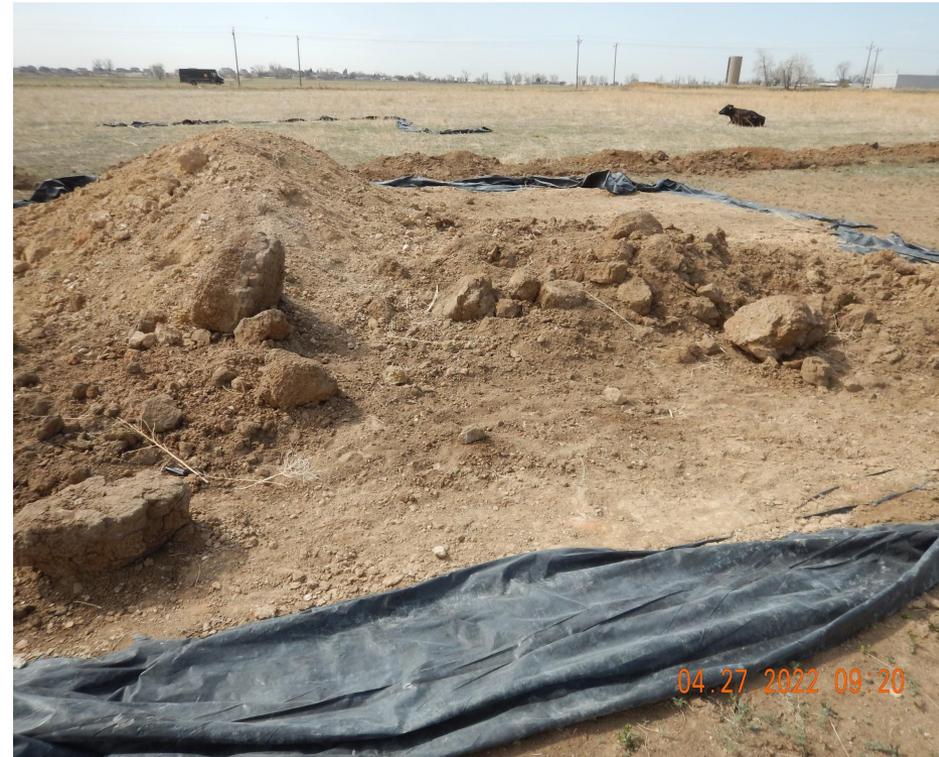
Photo 6. Photo taken southeast of the excavation, facing South. Photo illustrates what appears to be contaminated soil material that has not been excluded from cattle disturbances. Cattle have walked over the contaminated soil and could potentially compromise the liner.

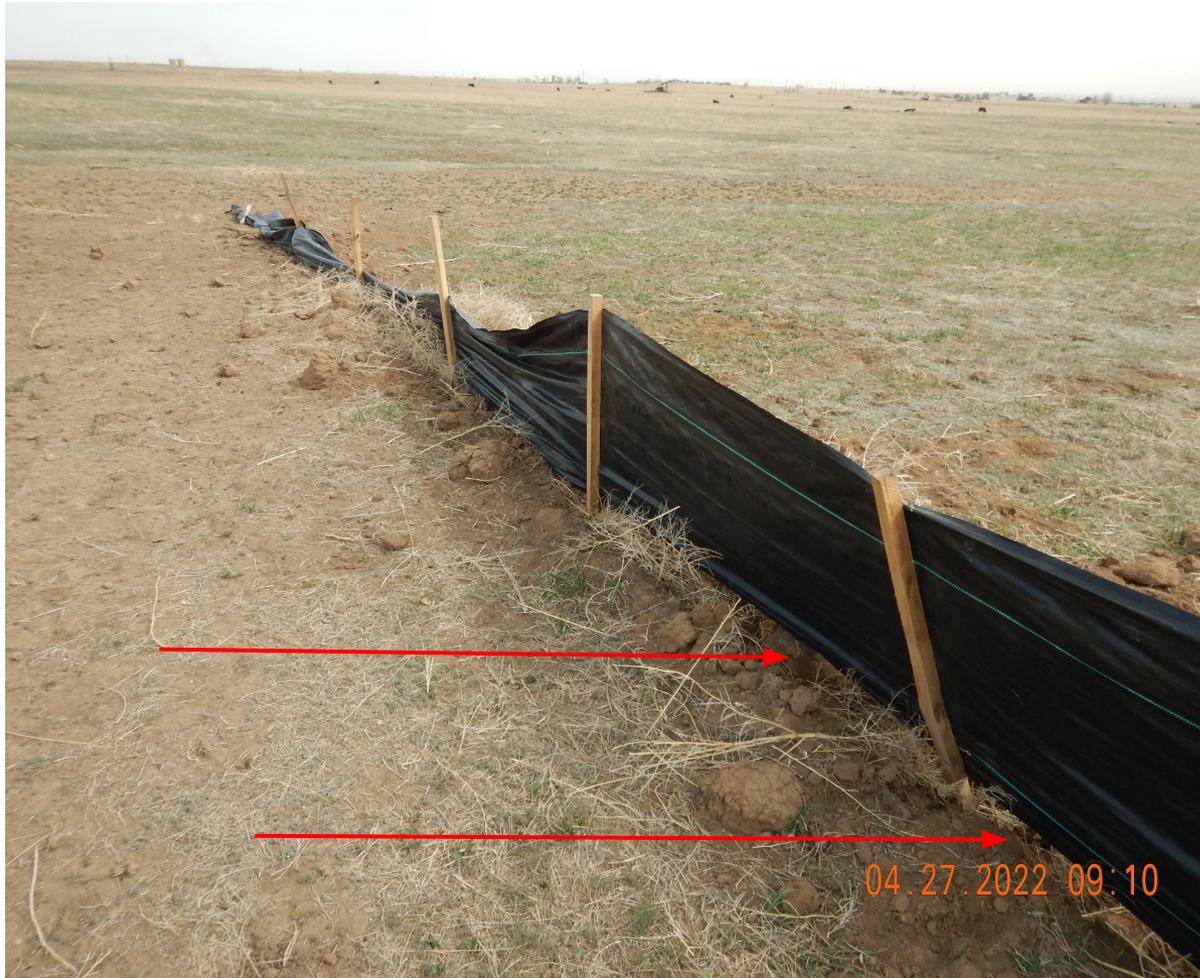
Photo 7. Photo taken east of the excavation, facing North. Photo illustrates Operator has improperly installed the silt fence BMP. The silt fence in this area would be acting to control runoff from the site; therefore, the Operator has installed the wooden stakes on the wrong side of the silt fence. Also, the silt fence has not been properly trenched, as there is daylight evident. The BMP is not in proper functioning condition.
