Inspection Photos

081-07096

Inspection Date: 4/26/2022

COLORADO
Oil & Gas Conservation
Commission
Department of Natural Resources

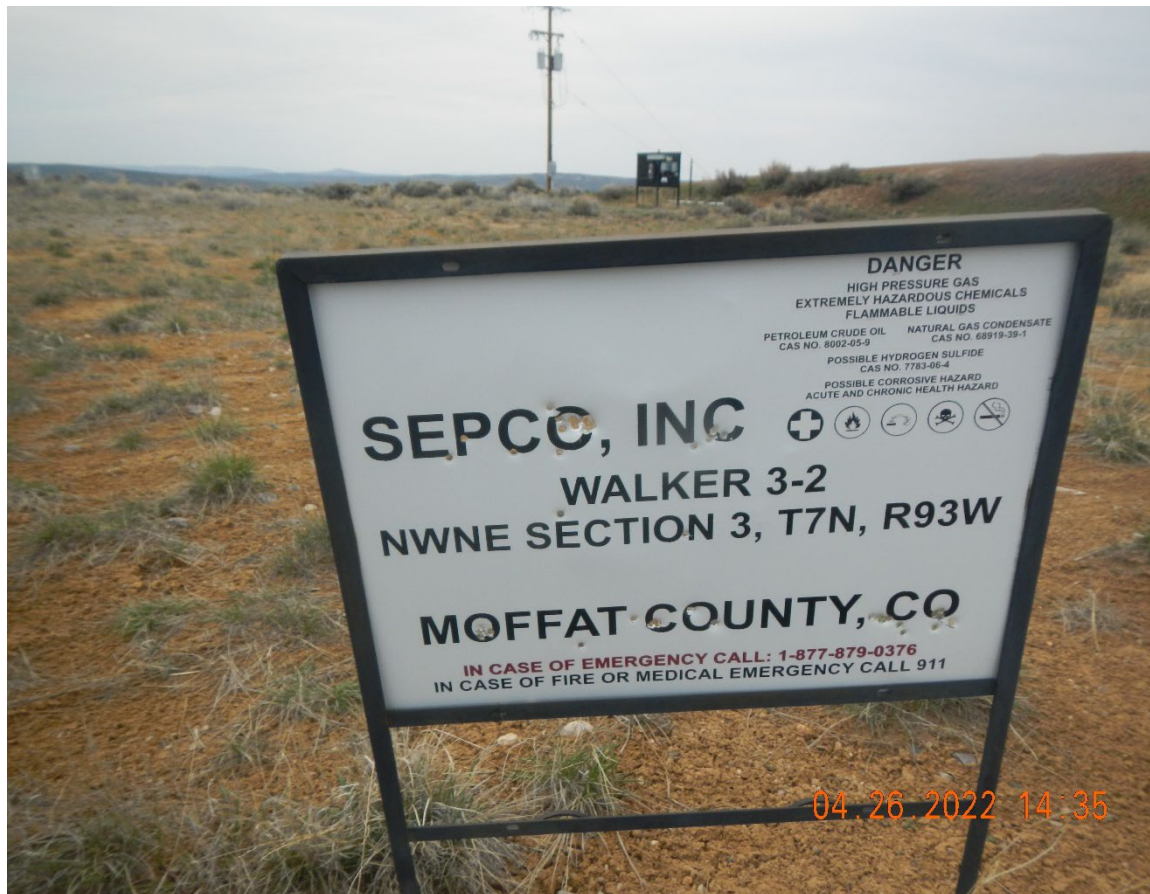
Photo #1 Sign on location

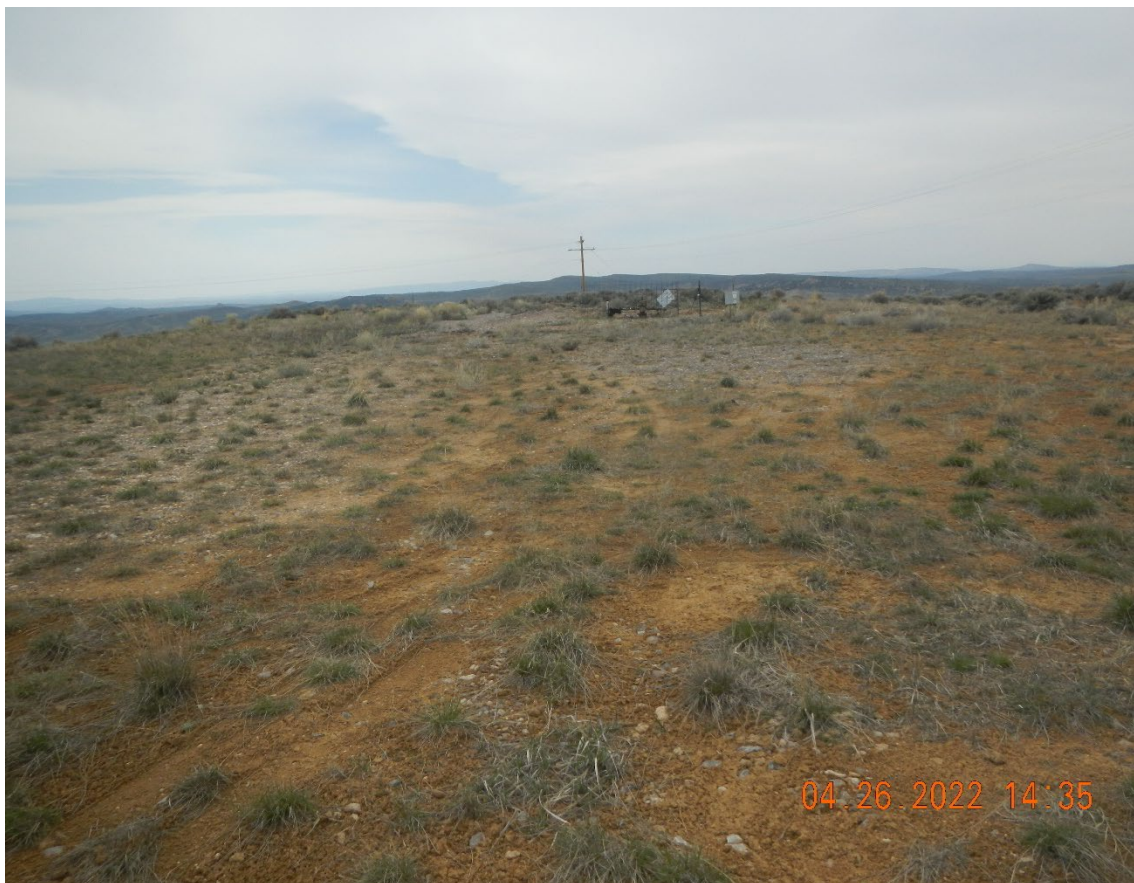
Photo #2 Pad surface, well in background.

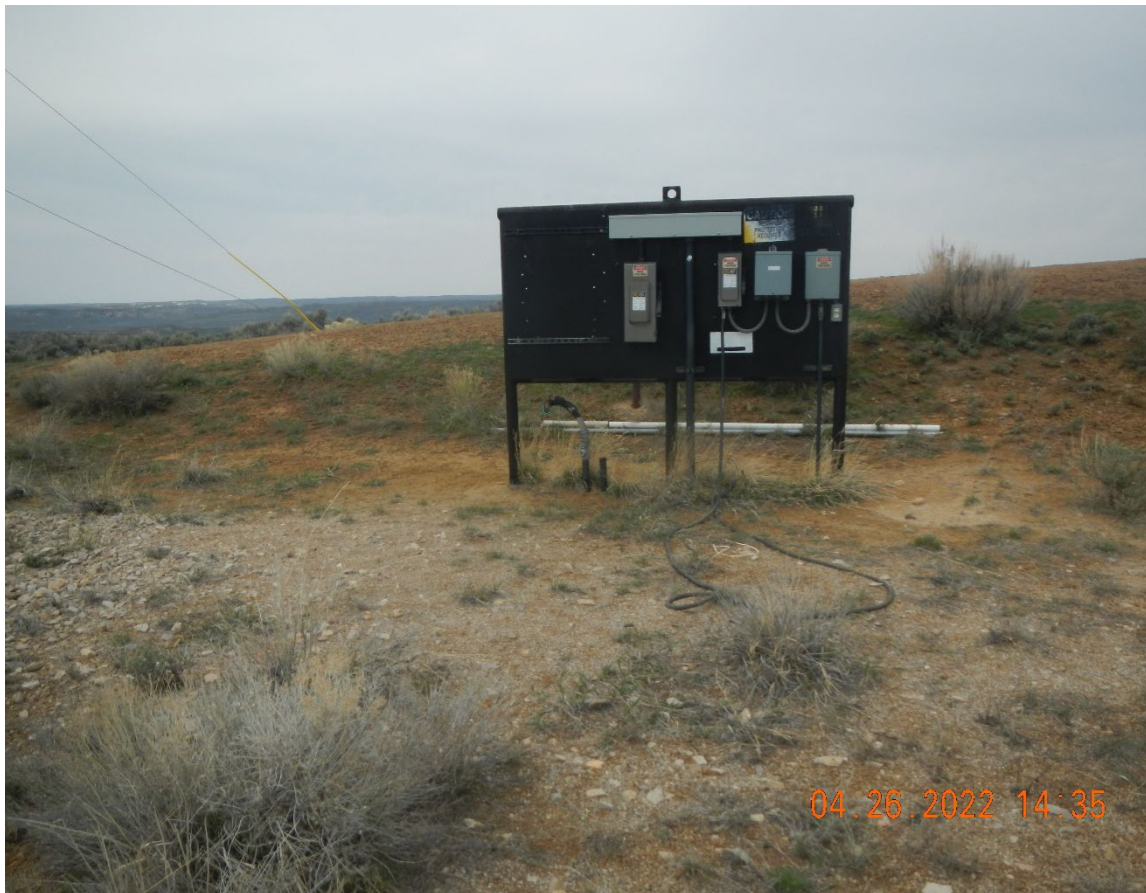
Photo #3 Electric sub panel.

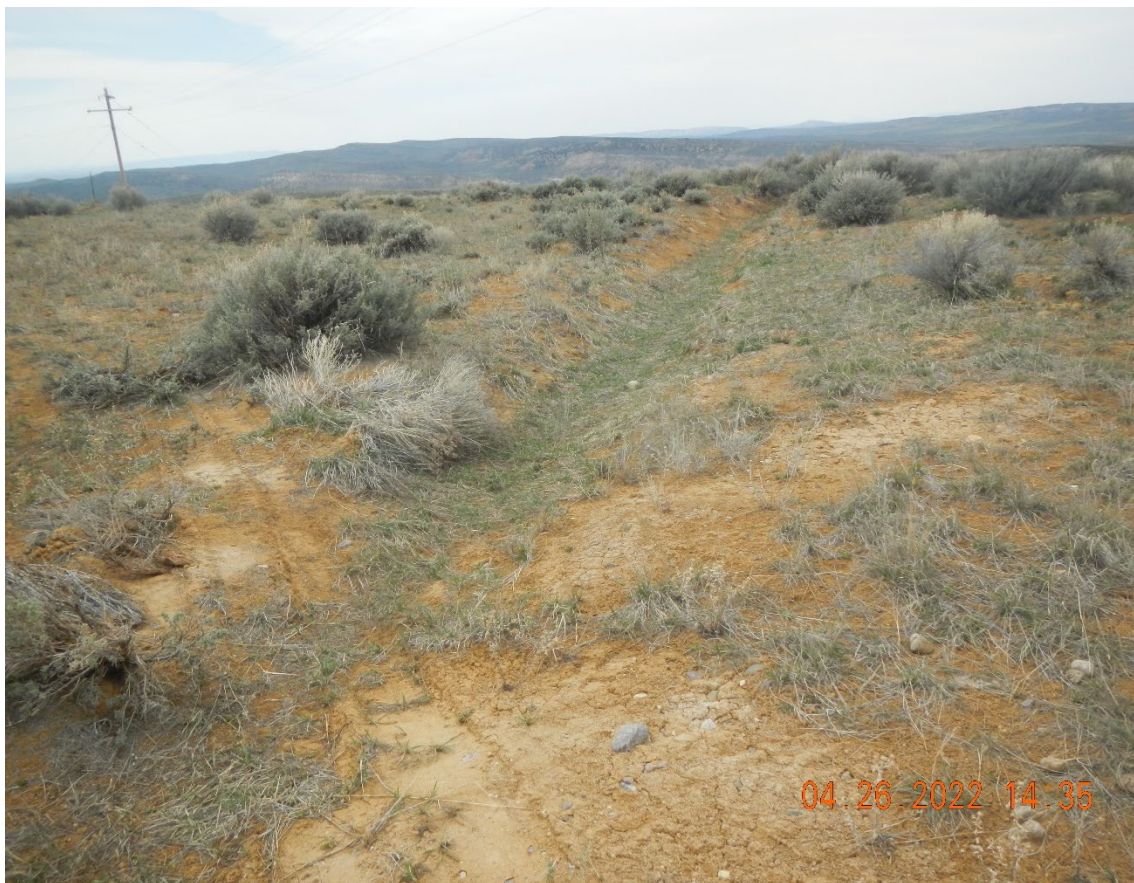
Photo #4 apparent surface water diversion on pad. The length of the diversion was walked, including the discharge. No apparent hydrocarbon or salt impacts were observed on the surface.

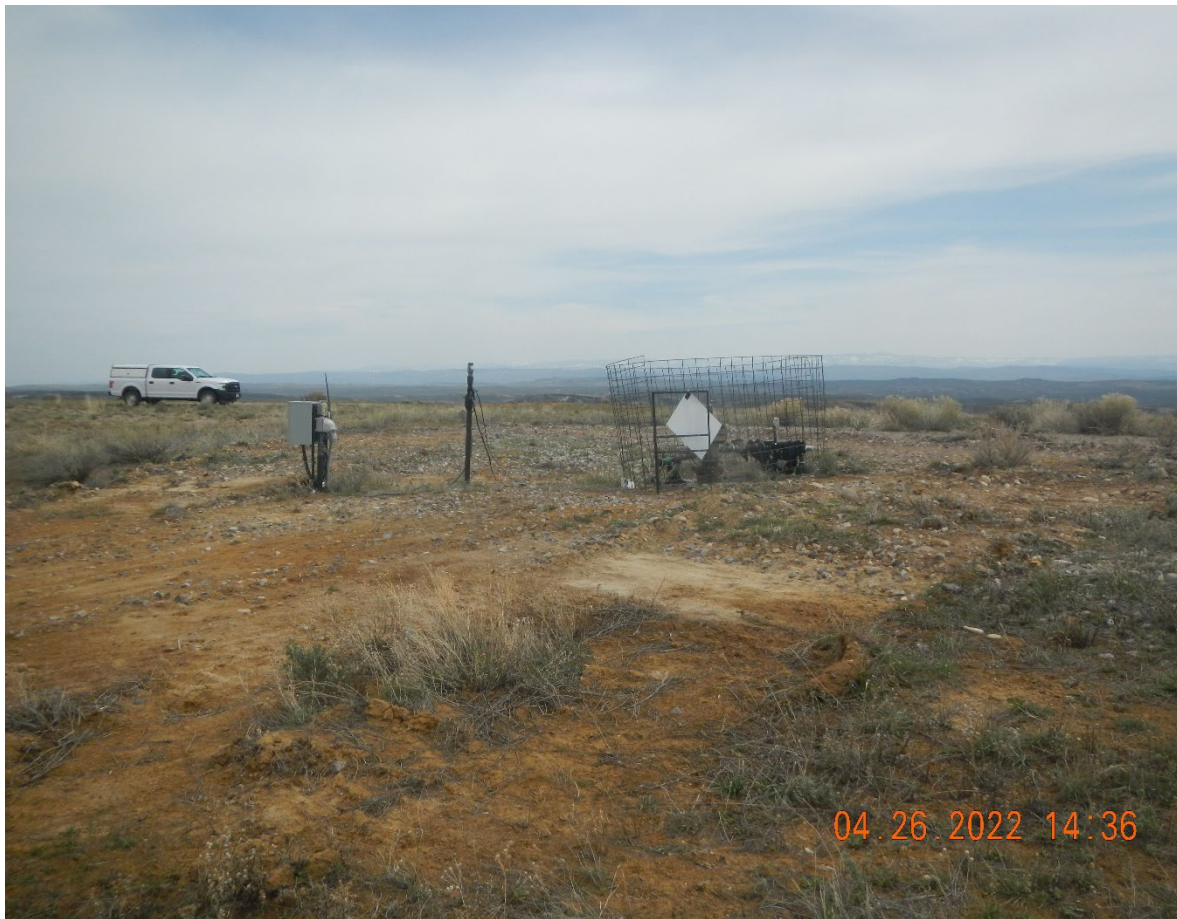
Photo #5 wellhead, production flowlines and electric sub panel.

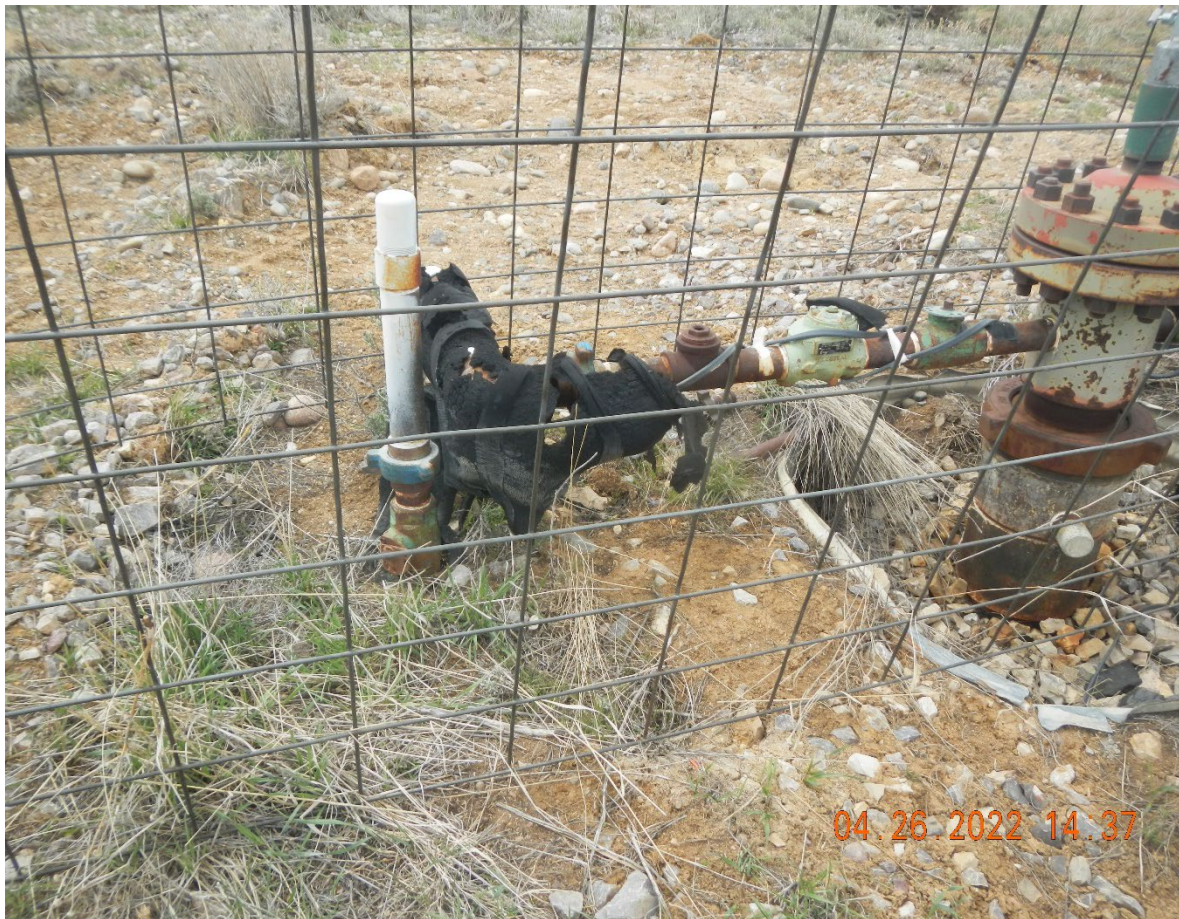
Photo #6 production flow line an wellhead.

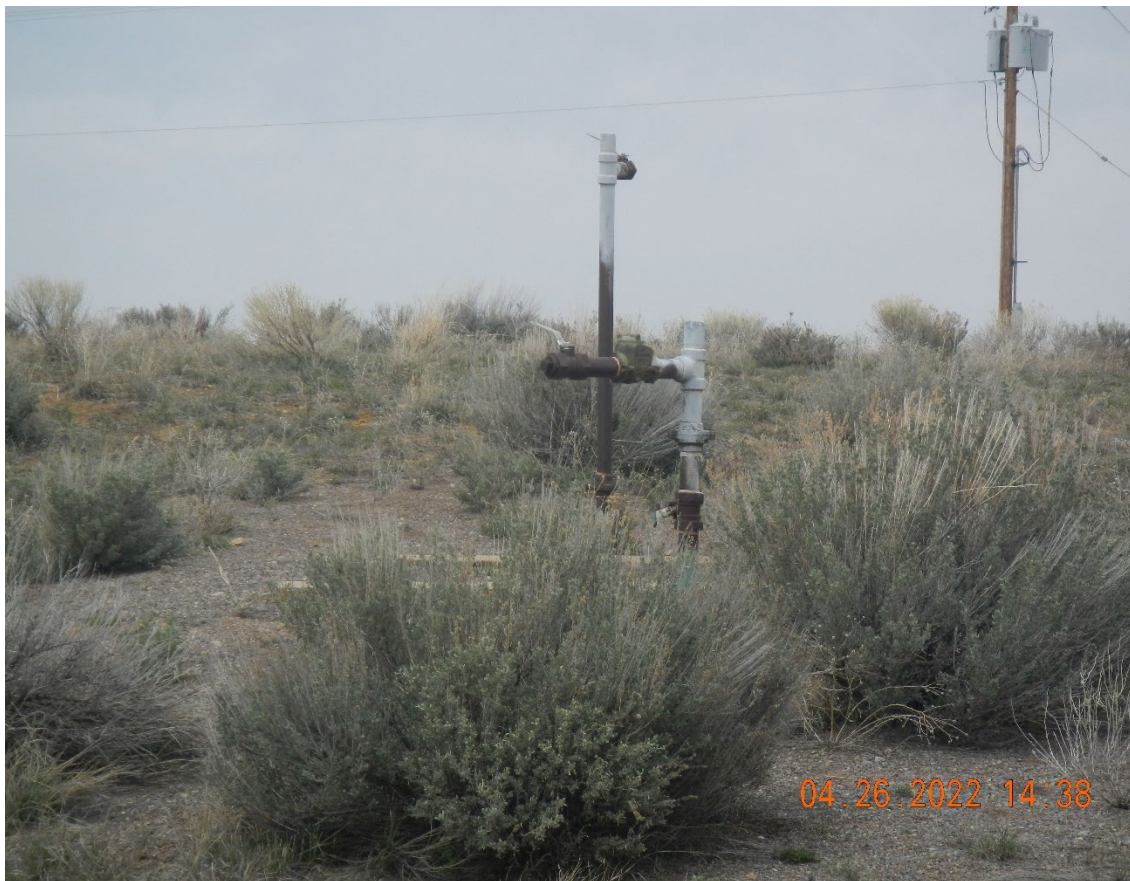
Photo #7 Flowline risers near main access road, wellhead fence can just barely be seen on the right side of photo (against sky).
