Site Inspection Report

Site: YOXALL FARMS MANIFOLD
04/14/2022

SITE/LOCATION	DATE	TIME	INSPECTOR
YOXALL FARMS MANIFOLD	04/14/2022	02:33 PM	COGCC Subcontractor
Comments	Staining within excavation.		
Work Activity Notes			
Changes since previous inspection?	No	Drive by inspection	No
Actively being worked?	No		
Fieldwork Oversight Performed?	No	Oversight Type	N/A
Were Oversight Samples Collected?	N/A	Sample Details	N/A

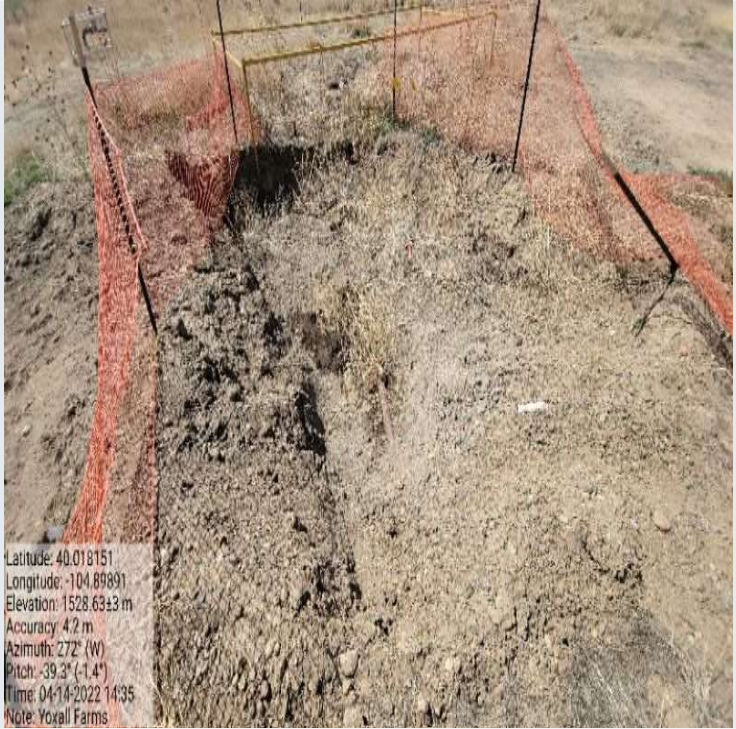
Remediation Activity Checklist	
	Photo
<p>Question: Open excavation? Approximate size (Length x Width x Depth, ft) Response: Yes Notes: 15x13x2</p>

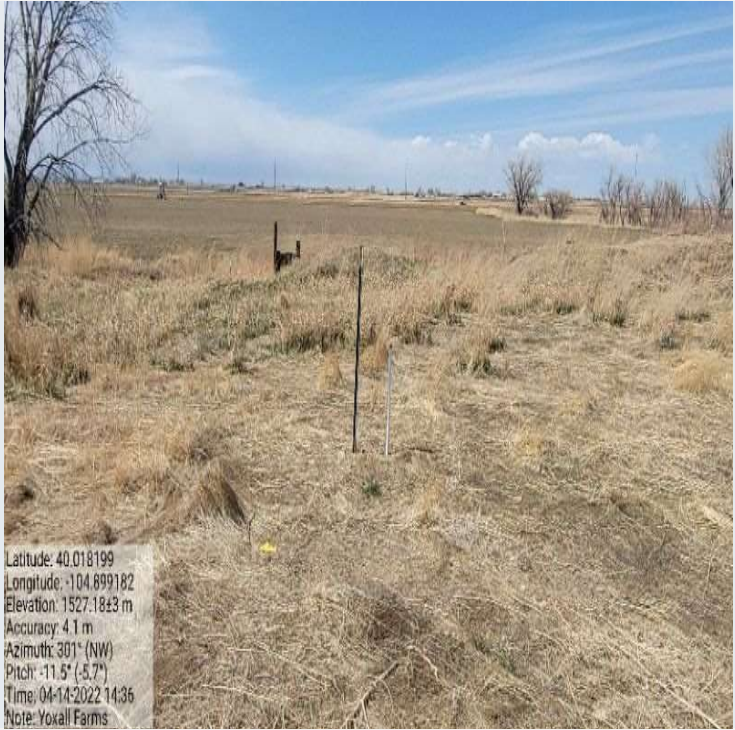
Photo
<p>Question: Monitoring well(s) present? If so note number and approximate location Response: Yes Notes:</p>

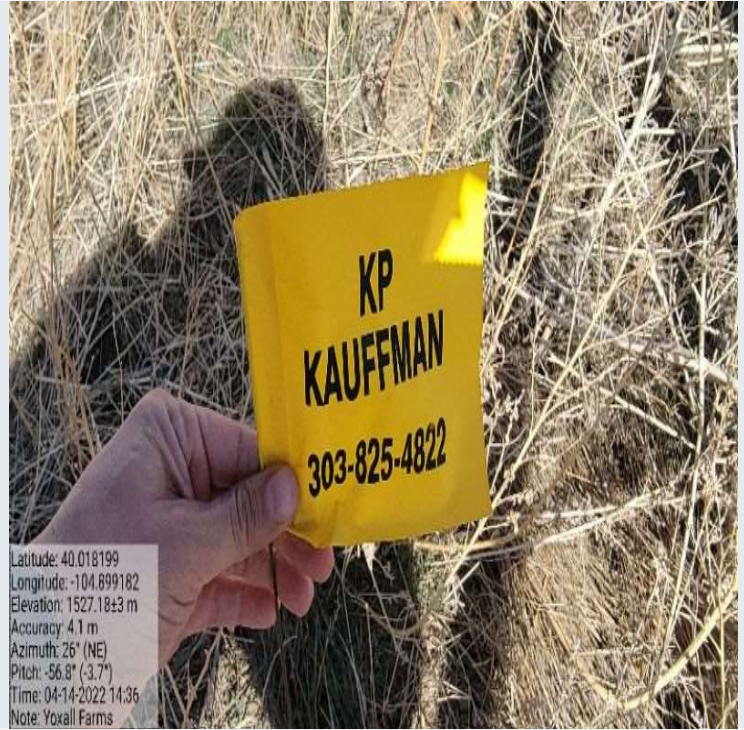
Question: Emergency sign in compliance with 605.g?

Response: N/A

Notes: Not inspected. KPK flags onsite.

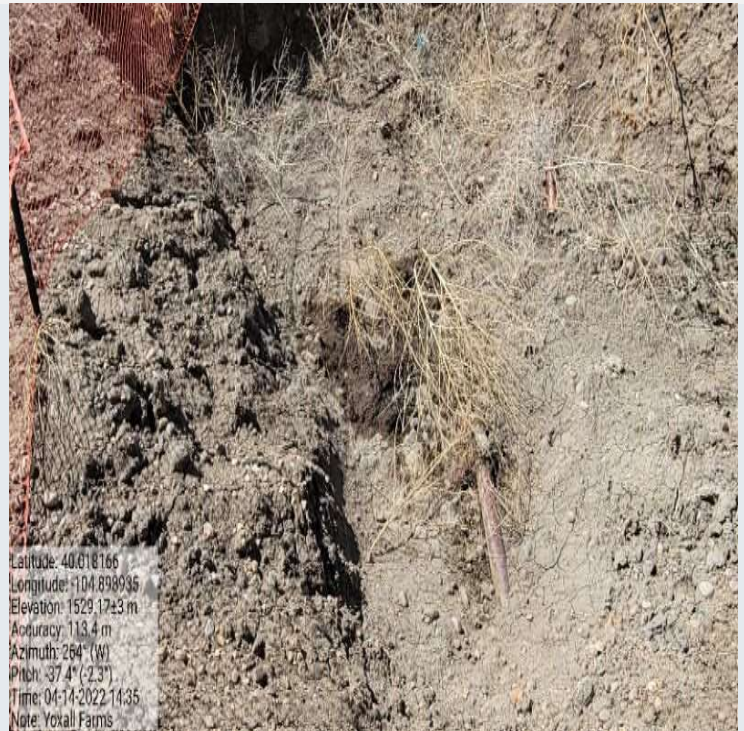
Question: Ground surface appears clean (no evidence of new equipment leaks, oil leaks, spills, or releases)?

Response: No

Notes: Staining remains adjacent to flowline.

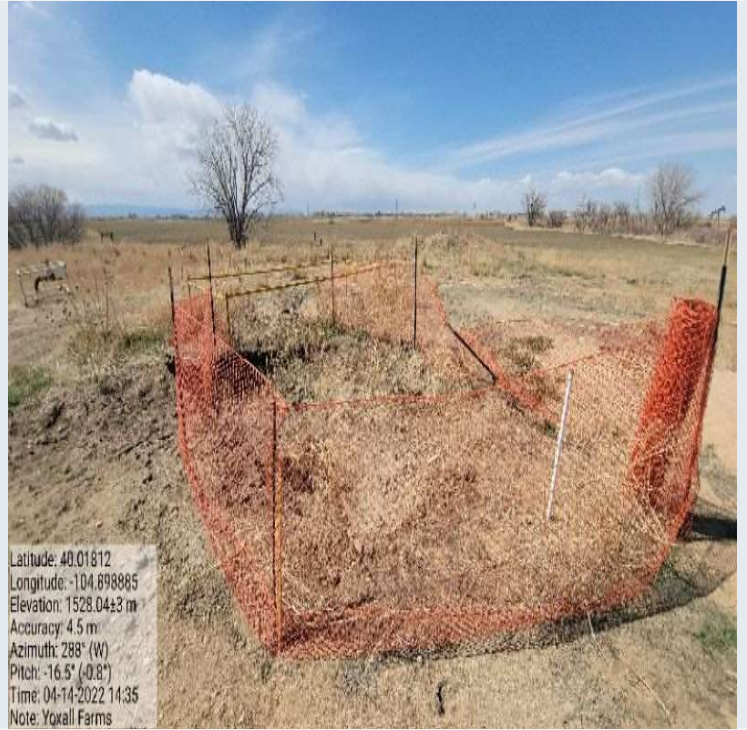
Question: Site properly fenced (in accordance with rule 913.b.(5)B.i)?

Response: No

Notes: Fencing falling.

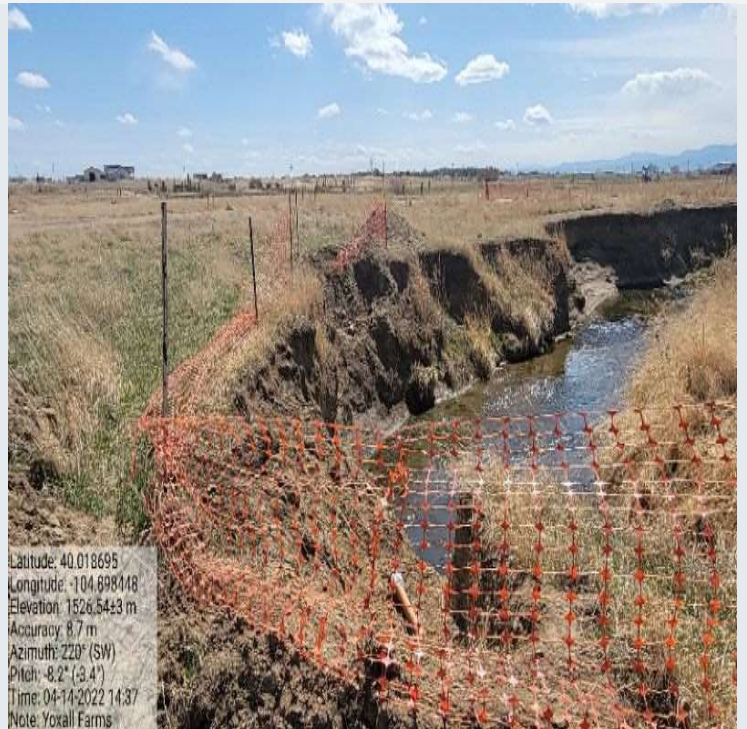
Question: Site properly fenced (in accordance with rule 913.b.(5)B.i)?

Response: No

Notes: Fencing has fallen.

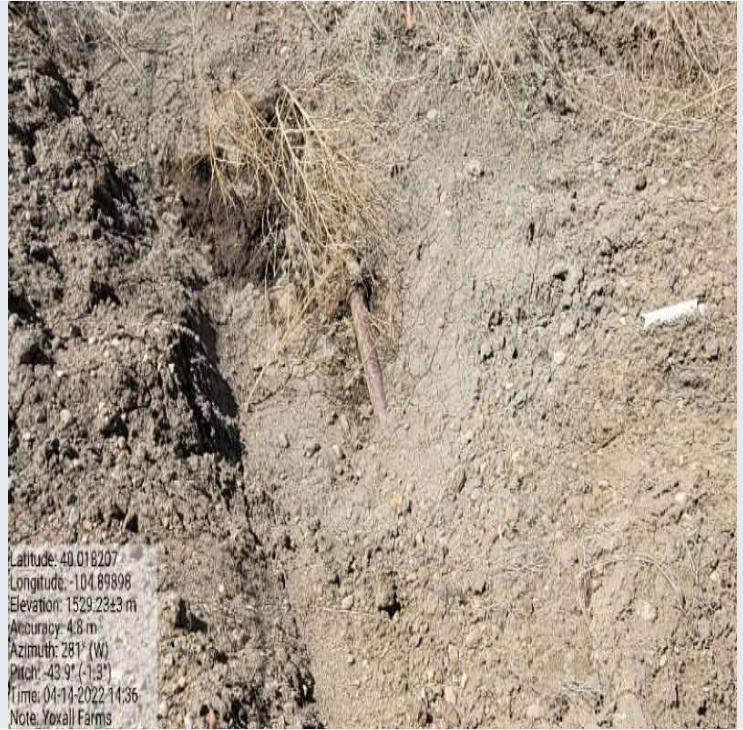
Question: Exposed buried/underground flowlines?
Response: Yes
Notes:

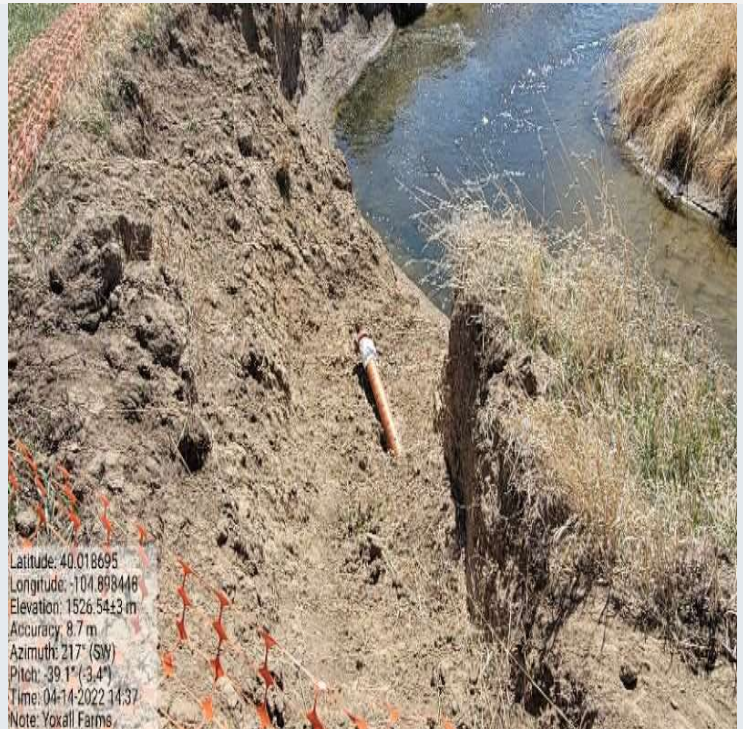
Question: If flowlines are exposed are they properly capped (bullnose plug, etc.)?
Response: Yes
Notes:

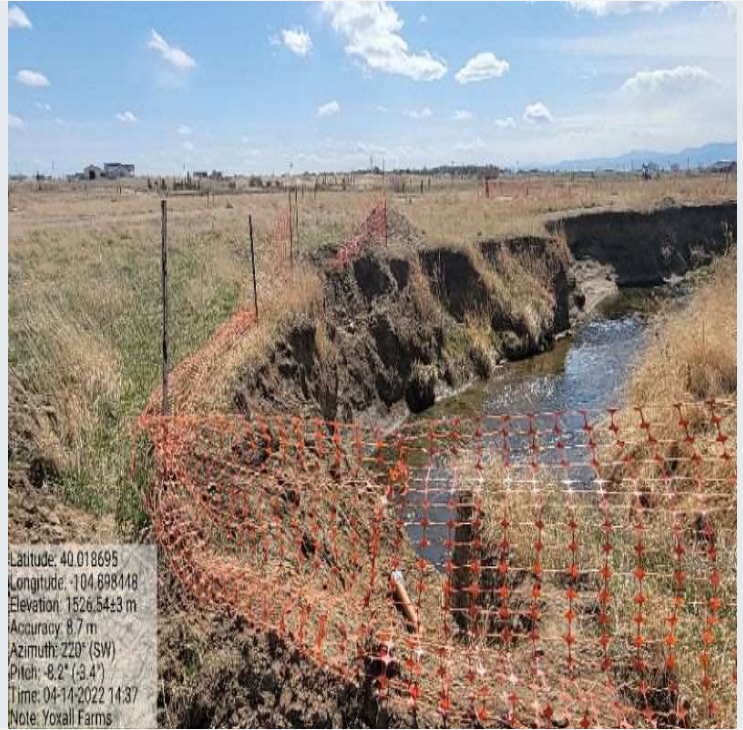
Question: All stormwater erosion control measures and BMPs are present and in good/working condition?

Response: No.

Notes: Not present.

Photo
<p>Question: Evidence of sediment/debris observed on adjacent roads? (If yes, is note tracking control BMP presence/conditions) Response: No Notes:</p>	<p>No Photo</p>
<p>Question: Additional stormwater control measures/maintenance recommended? Response: Yes Notes: Stormwater controls need to be installed.</p>	<p>No Photo</p>

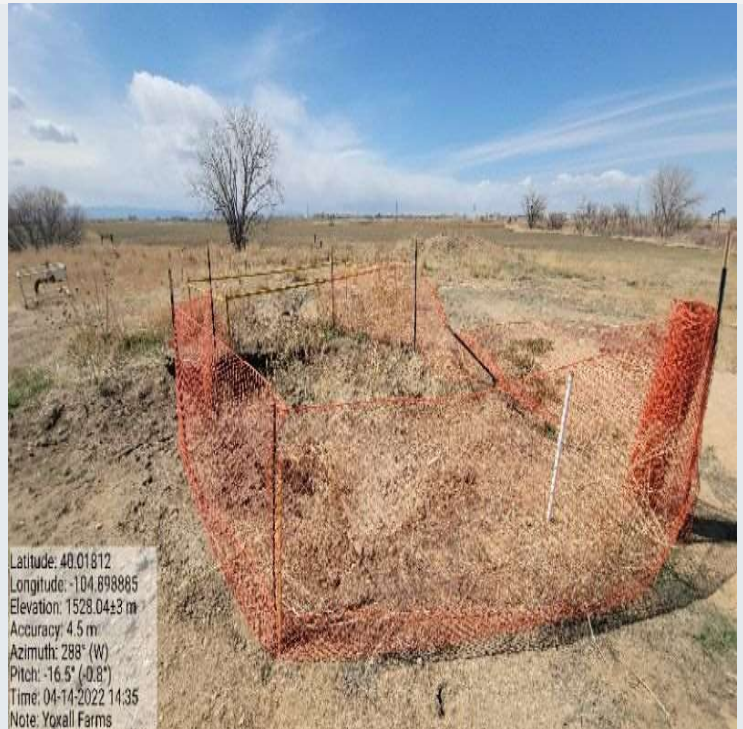
Question: Site is free of weeds/debris/trash?

Response: No

Notes: Weeds on location.
