Site Inspection Report

Site: MOSER 1A
04/22/2022

SITE/LOCATION	DATE	TIME	INSPECTOR
MOSER 1A	04/22/2022	12:44 PM	COGCC Subcontractor
Comments			
Work Activity Notes			
Changes since previous inspection?	No	Drive by inspection	No
Actively being worked?	No		
Fieldwork Oversight Performed?	No	Oversite Type	N/A
Were Oversight Samples Collected?	N/A	Sample Details	N/A

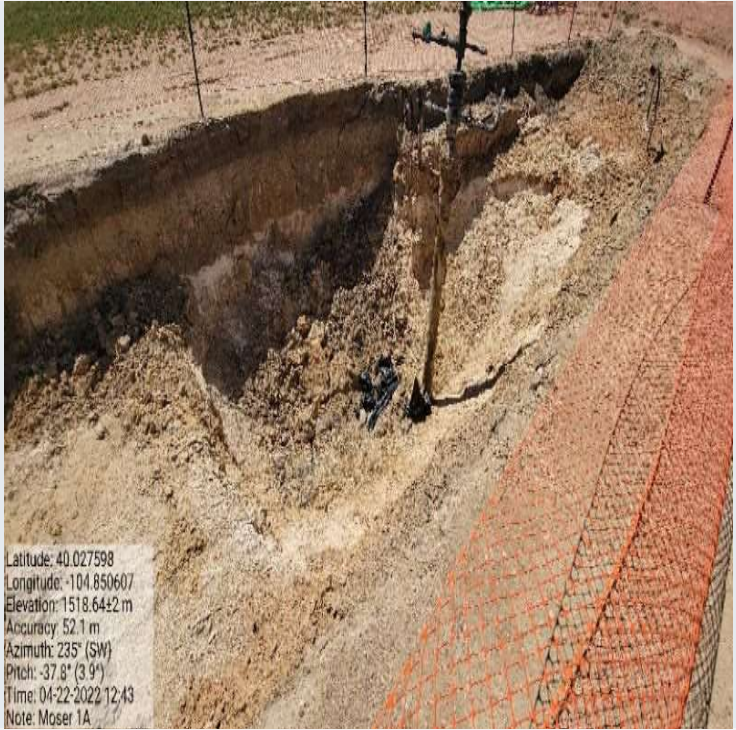
Photo
<p>Question: Open excavation? Approximate size (Length x Width x Depth, ft) Response: Yes Notes: 107x45x8</p>

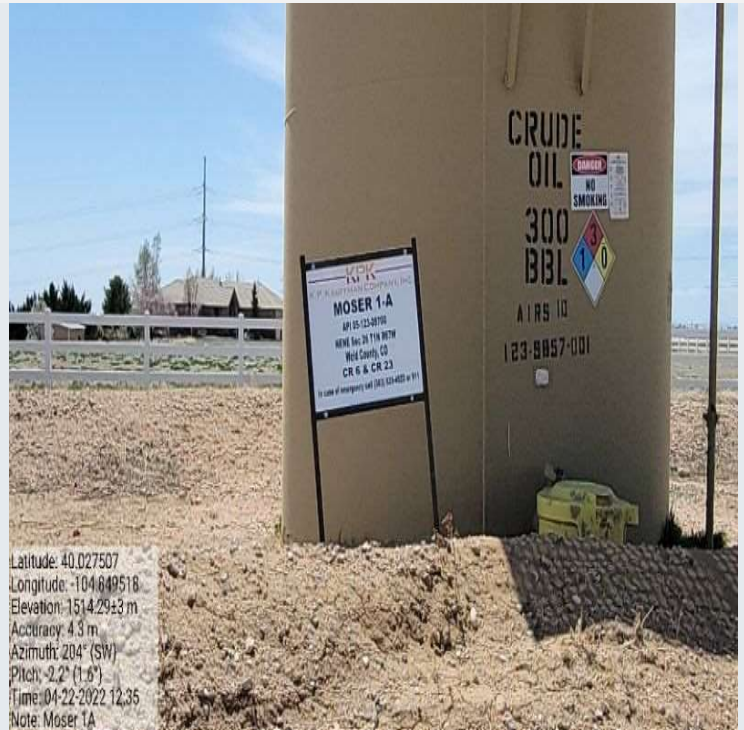
Question: Emergency sign in compliance with 605.g?
Response: Yes
Notes:

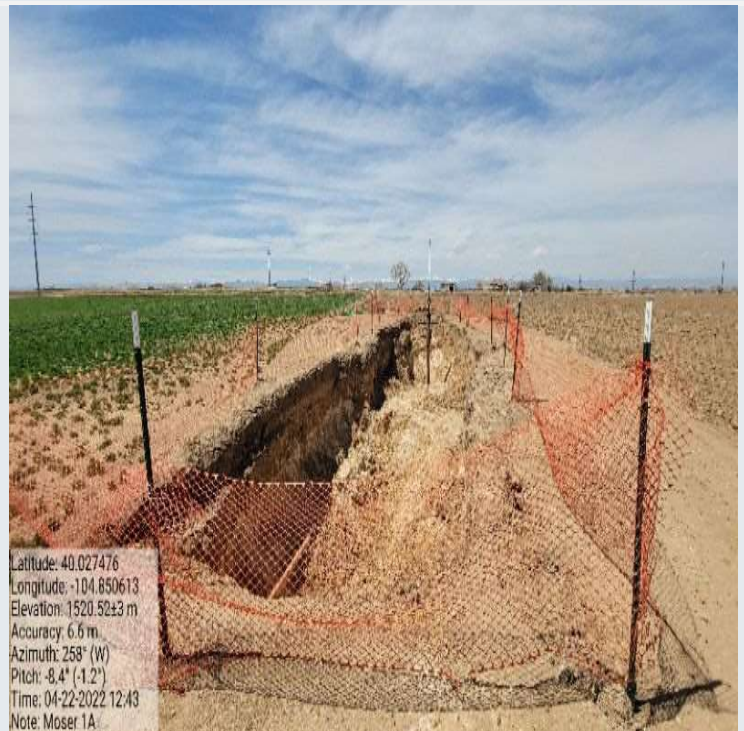
Question: Site properly fenced (in accordance with rule 913.b.(5)B.i)?
Response: Yes
Notes: Fencing surrounding excavation is beginning to fall.

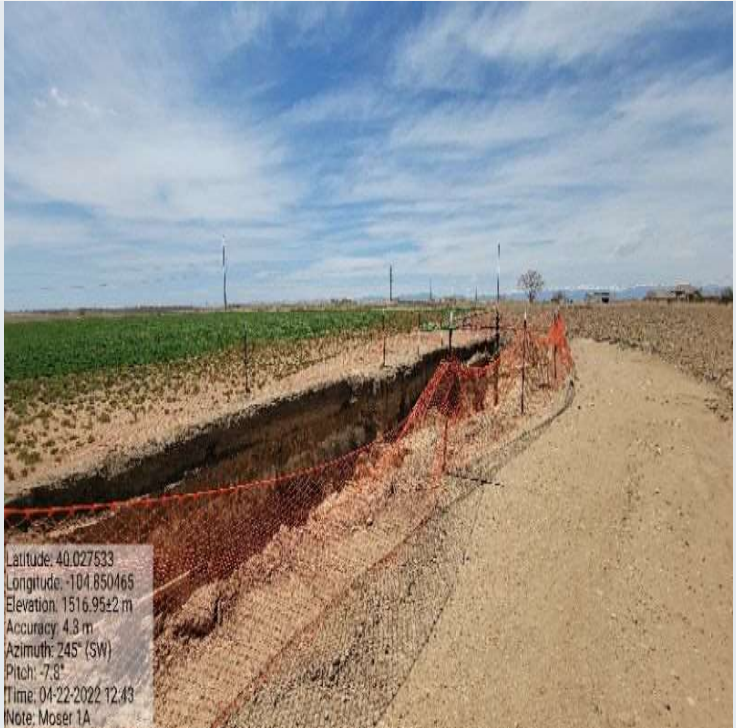
Photo
<p>Question: Is fencing adequate/appropriate for site and well maintained? Response: Yes Notes: Fencing surrounding excavation is beginning to fall.</p>

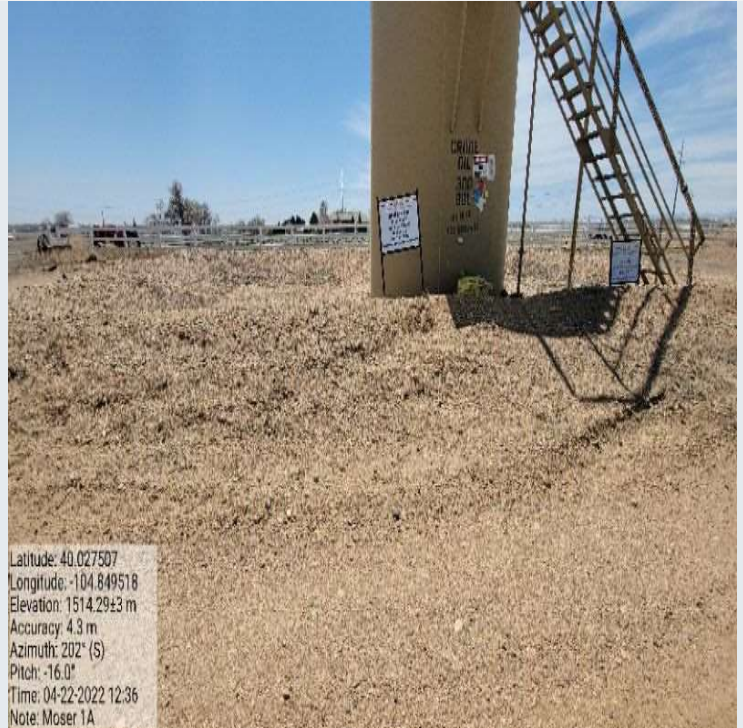
Question: Is an earthen berm secondary containment present and in good condition (no evidence of erosion, animal burrowing, etc.)?

Response: Yes

Notes: Earthen berms at tank battery are adequate.

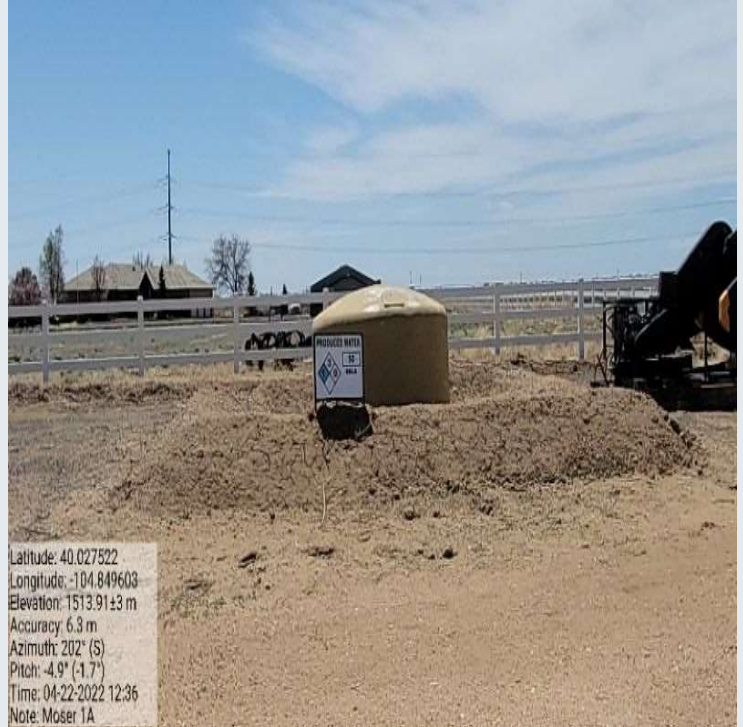
Question: Is an earthen berm secondary containment present and in good condition (no evidence of erosion, animal burrowing, etc.)?

Response: Yes

Notes: Earthen berms at tank battery are adequate.

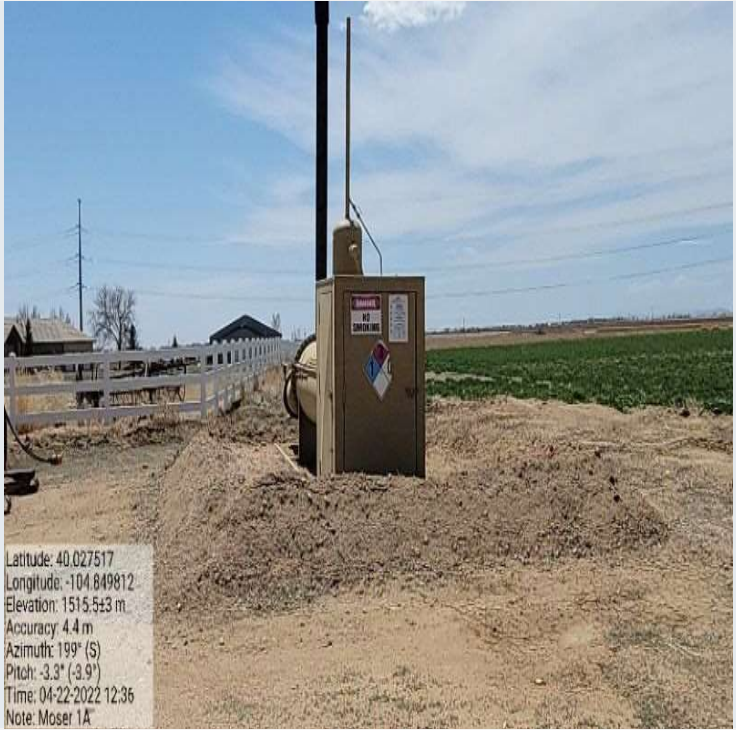
Photo
<p>Question: Is an earthen berm secondary containment present and in good condition (no evidence of erosion, animal burrowing, etc.)? Response: Yes Notes: Earthen berms at tank battery are adequate.</p>

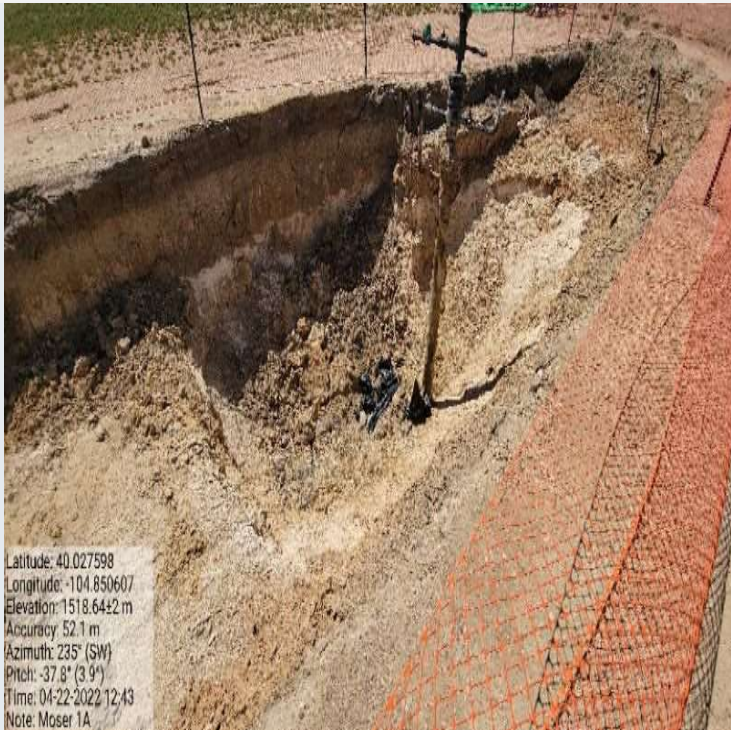
Photo
<p>Question: Site is free of debris/trash? Response: No Notes: Silt fencing has been removed/never fixed. Portion of the silt fence has blown into the open excavation.</p>

Photo
<p>Question: Evidence of sediment/debris observed on adjacent roads? (If yes, is note tracking control BMP presence/conditions)</p> <p>Response: No</p> <p>Notes:</p>	No Photo
<p>Question: Additional stormwater control measures/maintenance recommended?</p> <p>Response: Yes</p> <p>Notes: BMPs around perimeter of location.</p>	No Photo

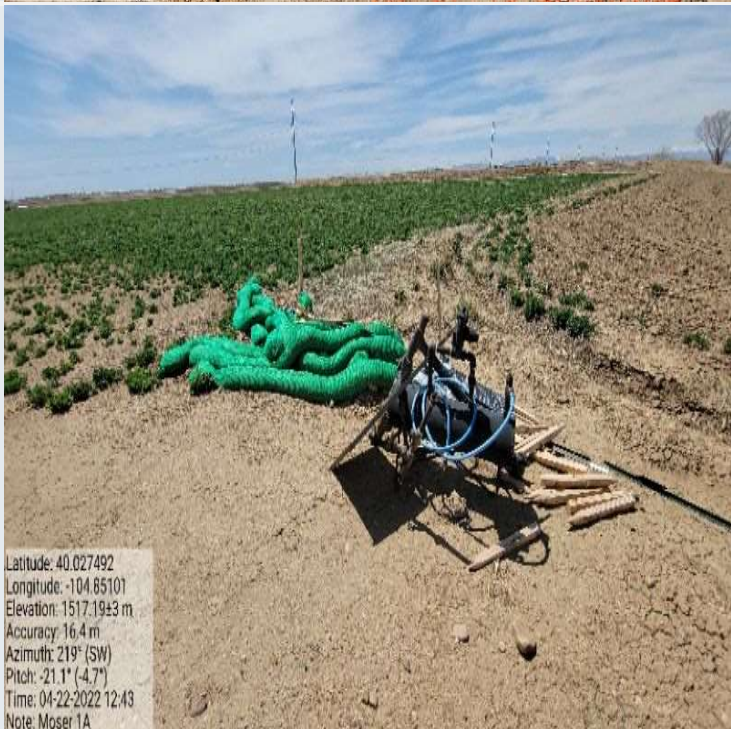
<p>Latitude: 40.027598 Longitude: -104.850607 Elevation: 1518.64±2 m Accuracy: 52.1 m Azimuth: 235° (SW) Pitch: -37.8° (3.9°) Time: 04-22-2022 12:43 Note: Moser 1A</p>
<p>Question: Site is free of debris/trash? Response: No Notes: Debris/Unused equipment is being stored on location.</p>
