Site Inspection Report

Site: UPRR 43 PAN AM I5
04/26/2022

SITE/LOCATION	DATE	TIME	INSPECTOR
UPRR 43 PAN AM I5	04/26/2022	03:07 PM	COGCC Subcontractor
Comments			
Work Activity Notes			
Changes since previous inspection?	No	Drive by inspection	No
Actively being worked?	No		
Fieldwork Oversight Performed?	No	Oversight Type	N/A
Were Oversight Samples Collected?	N/A	Sample Details	N/A

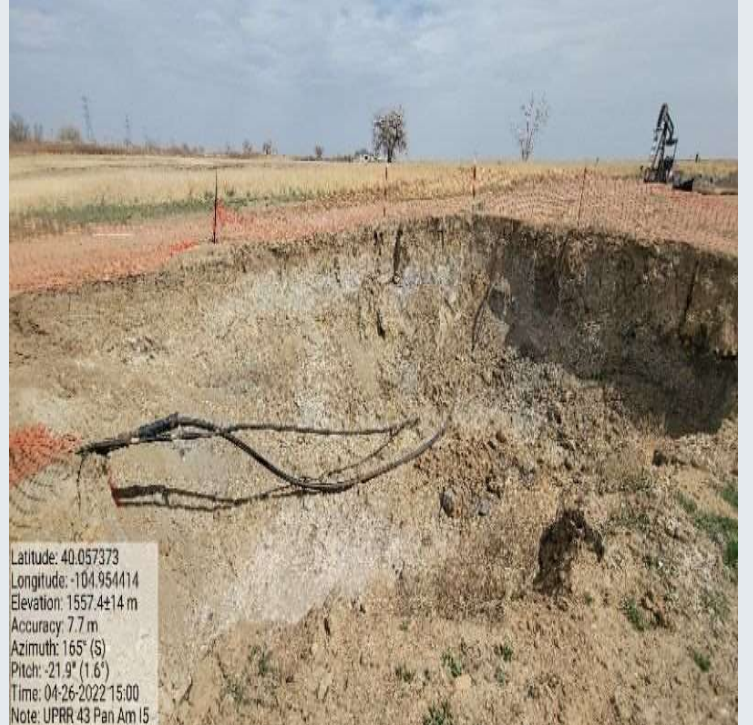
Remediation Activity Checklist	
	Photo
Question: Open excavation? Approximate size (Length x Width x Depth, ft) Response: Yes Notes: 52x36x8

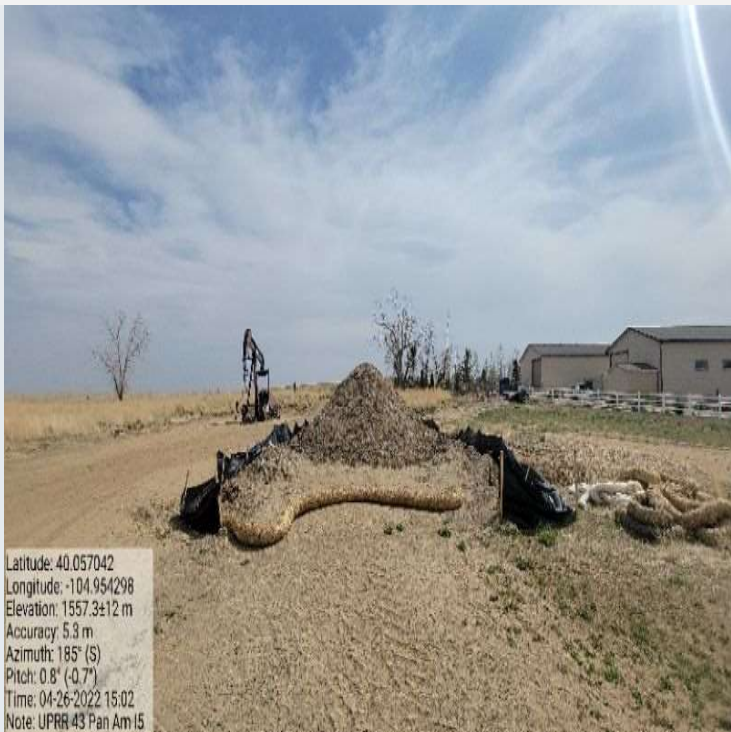
Photo
Question: Stockpiled waste and approximate volume (cubic ft) Response: Yes Notes: Not measured

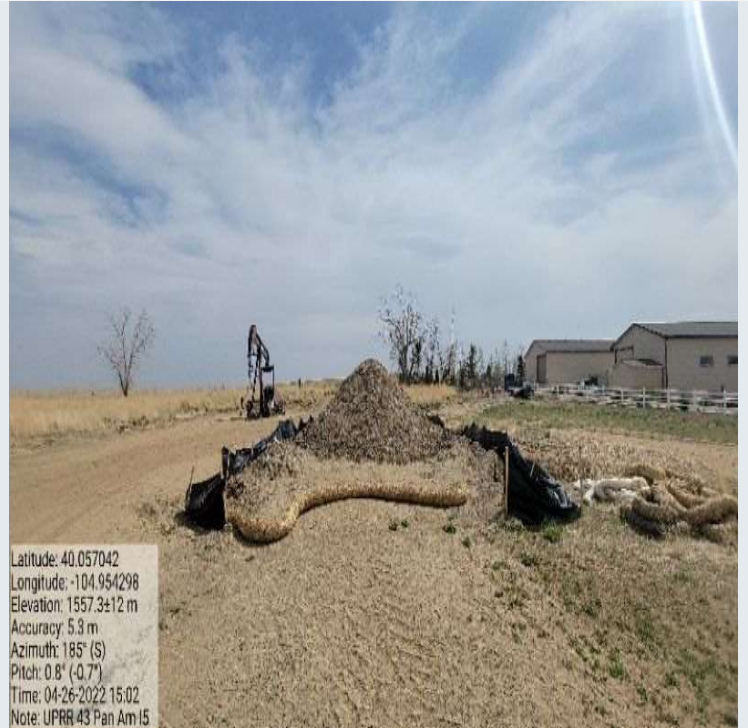
Question: Waste signage present, legible is accurate and up to date (in accordance with rule 913.b.(5)B.iv)?

Response: No

Notes: No signage.

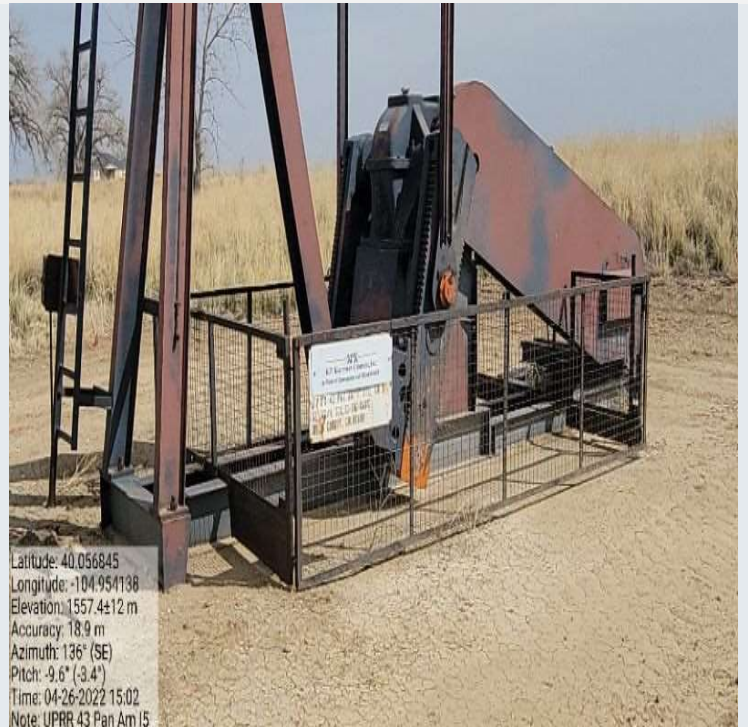
Question: Emergency sign in compliance with 605.g?

Response: Yes

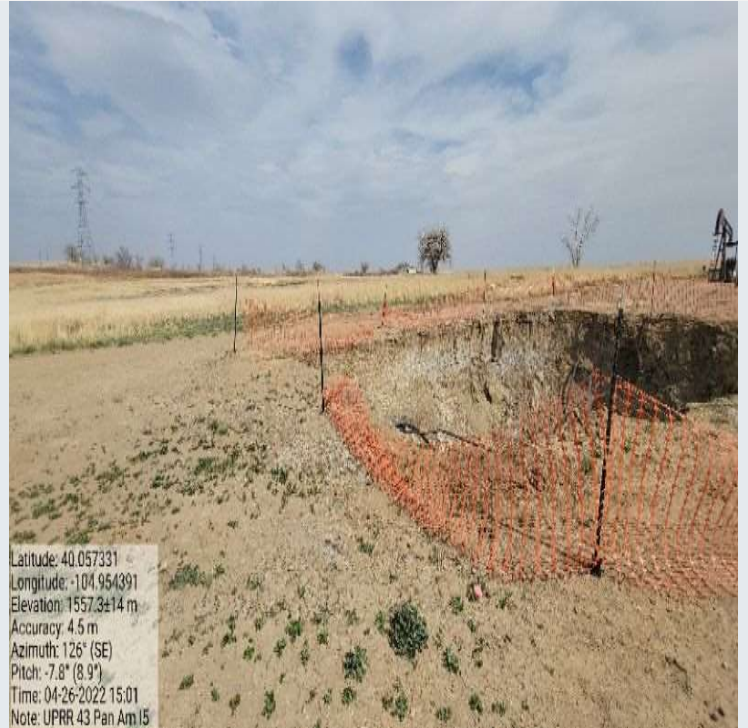
Question: Site properly fenced (in accordance with rule 913.b.(5)B.i)?

Response: No

Notes: Fencing around open excavation has fallen.

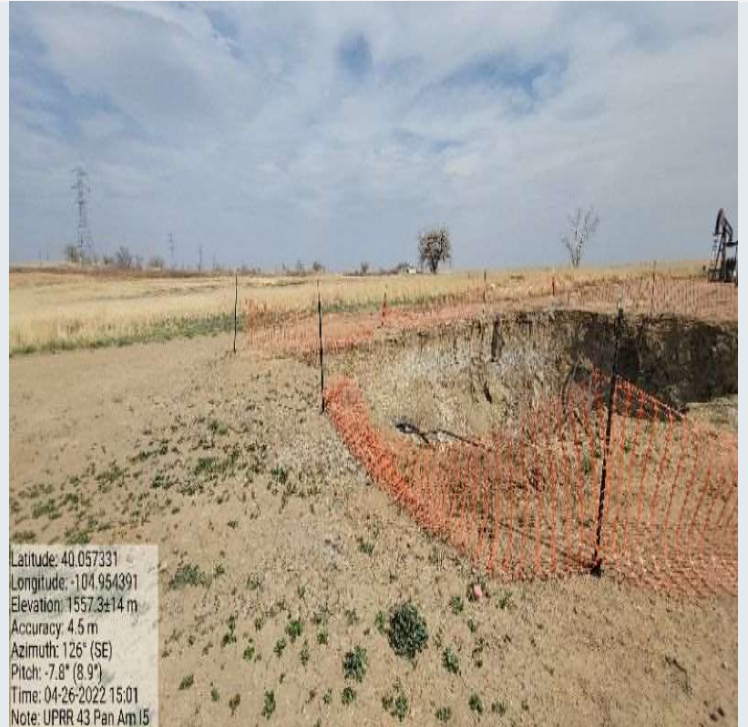
Question: Is fencing adequate/appropriate for site and well maintained?

Response: No

Notes: Fencing around open excavation has fallen.

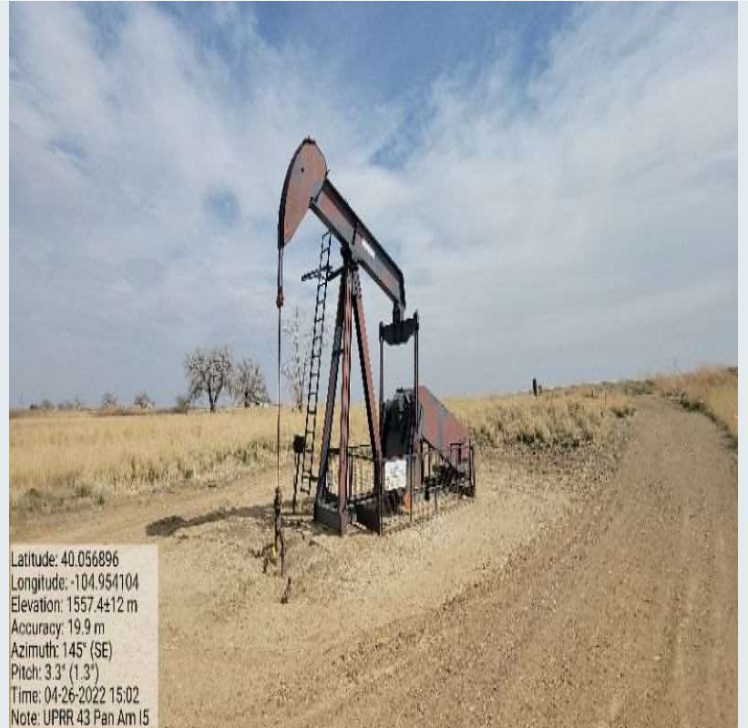
Question: Is fencing adequate/appropriate for site and well maintained?

Response: No

Notes: Fencing around pumpjack does not surround all moving parts.

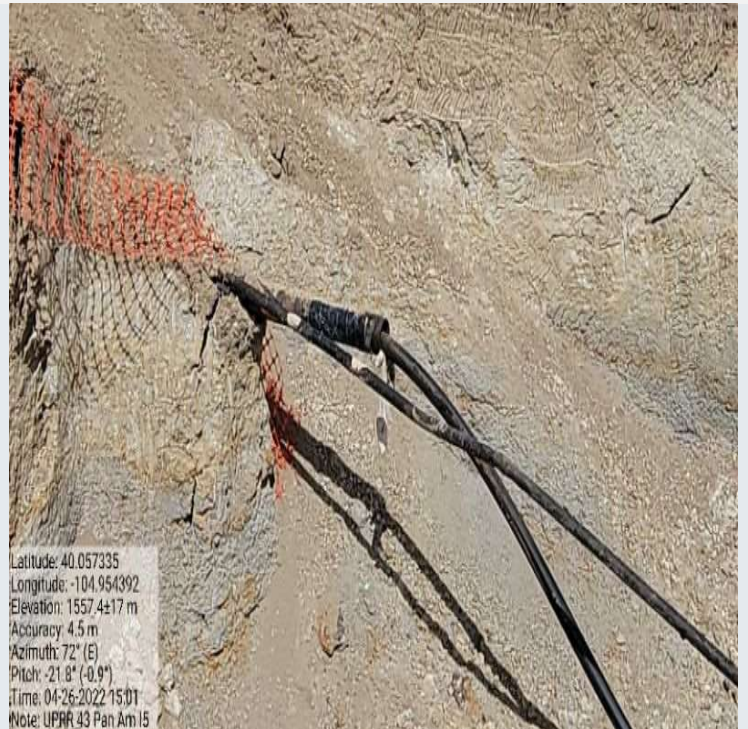
Question: Exposed buried/underground flowlines?

Response: Yes

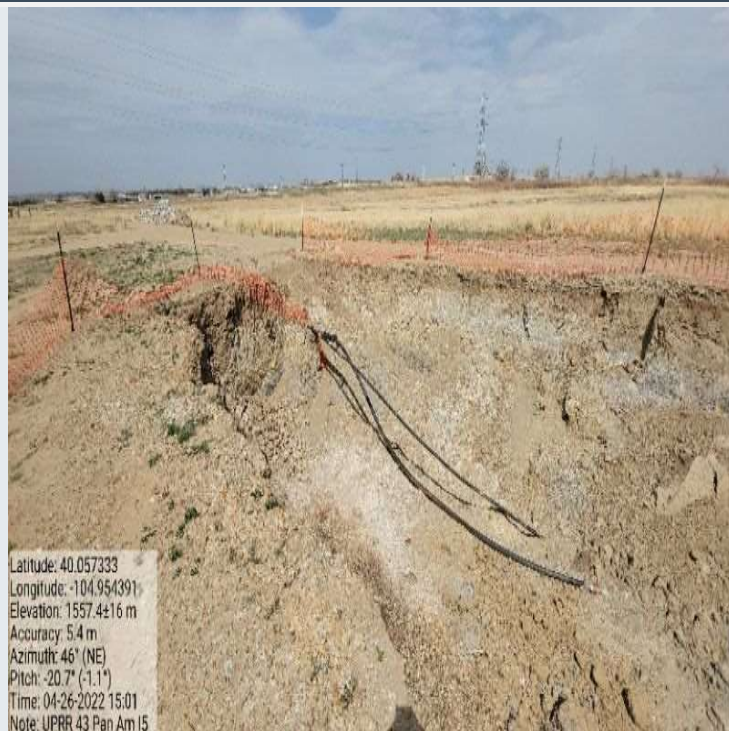
Question: Exposed buried/underground flowlines?

Response: Yes

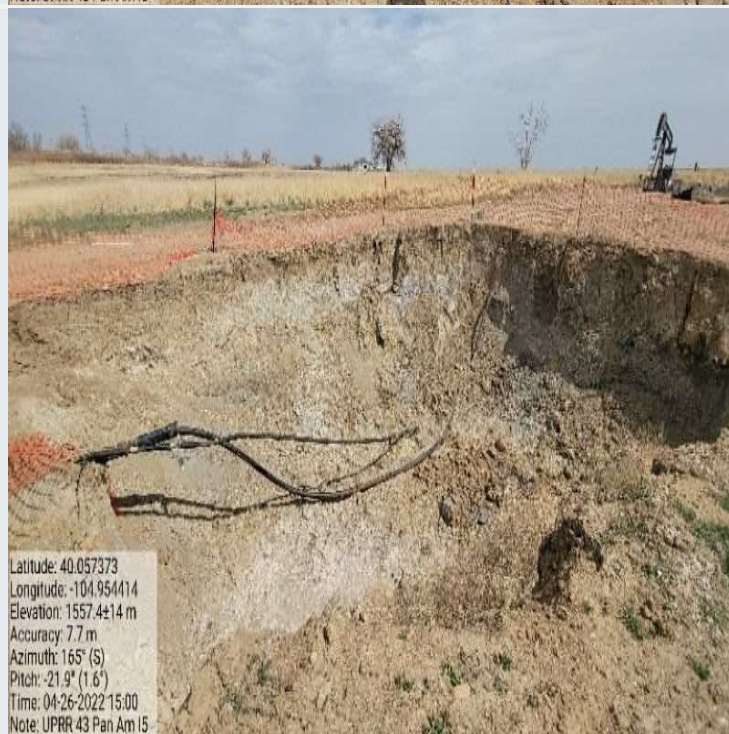
Question: Exposed buried/underground flowlines?

Response: Yes

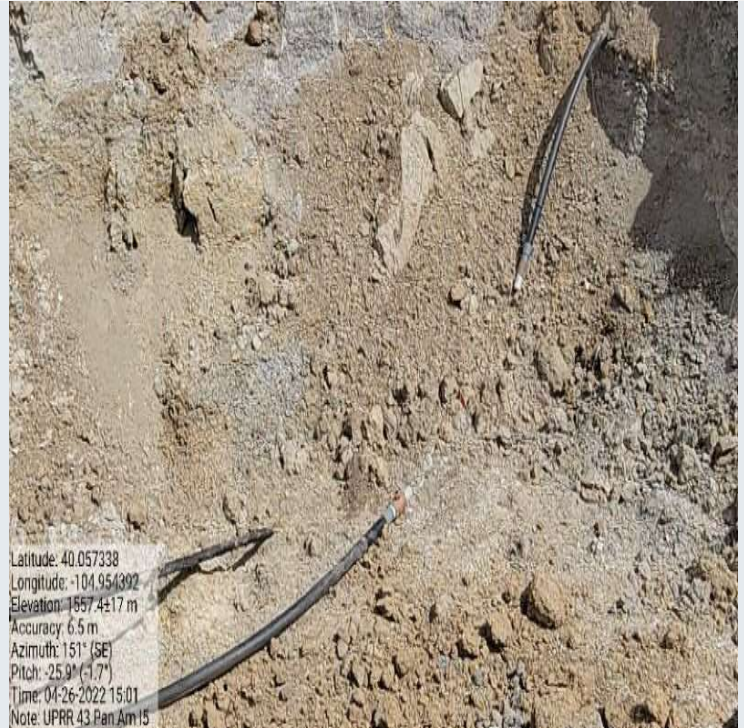
Question: If flowlines are exposed are they properly capped (bullnose plug, etc.)?

Response: Yes

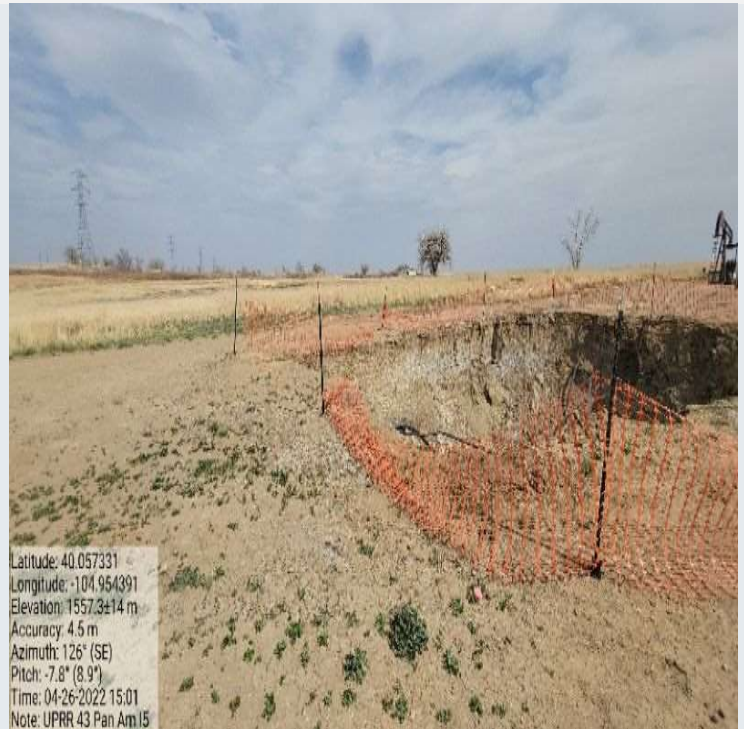
Question: Site is protected from vehicular traffic?

Response: No

Notes: Fencing surrounding open excavation has fallen and does not provide adequate protection from vehicular traffic or other access.

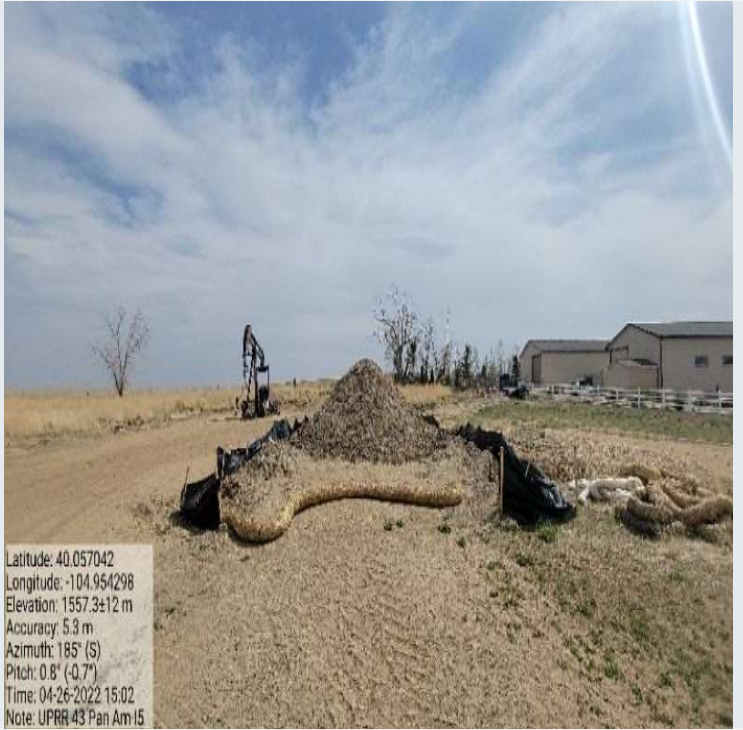
Photo
<p>Question: Is an earthen berm secondary containment present and in good condition (no evidence of erosion, animal burrowing, etc.)?</p> <p>Response: N/A</p> <p>Notes: Soil surrounding stockpiled appears to be installed to support silt fence.</p>

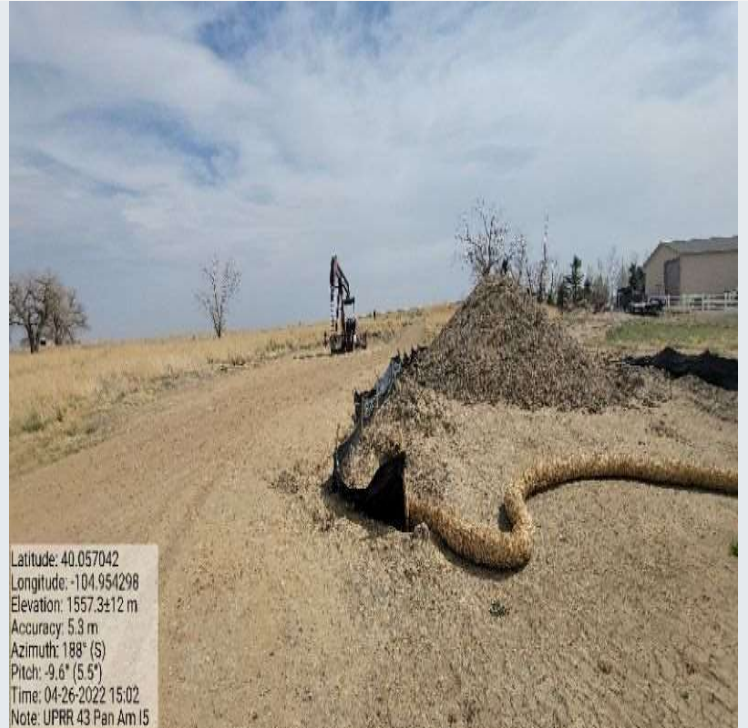
Question: All stormwater erosion control measures and BMPs are present and in good/working condition?

Response: No

Notes: Additional BMPs recommended. Silt fencing falling around stockpile, straw wattle around stockpile has been installed improperly.

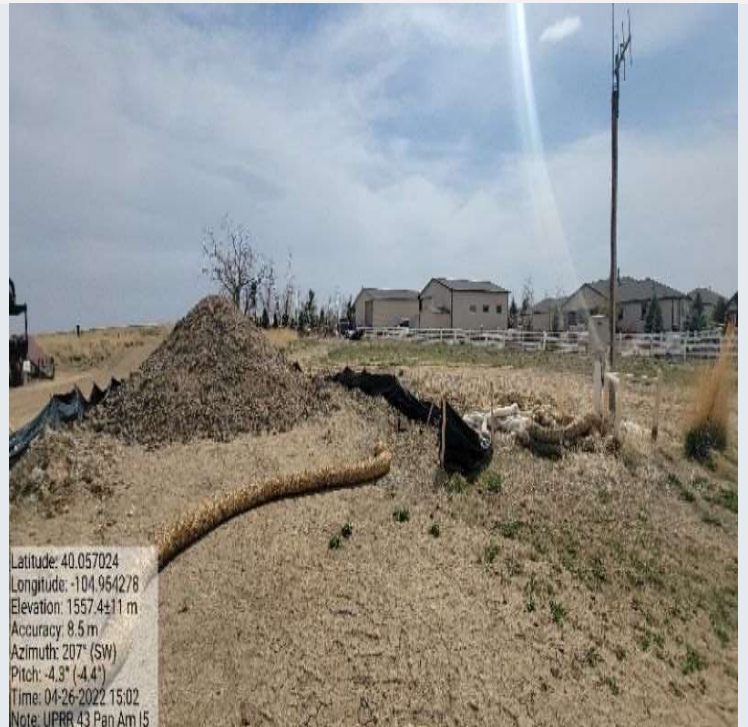
Question: All stormwater erosion control measures and BMPs are present and in good/working condition?

Response: No

Notes: BMPs recommended. Silt fencing falling around stockpile

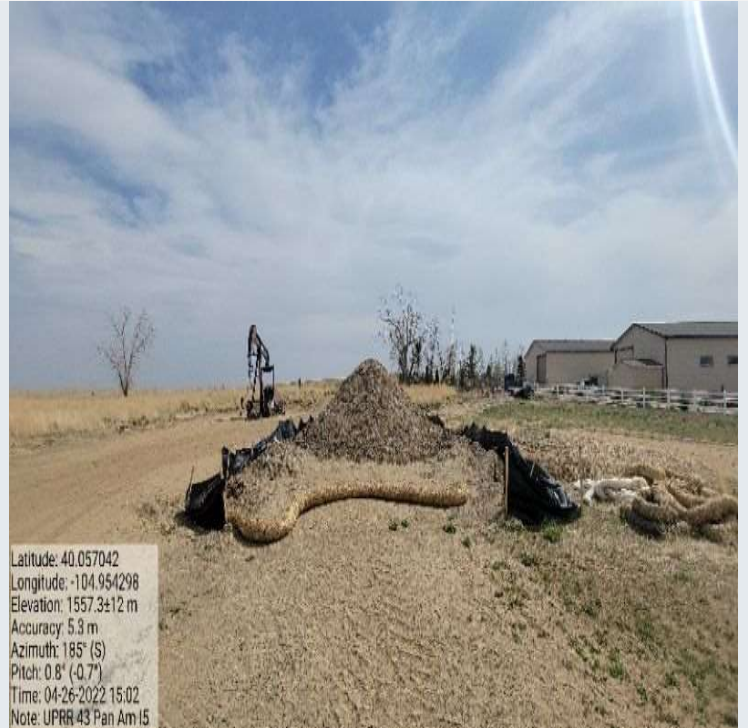
Question: Site is free of unused equipment, weeds, debris/trash?

Response: No

Notes: Unused booms and straw wattles are being stored on location. Weeds are beginning to grow throughout location.

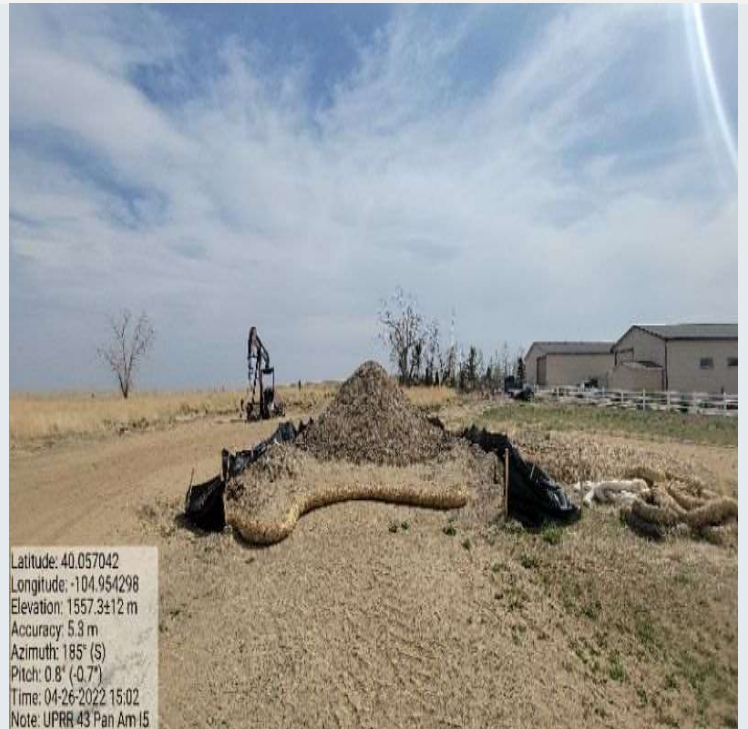
Question: Potential pollutants (trash, material stockpiles) are properly contained?

Response: No

Notes: Stockpiled soil is not properly contained.

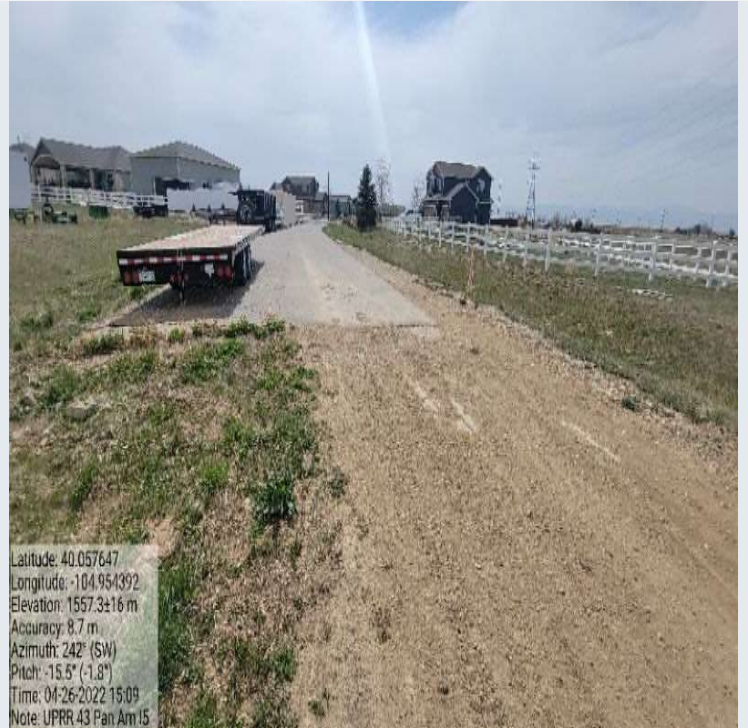
Question: Evidence of sediment/debris observed on adjacent roads? (If yes, is note tracking control BMP presence/conditions)

Response: Yes

Notes: Trackout control is needed.

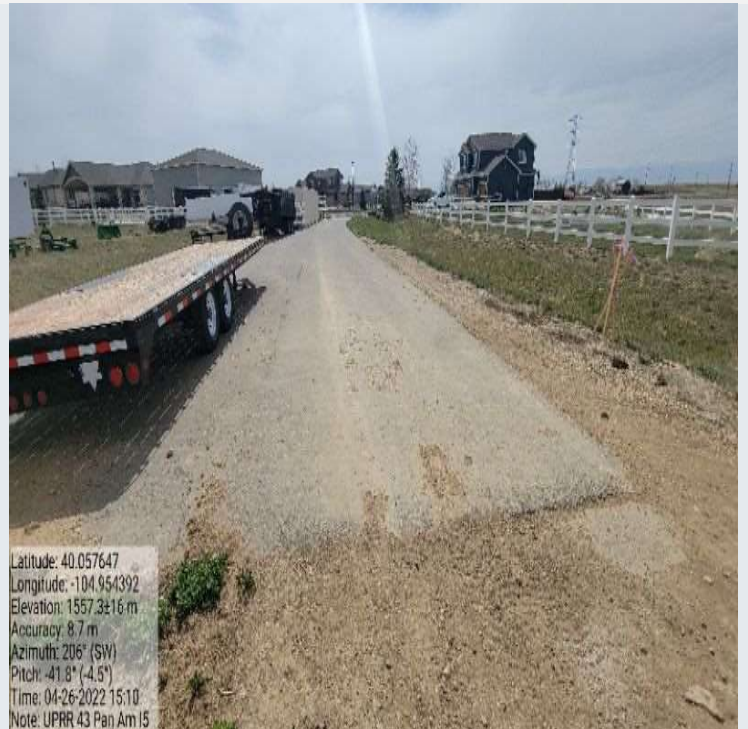
Question: Evidence of sediment/debris observed on adjacent roads? (If yes, is note tracking control BMP presence/conditions)

Response: Yes

Notes: Trackout control is needed.
