Site Inspection Report

**Site: EUGENE DOVERSBERGER #2 -
CONSOLIDATION FLOWLINE**
04/29/2022

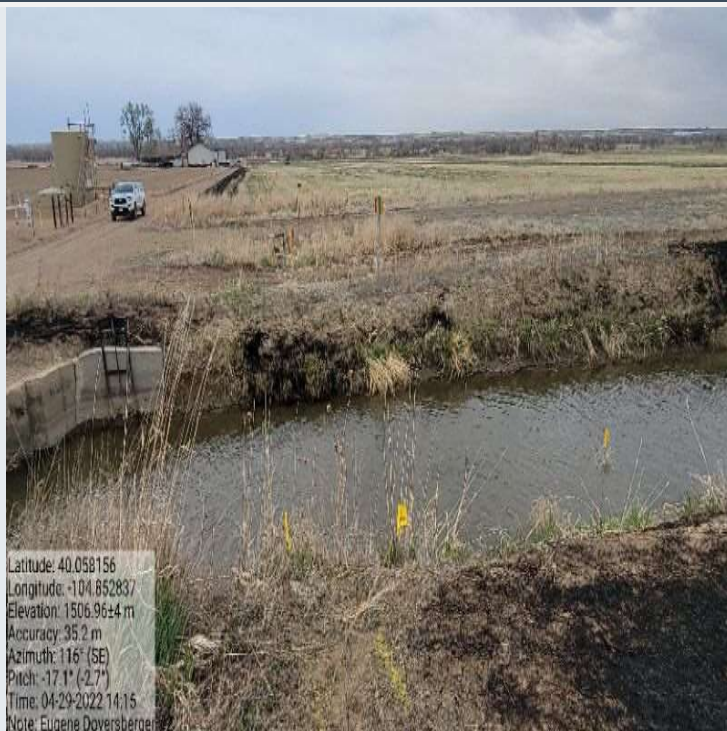
Notes: Flowline runs under active irrigation ditch.

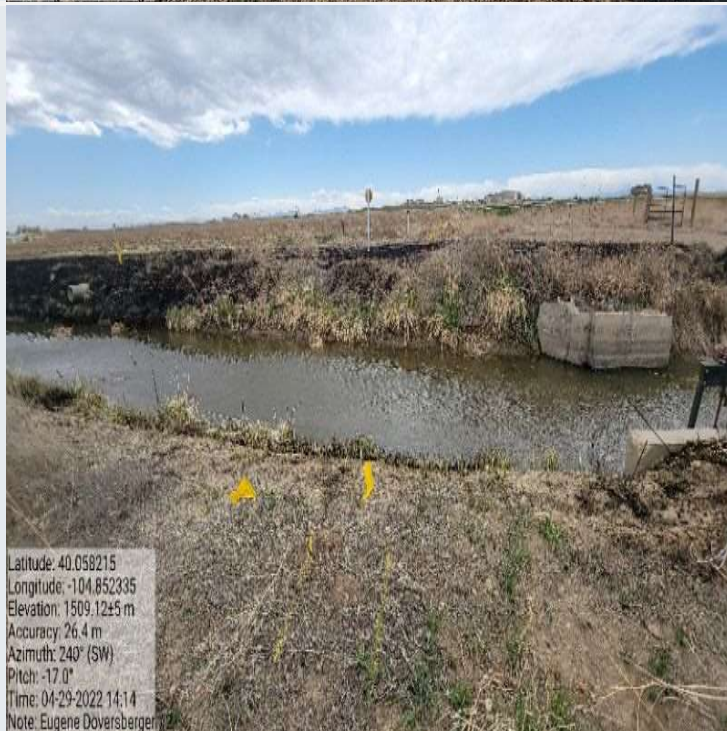
Notes: Flowline runs under active irrigation ditch.

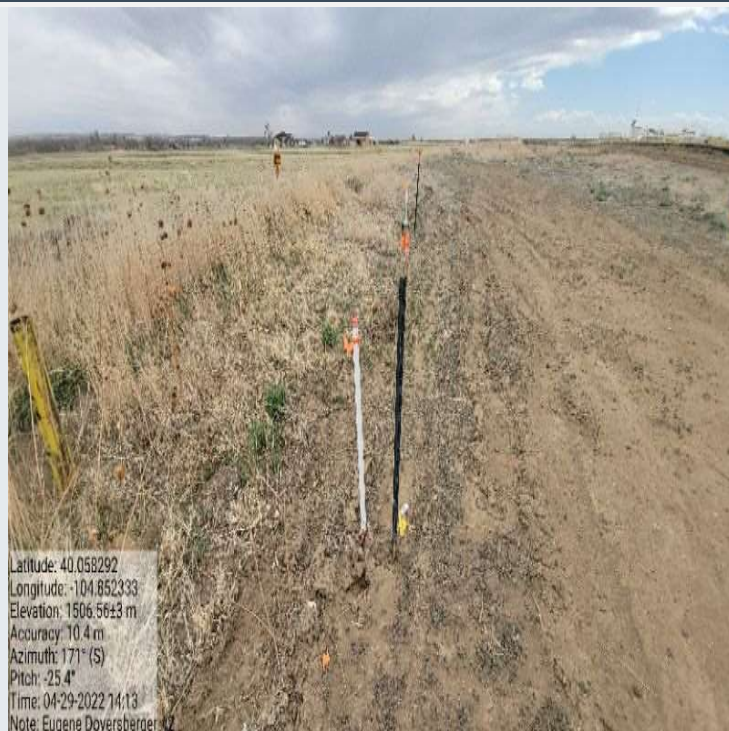
Question: Monitoring well(s) present? If so note number and approximate location

Response: Yes

Notes: 4

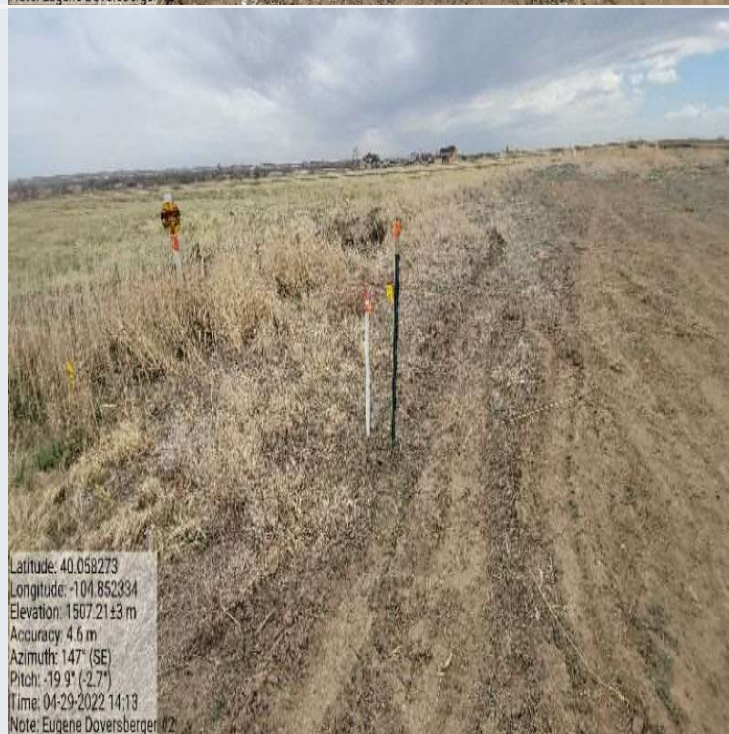
Question: Monitoring well(s) present? If so note number and approximate location

Response: Yes

Notes: 4

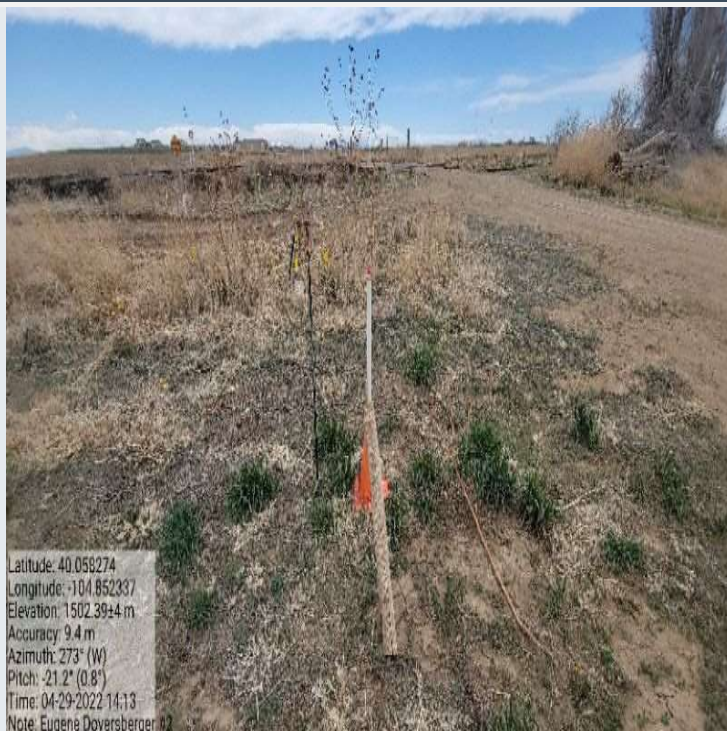
Question: Monitoring well(s) present? If so note number and approximate location

Response: Yes

Notes: 4

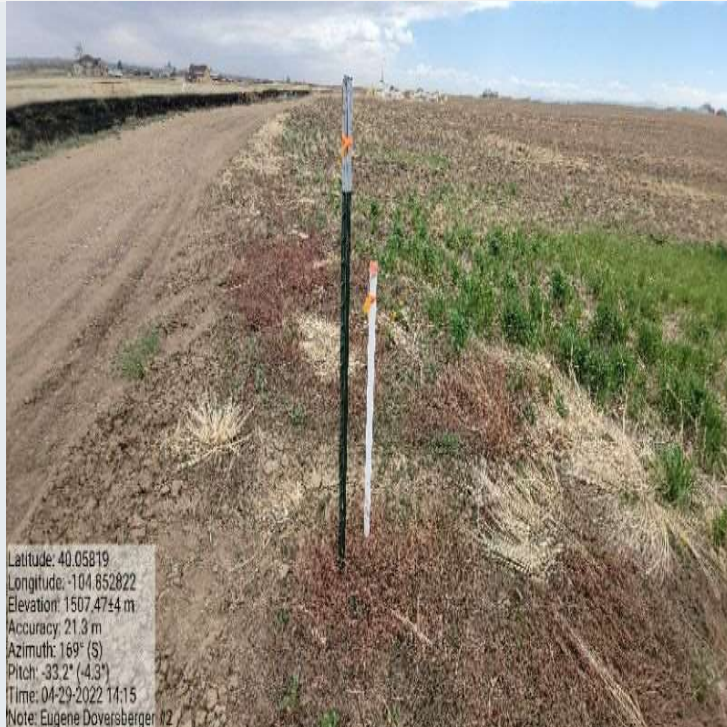
Question: Monitoring well(s) present? If so note number and approximate location

Response: Yes

Notes: 4

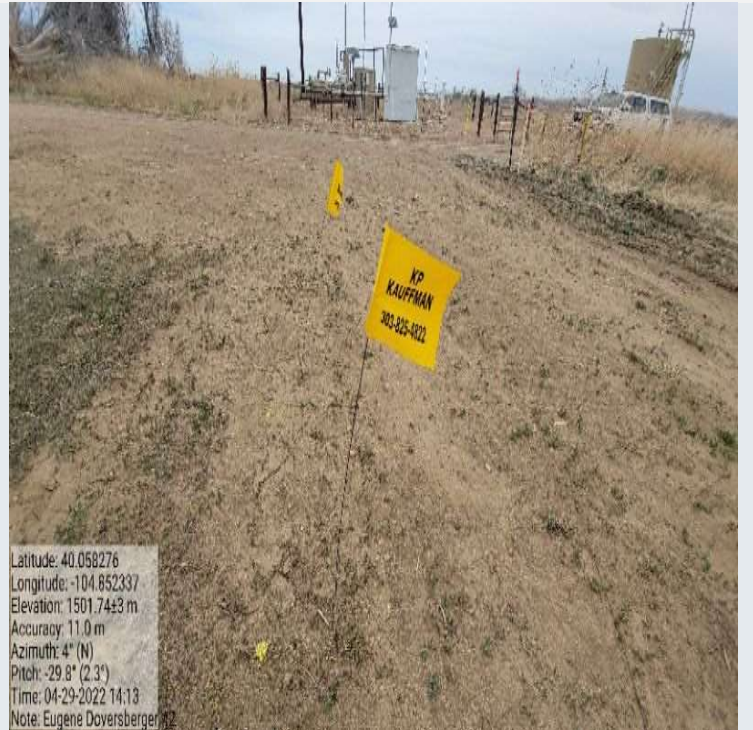
Site Condition Checklist	
Question: Waste signage present, legible is accurate and up to date (in accordance with rule 913.b.(5)B.iv)? Response: N/A Notes:	Photo No Photo
Question: Emergency sign in compliance with 605.g? Response: N/A Notes: Flags present to mark flowline location.
