# Site Inspection Report

**Site: FACILITY #8 CONSOLIDATION  
LINE**  
03/15/2022

## SITE INSPECTION REPORT

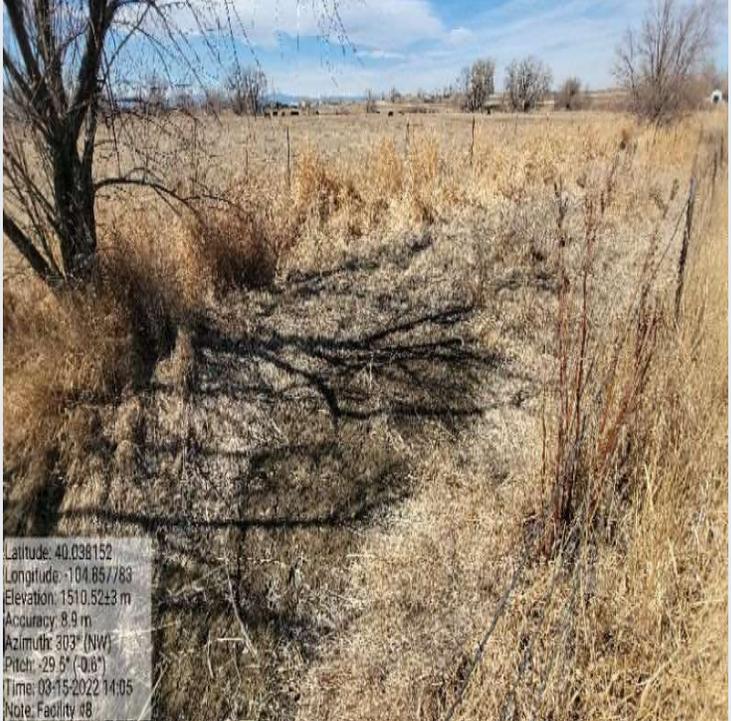
Site Condition Checklist	
	Photo
<p><b>Question:</b> Waste signage present, legible is accurate and up to date (in accordance with rule 913.b.(5)B.iv)?</p> <p><b>Response:</b> N/A</p> <p><b>Notes:</b></p>	No Photo
<p><b>Question:</b> Emergency sign in compliance with 605.g?</p> <p><b>Response:</b> N/A</p> <p><b>Notes:</b></p>	No Photo
<p><b>Question:</b> Ground surface appears clean (no evidence of new equipment leaks, oil leaks, spills, or releases)?</p> <p><b>Response:</b> Yes</p> <p><b>Notes:</b> No new evidence – Stunted vegetation from original spill.</p>

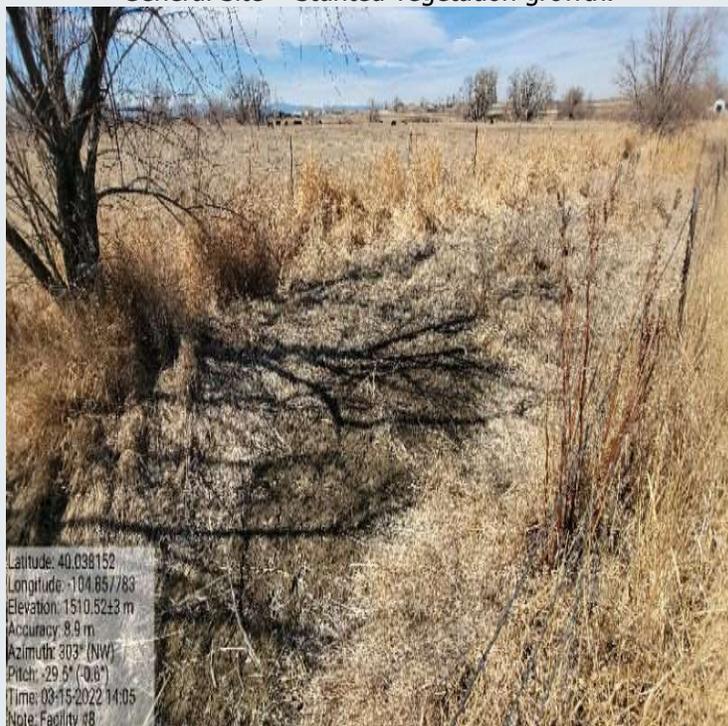
General Site – Stunted vegetation growth.
