# Site Inspection Report

**Site: CAMENISCH 1 SX FLOWLINE**  
**RELEASE**  
04/29/2022

## SITE INSPECTION REPORT

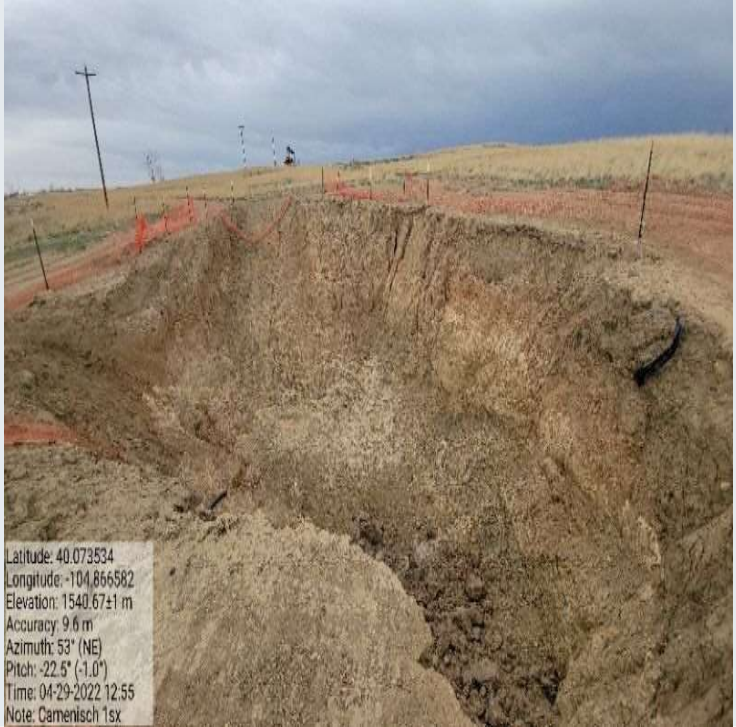
Photo
<p><b>Question:</b> Open excavation? Approximate size (Length x Width x Depth, ft)  <b>Response:</b> Yes  <b>Notes:</b> 107x59x15</p>

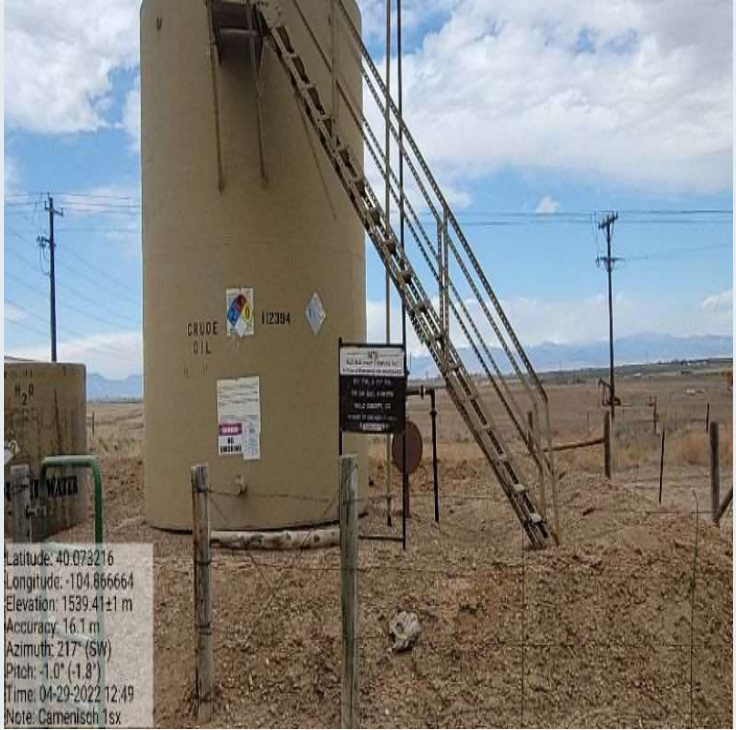
Photo
<b>Question:</b> Waste signage present, legible is accurate and up to date (in accordance with rule 913.b.(5)B.iv)? <b>Response:</b> N/A <b>Notes:</b>	No Photo
<b>Question:</b> Emergency sign in compliance with 605.g? <b>Response:</b> Yes <b>Notes:</b>

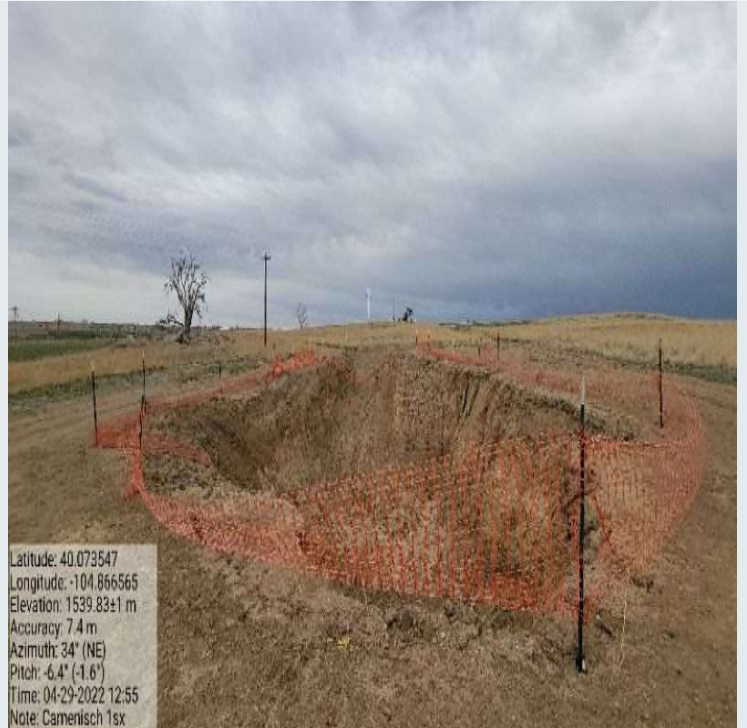
**Question:** Site properly fenced (in accordance with rule 913.b.(5)B.i)?

**Response:** No

**Notes:** Fencing around the perimeter of the open excavation has fallen and is inadequate to protect access/vehicular traffic.

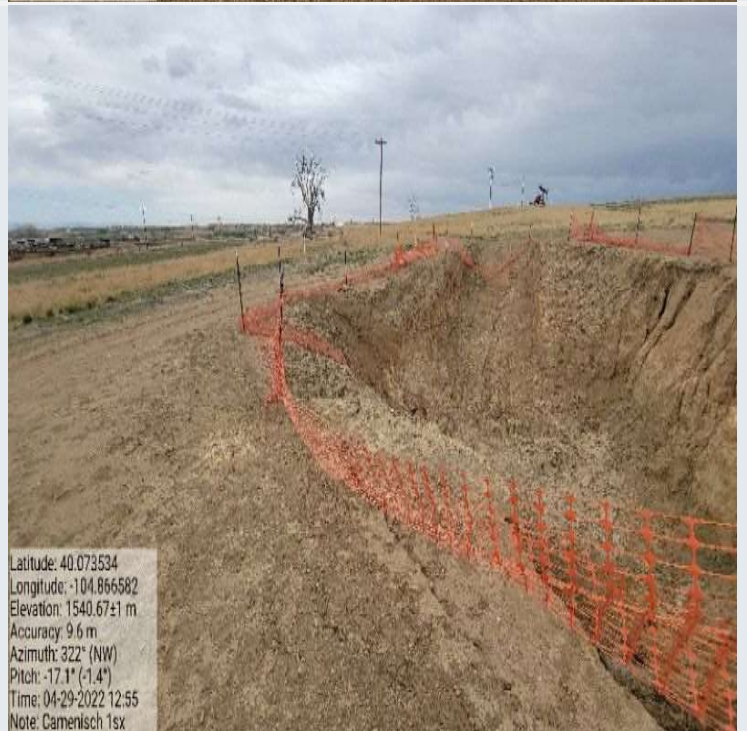
**Question:** Is fencing adequate/appropriate for site and well maintained?

**Response:** No

**Notes:** Fencing around the perimeter of the open excavation has fallen and is inadequate to protect access/vehicular traffic.

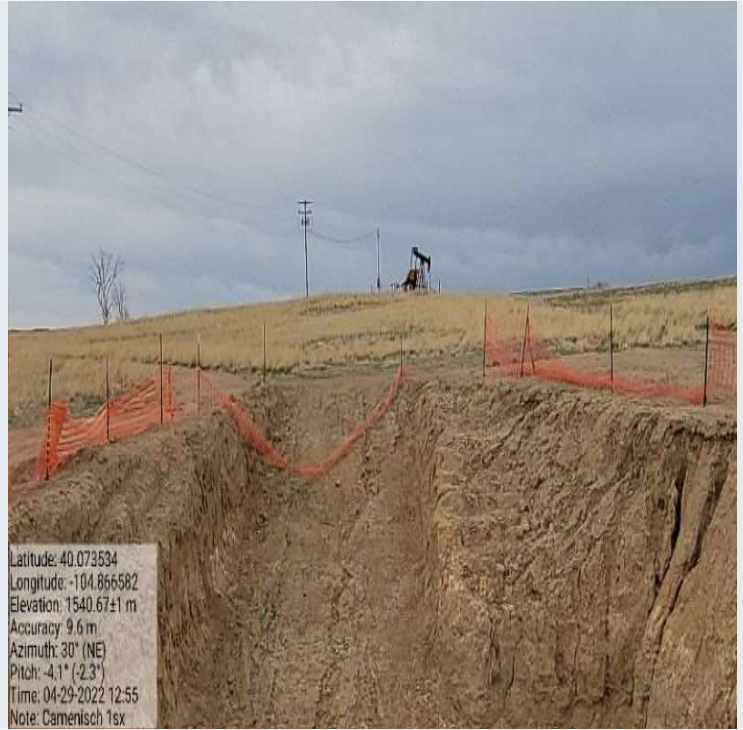
**Question:** Is fencing adequate/appropriate for site and well maintained?

**Response:** No

**Notes:** Fencing around the perimeter of the open excavation has fallen and is inadequate to protect access/vehicular traffic.

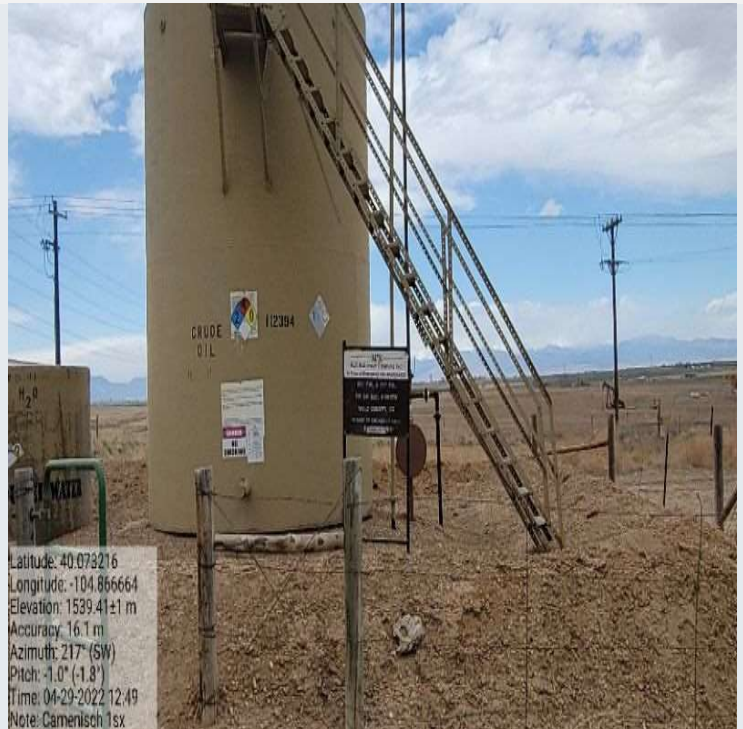
**Question:** Is fencing adequate/appropriate for site and well maintained?

**Response:** No

**Notes:** Gate providing access to crude oil ASTs was left ajar.

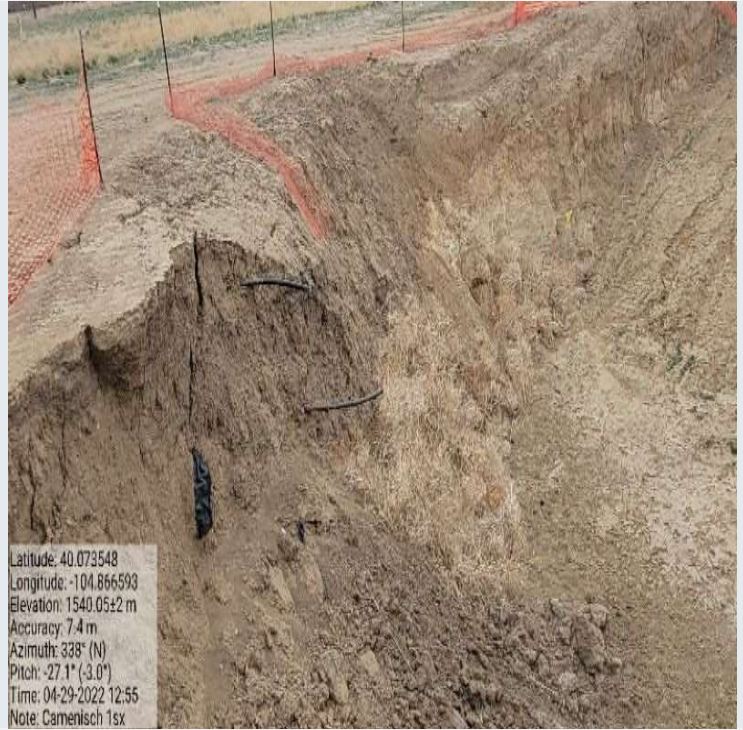
**Question:** Exposed buried/underground flowlines?  
**Response:** Yes  
**Notes:**

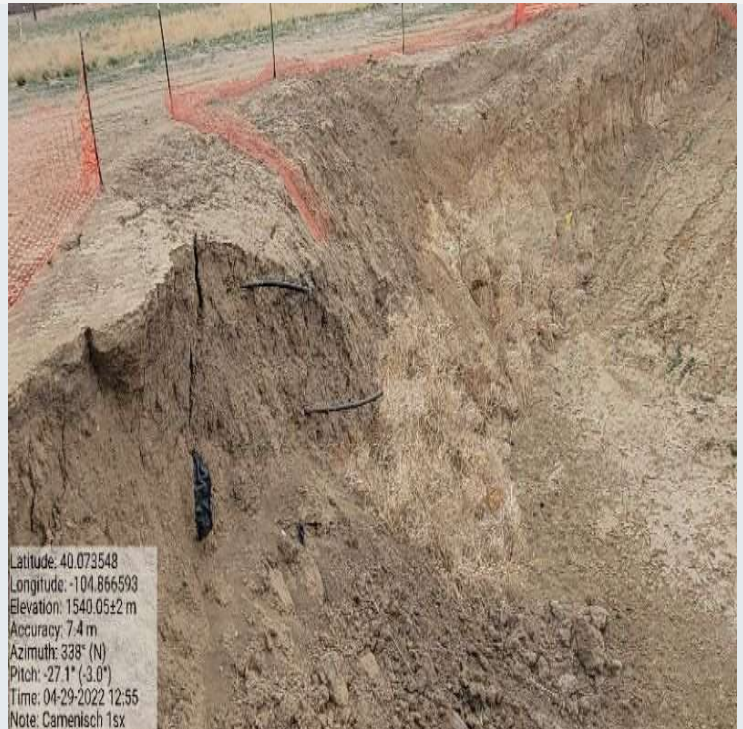
**Question:** If flowlines are exposed are they properly capped (bullnose plug, etc.)?  
**Response:** No  
**Notes:**

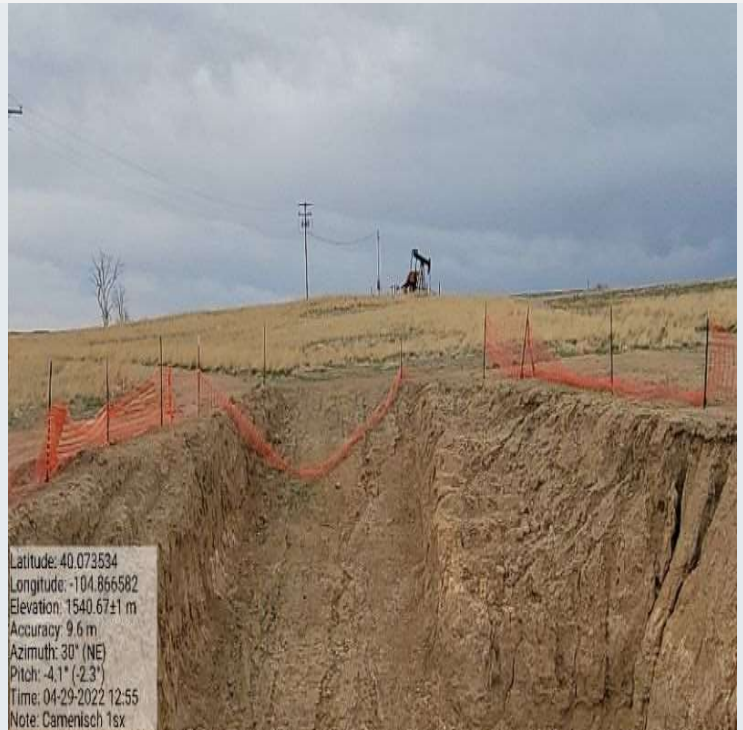
**Question:** Site is protected from vehicular traffic?  
**Response:** No  
**Notes:** Fencing around the perimeter of the open excavation has fallen and is inadequate to protect access/vehicular traffic.

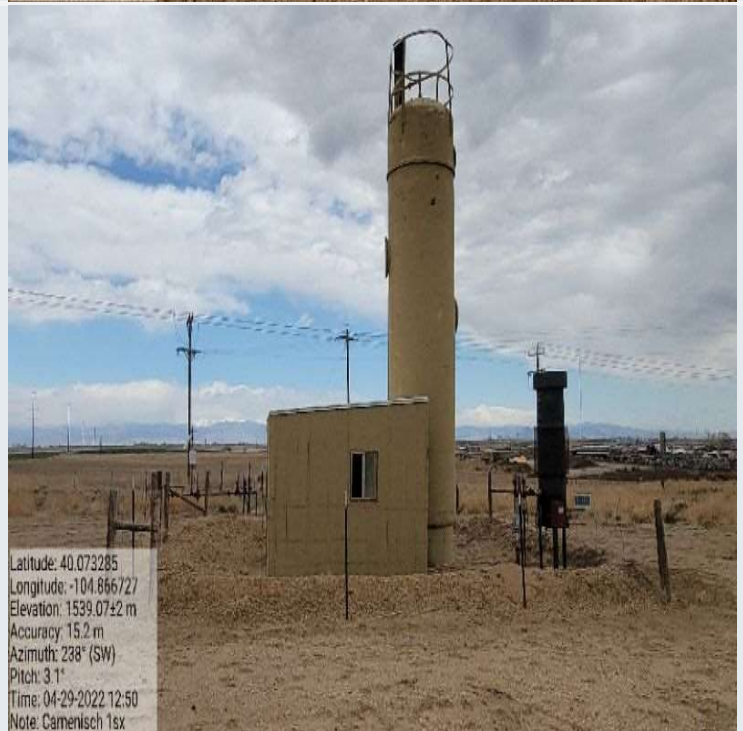
**Question:** Is an earthen berm secondary containment present and in good condition (no evidence of erosion, animal burrowing, etc.)?  
**Response:** Yes  
**Notes:** Tank battery earthen berms are adequate.
