# Site Inspection Report

**Site: JILISON 2A**  
05/03/2022

SITE/LOCATION	DATE	TIME	INSPECTOR
JILISON 2A	05/03/2022	03:43 PM	COGCC Subcontractor
Comments	Site has been excavated. Staining and odor remains within the excavation		
Work Activity Notes			
Changes since previous inspection?		Drive by inspection	No
Actively being worked?	No		
Fieldwork Oversight Performed?	No	Oversight Type	N/A
Were Oversight Samples Collected?	N/A	Sample Details	N/A

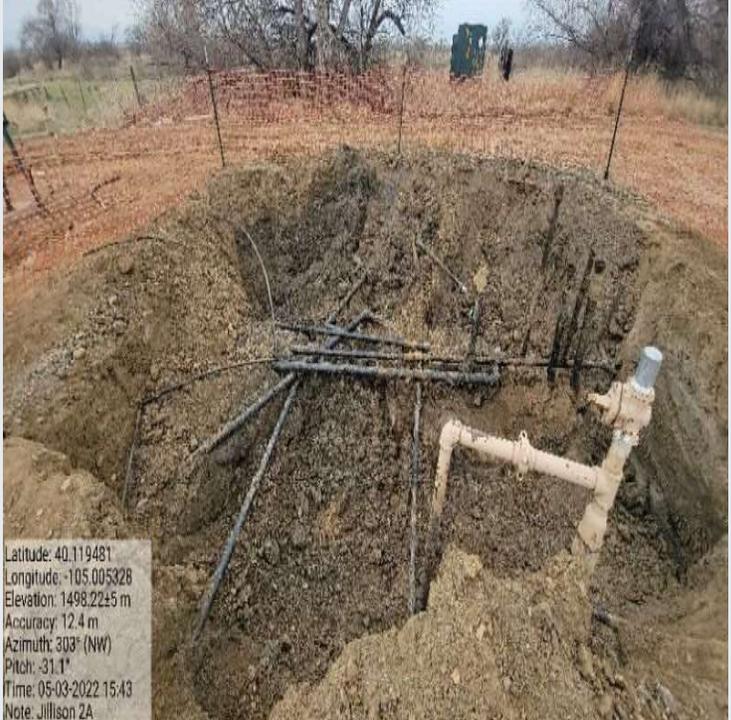
Remediation Activity Checklist	
	Photo
<p><b>Question:</b> Open excavation? Approximate size (Length x Width x Depth, ft)  <b>Response:</b> Yes  <b>Notes:</b> Excavation started.                      30x29x6</p>

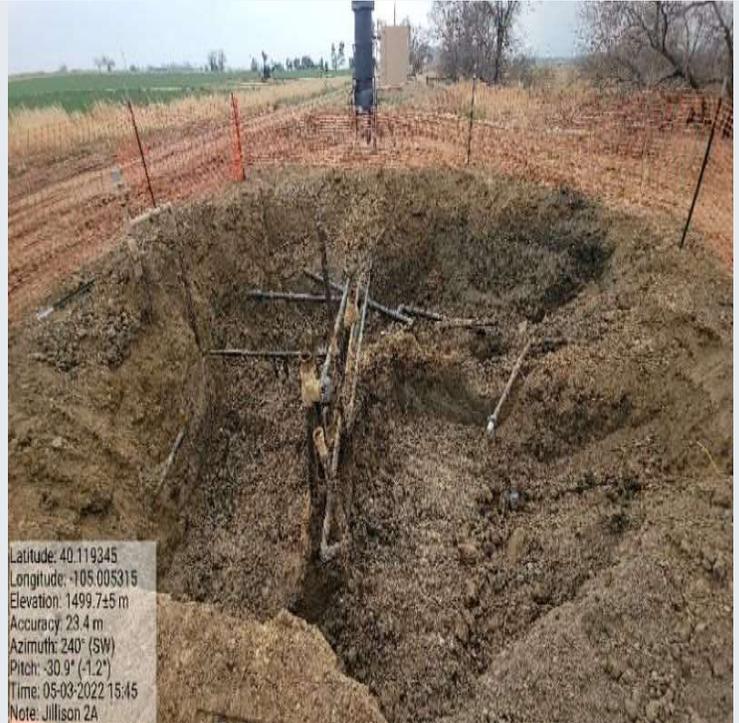
**Question:** Open excavation? Approximate size (Length x Width x Depth, ft)

**Response:** Yes

**Notes:** Excavation has been started.  
30x29x6

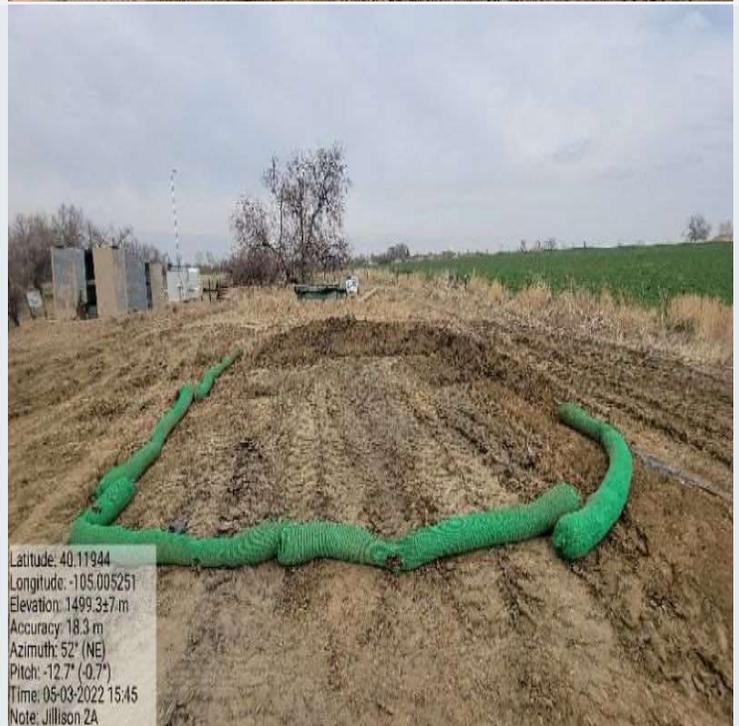
**Question:** Stockpiled waste and approximate volume (cubic yards)

**Response:** Yes

**Notes:** Most of the stockpile has been removed from the site.  
Remaining stockpile - 132 cubic feet

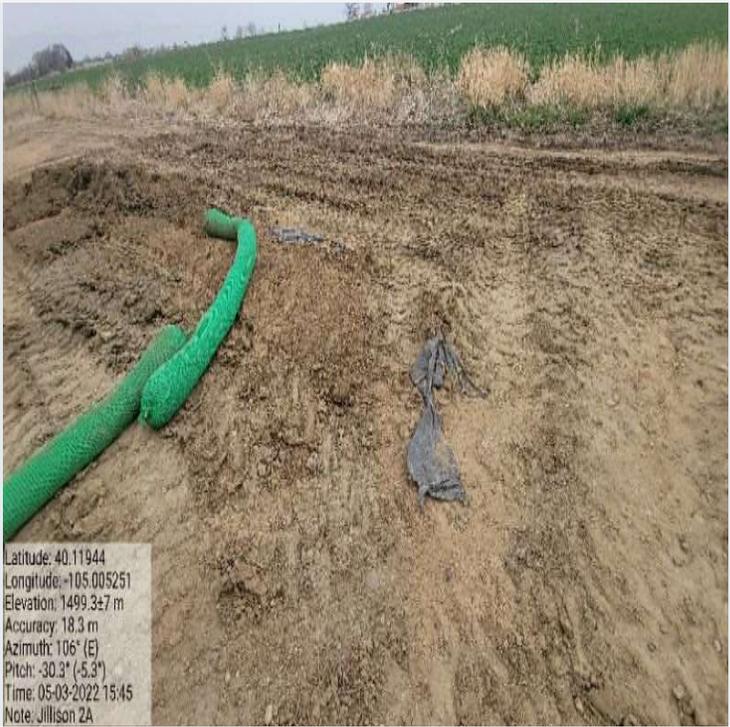
Photo
<p><b>Question:</b> Stockpiled waste and approximate volume (cubic yards)  <b>Response:</b> Yes  <b>Notes:</b> Most of the stockpile has been removed from the site. Remaining stockpile - 132 cubic feet</p>

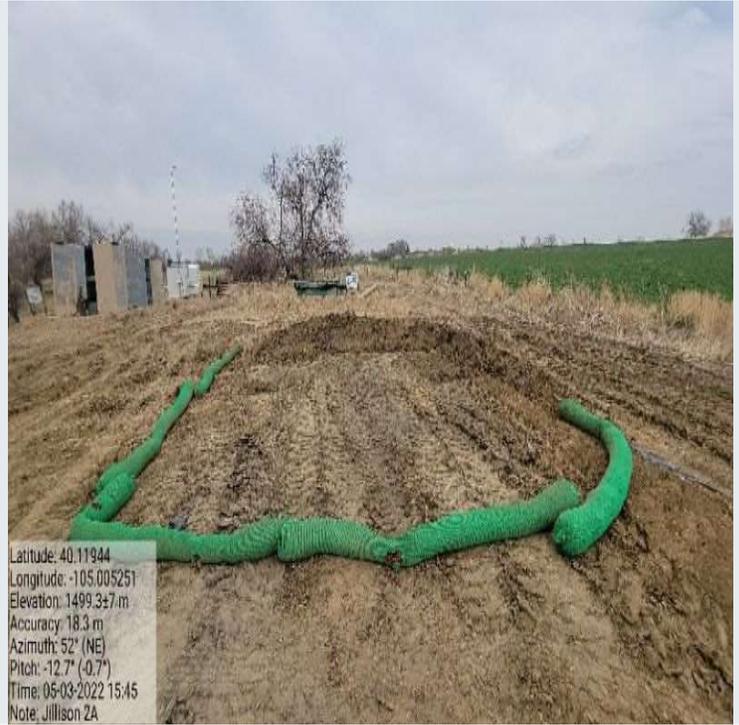
**Question:** Waste signage present, legible is accurate and up to date (in accordance with rule 913.b.(5)B.iv)?

**Response:** No

**Notes:** No waste signage.

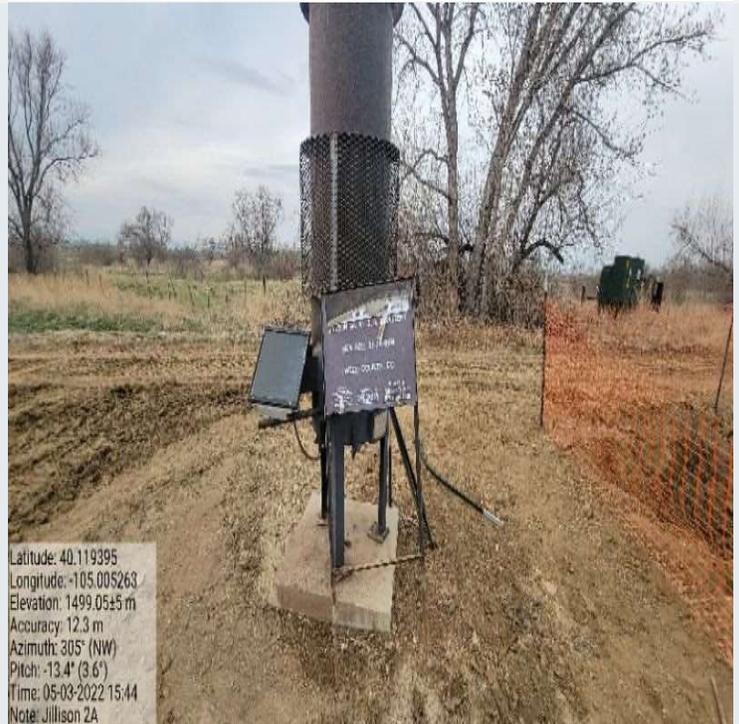
**Question:** Emergency sign in compliance with 605.g?

**Response:** Yes

**Notes:** Signage needs repaired/replaced.

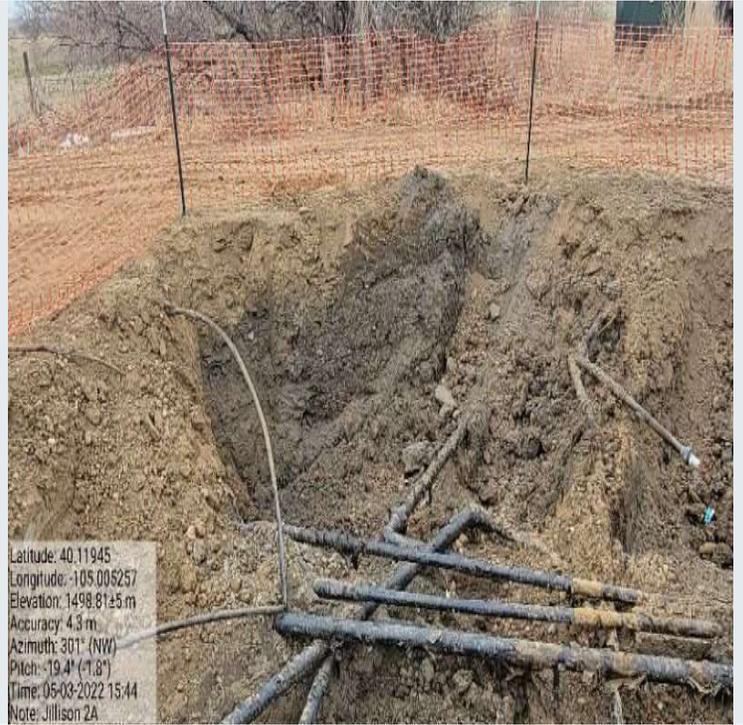
**Question:** Ground surface appears clean (no evidence of new equipment leaks, oil leaks, spills, or releases)?

**Response:** No

**Notes:** Staining and odor within the excavation.

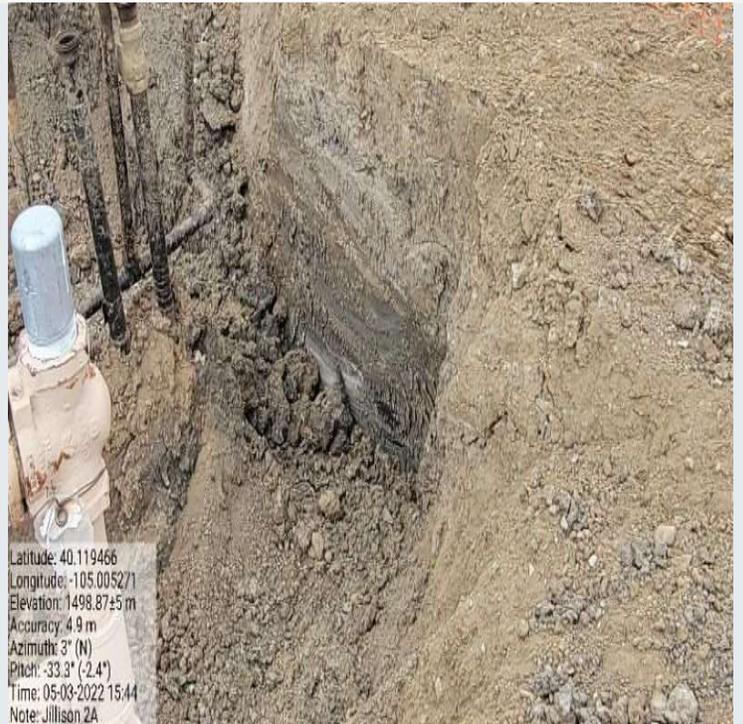
**Question:** Ground surface appears clean (no evidence of new equipment leaks, oil leaks, spills, or releases)?

**Response:** No

**Notes:** Staining and odor within the excavation.

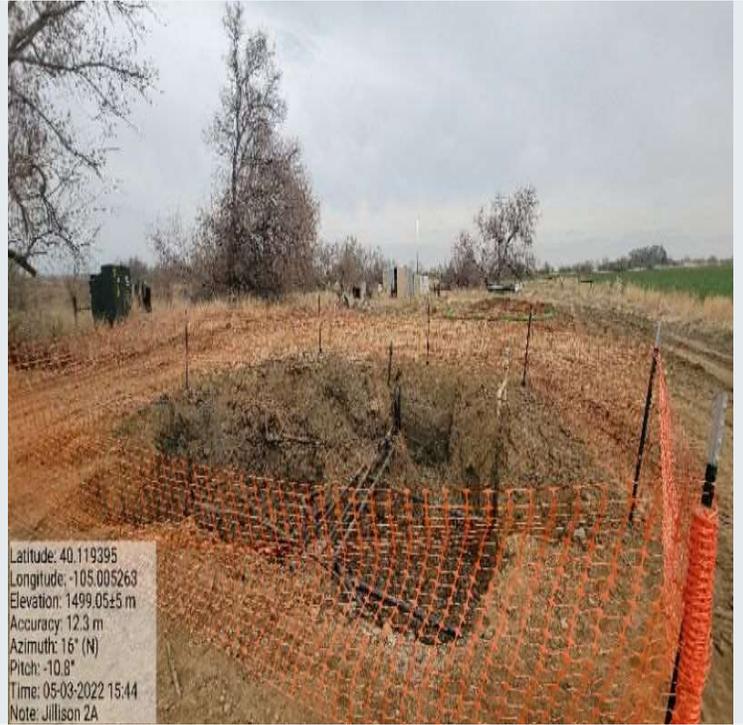
**Question:** Site properly fenced (in accordance with rule 913.b.(5)B.i)?

**Response:** Yes

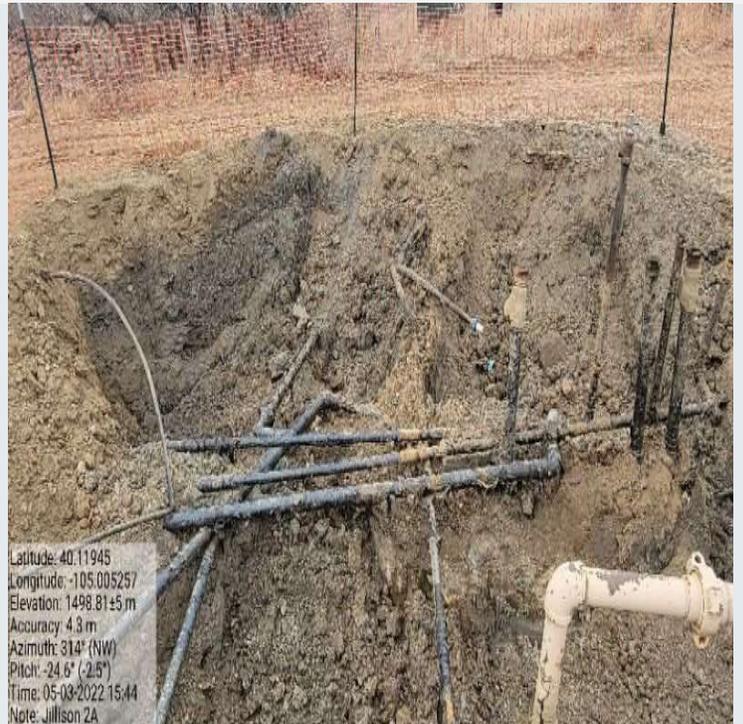
**Question:** Exposed buried/underground flowlines?

**Response:** Yes
